7.0 CONSERVATION MANAGEMENT POLICY

7.3 **Subject Site**

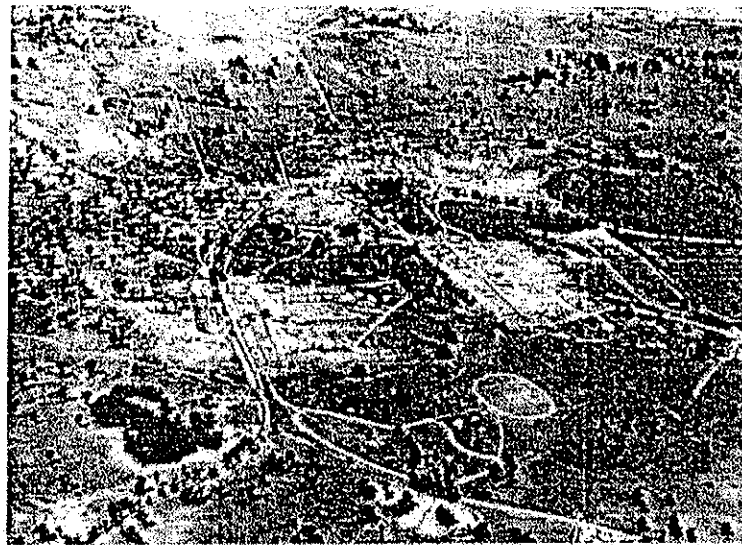
Most of the accommodation tents, with their associated recreation and mess huts, toilets and showers, are located in the centre and centre-right of the photo, running from the Northern Road across

Narellan Army Camp, Northern Road, Cobham during World War II "Giggs' Corner".
