### 3.2 Archaeology

## **3.5 Subject landscape**

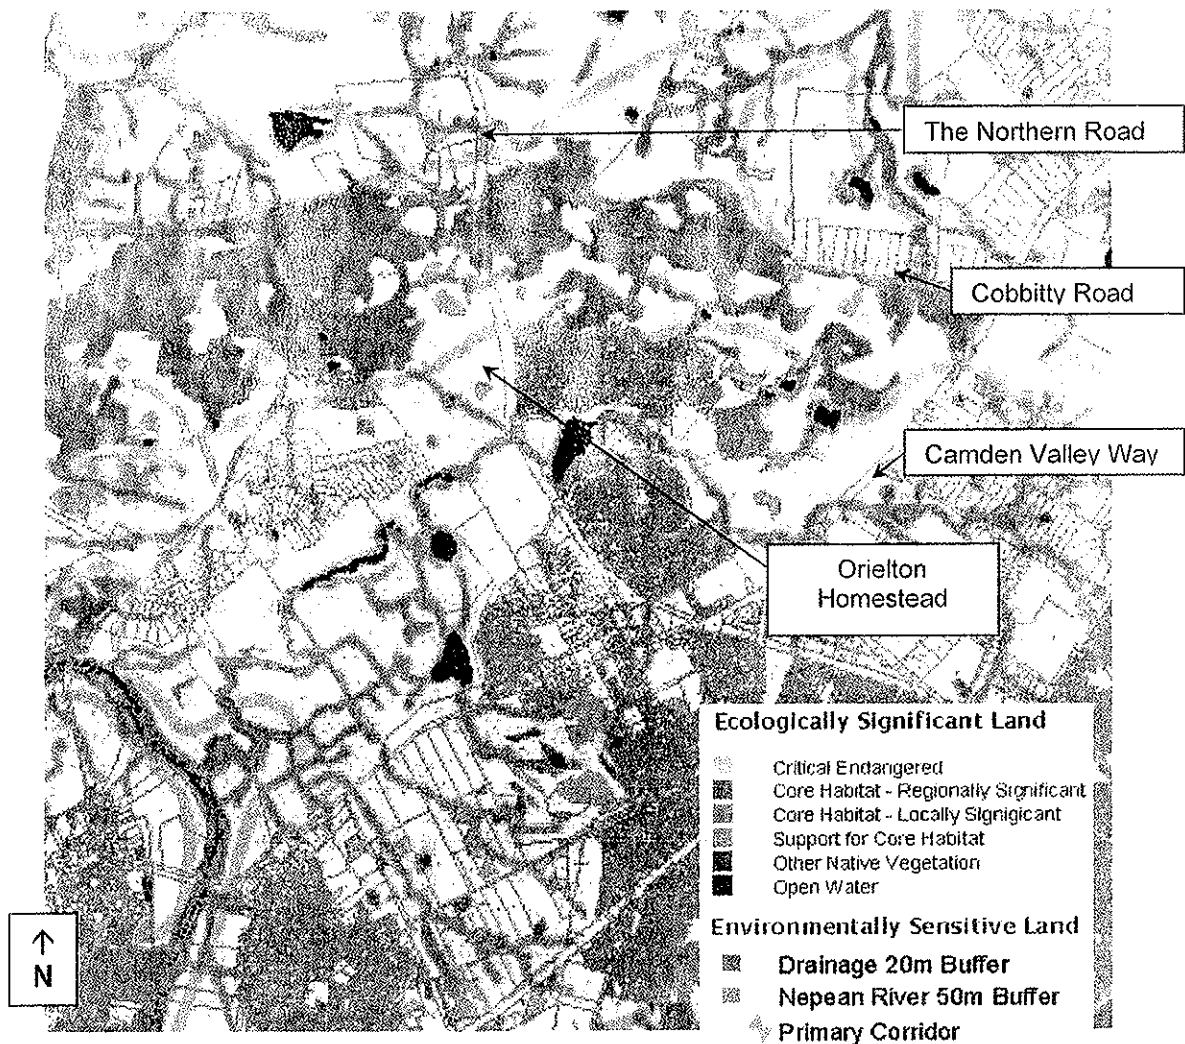
Figure No.11: This figure shows the ecological corridor to the northern section of the Orielton property. (Source: This figure is a section of the *Ecologically Significant and Environmentally Sensitive Land* figure in Camden Council's Natural Assets Policy, Camden Council website).

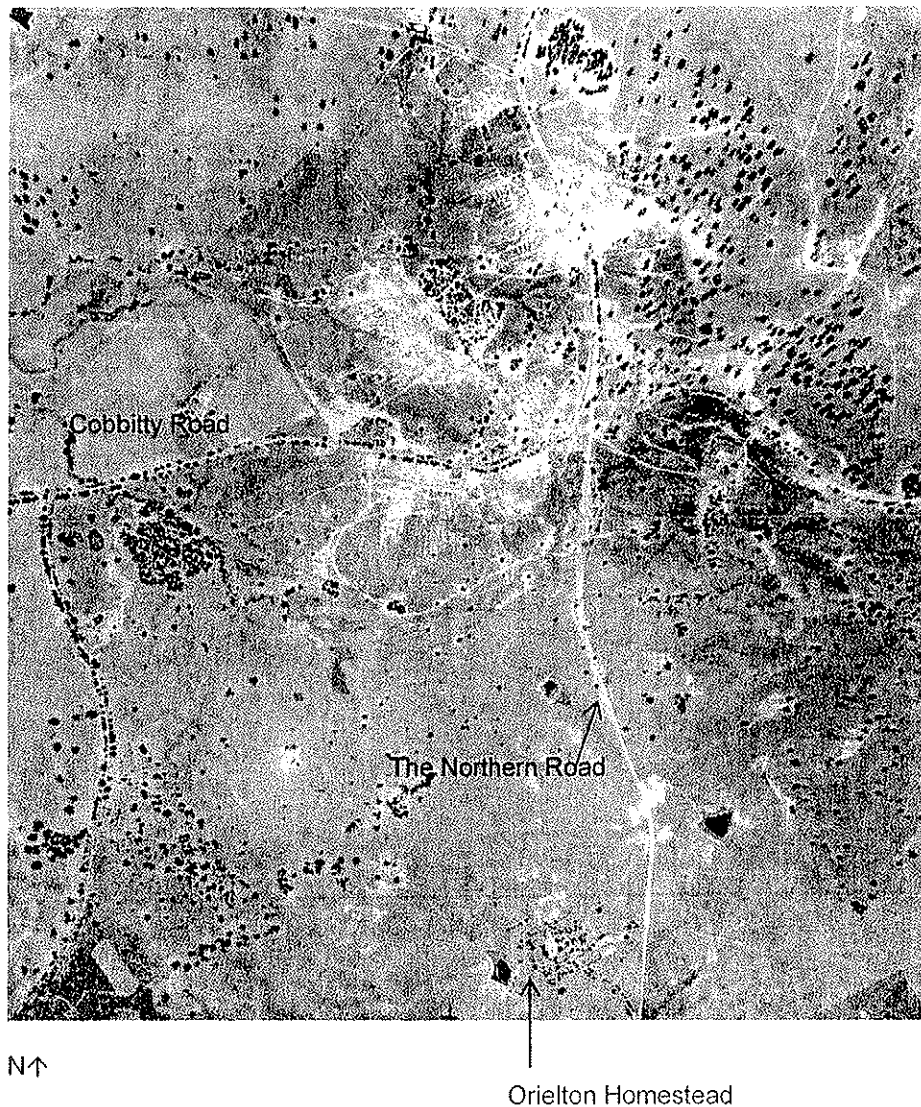
Figure No.13: 1947 aerial photograph (military occupation) at junction of The Northern Road and Cobbitty Road. (Source: LPI).

The 1947 aerial photograph (Figure No.13, pg.35) shows evidence of military occupation closely linked to the aerodrome in Camden. Roads are structured within the boundaries of Orielson directly off Cobbitty Road. The military occupation does not present adverse effects on the landscape apart from woodland clearing. Evidence of occupation has been limited to the north-east corner of the site, suggesting little impact on the homestead and surrounding pastures. While the revegetated wood land may have reduced the likely level of remains relating to the military use, there is potential for further archaeological investigation. The intersection of Cobbitty Road and The Northern Road has changed to its present form. Archaeological evidence may filter into adjoining properties.

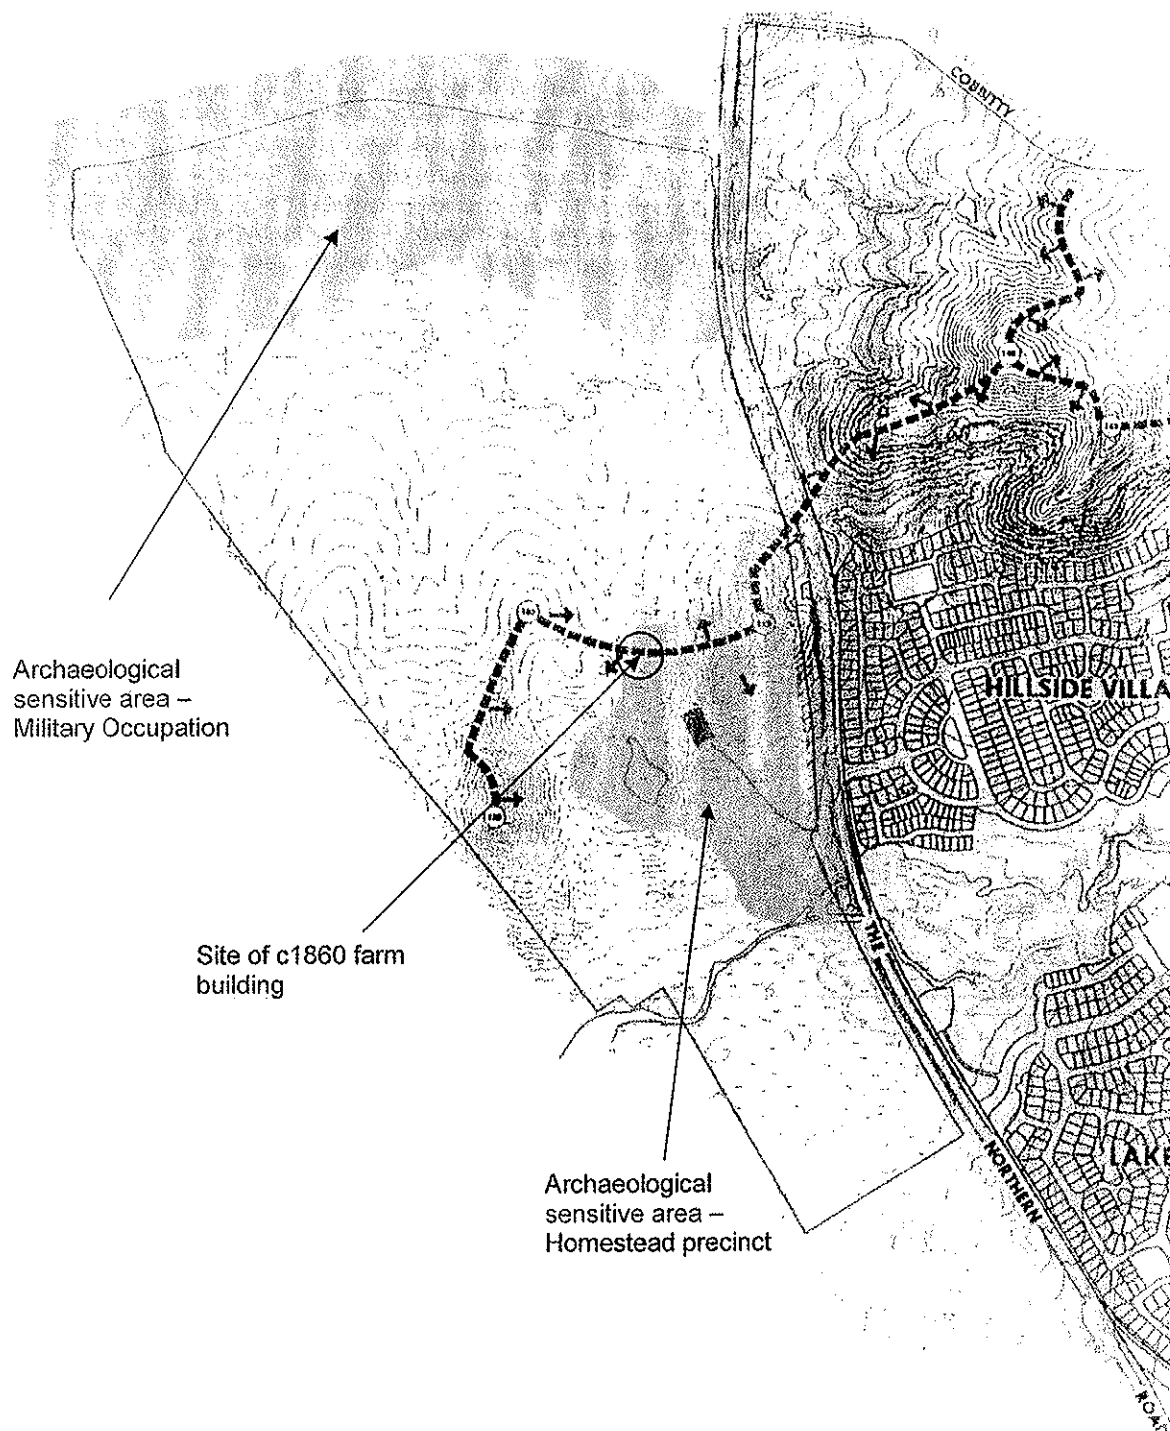
Figure No.14: Archaeological Potential.

The two main precincts considered to be archaeologically sensitive are the Military and Homestead precincts identified in Figure No.14, pg.36. Physical evidence indicates some archaeological remnants however more relics may lie beneath the sub-surface or beyond the identified areas.

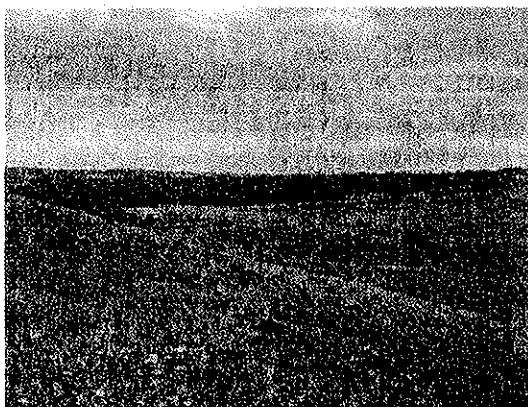
Figure No.19:  
View of pastures  
looking north.

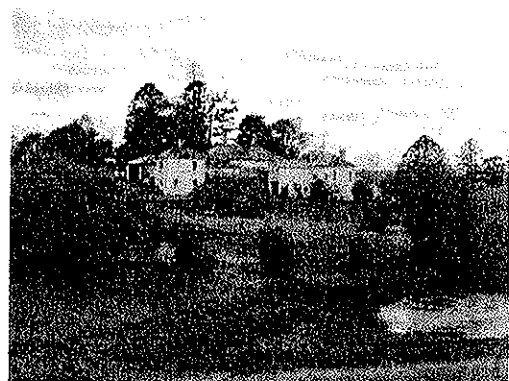
Figure No.23: View of homestead and picking garden looking east from west paddocks.

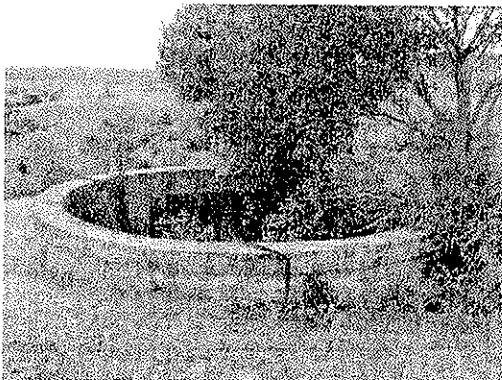
Figure No.24: Well on the northern ridge looking west.

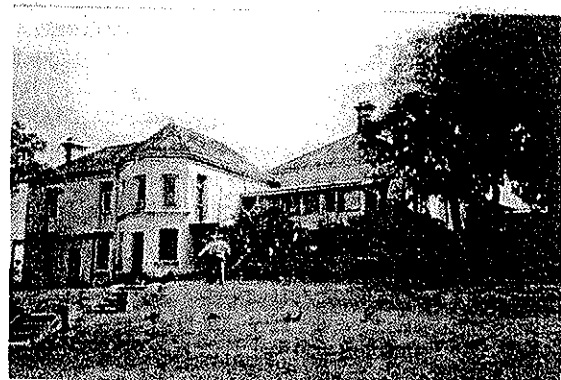
Figure No.25: Victorian addition and mid-Victorian design connected with fibro corridor.

The Italianate addition is focused to the south of the property and is characterised by a three faceted bay window. The asymmetrical façade is two storeys and has a low pyramidal roof and larger chimney tops. A 1940s fibro addition to the south connects the original building to the east with the Italianate addition to the south.

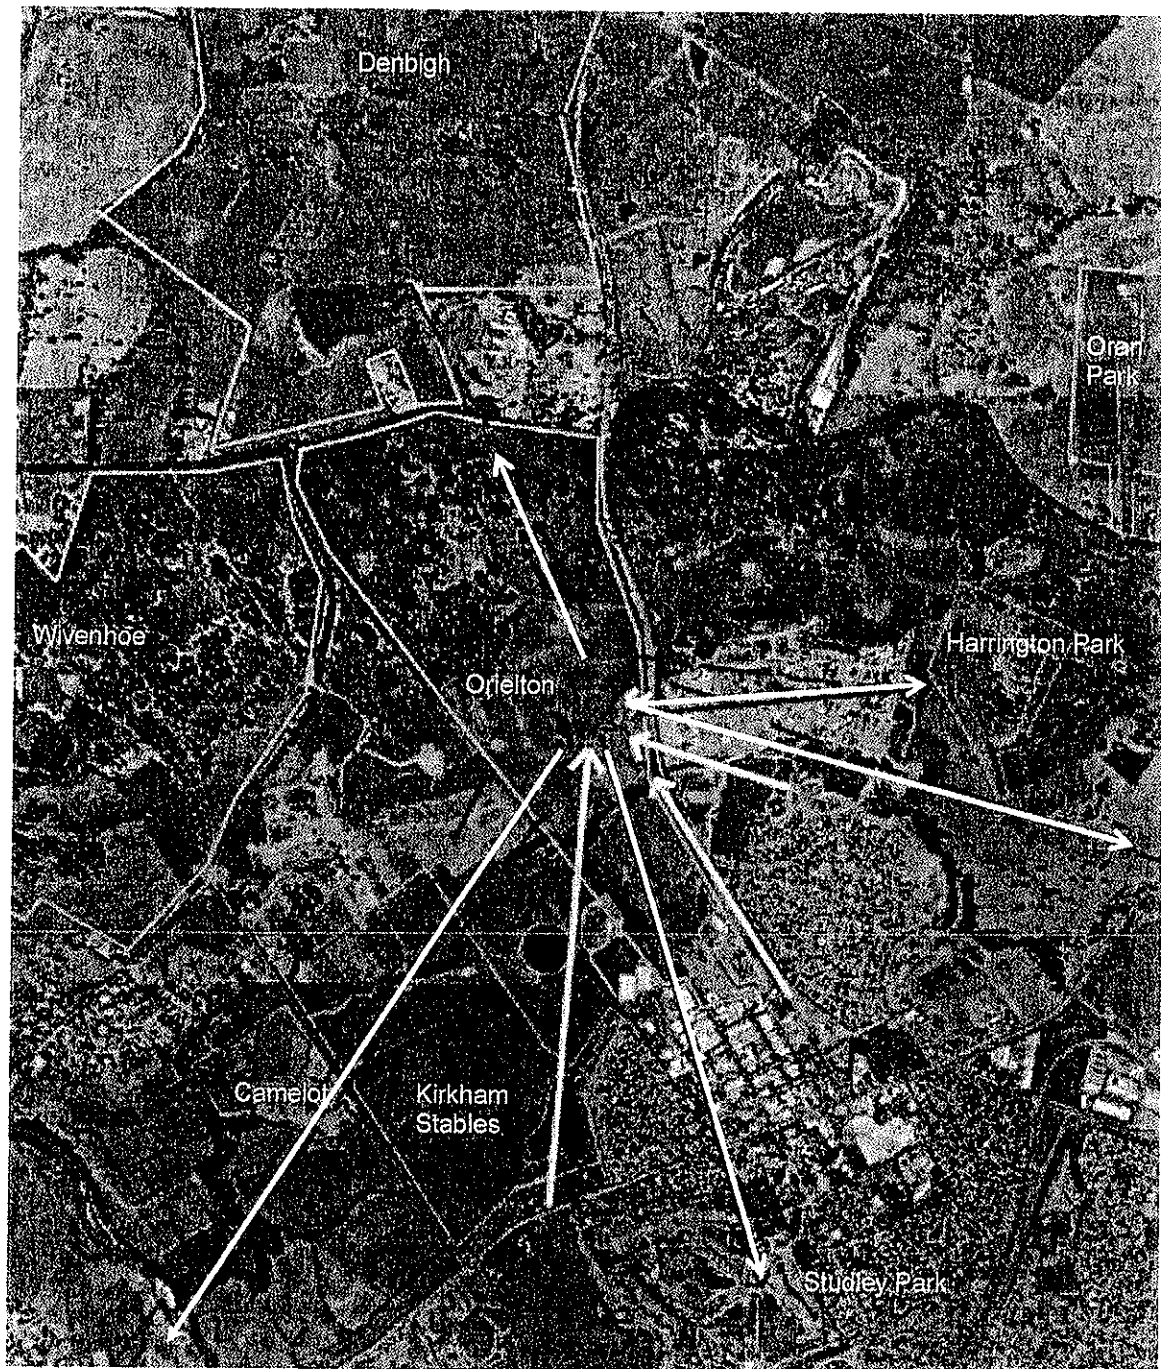
Figure No.26: Broad views and vistas to and from Orielson Homestead.

Refer Figure No.26 & 27, pp.41 & 42.

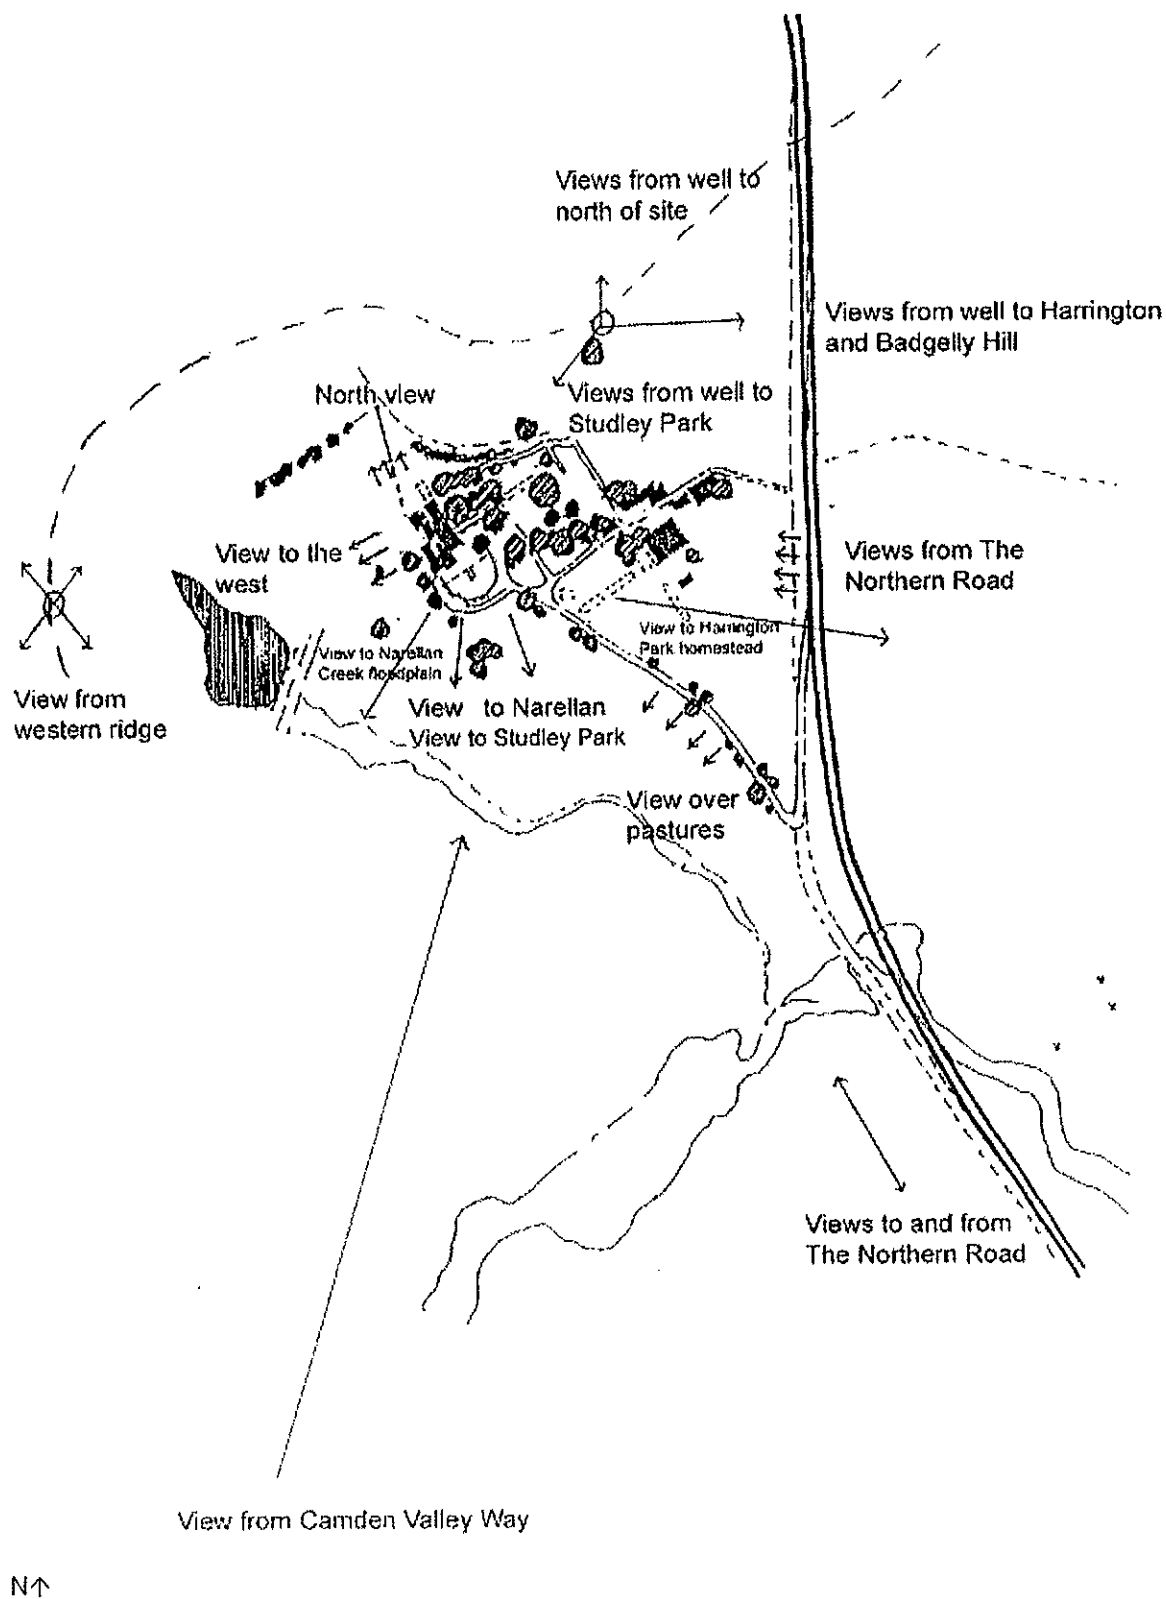
Figure No. 27: Views and vistas to and from Orielson Homestead

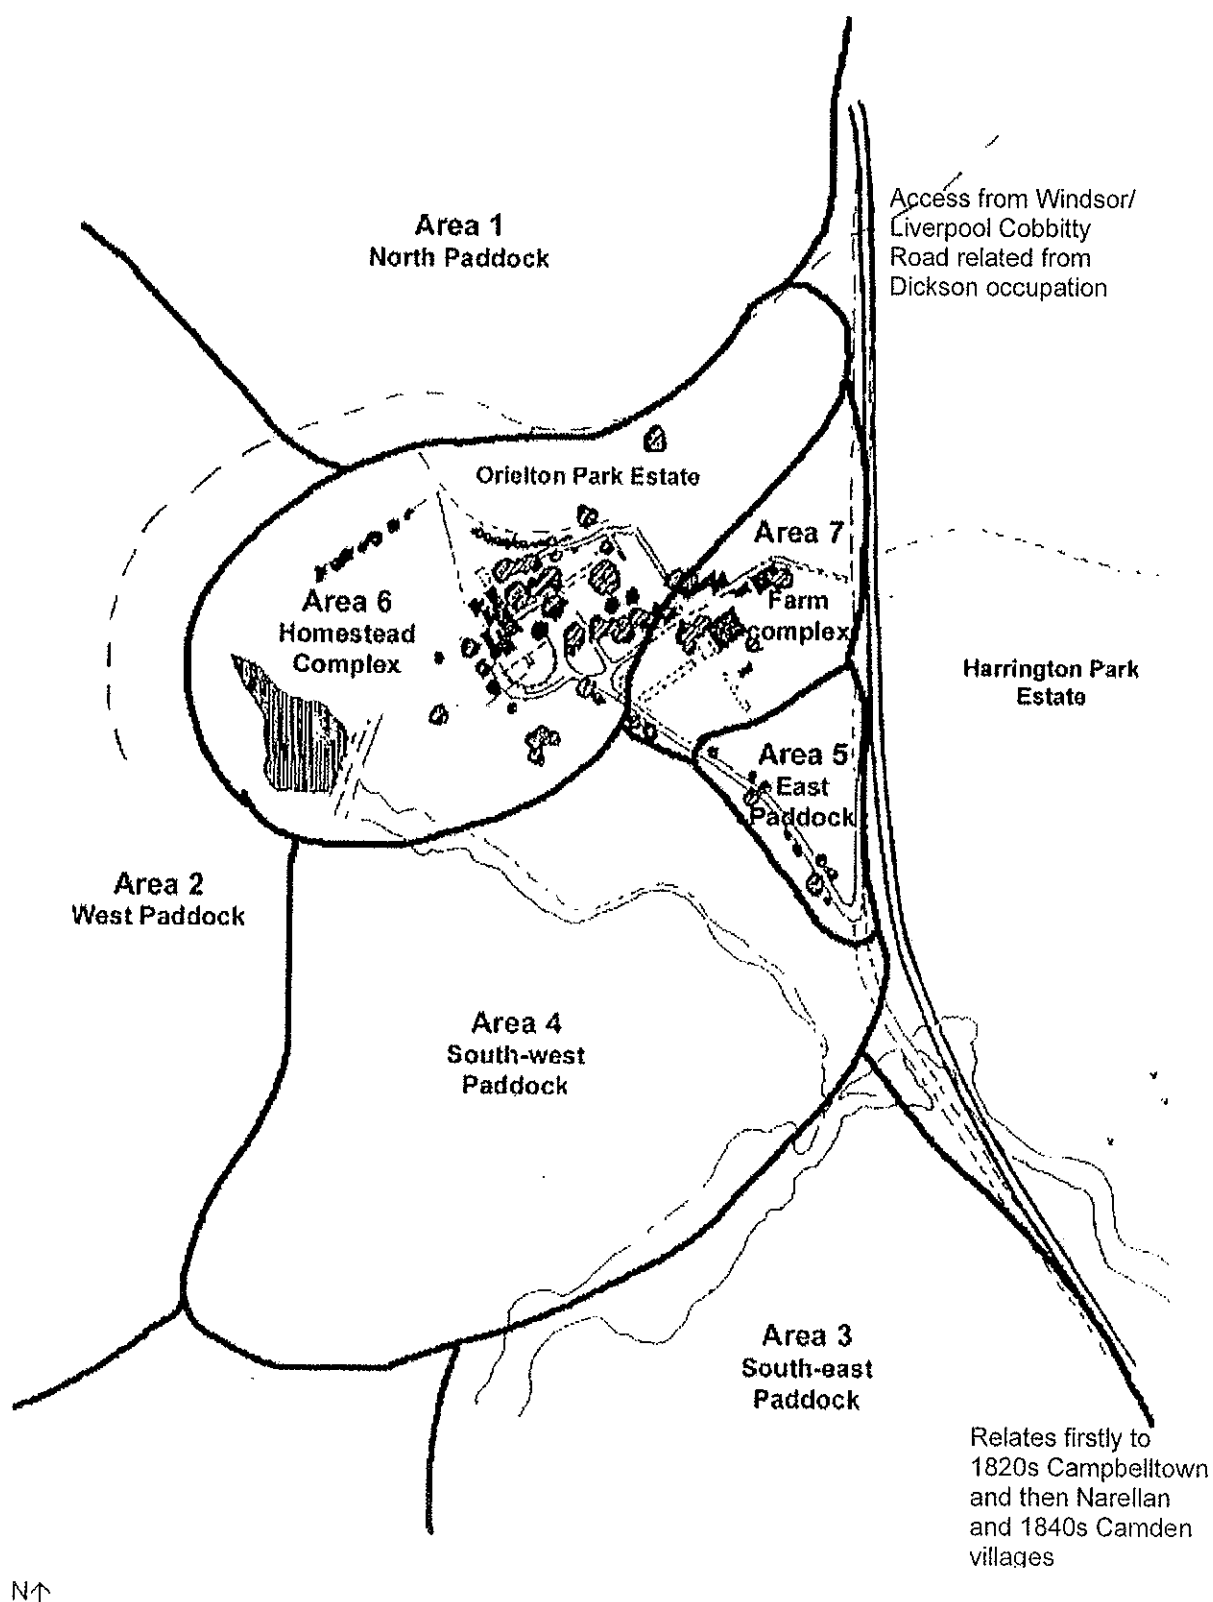
Figure No. 28: Subject Site – Landscape areas.

Refer to Figure No.28, pg.43.

Refer Figure No.28, pg.43.

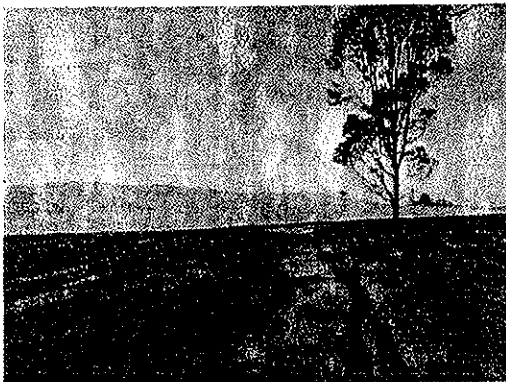
Figure No.29: View of the north ridge looking south from the north paddock. Distant glimpses of the homestead trees begin to appear.

The majority of the area is grassed for the grazing of cattle with a north east pocket of revegetated wood land. The area has evidence of remnants from previous buildings that existed on the land. Towards the Cobbitty road boundary the site has potential for archaeological finds. During World War II this part of the site was once occupied by the air force, but the revegetated wood land and clearing of the site has limited the potential for discovery. The site was also used for dump deposits by previous occupants of the property and there are scattered pits throughout this area. This part of the estate has numerous riding trails associated with the equestrian centre at the farm complex.

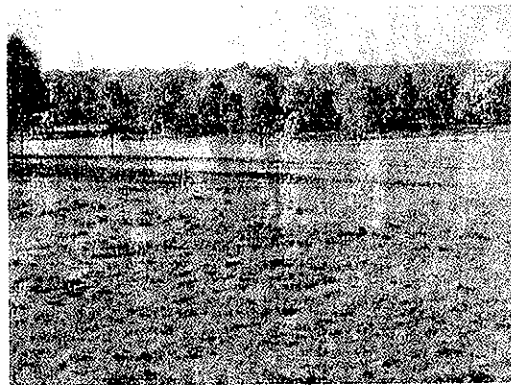
Figure No.30: View of the north paddock into the revegetated woodland. In the foreground remnant bricks of a former building appear.

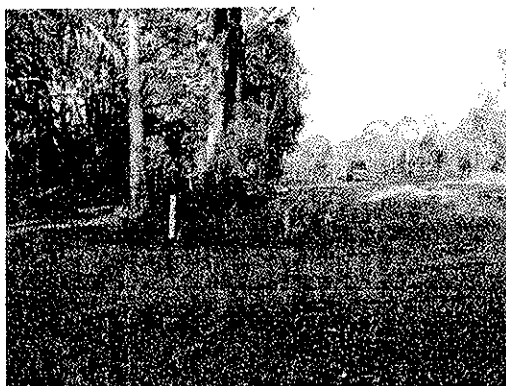
Figure No.31: Southern view of Cobbitty Road. To the left is the original alignment of Cobbitty Road with the current boundary of Oriellon to the right.

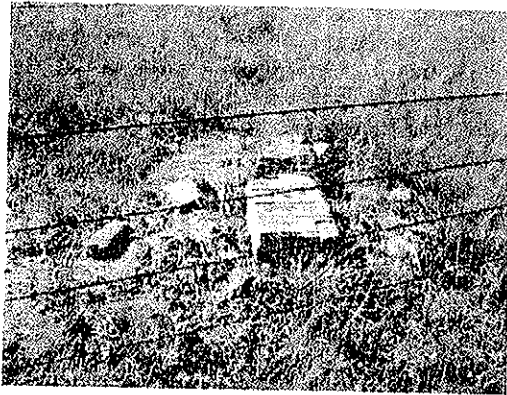
Figure No.33: Remnant footings from the military occupation closely located at the Cobbitty Road boundary of Orielson.
