**STAGE 1 ENVIRONMENTAL SITE ASSESSMENT**

**PROPOSED MIXED-USE DEVELOPMENT**

**42-44 DUNMORE STREET, WENTWORTHVILLE**

**REF: E28229Krpt**

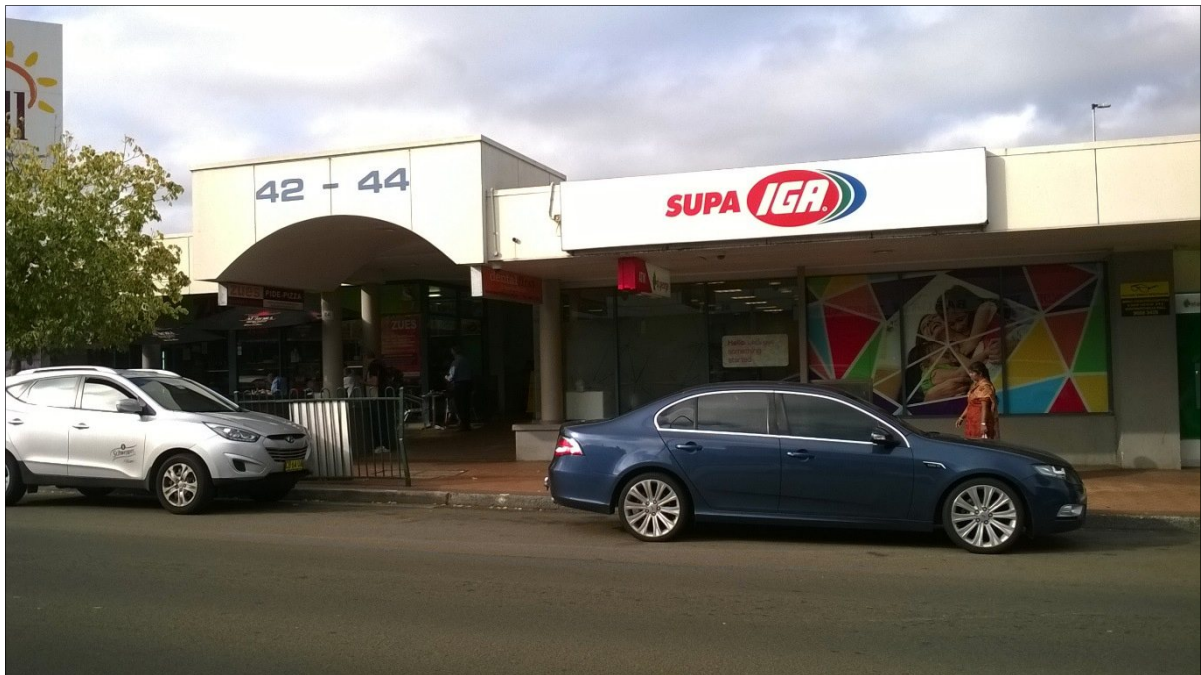
**Plate 1:** the entrance to the shopping mall viewed from across Dunmore Street.

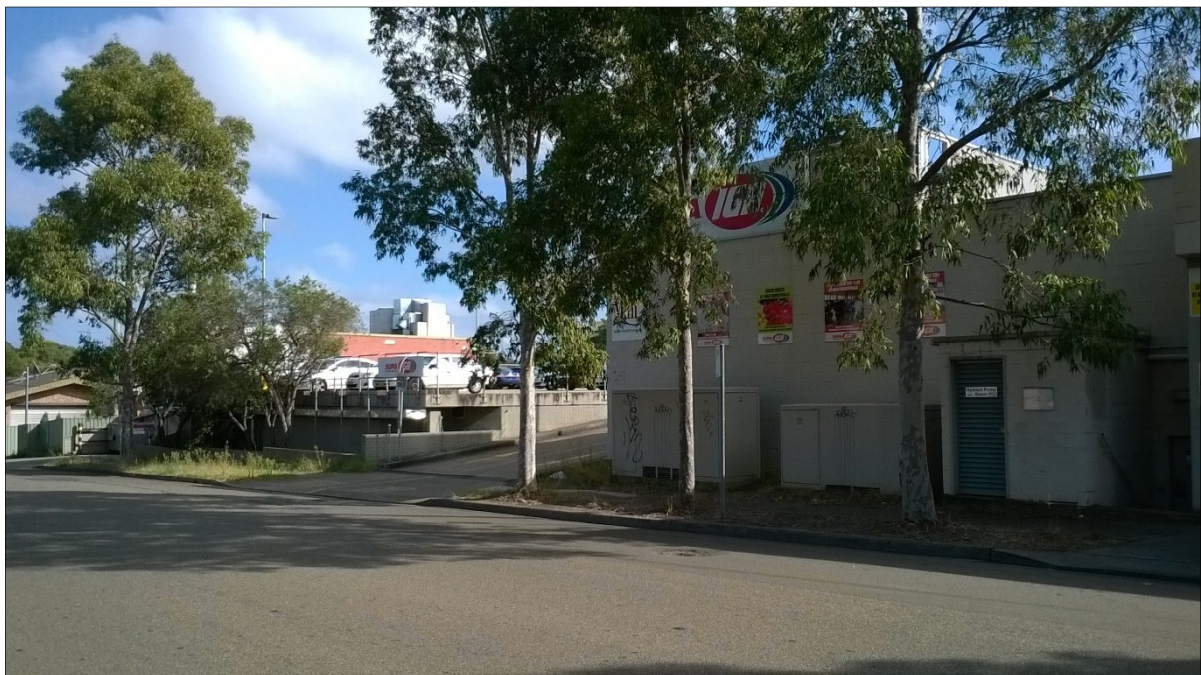
**Plate 2:** the shopping mall viewed from across Pritchard Street showing the electrical substations.

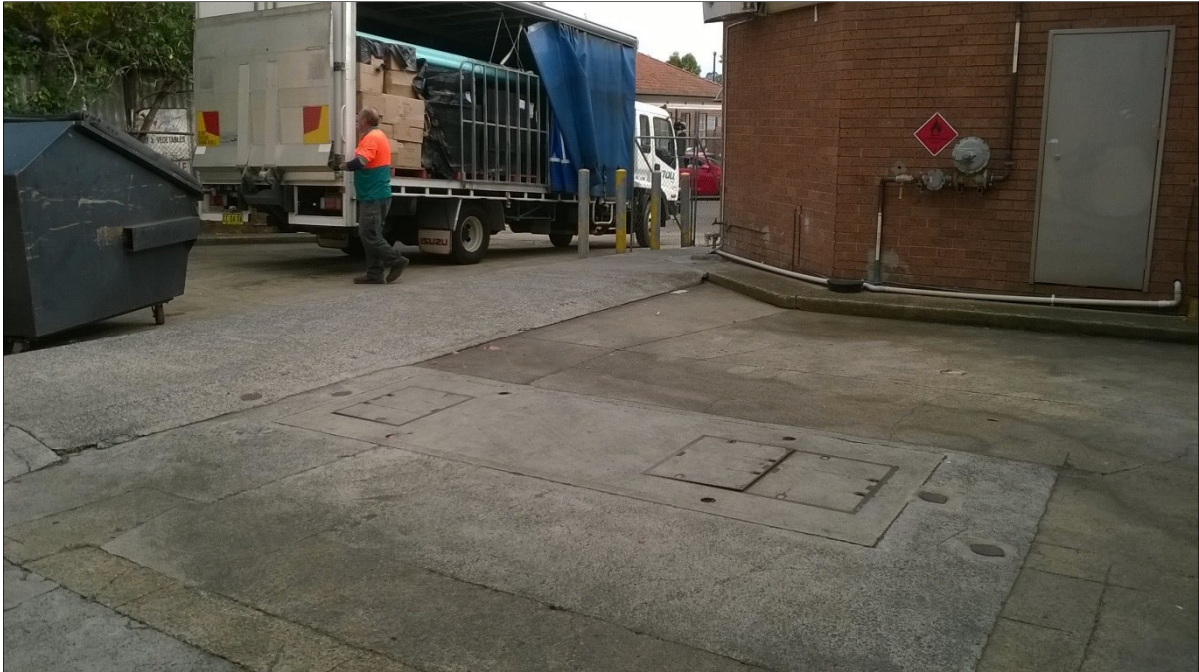
**Plate 3:** the loading dock in the north-western section of the site.

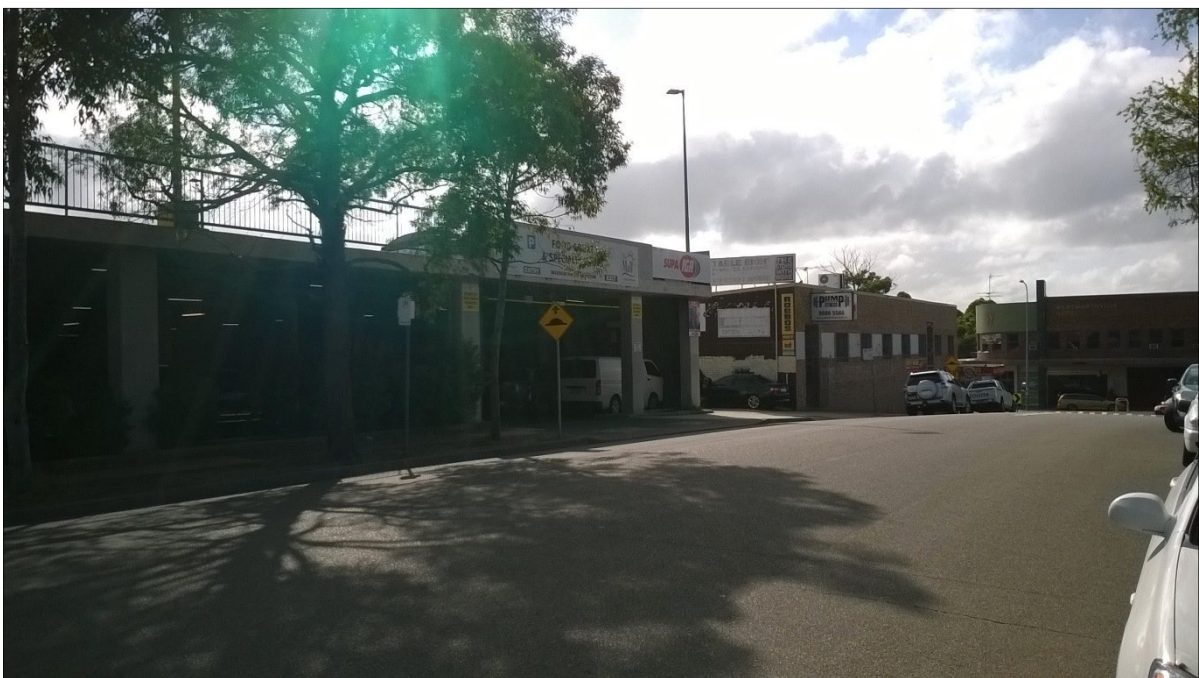
**Plate 4:** the south-eastern section of the site viewed from across Pritchard Street, showing the undercroft and roof-top parking areas.
