**7-9, 11-13 & 15 RANDLE STREET,
SURRY HILL, NSW**

CONSERVATION MANAGEMENT STRATEGY

April 2016

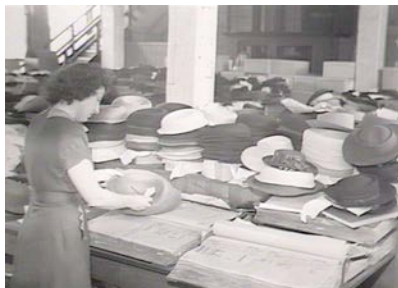
Figure 3.2 Quality control and checking. Both the staircase and hardwood columns are visible. March 1949

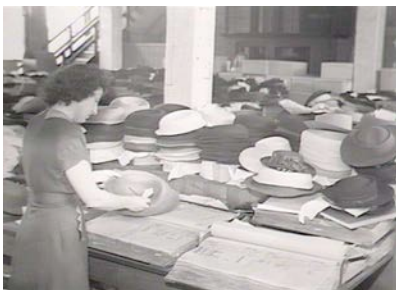
Figure 5.3.8 Quality control and checking. Both the staircase and hardwood columns are visible. March 1949
