## **DETAILED SITE INVESTIGATION (DSI)**

**183 & 218 New Canterbury Road, Lewisham NSW**

**Illuminate Living Pty Ltd**

**March 2016**

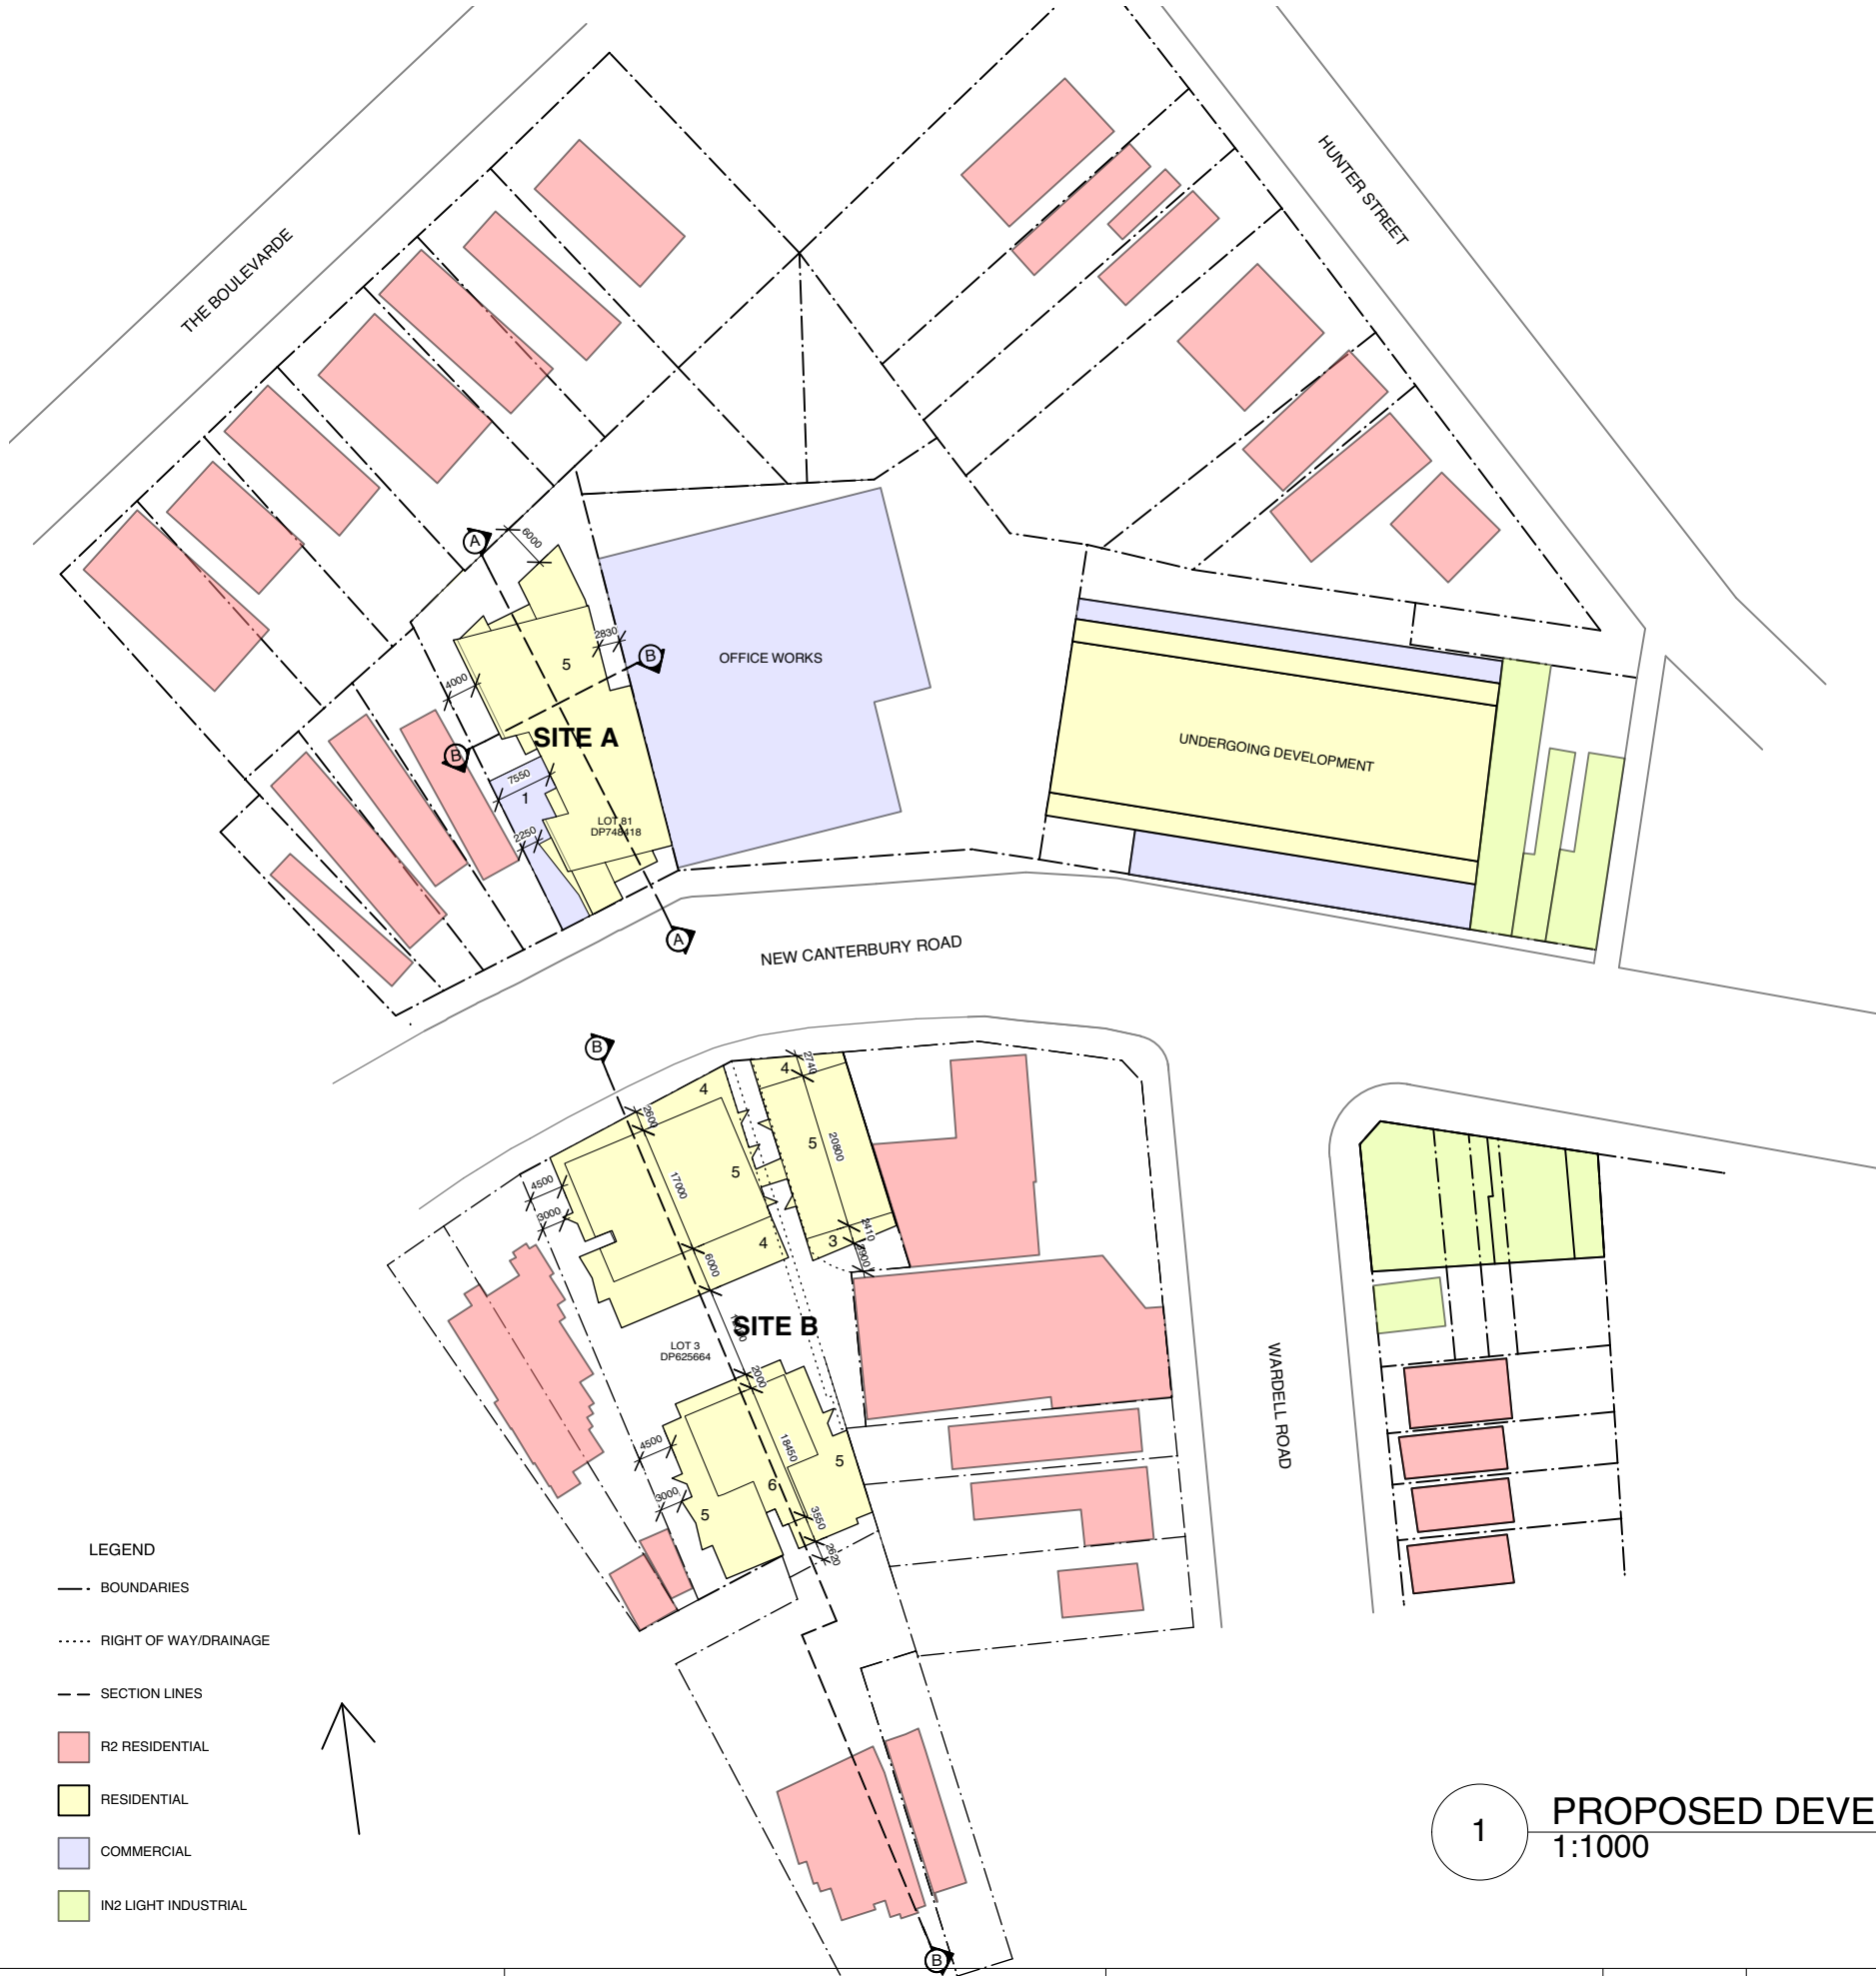
1 PROPOSED DEVELOPMENT  
1:1000

PROPOSED ZONING: R4  
MAXIMUM PROPOSED HEIGHT: 16.8m  
PROPOSED FSR: 2.1/1
