Report on  
Detailed Site Investigation for Contamination with  
Limited Sampling

Proposed Residential Subdivision  
Menangle Park South, NSW

Prepared for  
Dahua Group Sydney Project 3 Pty Ltd

Project 76744.04  
April 2017

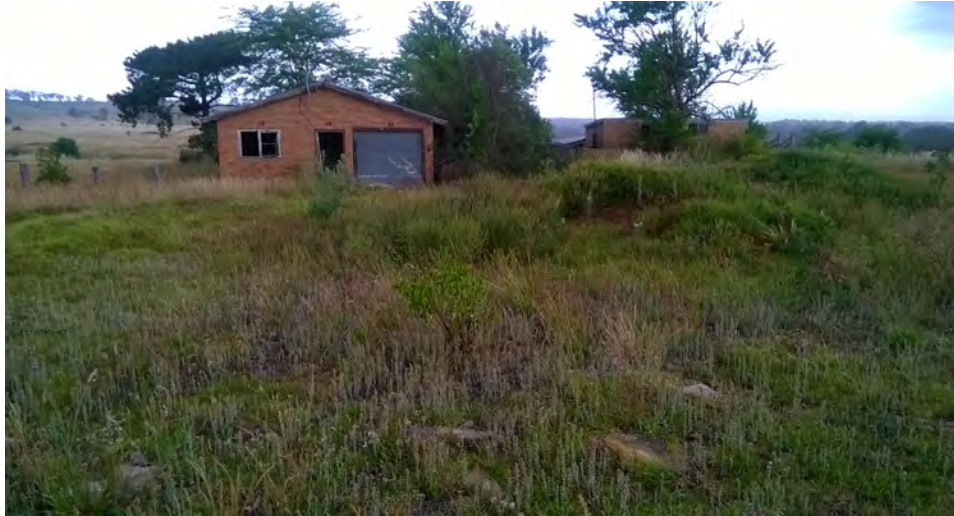
Photograph 1 - Brick and corrugated steel house

- In the western part of the site a brick and corrugated steel house, separate garage and corrugated steel animal stall areas and associated grazing paddocks was observed (photograph 1). The house and adjacent structures were generally in a dilapidated condition. Suspected bonded asbestos containing materials (ACM) may possibly be present in the ceiling materials located inside the house (photograph 2).

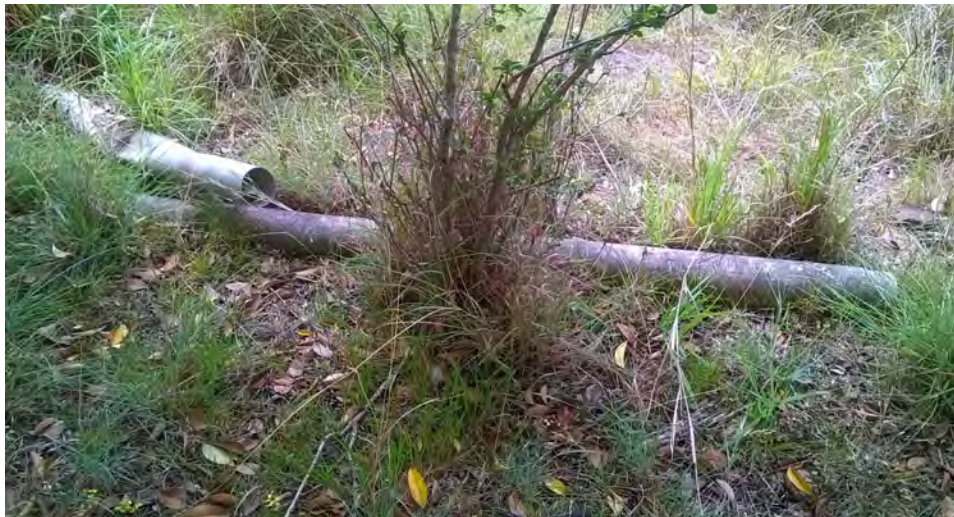
Photograph 3 - ACM pipe

- A suspected ACM pipe partially covered with concrete was located near to the Nepean River in the south east corner of the site (photograph 3).
- Minor fly tipping of materials including loose timber fencing, dilapidated steel shed, tyres, a lawnmower engine and exhaust pipe was observed next to the Nepean River in the south east part of the site. No staining or evidence of spill was observed on the underlying ground (photograph 4).

11	Stockpile containing soil and some building material	Stockpile analytical results did not identify any any contaminants above SAC or any asbestos.	No
12	ACM pipe	Identified ACM pipe will require remediation.	Yes
13	Minor fly tipping near Nepean River	No staining or evidence of spill was observed on the underlying ground.	No
14	Historical agricultural land use	Concentrations of COPC were below the LOR and / or the SAC.	No

An ACM pipe was observed during the site walkover which will require remediation and validation prior to earthworks.
