Report on
Preliminary Site Investigation with Limited Intrusive
Sampling

Proposed Residential Subdivision
Menangle Park North, Menangle Park

Prepared for
Dahua Group Sydney Project 2 Pty Ltd

Project 76744.01
April 2017

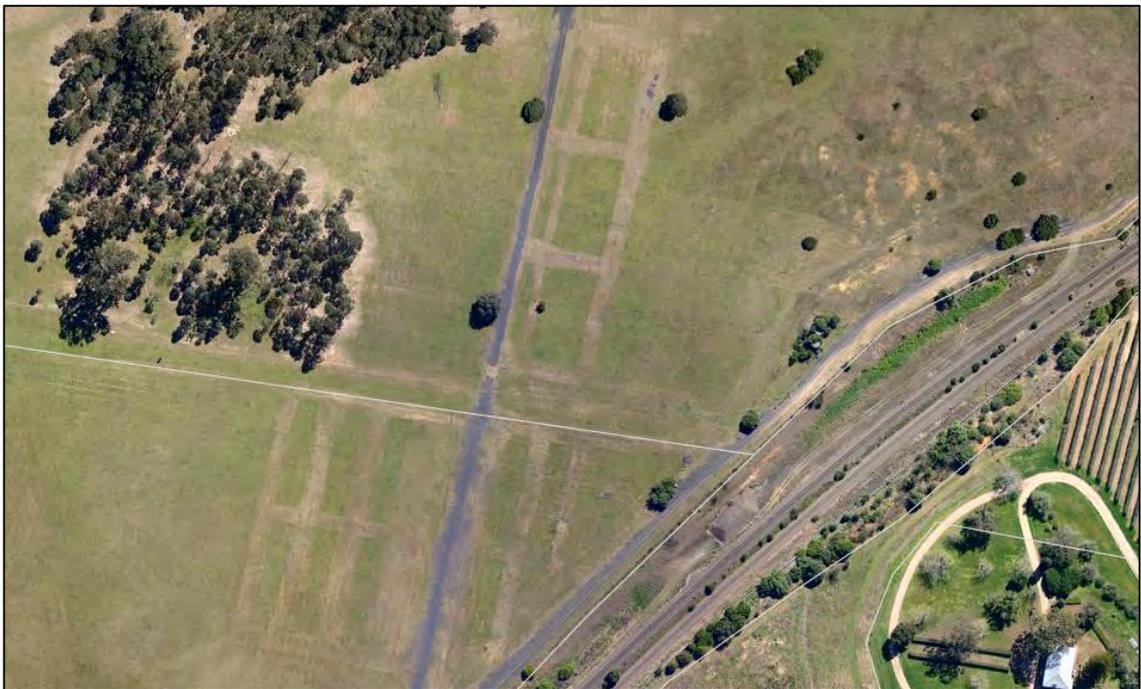
Structures previously visible in the south west portion of Precinct 400 are no longer visible. Several 'figure 8' like suspected ground disturbance features are visible in the eastern part of Precinct 500 in several aerial photographs, including September 2010 (Figure 3 below). These are located in the same area as observed in the 1994 aerial photograph. No structures were visible in this portion of the site in historical aerial photographs that were reviewed as part of this PSI.

Figure 3 – Several 'figure 8' like features visible in Precinct 500 (September 2010)

- Several “figure 8” like features visible on historical aerials (and discussed in Section 4.1) were closely inspected during the walkover (MRP 8); no suspected filling was observed, however a clear difference in vegetation type here indicates filling could possibly be present.

4	Several "figure 8" like features visible on aerial photographs and during the walkover may contain filling – Precinct 400.	Test pits completed as part of this investigation were inspected for any possible fill materials.
5	Suspected coal wash was observed during the site walkover stockpiles located next to Howes Creek (Precinct 500).	Coal wash may have associated petroleum hydrocarbon and metal impact. As per the Client's request, detailed testing of suspected coal wash material was not included in the current scope of works. Recommendations for future investigation works are considered further in Section 14.
6	Stockpiles containing construction and demolition type materials.	Stockpiles containing construction and demolition type materials may potentially contain other COPC, including asbestos. As per the Client's request, limited stockpile testing was conducted as part of the PSI. Recommendations for additional testing are included in Section 14.

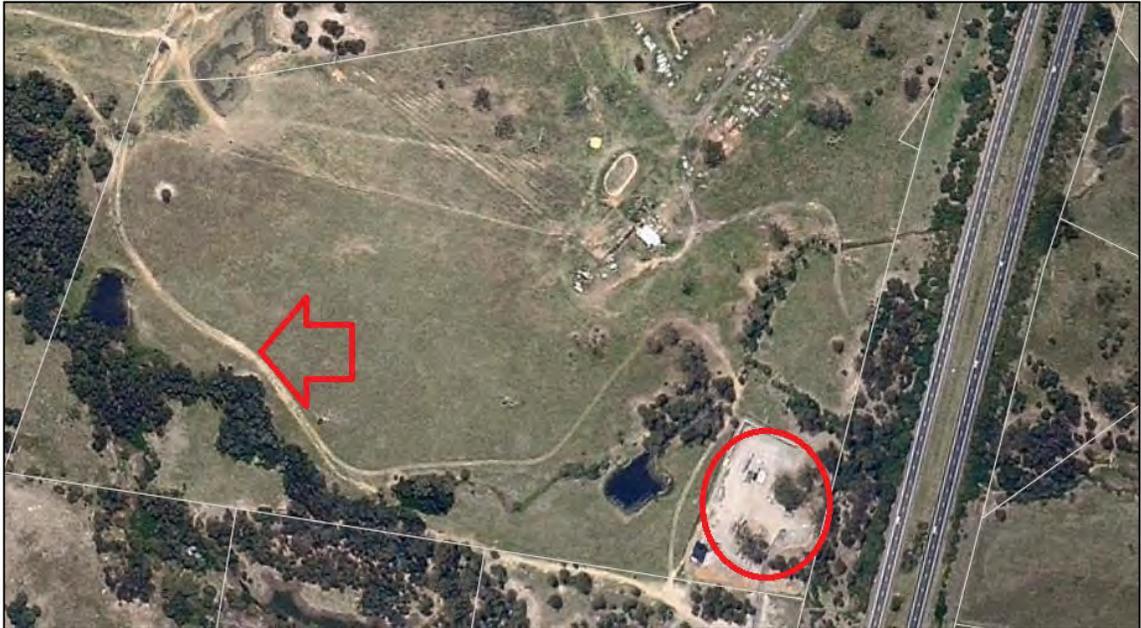
The construction of the coal seam gas well located in the south eastern corner of Precinct 100 appears to have commenced in approximately October 2011, as visible in Figure 4 below.

Figure 4 – Construction of coal seam gas well (circled red) and associated gathering lines (red arrow) in south east corner of Precinct 100 (February 2011)

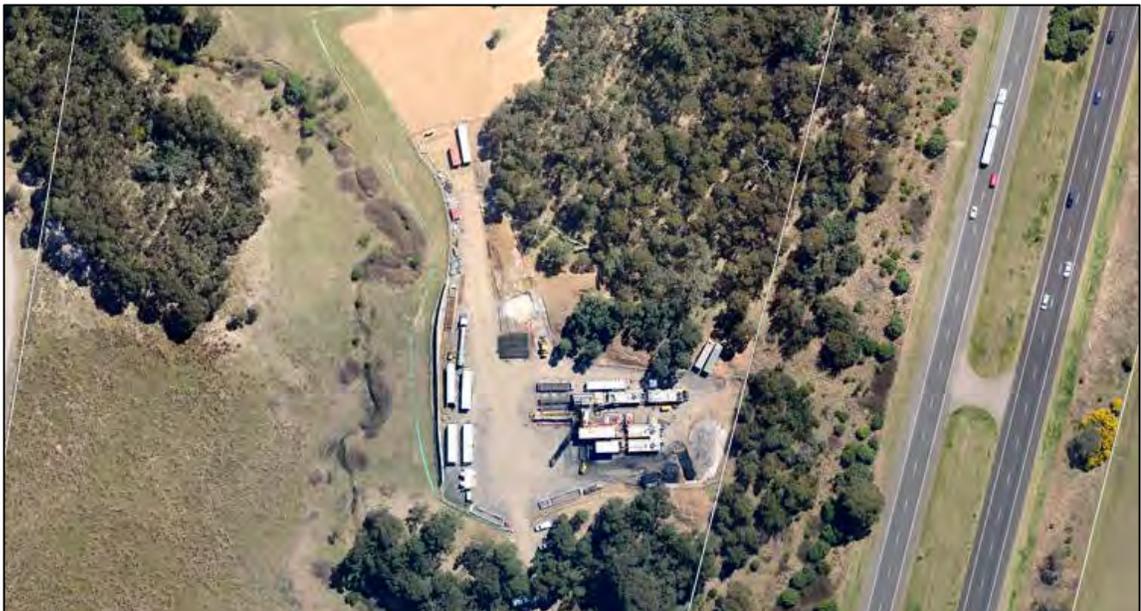
Figure 5 – Construction of coal seam gas well in south east corner of Precinct 100 (October 2011)

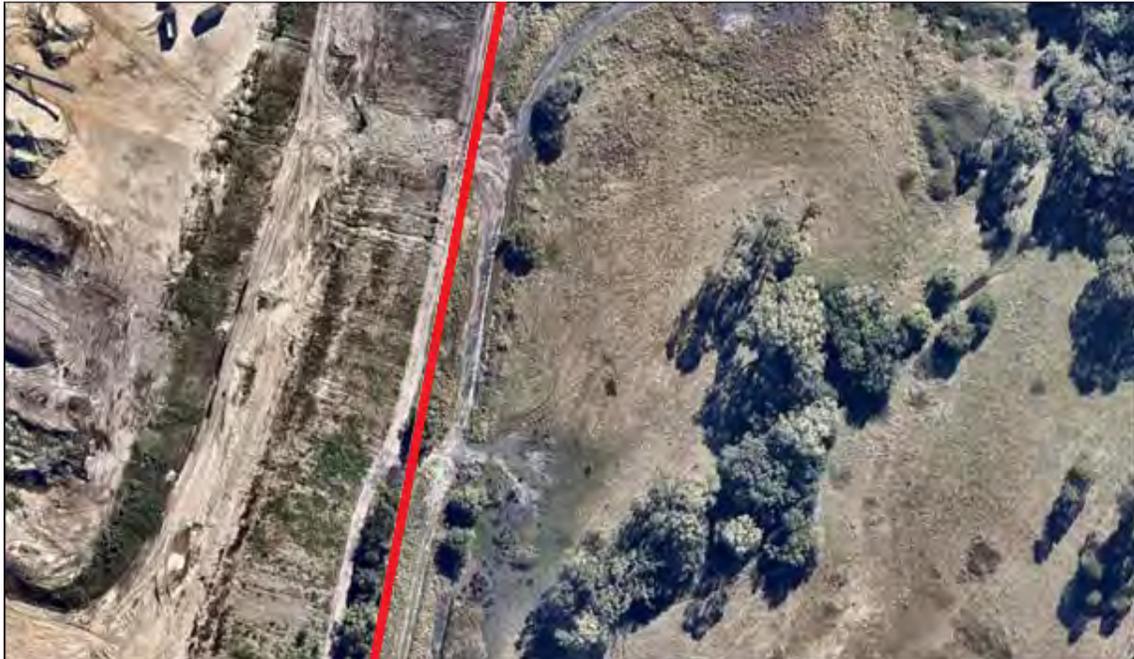
Suspected washout of material between the coal processing plant and the north west part of Precinct 500 is visible in several Nearmap aerial photographs, including May 2015 (see Figure 6 below):

Figure 6 – Suspected washout of material (May 2015)

1	Suspected coal wash was observed during the site walkover on the ground surface and in stockpiles in several locations in the north west of the site (Precinct 500). Recent aerial photographs on Nearmap indicate washout of suspected coal wash from the adjacent coal processing plant may have recently occurred.	Coal wash may have associated petroleum hydrocarbon and metal impact. As per the Client's request, the testing of suspected coal wash material was not included in the current scope of works. Recommendations for future investigation works are considered further in Section 14.
2		
3	Suspected filling was observed in the dam wall during the site walkover.	The site walkover identified possible foreign fill material (i.e. not reworked natural) in one dam wall at the site. As per the Client's request, the testing of the dam wall was not included in the current scope of works. Recommendations for future investigation works are considered further in Section 14.

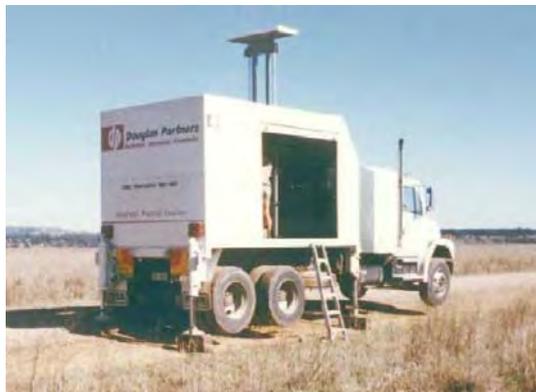
Figure 2: Purpose built CPT rig

The cone is thrust into the ground at a steady rate of about 20 mm/sec, usually using the hydraulic rams of a purpose built CPT rig, or a drilling rig. The testing is carried out in accordance with the Australian Standard AS1289 Test 6.5.1.

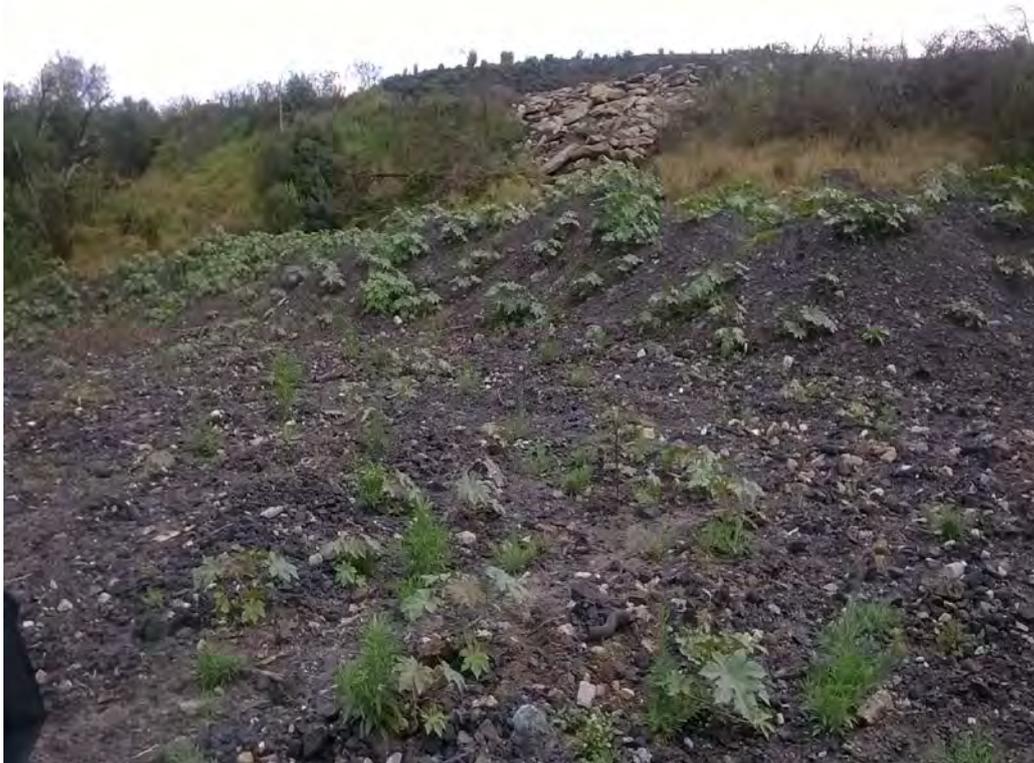
- Several areas in the north west part of the site (Precinct 400) were covered with surface fill comprising dark grey / black fill (MRP 1) suspected to be coal wash material possibly sourced from the adjacent coal processing plant (photograph 1). Suspected coal wash material was also observed in a small creek located near the north west corner of the site (MRP 2) and stockpiled next to the north western site boundary (MRP 4).

Photograph 1 - Suspected Coal Wash

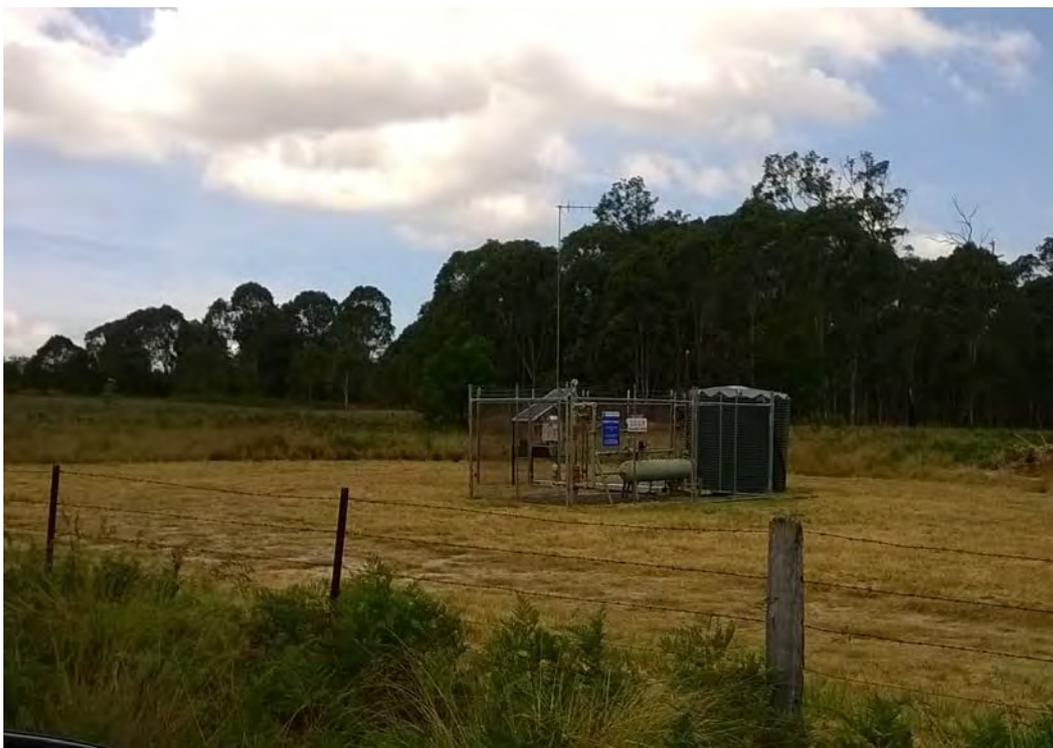
- A total of two on site and five off site gas wells were observed across and near to the site (MRPs 3, 12, 27, 33, 38, 39 and 40; see photograph 2).
- Timber and corrugated steel were observed in part of Precinct 400, likely relics of a former structure (MRP 5; photograph 3).

Photograph 2 - One of four gas wells

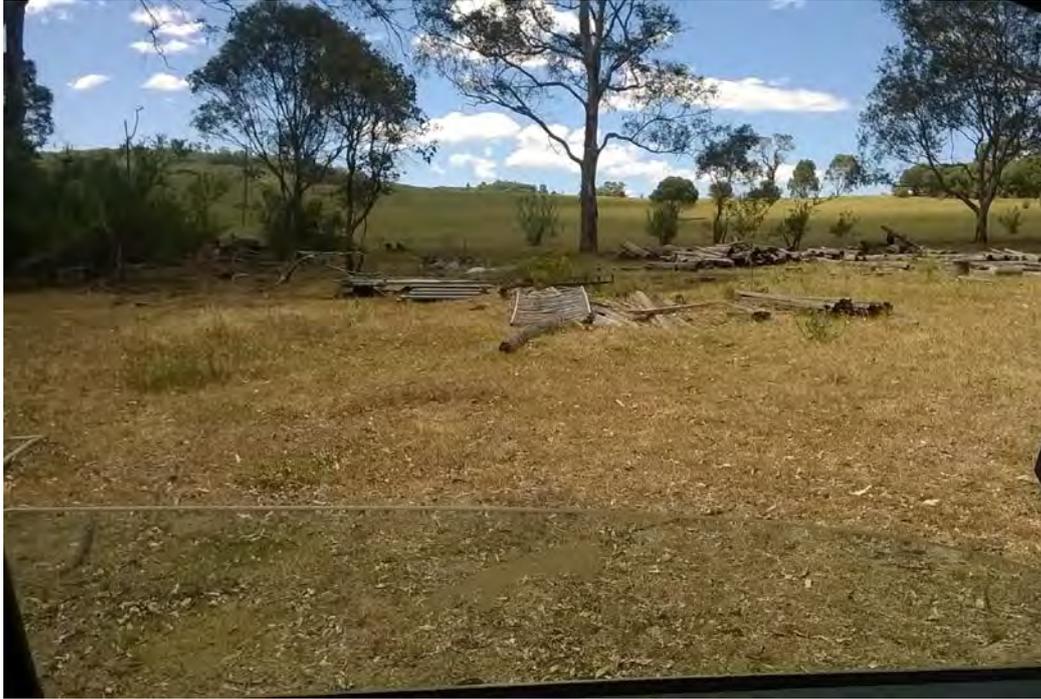
Photograph 3 - Stockpiles of timber and corrugated steel

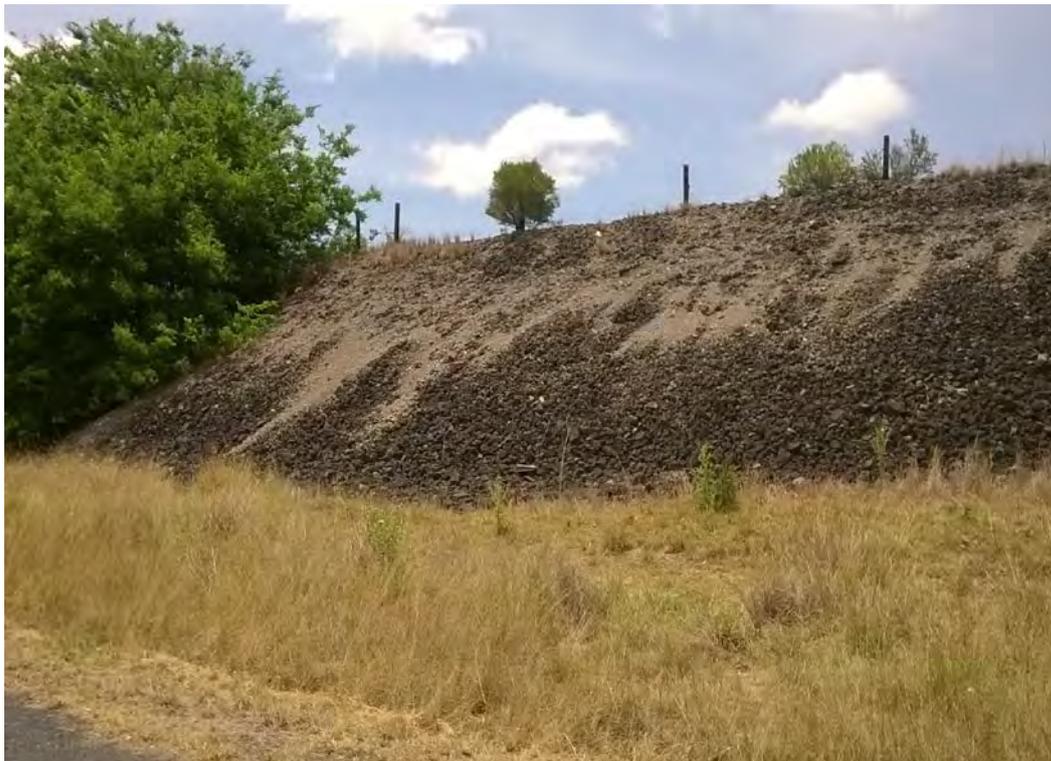
- Four coal wash stockpiles were observed on suspected coal wash filling next to Howes Creek in Precinct 500 (MRP 9).
- The railway embankment running between Precinct 400 and Precincts 100 and 200 (outside of the site boundary) contains fill, possibly including suspected coal wash material (MRP 10; photograph 4). The embankment is located outside of the site boundary and is therefore not likely to affect the proposed development of the site.

Photograph 4 - Fill associated with the railway embankment

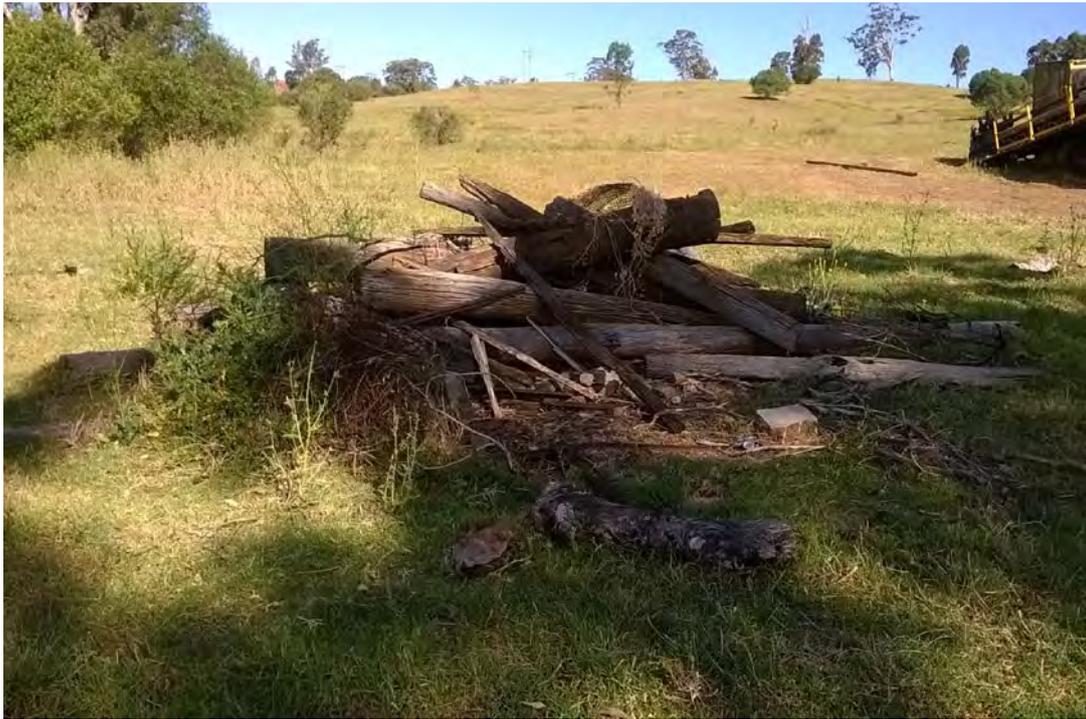
Photograph 5 - Stockpile of loose timber fence posts

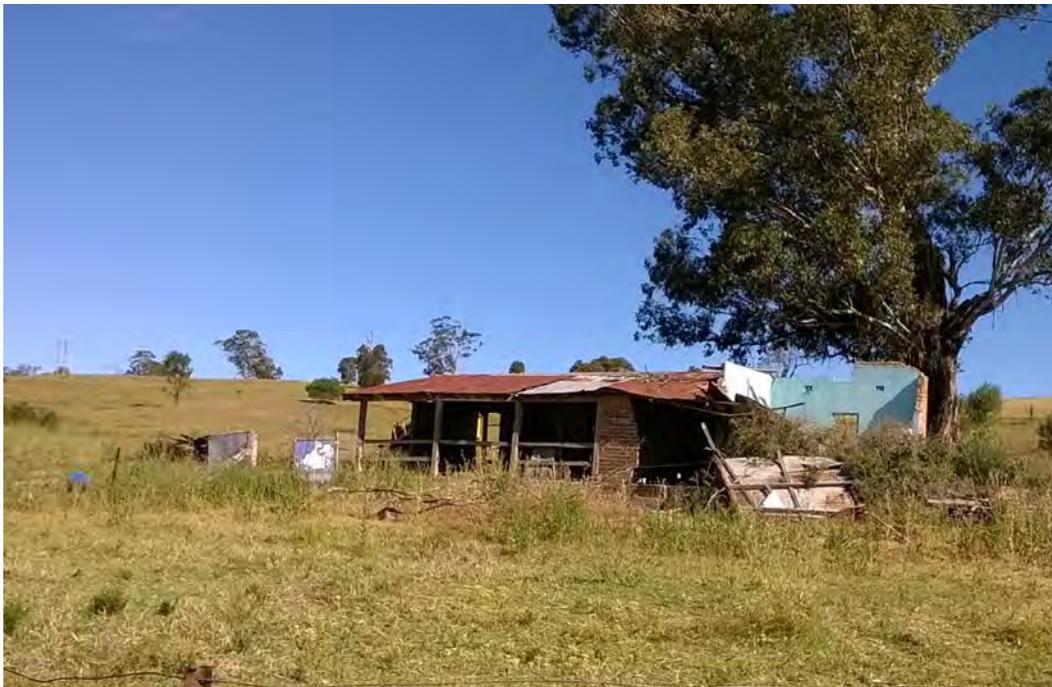
- Three stock watering wells were observed on the northern part of Precinct 100 (MRPs 15 and 18).
- A dilapidated horse shelter constructed with brick and corrugated steel was observed in the northern part of Precinct 100 and was in use at the time of the walkover (MRP 16; photograph 6).

Photograph 6 - Dilapidated horse shelter

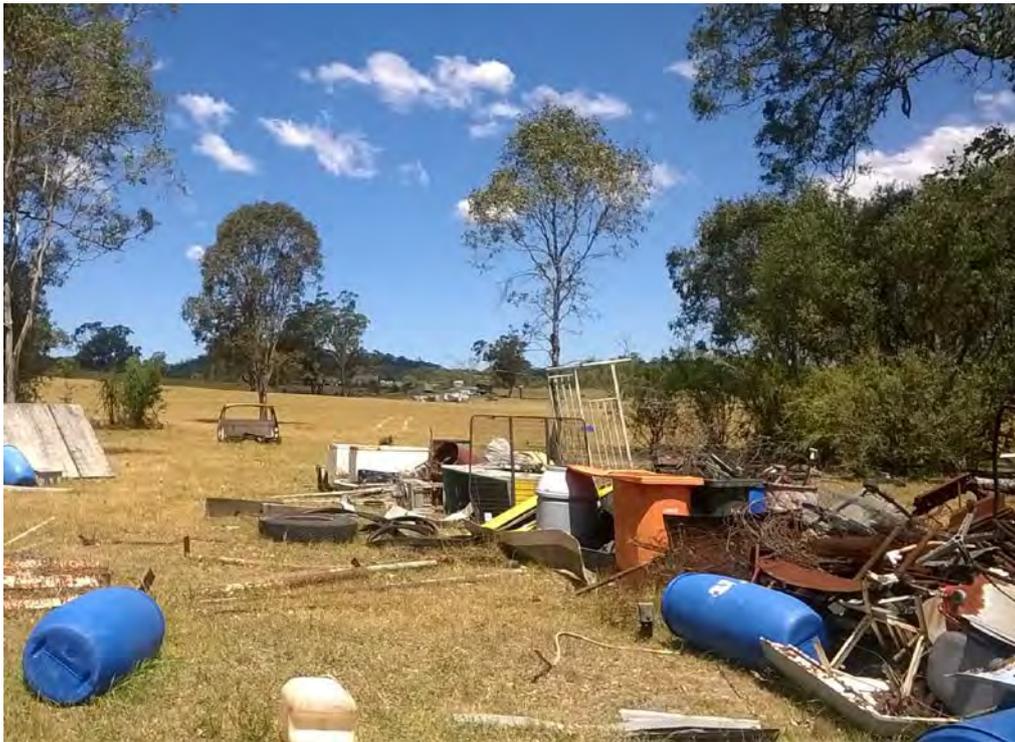
Photograph 7 - Scattered rubbish in lay down / scrap yard

10	A scrap yard and storage area was observed during the site walkover. Machinery maintenance and storage occurred nearby.	The storage and maintenance of machinery may be a possible source of metal and hydrocarbon impact.
11	Possible filling was observed on the site surface however grass cover prevented closer inspection.	As per the Client's request, limited targeted testing was conducted as part of the PSI. Recommendations for additional testing are included in Section 14.
12	Possible filling was observed on the site surface however grass cover prevented closer inspection.	As per the Client's request, limited targeted testing was conducted as part of the PSI. Recommendations for additional testing are included in Section 14.

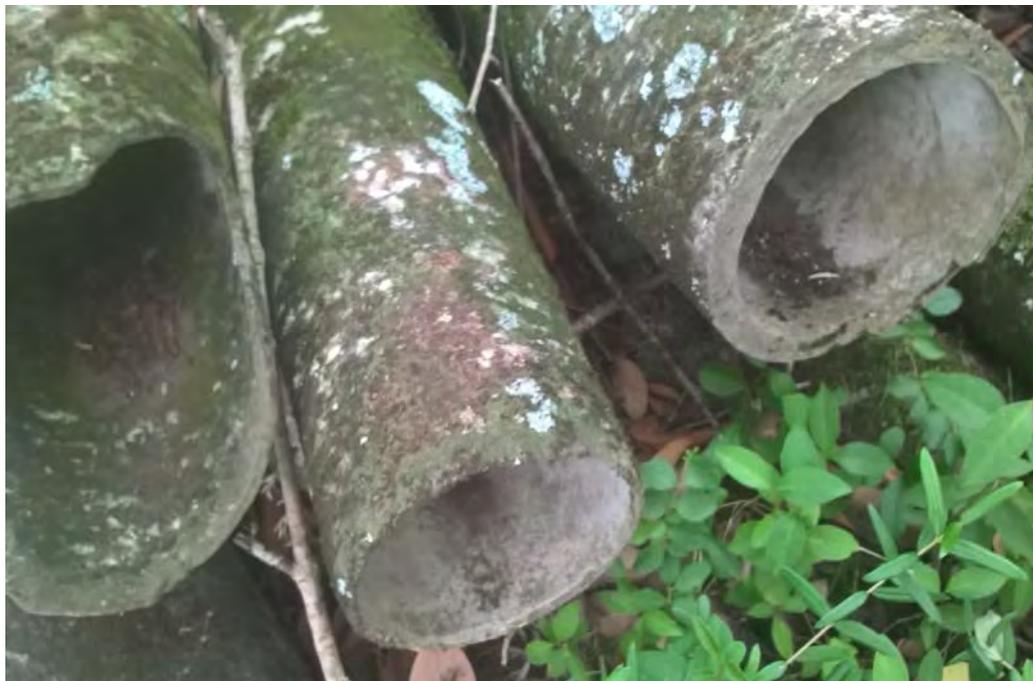
- Several ACM pipes and fragments of asbestos were observed on Precinct 500 near to the Nepean River (MRP 34; photograph 8). Two large water tanks and metal sheeting were also noted in the vicinity of the area. An old shanty with disused electrical appliances was also observed (MRP 35; photograph 9).

Photograph 8 - ACM pipes

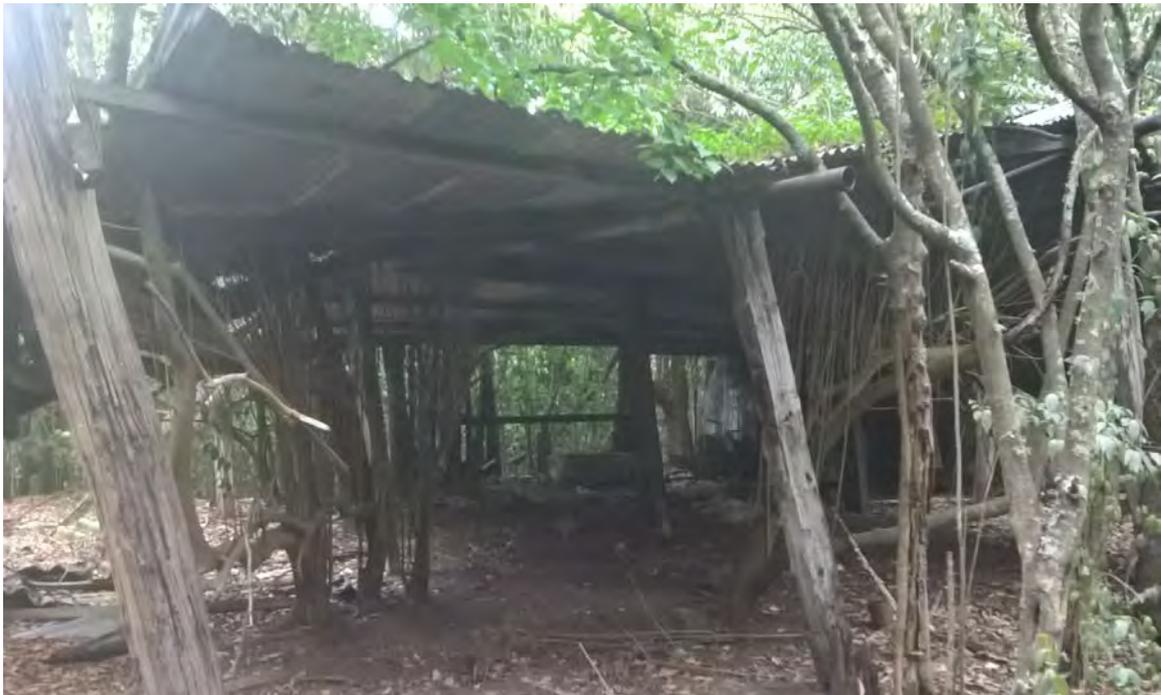
Photograph 9 - An old shanty with disused electrical appliances inside

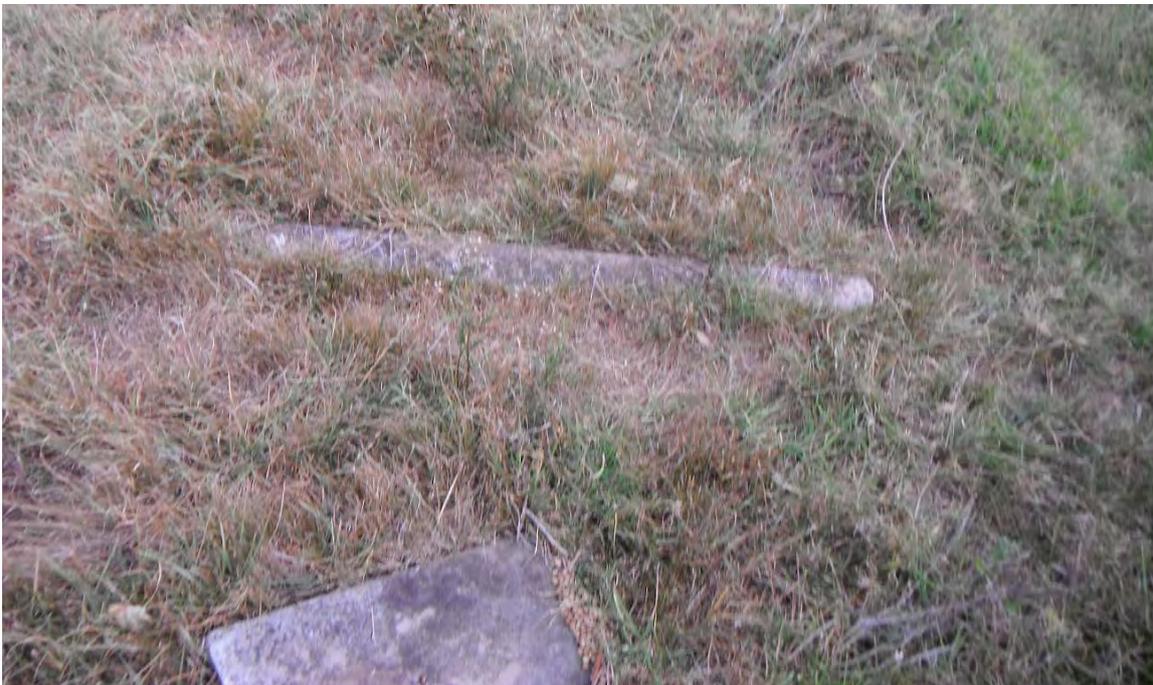
- A grass covered stockpile containing suspected ACM pipes and concrete was observed in the southern portion of Precinct 300 (MRP 36; photograph 10).
- A stockpile containing reworked natural material was observed in the south east portion of Precinct 300 (MRP 37). No suspected anthropogenic material was observed.

Photograph 10 - Grass covered stockpile with suspected ACM pipe and concrete slab
