BUSHFIRE HAZARD ASSESSMENT

**79, 95, 100 Bells Lane & 457 Bells Line of Road,
Kurmond NSW**

REP-168814

9th December 2014

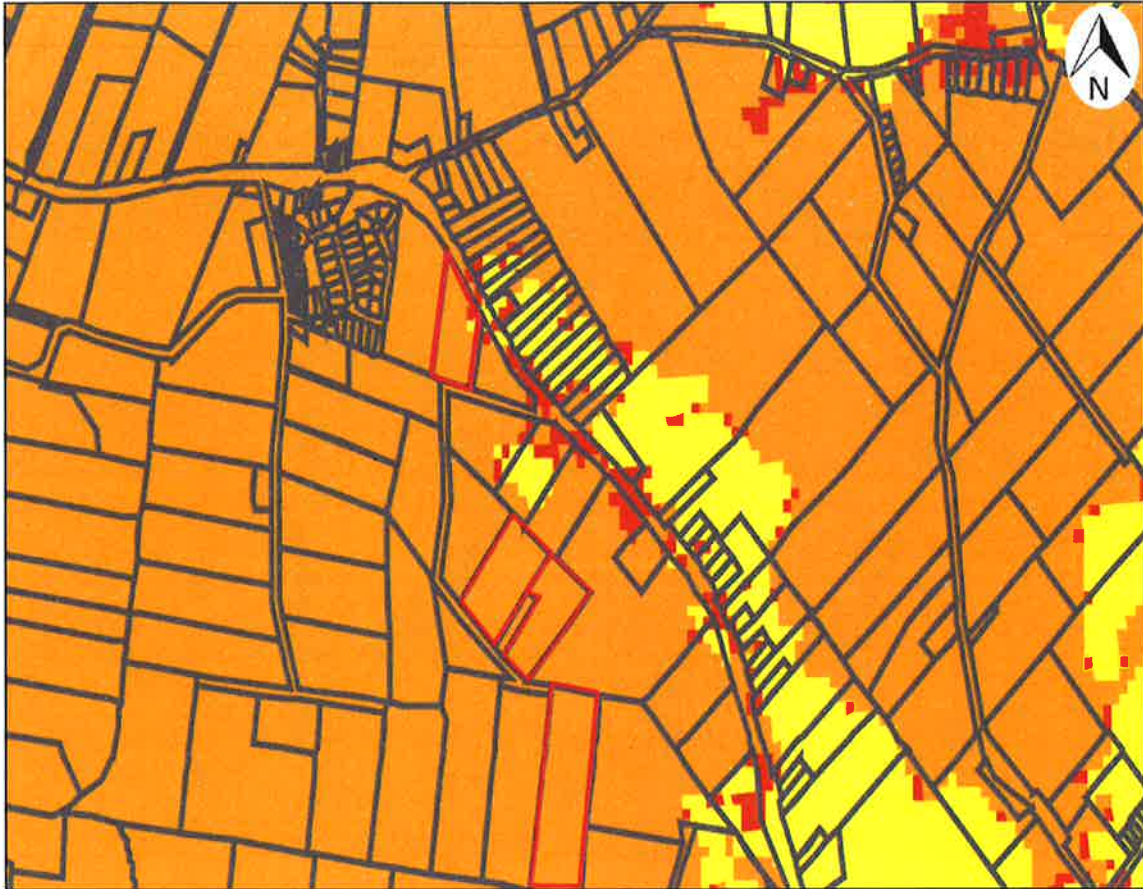
Figure 6. Hawkesbury LGA Bush Fire Prone Land map

-   Subject sites
-   Bush Fire Prone Land – Vegetation Category 1
-   Bush Fire Prone Land – Vegetation Category 2
-   Bush Fire Prone Land – Vegetation Buffer 30 m and 100 m

The sites are identified as bushfire prone land as per the Hawkesbury Bushfire prone land map (see figure 3. below). As such the following report addresses the requirements of section 100B of the *Rural Fires Act 1997* and the planning provisions of *Planning for Bushfire Protection (PBP) 2006*.

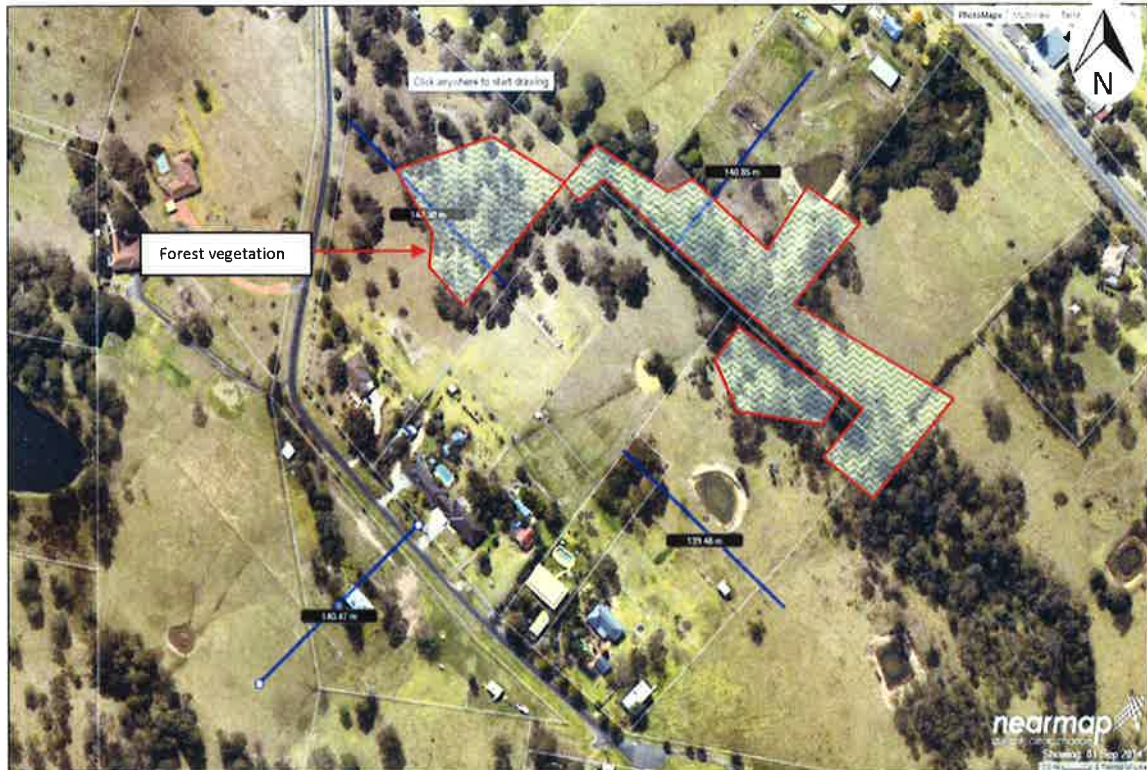
Figure 8. Vegetation considered as a bushfire risk identified within 140m of the site (Accessed via www.NearMap.com on the 2/12/2014)

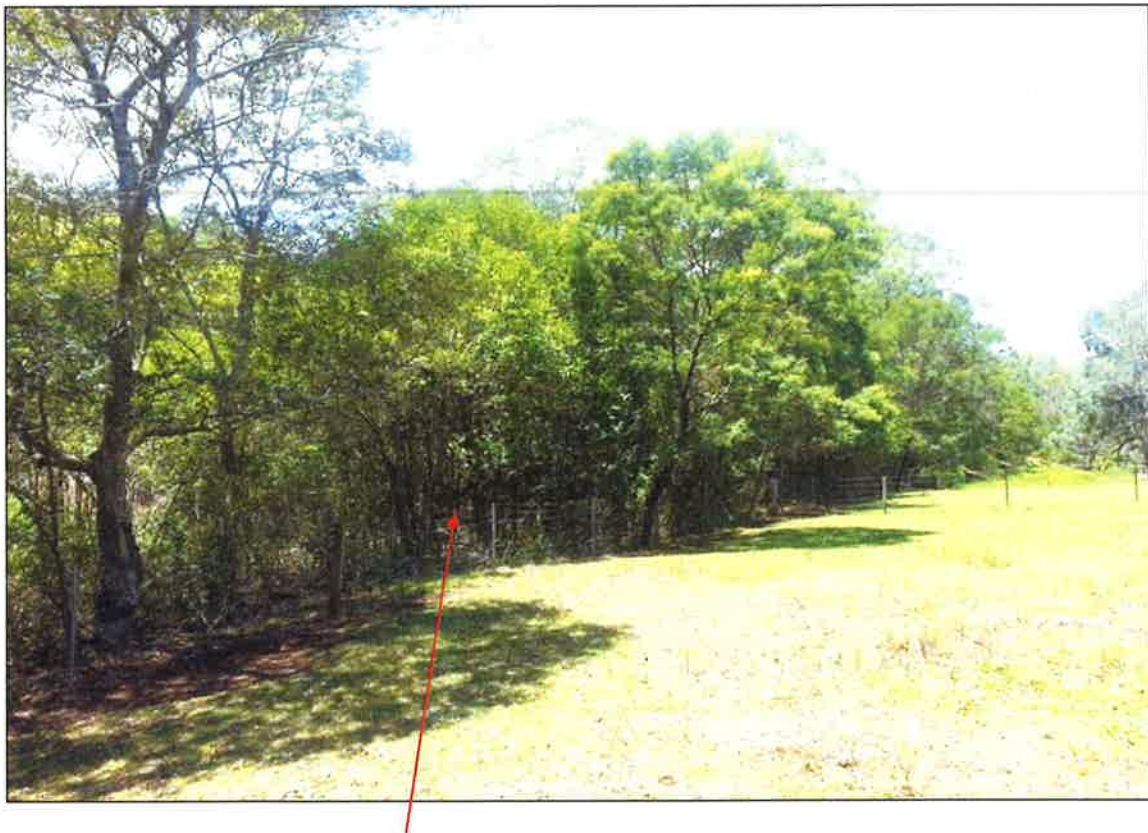
Figure 9. Vegetation to the north –forest immediately adjacent northern boundary

The patch of five (5) trees are present in the northern portion of the site which are not considered significant vegetation and will likely be incorporated within the asset protection zone and or removed for the purpose of the development. Vegetation occurring adjacent the northern boundary has an effective slope of downslope in relation to the development. As the width of the vegetation is greater than 20m it is considered forest. The effective slope beneath the vegetation of the creekline was observed to be 5-10°.

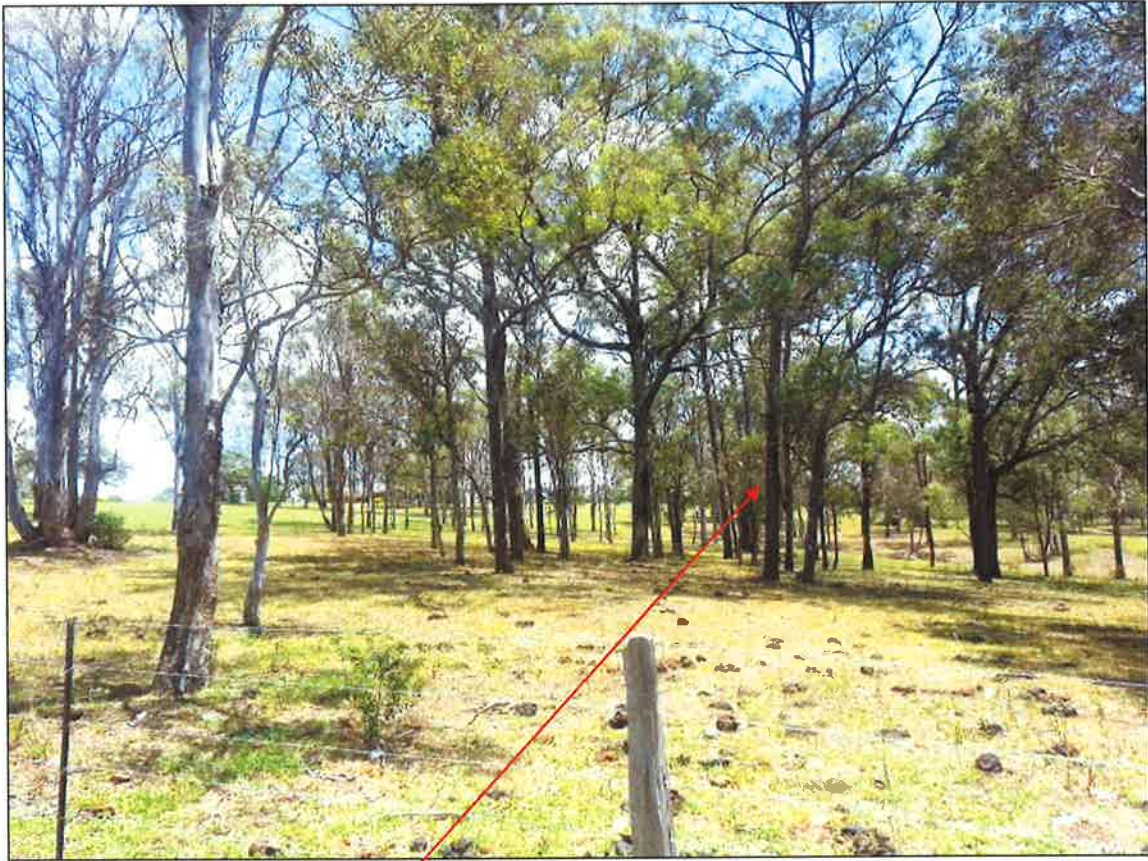
West – The predominant vegetation to the west is considered forest with an effective slope of 6° placing it within the 5-10°.

Figure 10. Vegetation to the west, forest with an effective slope of 5-10°

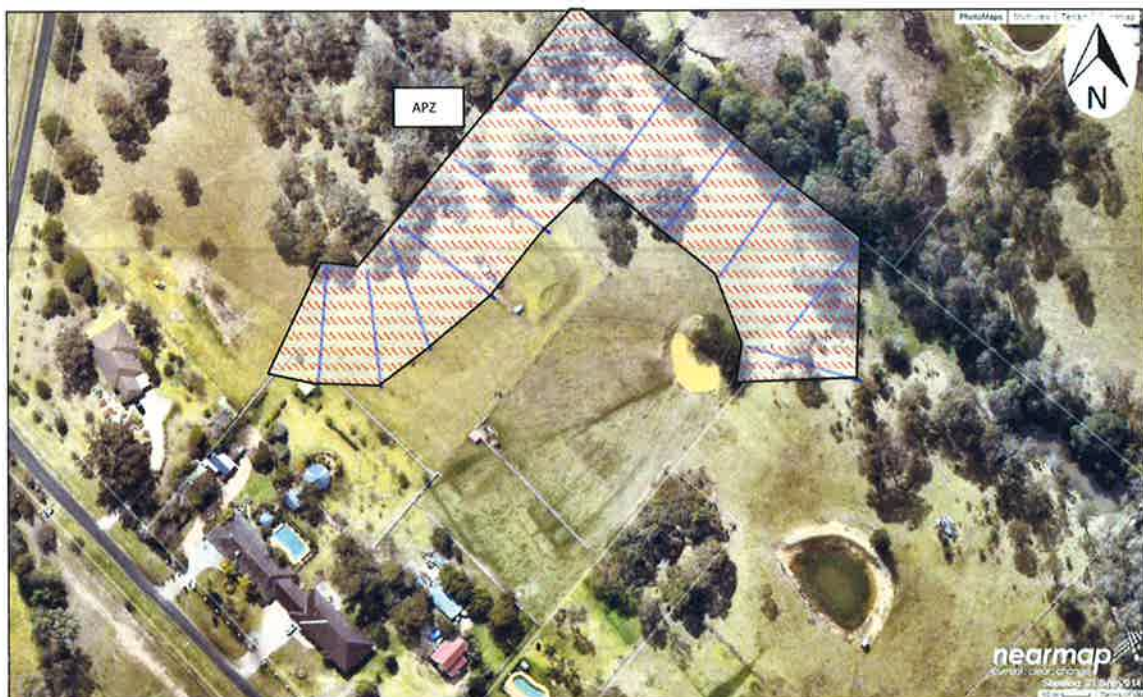
Figure 11 below details the proposed location for a building envelope in regard to the vegetation type and slope to ensure that the BAL does not exceed BAL 29.

Figure 11. Proposed APZ zone on the northern boundary to achieve a maximum BAL of BAL29 (Accessed via www.NearMap.com on the 2/12/2014).

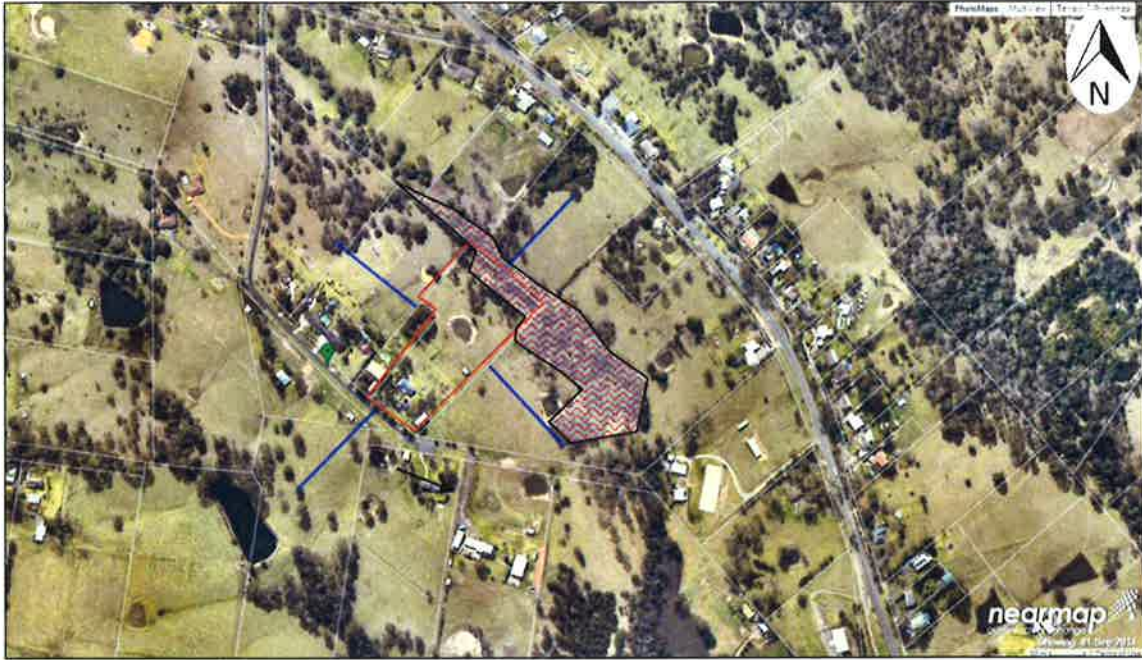
Figure 12. Vegetation considered a bushfire risk identified within 140m of the site (Accessed via www.NearMap.com on the 2/12/2014).

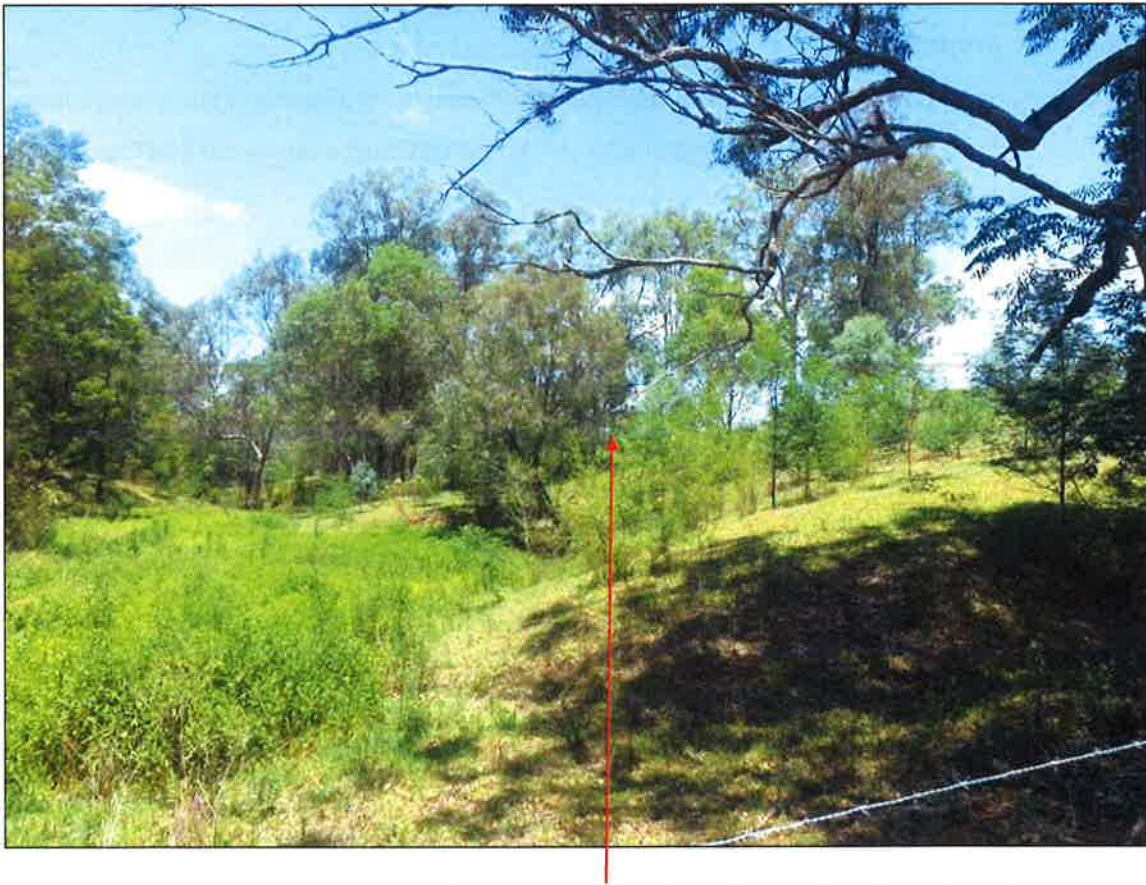
Figure 13. Side profile of the vegetation to the north – forest with an effective downslope of 5-10°.

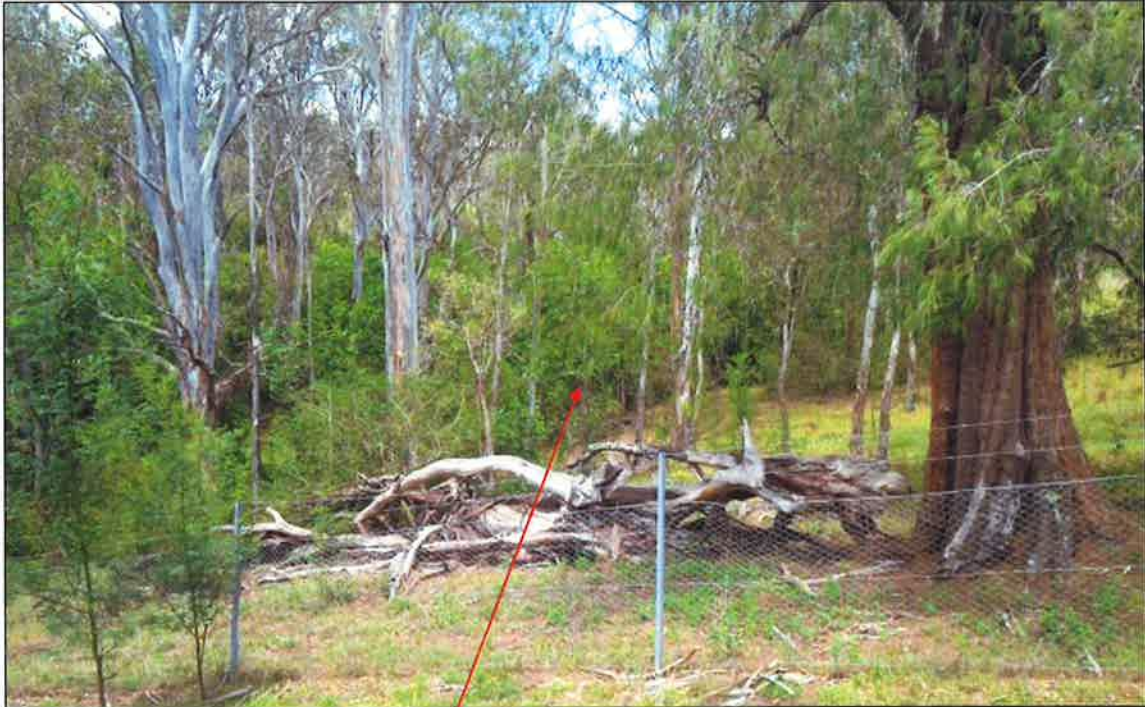
Figure 14. Vegetation to the north-east, forest with an effective down slope of 5-10°

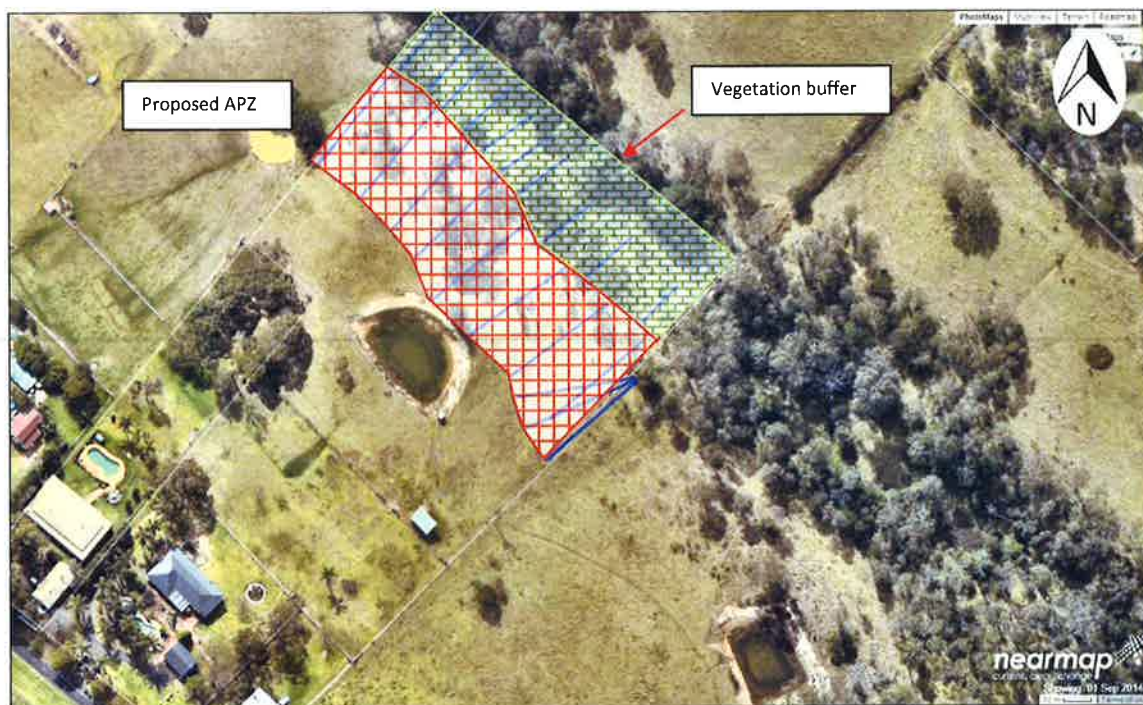
Figure 15 below details the proposed clearances for building envelopes in regard to the vegetation type and slope to ensure that the BAL does not exceed BAL 29.

Figure 15. Proposed APZ zone on the northern boundary and set back area surrounding watercourse to achieve a maximum BAL of BAL29.

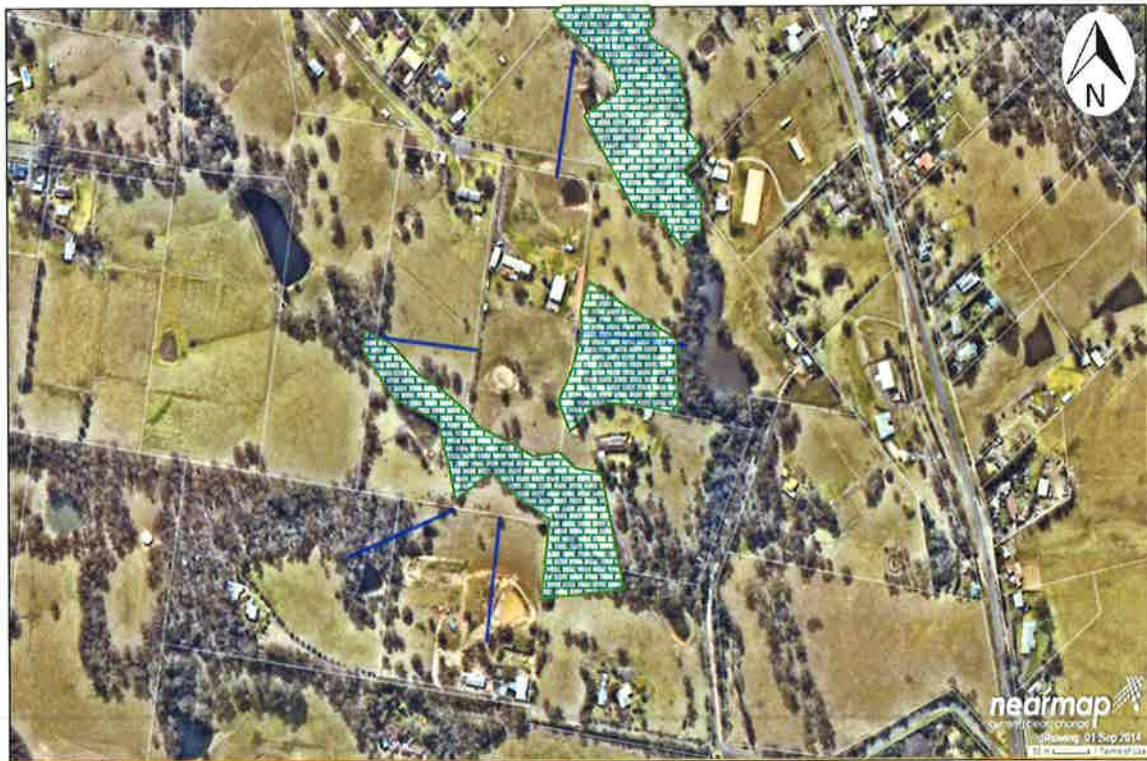
Figure 16. Vegetation considered as a bushfire risk on and offsite (Accessed via www.NearMap.com on the 2/12/2014).

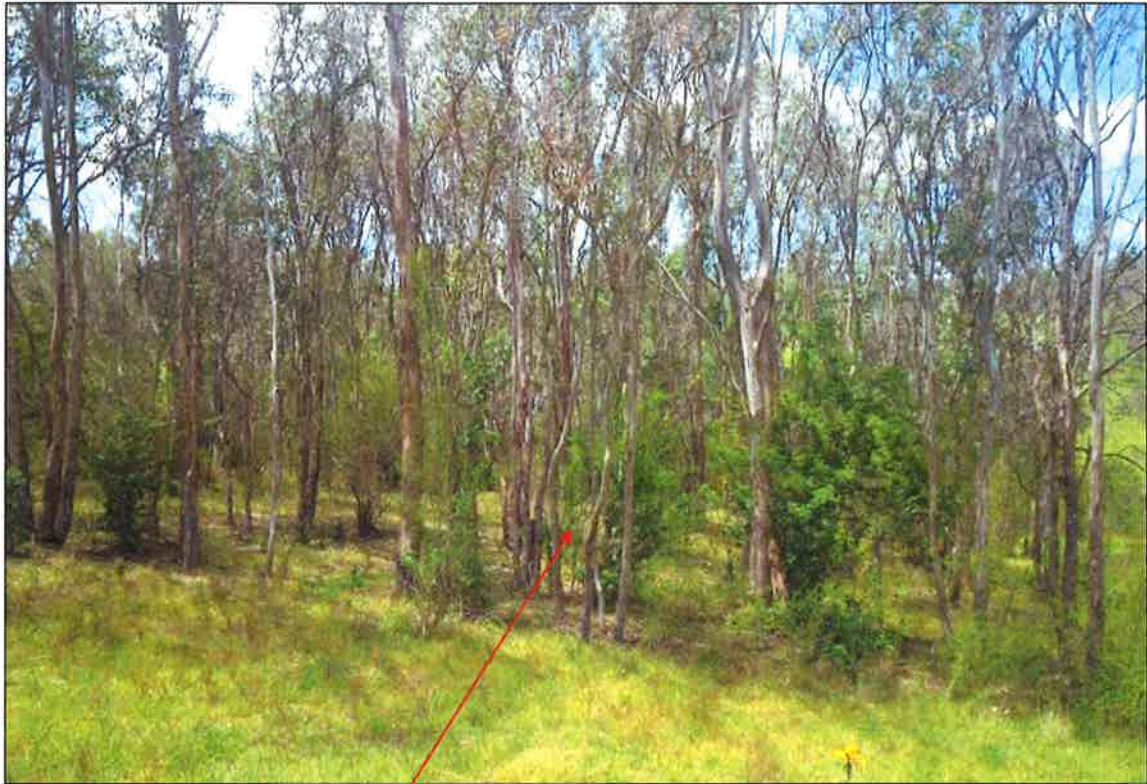
Figure 17. Vegetation to the north – forest with an effective downslope of 0-5°

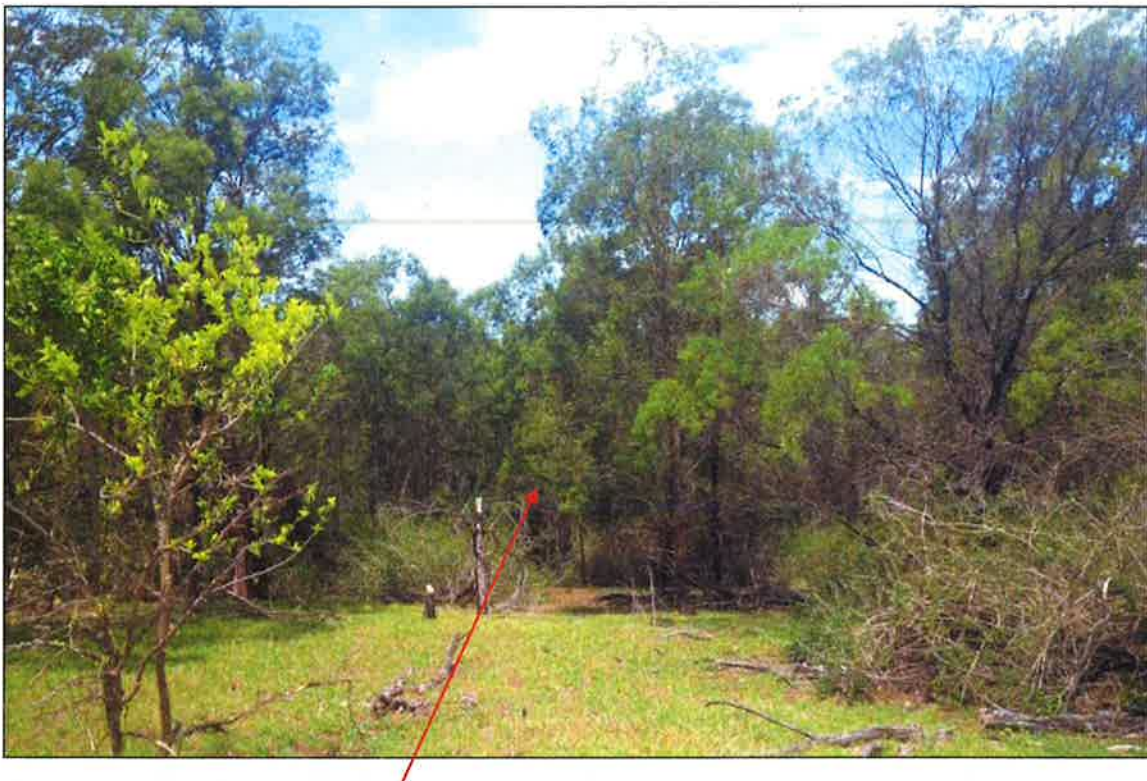
Figure 18. Vegetation to the east, forest with an effective slope of 5-10°

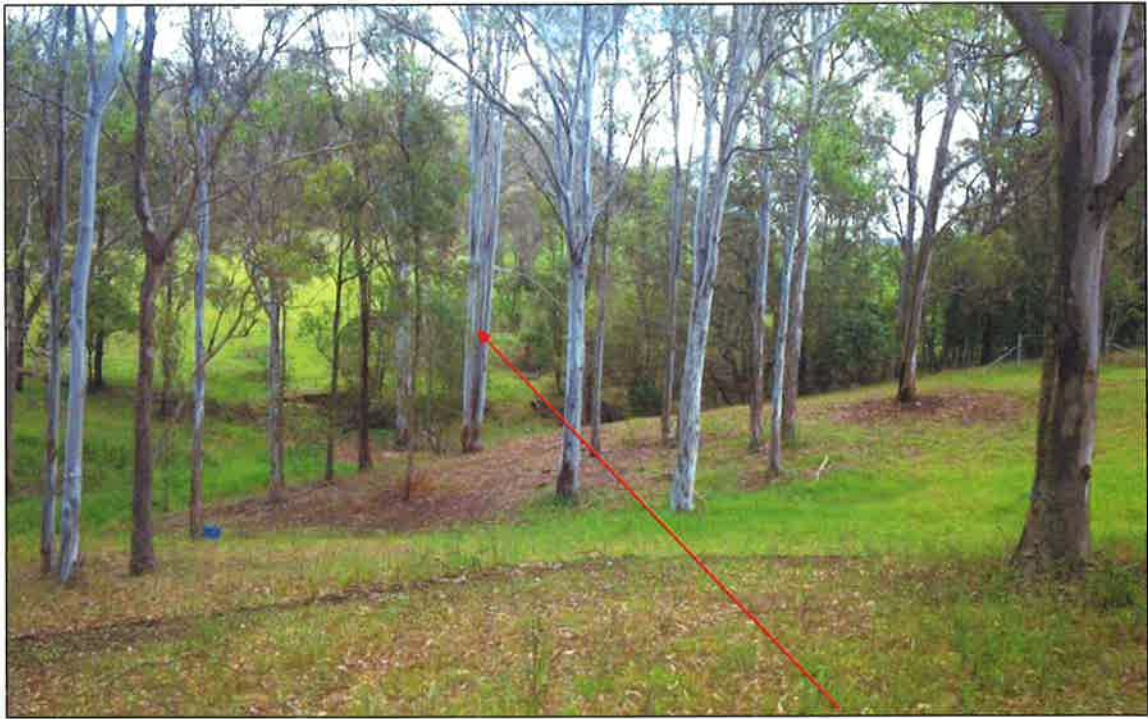
Figure 19. On site vegetation occurring on the northern side of the creekline, forest with an effective slope of 5-10°

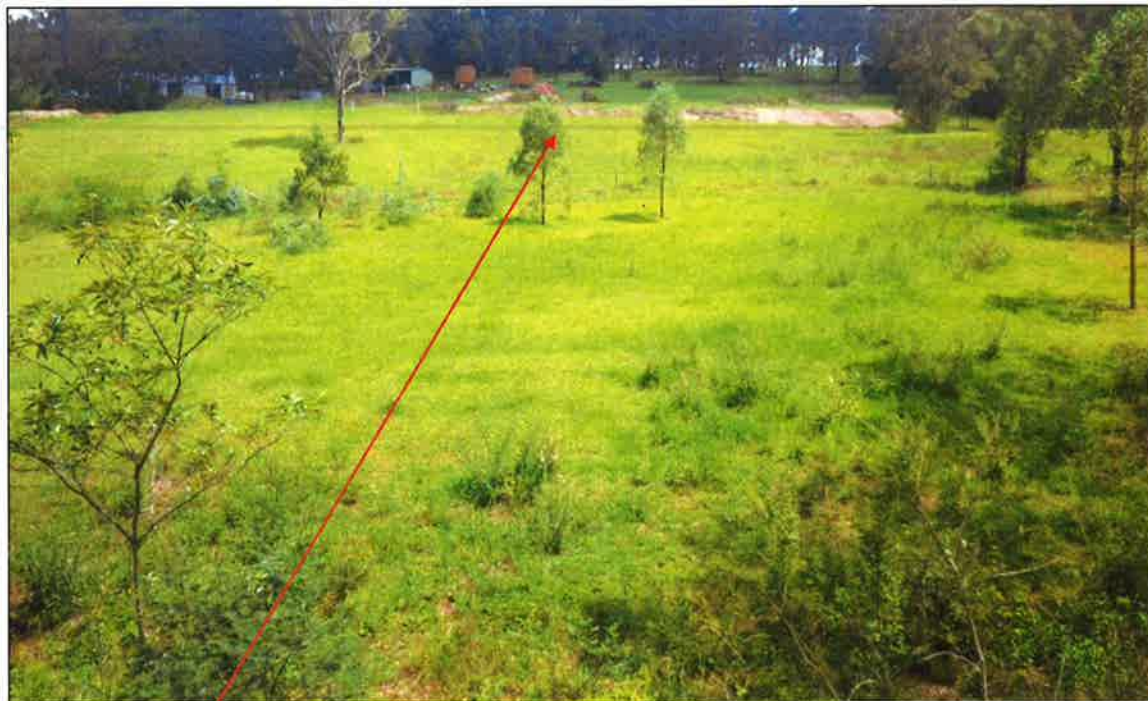
Figure 20. Up slope view looking south towards the southern boundary of the site

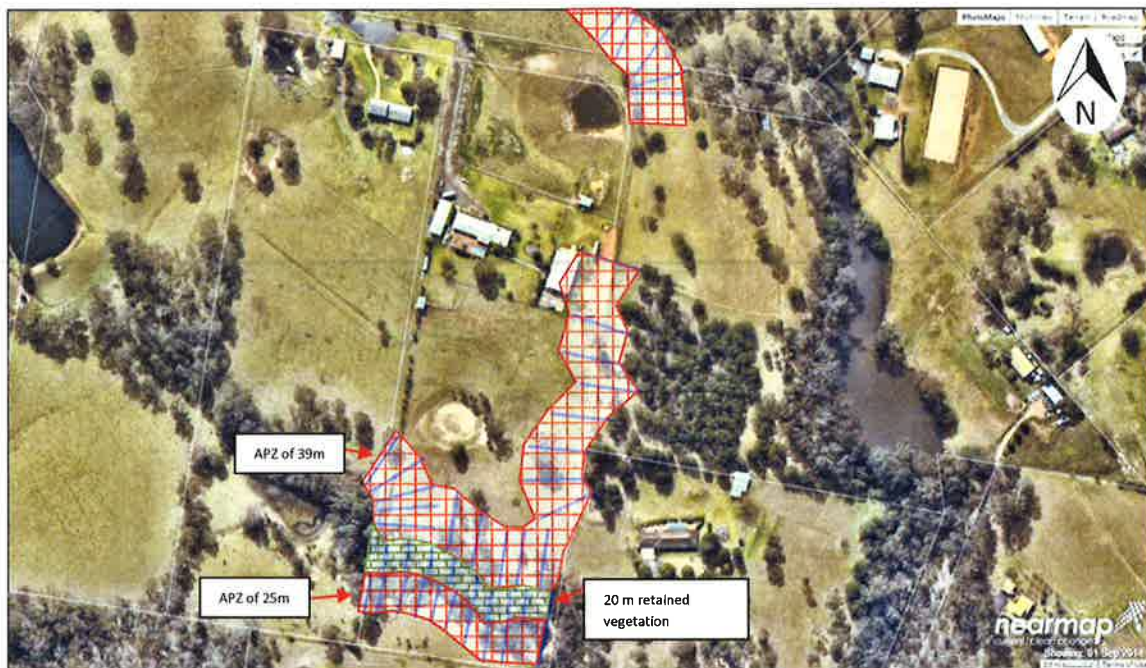
Figure 22 below details the proposed clearances for building envelopes in regard to the vegetation type and slope to ensure that the BAL does not exceed BAL 29.

Figure 21. Proposed APZ zone on the southern boundary and set back area surrounding watercourse to achieve a maximum BAL of BAL29 (Accessed via www.NearMap.com on the 2/12/2014).

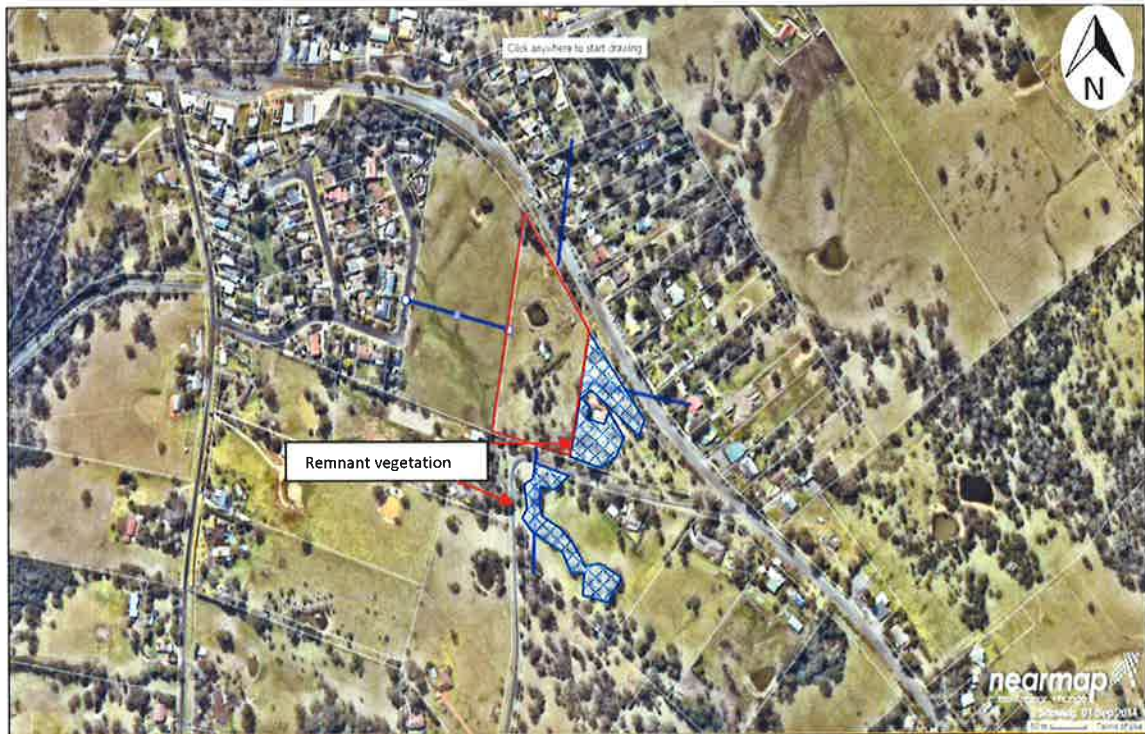
Figure 22. Vegetation considered a bushfire risk identified within 140m of the site (Accessed via www.NearMap.com on the 2/12/2014).

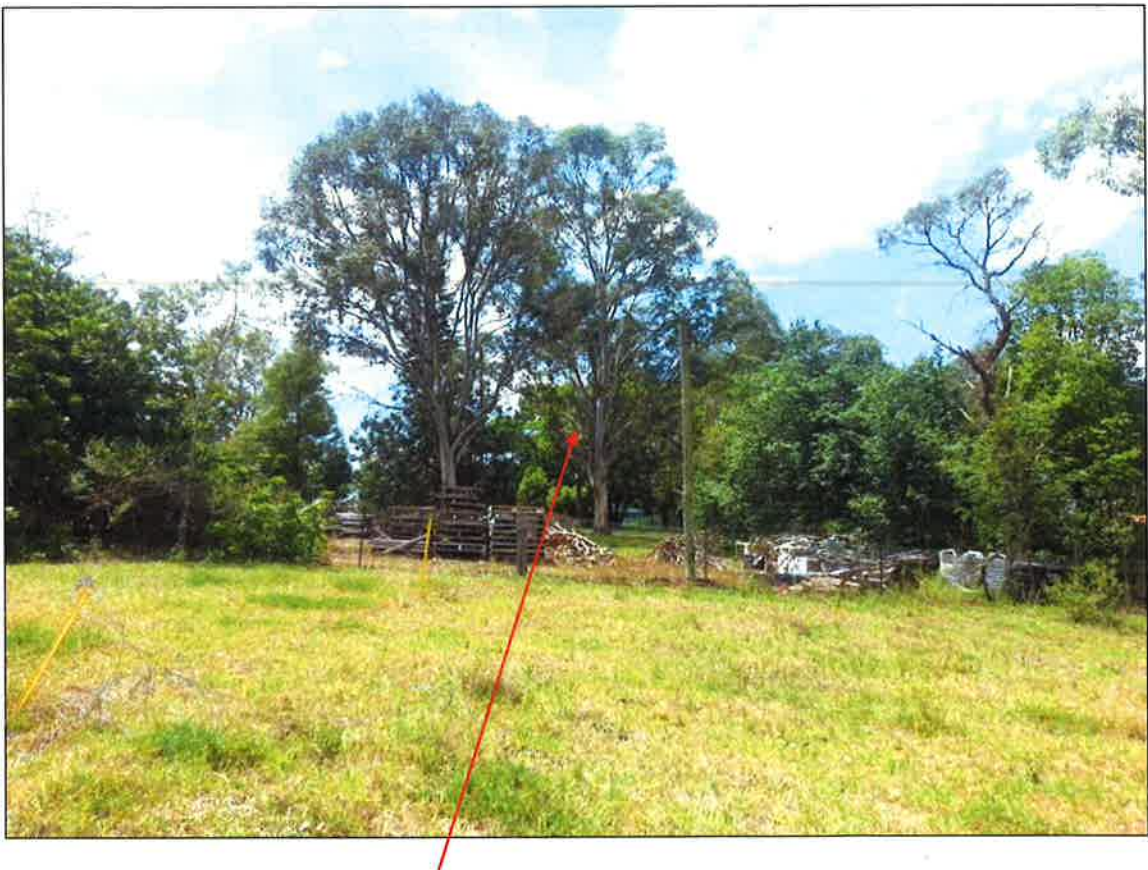
Figure 23. Vegetation to the east – managed land with remnant vegetation

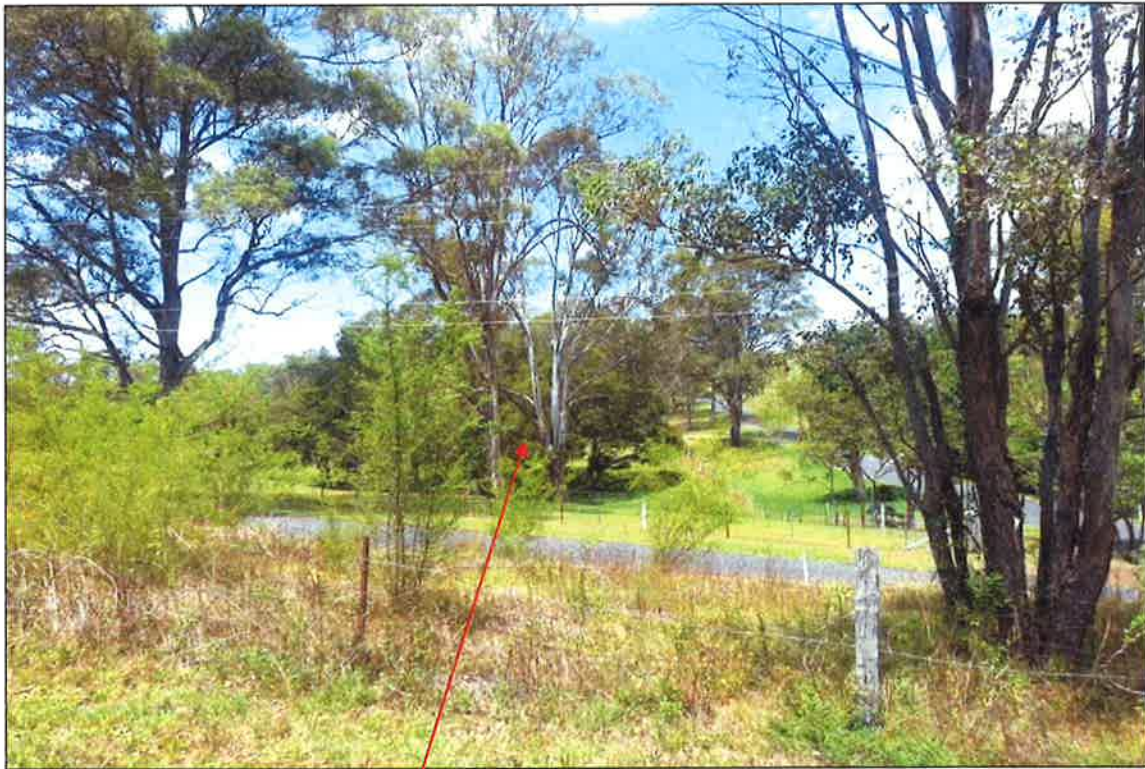
South - To the south of the site is remnant vegetation of less than a hectare with a downslope of 0-5°. A separation of 19m in the form of the road occurs.

Figure 24. Vegetation to the South, remnant vegetation across road.

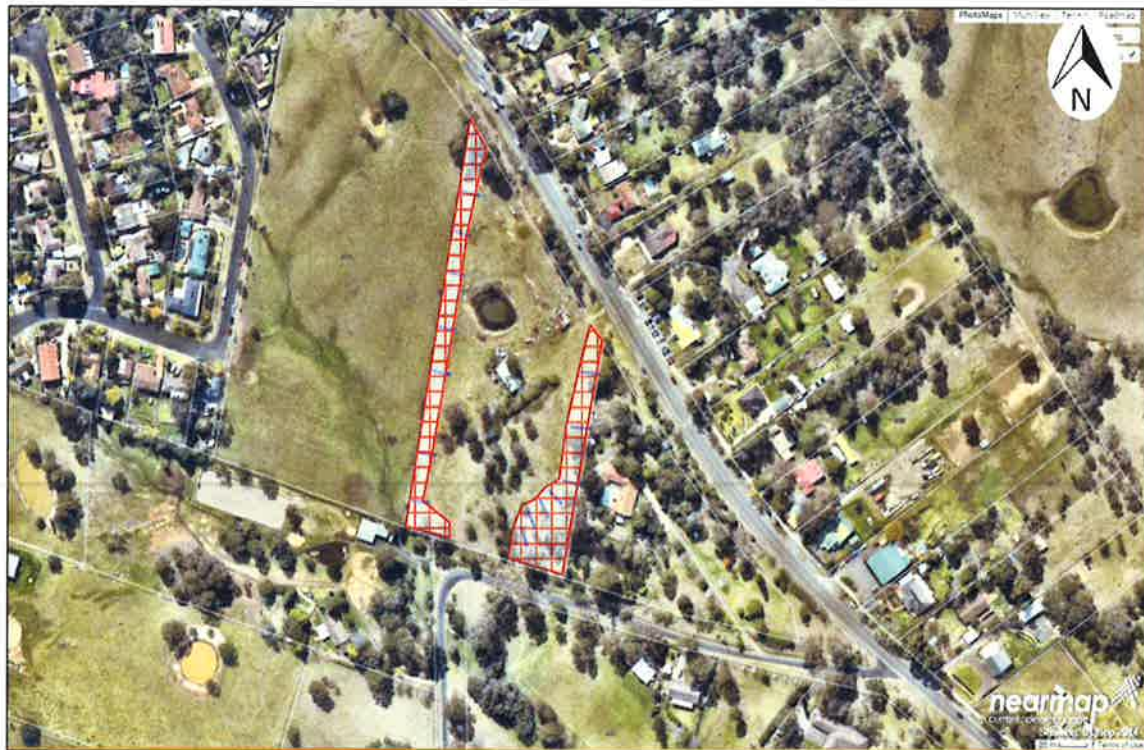
Figure 27 below details the proposed clearances for building envelopes in regard to the vegetation type and slope to ensure that the BAL does not exceed BAL 29.

Figure 26. Proposed APZ zone on the southern boundary and set back area surrounding watercourse to achieve a maximum BAL of BAL29 (Accessed via www.NearMap.com on the 2/12/2014)
