**G**EOTECHNIQUE<sup>®</sup>  
PTY LTD

re: **Proposed Commercial Development  
Lots 1 and 2 in DP1193931 - John Hines Avenue, Minchinbury  
Contamination Assessment Update**

13649/1-AA

Lots 1 and 2 in DP1193931 - John Hines Avenue, Minchinbury

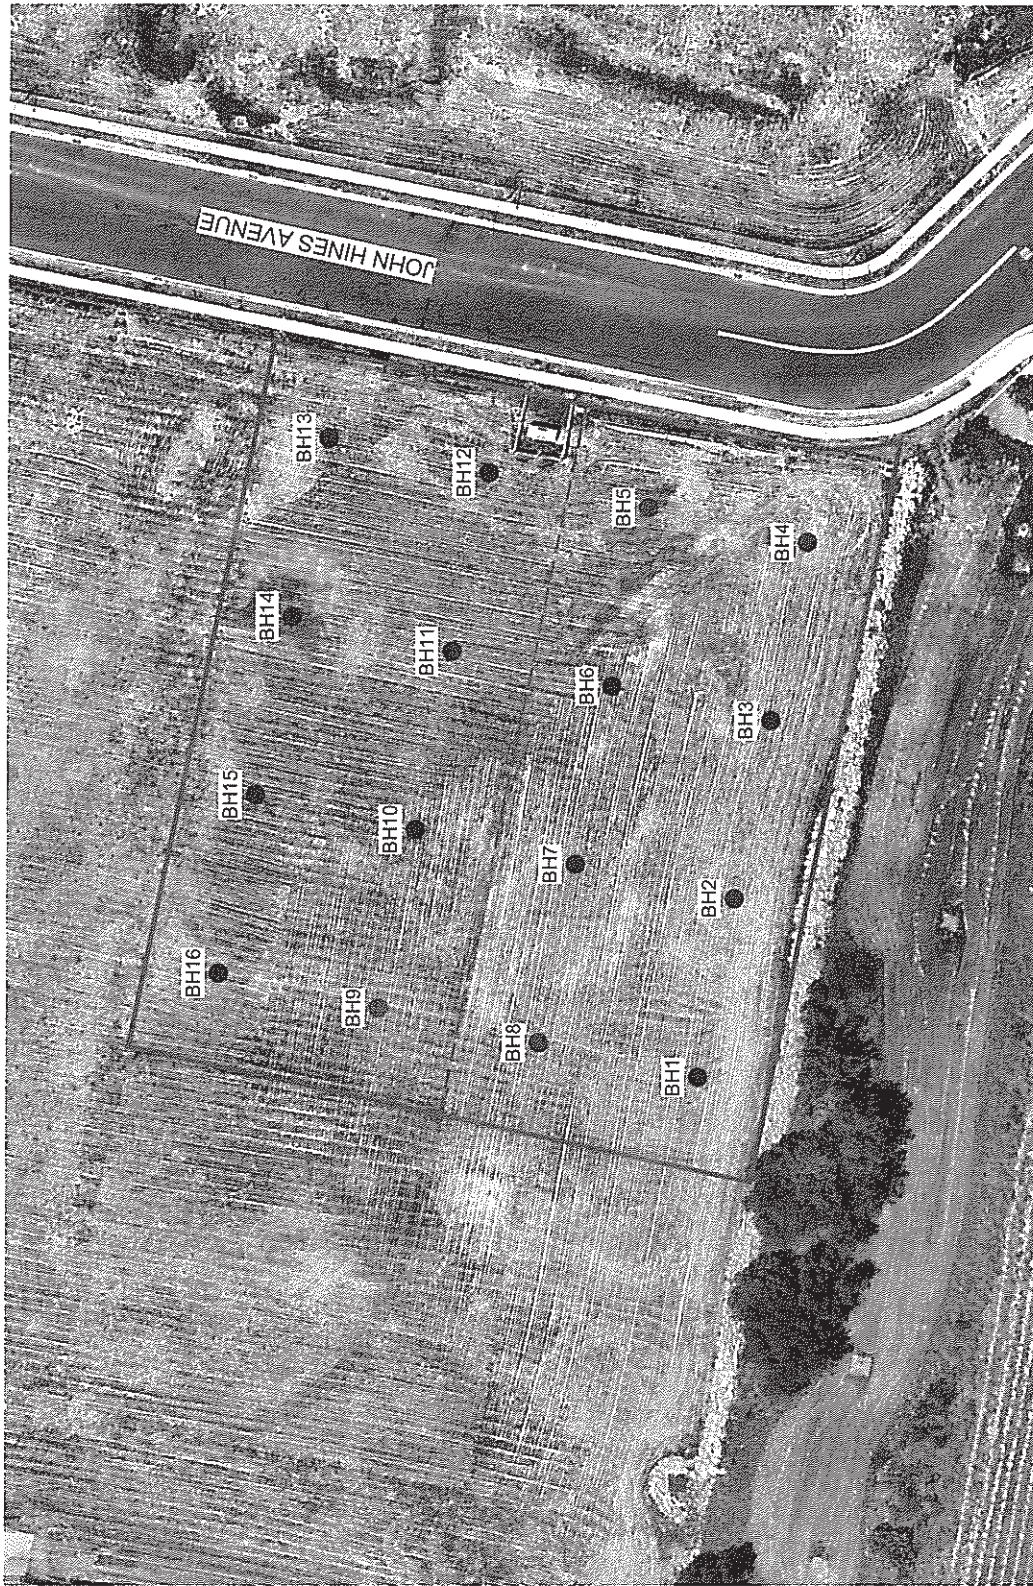
*13649/1-AA1*

As shown on Drawing No 13649/1-AA1, the site is rectangular in shape, measuring about 70m along the John Hines Avenue frontage, with a depth of about 80m along the northern boundary and covering an area of 5,610 square meters (m<sup>2</sup>).

In accordance with the NSW EPA "Sampling Design Guidelines for Contaminated Sites", for a site area of 5,610 m<sup>2</sup>, fifteen sampling points are required. Sixteen boreholes (BH1 to BH16) as shown on Drawing No 13649/1-AA1 in Attachment C were systematically drilled to depths ranging from about 0.8m to 1.5m below the existing ground level across the site, which cover the layer of fill placed in June 2014. A number of representative fill samples were recovered.

*Borehole Locations*
