Preliminary Site Investigation and  
Preliminary Acid Sulfate Soils  
Assessment:  
Sydney Polo Club  
Planning Proposal,  
Richmond Lowlands, NSW

P1605208JR02V01  
April 2016

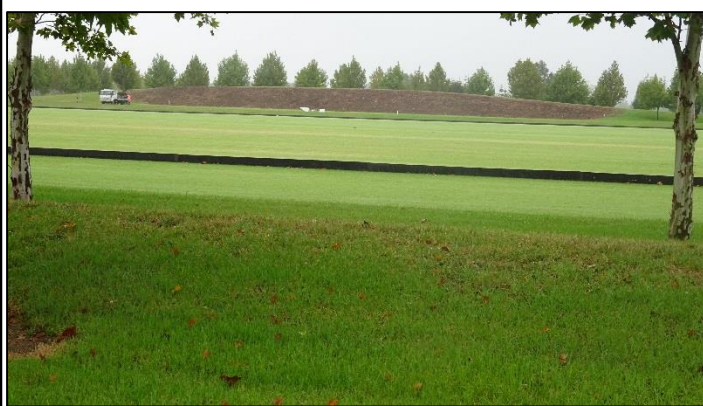
- A large fill embankment is located near the southwestern boundary of the Sydney Polo Club property, Client advises fill sourced from levelling of adjacent polo field. Embankment volume approximately 2,400 m<sup>3</sup>.

**Plate 3:** View of constructed mound, facing northeast.

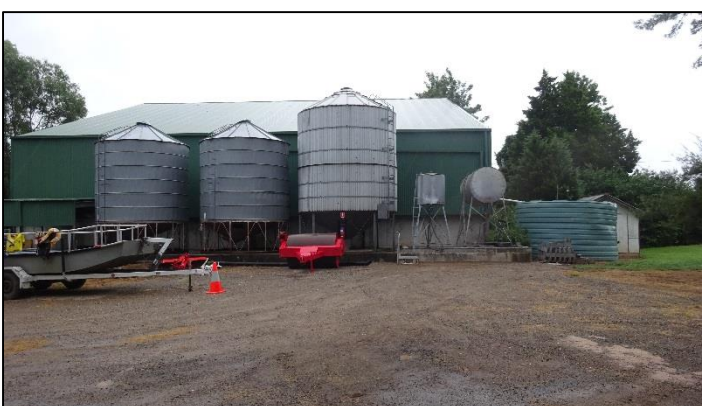
- Two metal above ground storage tanks (ASTs) labelled 'Diesel' and 'Unleaded' north of the maintenance shed. Tanks are with a concrete bund in good condition, with some staining.

- A third metal AST on unbunded concrete pad is located east of the tanks above. It likely also used for storage of fuel.
- Three metal feed silos are located north of the maintenance shed.

**Plate 4:** Two metal ASTs and three metal feed silos north of maintenance shed.

- Several ASTs observed containing known (diesel and unleaded) and unknown content may have introduced contaminants to the soil. Bunding of two of the three ASTs mitigates this risk significantly.

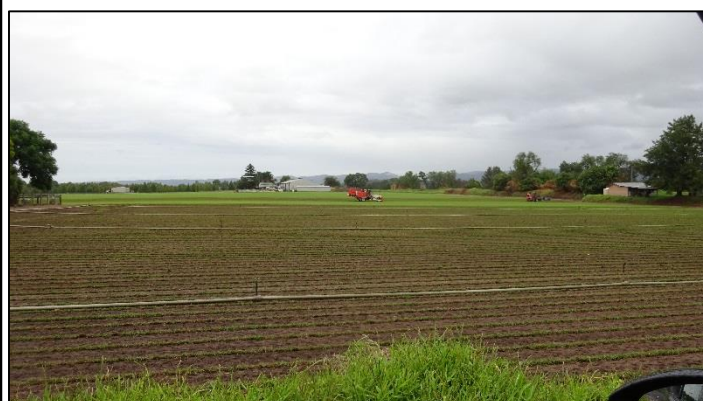
- Sunnybrook Barn is located near the northern boundary, and is used for functions.
- Turf farm located in northeastern portion of site, adjacent to Hawkesbury River.

**Plate 5:** Turf farm near northern boundary, view facing east.

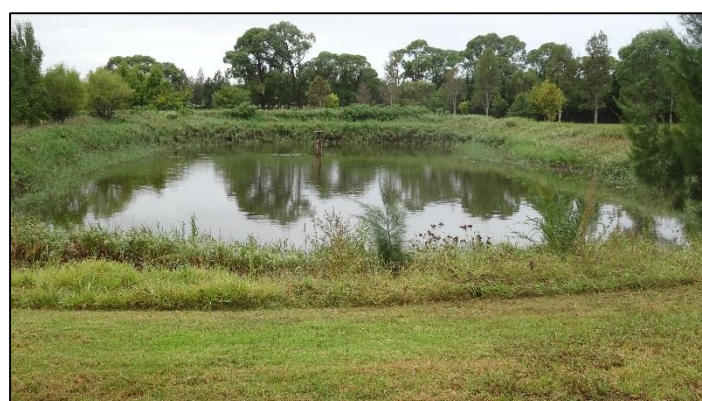
- Dam constructed as part of quarry rehabilitation is located near the site's northwestern boundary, currently located adjacent to polo fields.
- Cabins used as rural tourist accommodation are located near the site's northwestern boundary.

**Plate 6:** Former quarry dam in northwestern portion of site, view facing south.
