## PHASE 2 ENVIRONMENTAL SITE INVESTIGATION

10 Herbert Street, St Leonards, NSW

12/09/2013

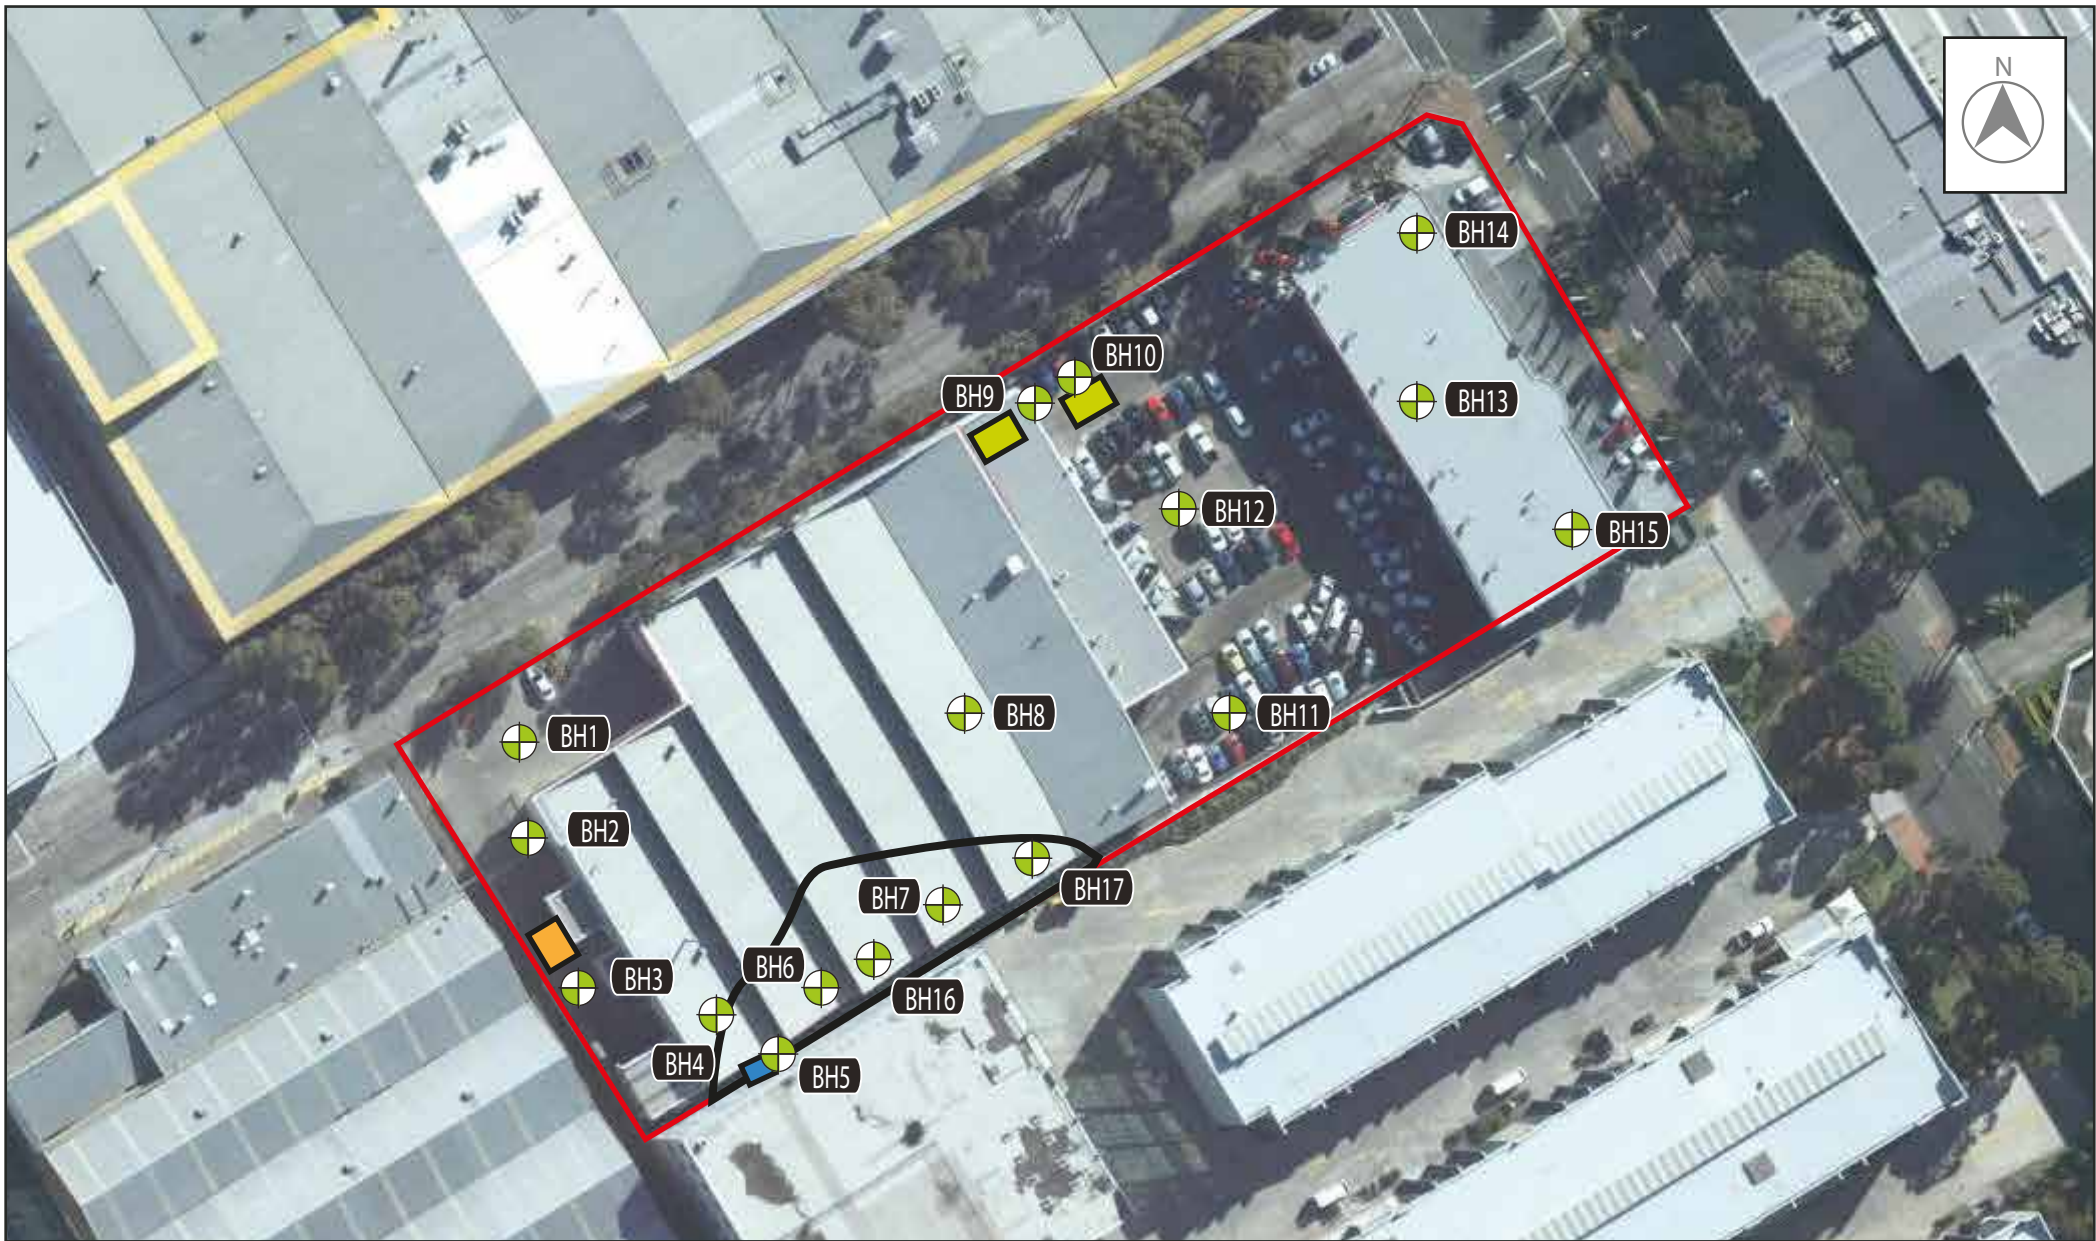
- Site Boundary
- Operational UST
- Non-Operational UST
- Oil / Water Separator
- Approximate Lateral Extent of Former Quarry Area on Property
- BH1 Borehole Location

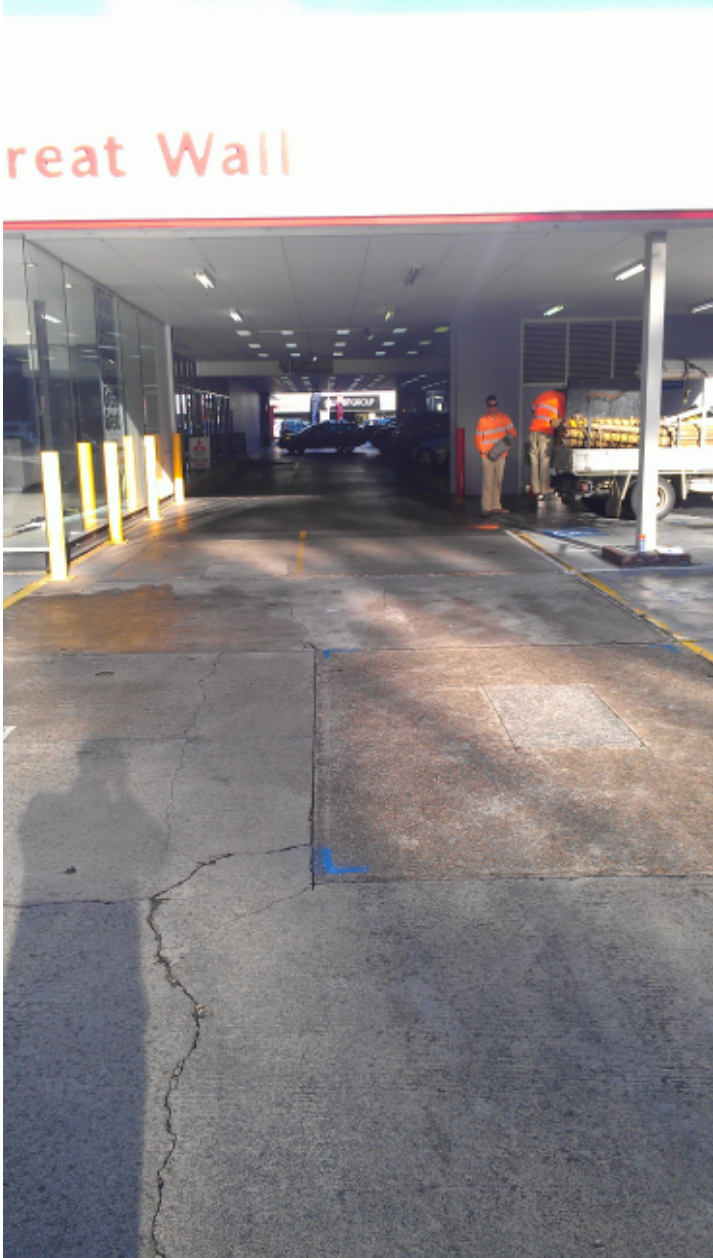
In addition, WSP (2013) identified a potential fill/dip point associated with an underground storage tank (UST) to the centre of the northern boundary. No other infrastructure related to the potential USTs was observed (e.g. bowser, vent pipes) indicating that the potential USTs are no longer operational.

| Photo No. | Date | |
|---|---|---|
| <b>Description</b><br>View of potential non-operational UST location (blue paint) in the driveway in the central northern portion of the site adjacent Frederick Street.<br><br>No above ground infrastructure was observed. | | |

No aboveground infrastructure was observed in the vicinity of the non-operational USTs, GPR scanning indicated a sub-surface anomaly and there was evidence of concrete re-working. Based on these observations, WSP considers it likely that the two non-operational USTs have been decommissioned in situ.

WSP also considers that the site is likely to be suitable for residential landuse with accessible soils or limited access to soils. WSP recommends that a further assessment of site specific risks is completed once the proposed use and site layout is developed for this land use scenario. It is also recommended that all USTs be removed prior to Site redevelopment for residential use.

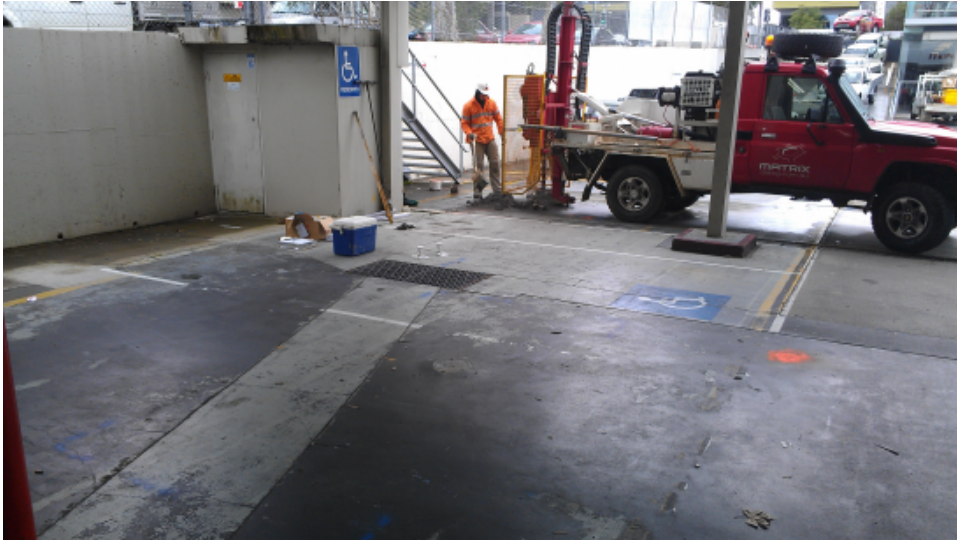
The location of one of the potential USTs was identified by visual evidence of concrete cutting and replacement. A scan completed with ground penetrating radar (GPR) confirmed a sub-surface anomaly beneath the concrete cut, which could potentially indicate that a UST is still present (likely decommissioned in-situ) or that the UST has historically been removed and the anomaly is indicative of back-fill material. No fill or dip points were observed.

| Photo No. | Date | |
|---|---|---|
| <b>Description</b><br>View of potential non-operational UST location (blue paint) beneath the car park awning in the central northern portion of the site adjacent Frederick Street.<br><br>No above ground infrastructure was observed. | | |

Whilst the decommissioned status of the two non-operational USTs is unknown, it is noted that no aboveground infrastructure was observed at the site and evidence suggests that previous works have been completed in the vicinity of the USTs. As such, WSP consider it reasonable to conclude that the USTs have been historically decommissioned in-situ.

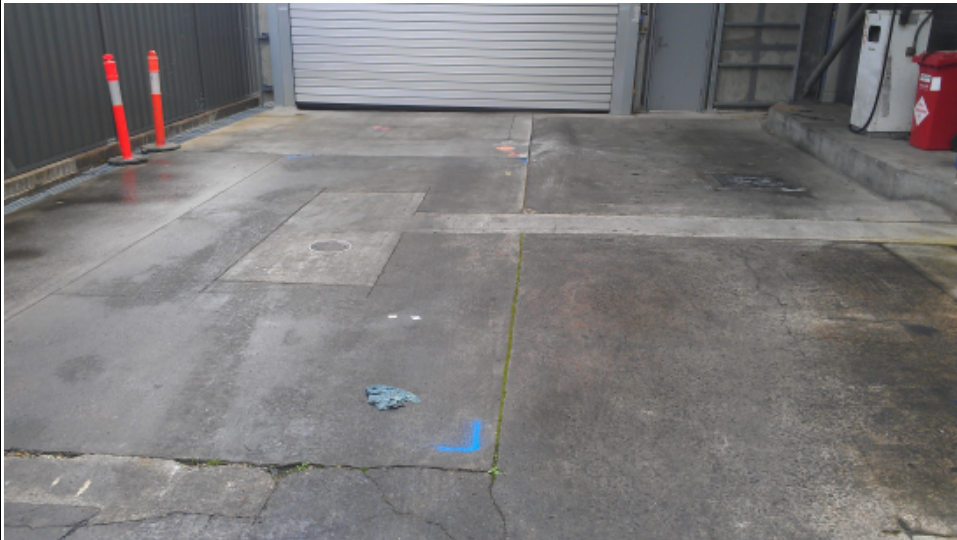
| Photo No. | Date | |
|---|---|---|
| 3 | 9 July 2013 | |

| Photo No. | Date | |
|---|---|---|
| <b>Description</b><br>View of the operational UST location (blue paint) in the western portion of the site.<br><br>The bunded bowser area can be seen to the east of the UST. | | |

- The test was conducted in association within one 22,500 litre underground tank containing unleaded fuel (Note: WSP assumes this to be the tank located adjacent to the western Site boundary);
- The tank showed no signs of air or water ingress or excessive vacuum decay and no audible faults were detected;
- The tank tested tight;
- The Precision Tank Test used during the assessment exceeded the U.S. EPA required leak detection criteria of 0.38 Litres Per Hour (LPH); and
- Unleaded suction line #1 off tank #1 passed hydrostatic pressure testing with a Final Leak Rate of -0.026 litres per hour.

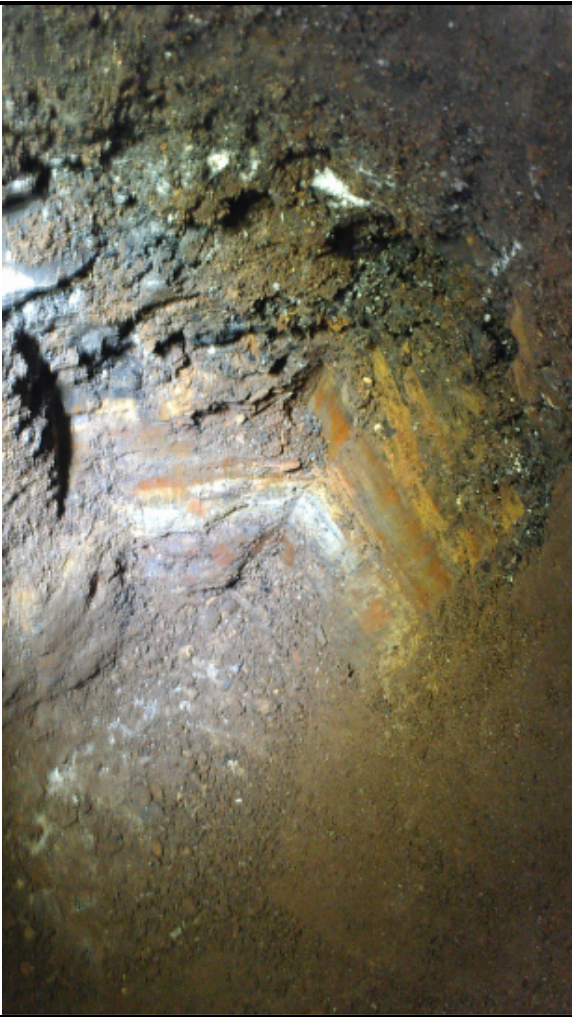
| Photo No. | Date | | |
|---|---|--|---|
| 4 | 10 July 2013 | | |

| Photo No. | Date | | |
|---|---|--|---|
| <b>Description</b><br><br>View of BH6. The natural shale underlying sandy and clayey fill material can be seen. | | | |

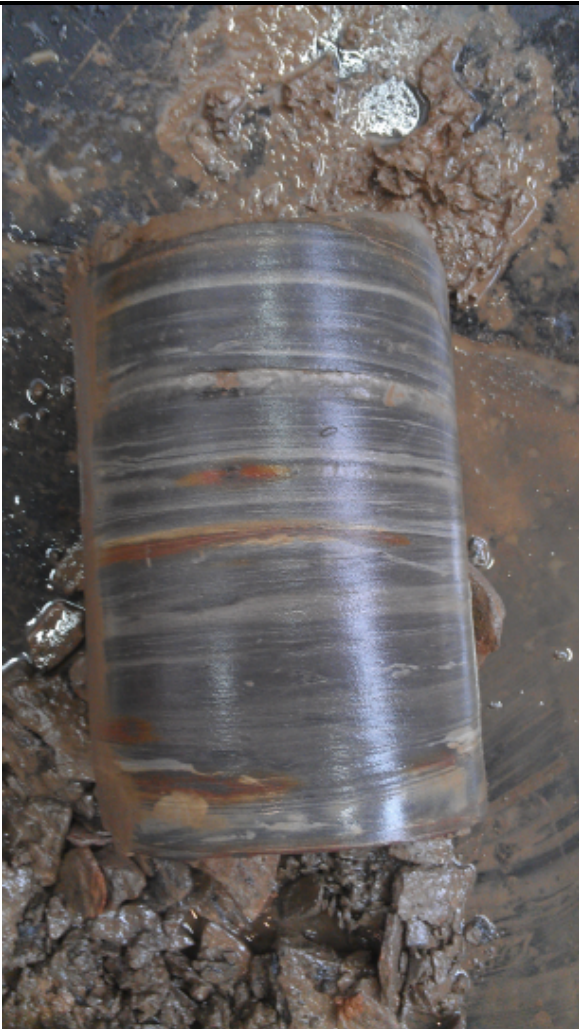
| Photo No. | Date | | |
|---|---|---|--|
| 5 | 10 July 2013 | | |

| Photo No. | Date | | |
|---|---|---|--|
| <b>Description</b><br><br>View of a portion of the shale core from BH16. | | | |
