## PHASE 1 ENVIRONMENTAL DUE DILIGENCE ASSESSMENT (EDD)

10 Herbert Street, St Leonards, NSW  
Napier & Blakeley Pty Ltd

12/09/2013

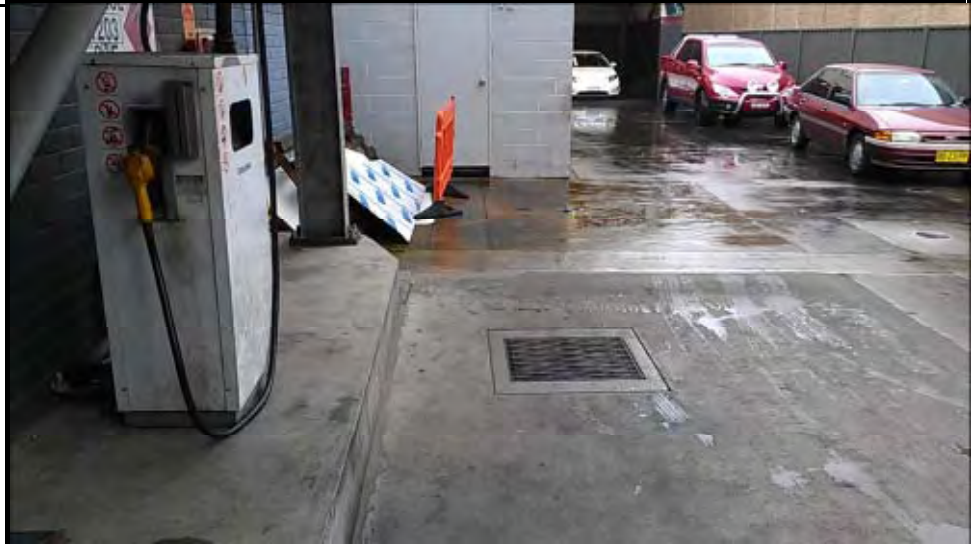
- Although bunding was provided within the refuelling area to the south of the fuel bowser, a metal grilled pit was identified within the bunded area (Photos 1 and 2 within Appendix B) and liquid was noted within the pit – depth unknown. No further information was obtained as to:

Bunded area surrounding bowser. Note metal grilled covered pit.

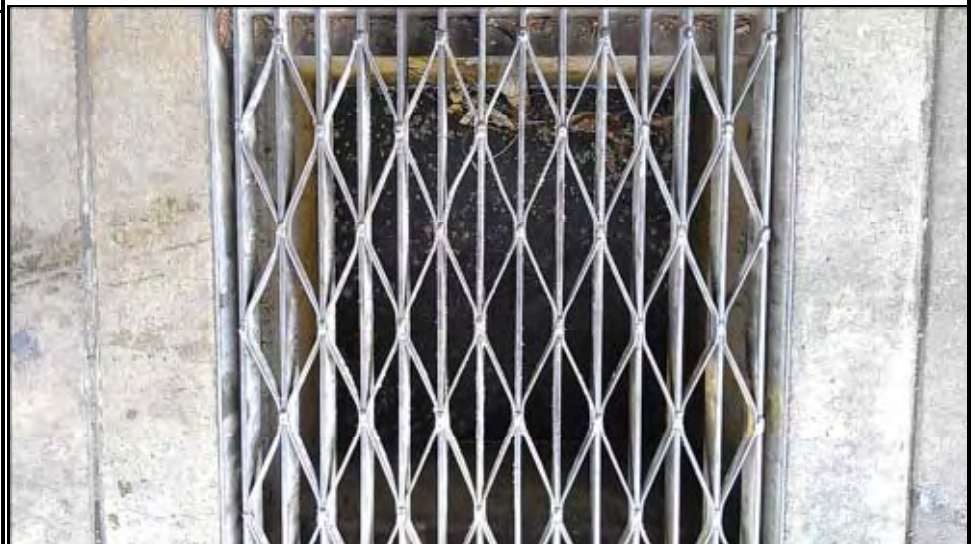
2

Metal grill covered pit within bunded area surrounding bowser. Note liquid within pit.

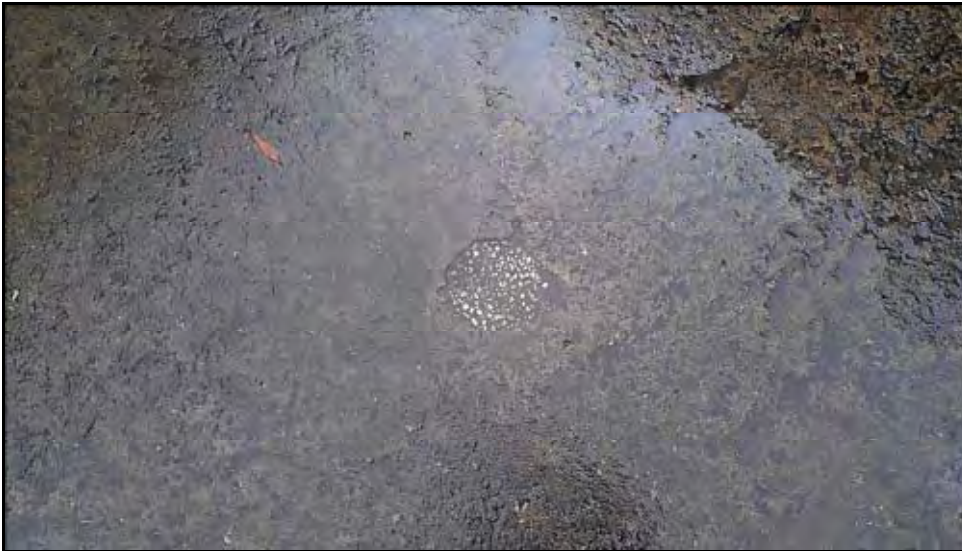
| Photo No. | Date | |
|---|---|---|
| 3 | 3 July 2013 | |

| Photo No. | Date | |
|---|---|---|
| <b>Description</b><br>Potential borehole location of previous soil and/or groundwater investigation within vicinity of UST and wash down bay. | | |

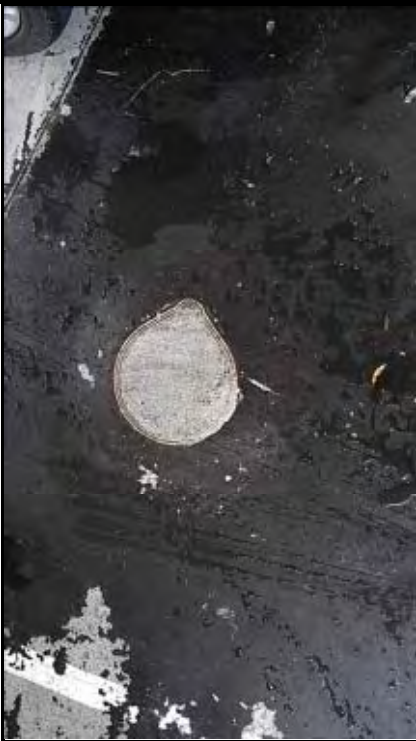
| Photo No. | Date | |
|---|---|---|
| 4 | 3 July 2013 | |

| Photo No. | Date | |
|---|---|---|
| <b>Description</b><br>Potential fill/dip point of additional UST to centre of northern boundary. | | |

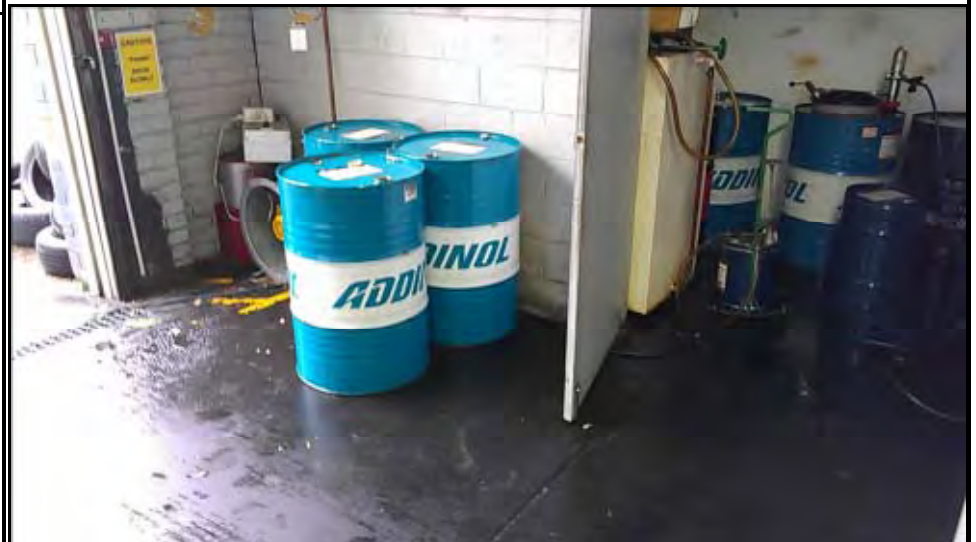
6

- Significant quantities of oil and lubricants were located within the vehicle service centre, including large above ground storage tanks and within a Main Oil Storeroom to the south eastern corner of the vehicle maintenance area. Moderate levels of oil/lubricant were noted to the storeroom floor and at least one 44 gallon drum appeared to be overflowing with oil due to a pump transferring oil into the drum. This room was not bunded and was adjacent to an open drain (Photos 6, 7 and 8 within Appendix B).

Main Oil Storeroom – note open drain to roller door

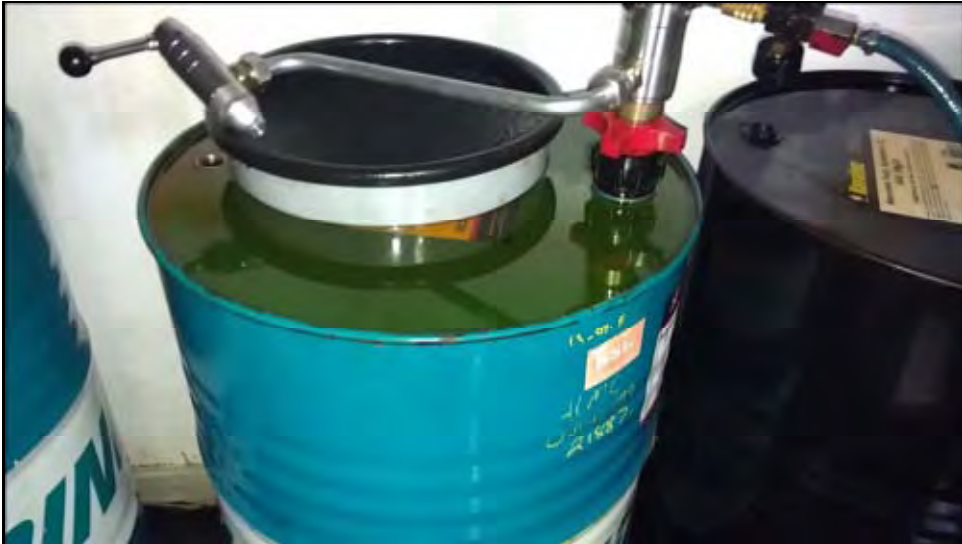
| Photo No. | Date | |
|---|---|---|
| 7 | 3 July 2013 | |

Although the majority of stored oil and lubricants were stored in adequate containers and aboveground storage tanks, a moderate quantity of oil/lubricant was noted to the concrete floor of the Main Oil Storeroom. This is considered to be the result of an "overflowing" 44 gallon drum and several incorrectly stored drums. The storeroom did not contain secondary containment and an open drain was located within close proximity. A potential remains for hydrocarbon based liquids to enter the open drain and migrate into the surrounding environment.

| Photo No. | Date | |
|---|---|---|
| <b>Description</b><br>Overflowing 44 gallon drum within Main Oil Store. | | |

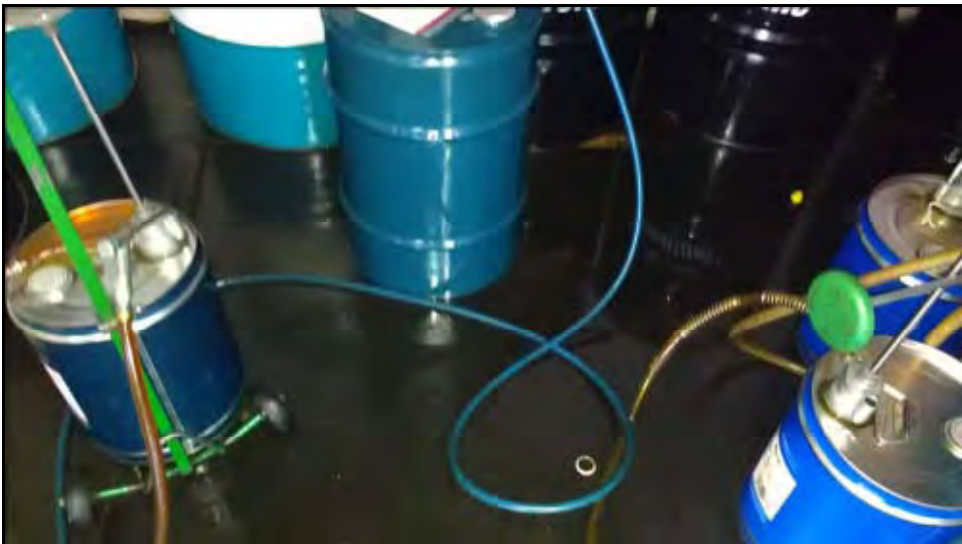
| Photo No. | Date | |
|---|---|---|
| 8 | 3 July 2013 | |

| Photo No. | Date | |
|---|---|---|
| <b>Description</b><br>Oil/lubricant to concrete floor of Main Oil Store. | | |

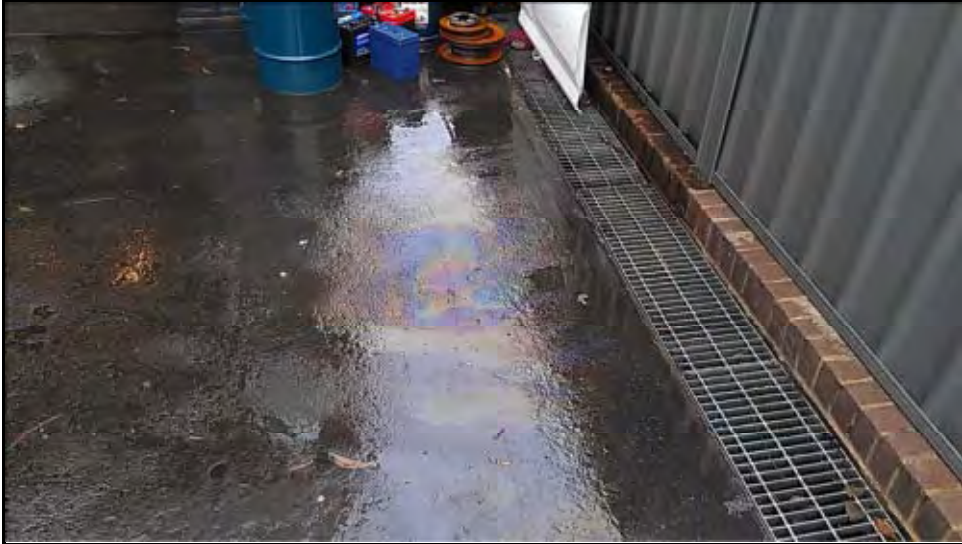
| Photo No. | Date | |
|---|---|---|
| 9 | 3 July 2013 | |

Hydrocarbon sheens were noted to several locations throughout the Site, and in particular to the western half of the Site. These sheens are considered to be the result of the inadequate storage and leaks and spills of hydrocarbon based products. The sheens were identified in areas adjacent to open drains and no information was provided regarding the discharge point for the drainage network. A potential remains that the leaks and spills have entered the surrounding environment through the open drains and cracks/penetrations within the concrete/asphalt hardstand.

| Photo No. | Date | |
|---|---|---|
| <b>Description</b><br>Hydrocarbon sheen to open drain adjacent to wash down bay. | | |

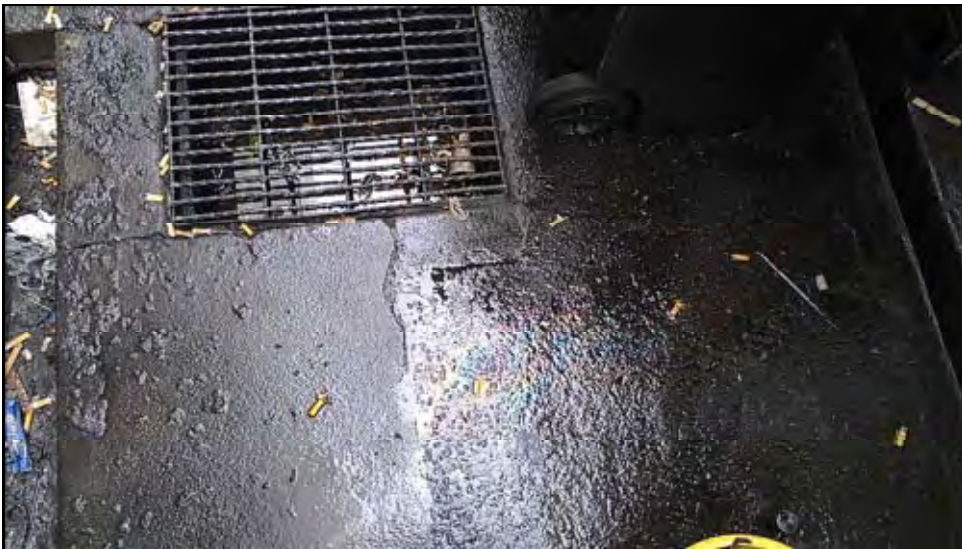
| Photo No. | Date | |
|---|---|---|
| 10 | 3 July 2013 | |

| Photo No. | Date | |
|---|---|---|
| <b>Description</b><br>Hydrocarbon sheen to open drain adjacent to Oil/Water Separator. | | |

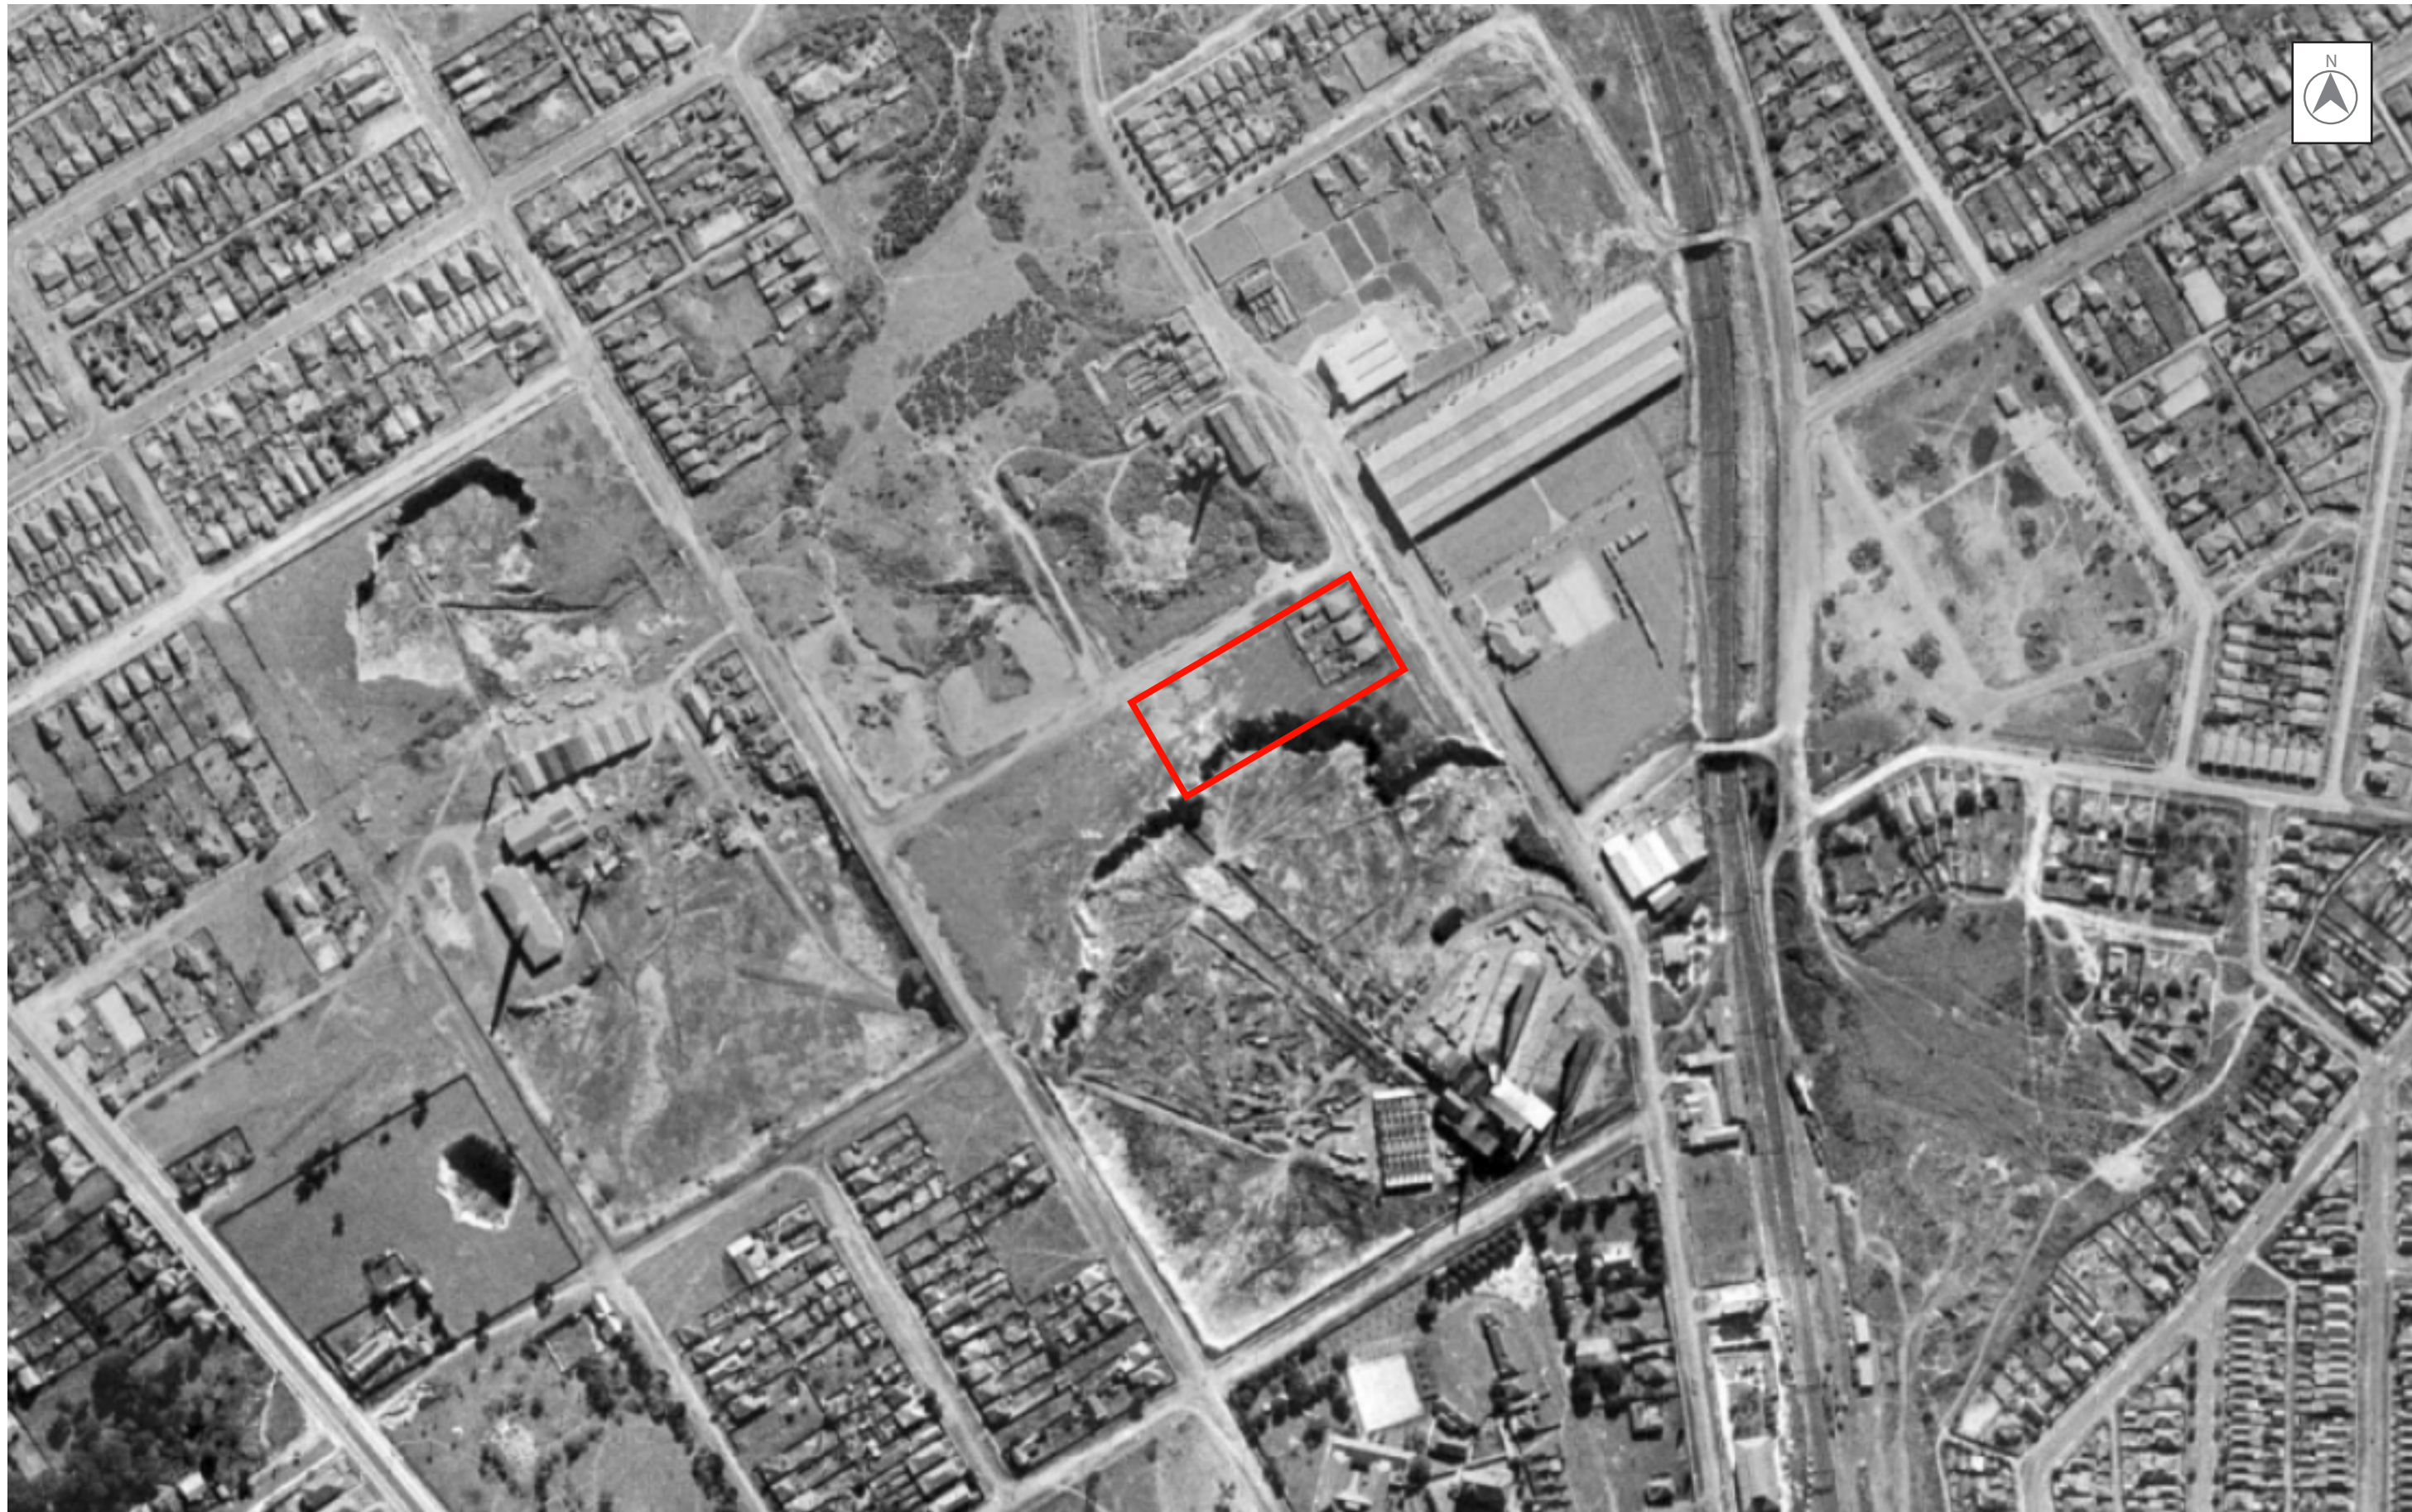
Aerial Photograph (1965)

From 1965 the Site had been developed to include a large warehouse within the western half and open air car park and an additional building to the east, south east. The Site remained relatively unchanged until at least 1986. By 1999 the eastern boundary building had been extended and minor changes were noted to the warehouse building.
