# Heritage Impact Statement

No. 95 Great Southern Road, Bargo  
May 2017

**Weir  
Phillips**  
Heritage

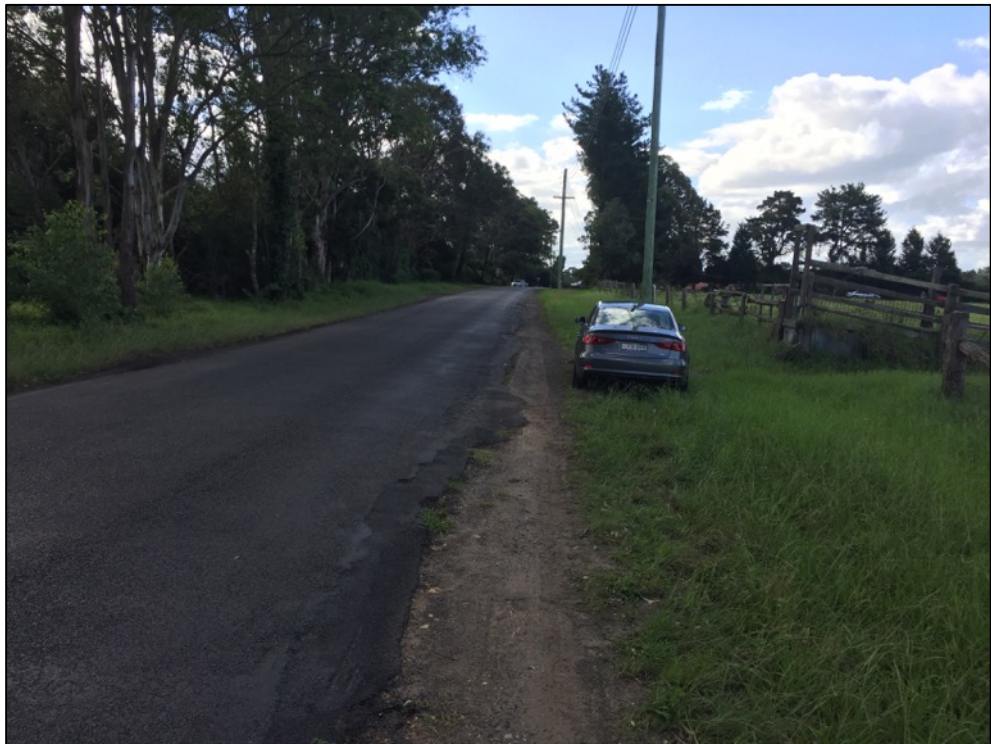
**Figure 3: Looking north along Great Southern Road. Note the stock ramp at the front of the site.**

The stock path is also typical of vernacular stock ramps. It also is of little heritage value.

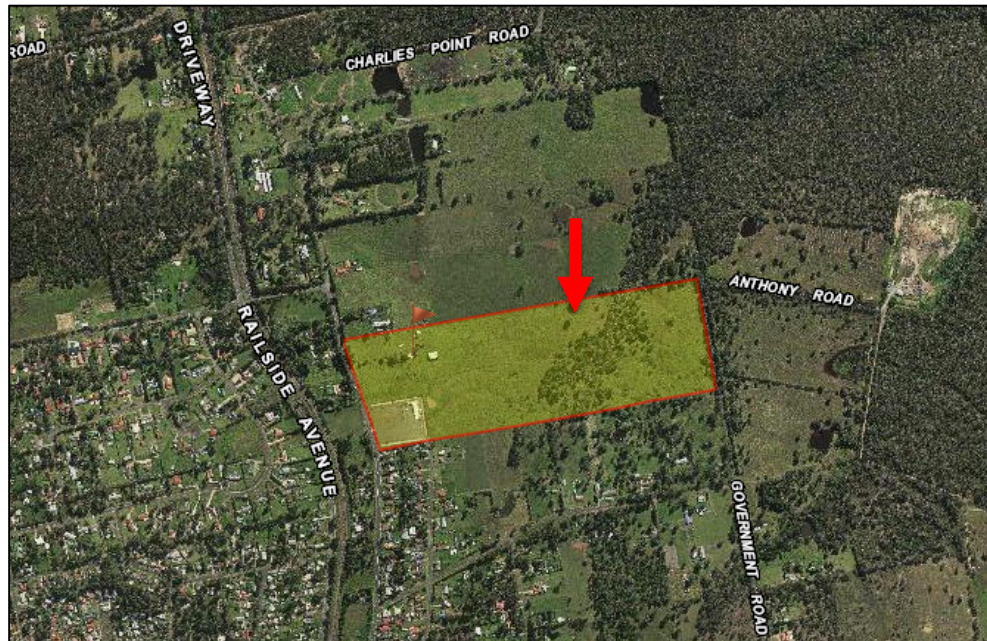
**Figure 4: An aerial photograph showing the subject site and its surrounds.**

For the following, refer to Figure 4, an aerial photograph over the site, and to the survey that accompanies this application.

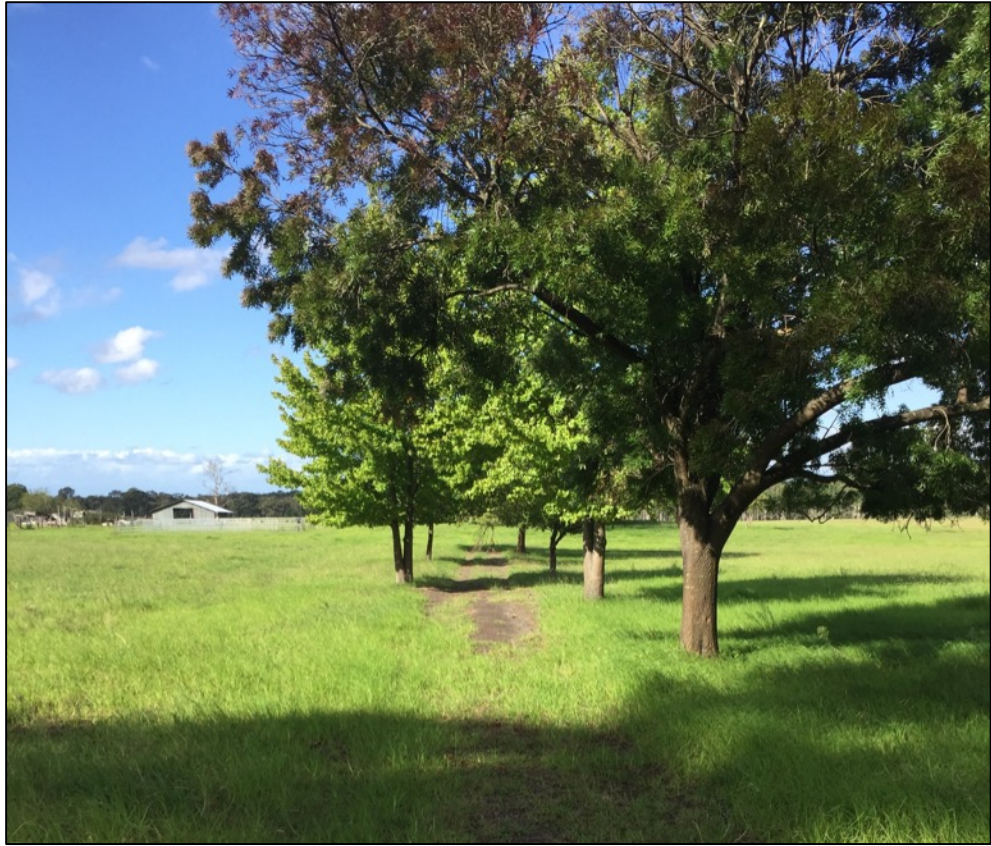
The subject site boundary adjoins the Great Southern Road. Next to the entrance gates are the ruins of a stock yard and ramp. The entrance driveway is lined with an avenue of trees and cleared paddocks to both sides. (Figure 5).

**Figure 5: The driveway to the homestead and avenue of trees.**

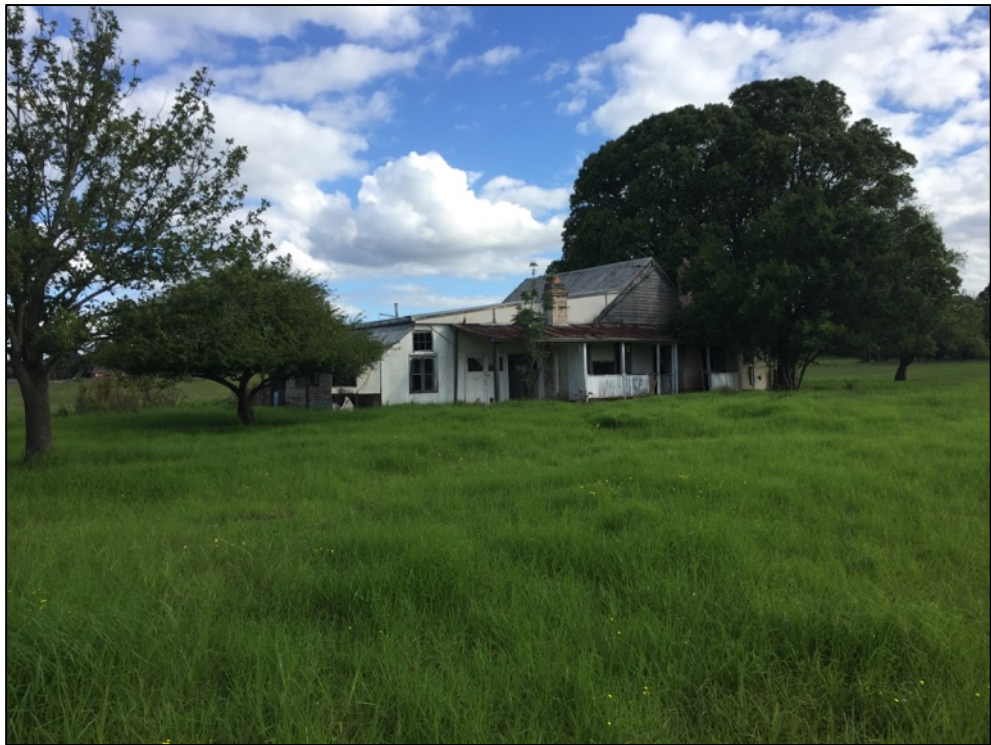
The driveway ends at the Old Coomeroo house, a cottage constructed of a mix of slabs, weatherboard and asbestos cement sheet. The cottage has brick chimneys with the central chimney being constructed of a combination of concrete blocks, decorative concrete blocks and brick. (Figures 6 - 10). Between the house and a large steel shed (Figure 11) there is a prominent brick silo (Figure 12). To the north of the silo is a concrete Octagonal cement slab, probably the remains of another silo, and an animal feeding shed.

**Figure 6: Old Cameroo Homestead.**

The cottage has undergone extensive and unsympathetic alteration over time. From the outset, it was poorly built, without adequate underfloor ventilation and damp proofing. Later additions made extensive use of asbestos cement. The building and its structure have not been maintained for many years.

The cottage, as outlined in previous reports, is in a parlous condition. Its original construction means that it is set right on the ground and to be made habitable would require lifting and replacement of almost every timber component. Extensive removal of asbestos cement sheeting would also be required. It is not viable to restore the cottage in a manner that would be true to the Burra Charter.

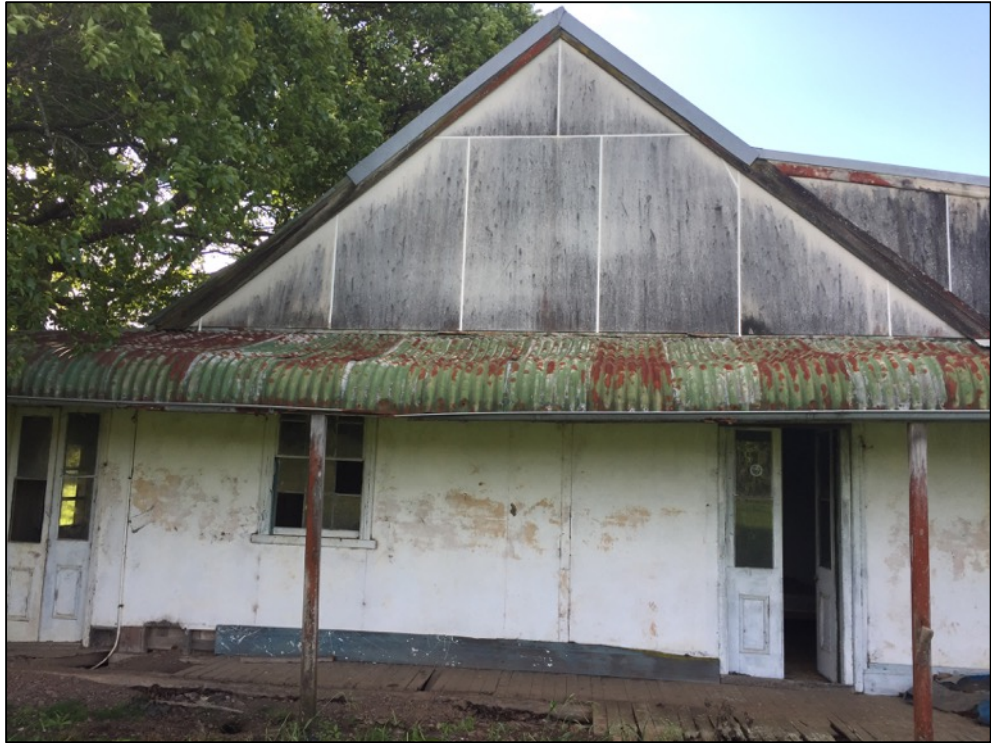
**Figure 7: A detail of the dilapidated state of the homestead.**

In general, Old Coomeroo is in very poor condition. The house is no longer habitable. Internal timbers on roof and floor are damaged. The brick chimneys are cracked and in disrepair. Verandah floorboards are missing and the floors in the interior of the house are broken/missing and appear unstable. There are holes in the external fibro walls. An independent condition assessment of the homestead has found it to have extensive rot and damage throughout, as well as extensive termite damage.

- (i) That the cottage be archivally recorded to Heritage Office standards.
- (ii) That the cottage be removed by contractor with an asbestos removal licence.
- (iii) That the cottage be interpreted as part of an interpretation strategy.

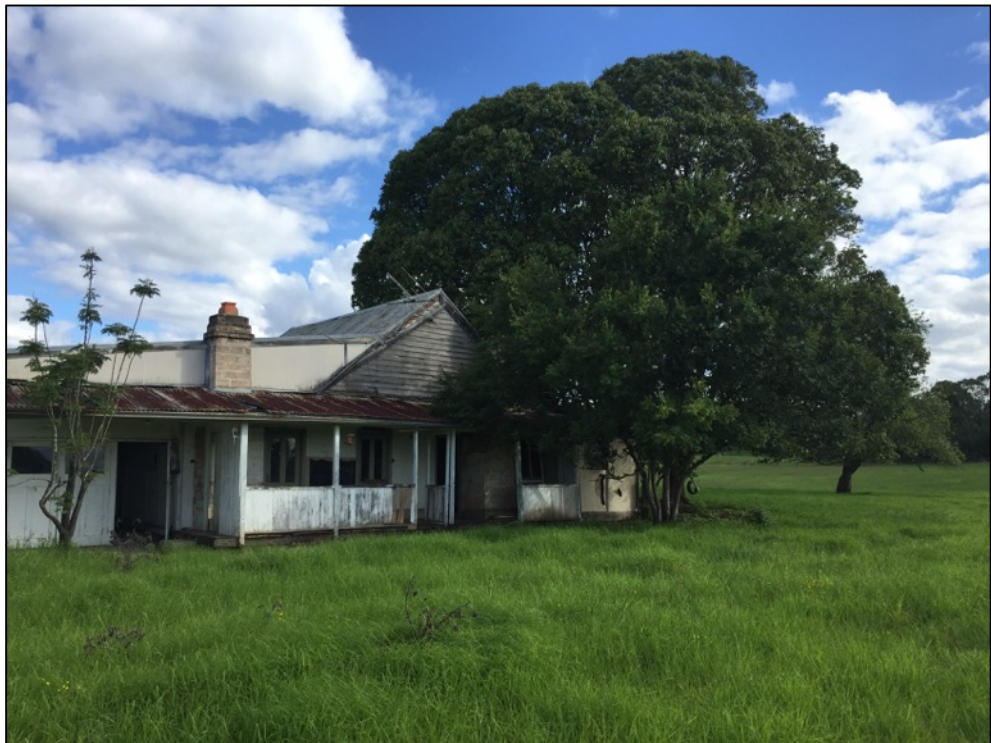
**Figure 8. The cottage viewed from the silo.**

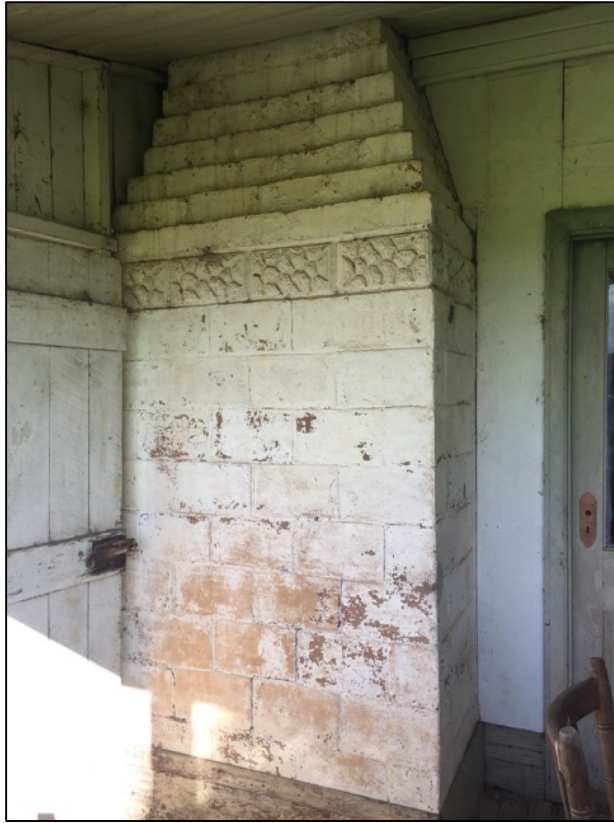
**Figure 9. Detail of the middle chimney.**

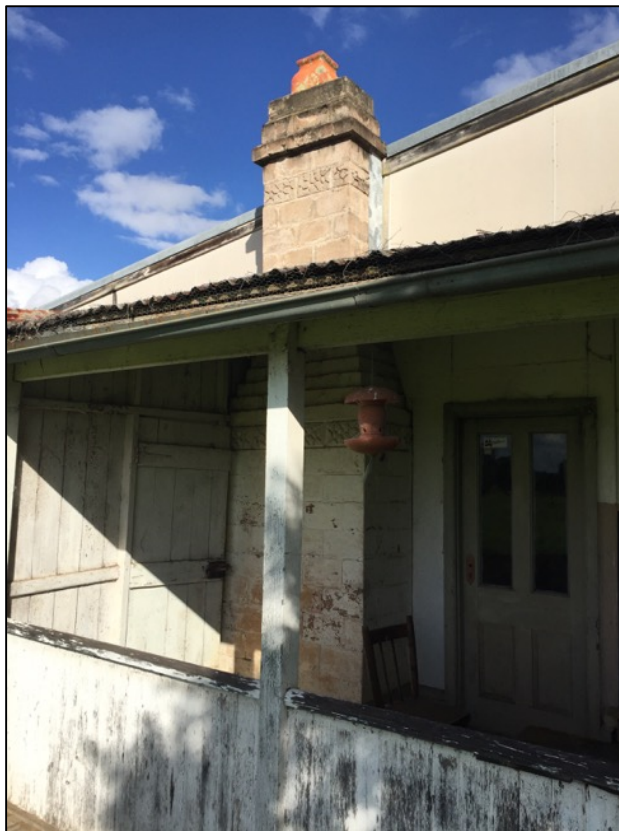
**Figure 10. Upper part of the middle chimney.**

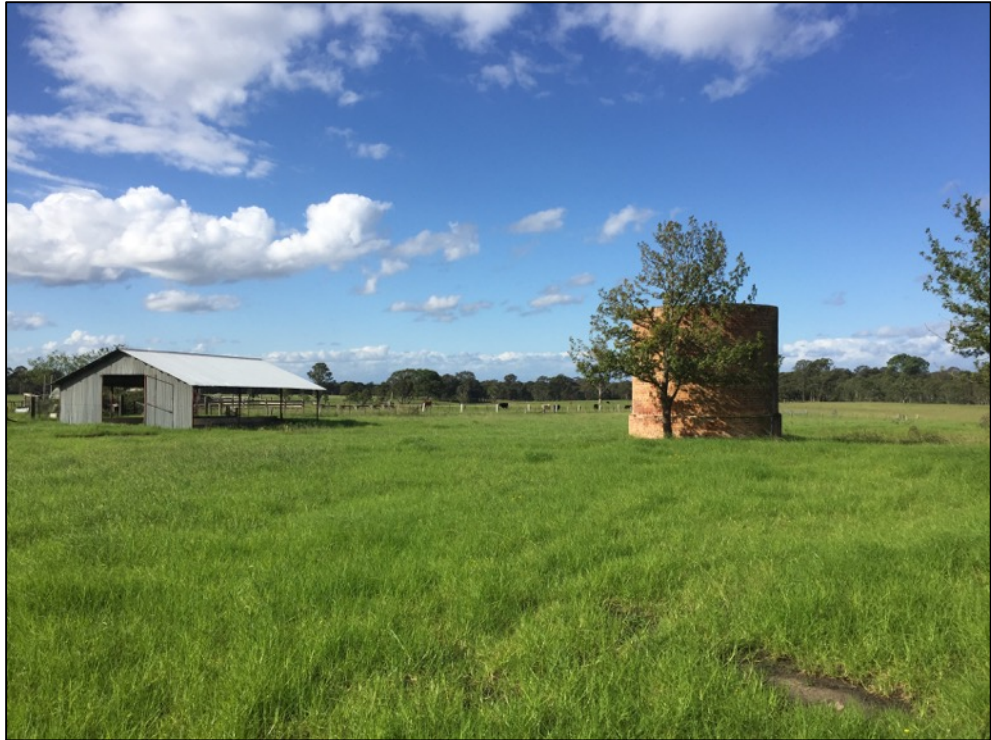
**Figure 11: The iron shed and brick silo.**

The steel shed dates from the latter part of the twentieth century. It is typical of sheds of the period. These sheds are represented throughout rural Australia. The shed of little or no heritage value.

The early timber slab buildings have been removed from the site. The remaining buildings are modern steel structures. These buildings add little to the narrative of the site, or to the themes that could be explored in the interpretation strategy. As part of future works to a site containing the silo and the cottage or its remains, these structures could be retained for use as public shelter or removed entirely.

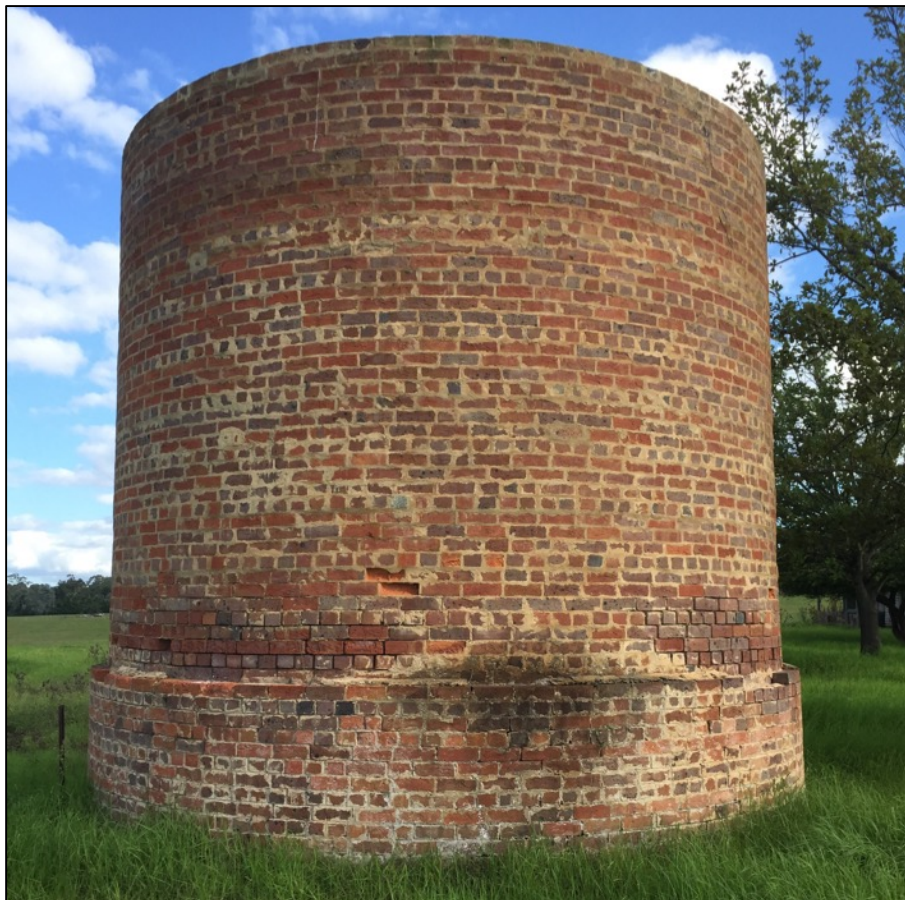
**Figure 12: A detail of the brick silo.**

The silo is an unusual structure in that it is not rendered and is of a larger diameter than a typical rural silo of the period. Recent illustrations indicate it had a gabled roof structure.

The silo is unusual as it is of face brick construction. Normally silos are rendered and have a corrugated iron gable roof to ensure a level of waterproofness. The simple gabled roof has been removed and the brickwork is slowly decaying.

The silo should be restored in the following manner:

- The gable roof should be reconstructed. There is sufficient evidence from recent photographs to carry out this work with little conjecture. Such roofs were of vernacular construction. (See Figure 18)
- The entrances to the silo should be secured for maintenance access only.
- Appropriate drainage should be put in place around the silo to ensure its stability and to, as best as possible, prevent further decay due to rising damp.

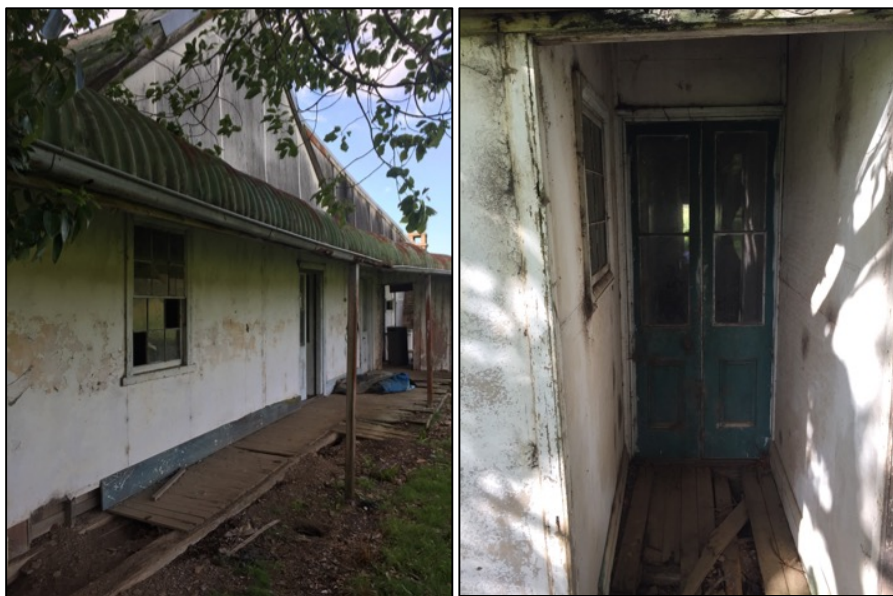
**Figures 14 and 15: Exterior photographs of the Old Coomeroo Homestead showing the extent of dilapidation.**

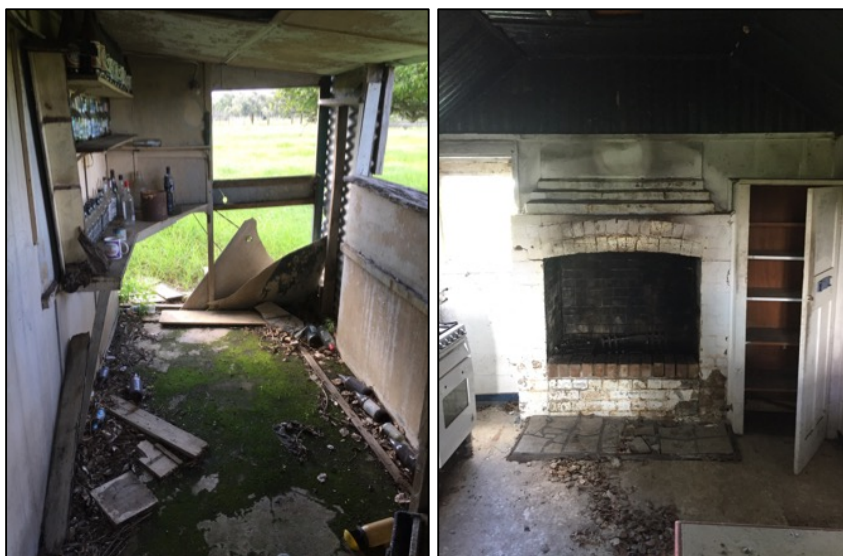
**Figure 16 and 17: Internal photographs showing poor condition of the homestead.**

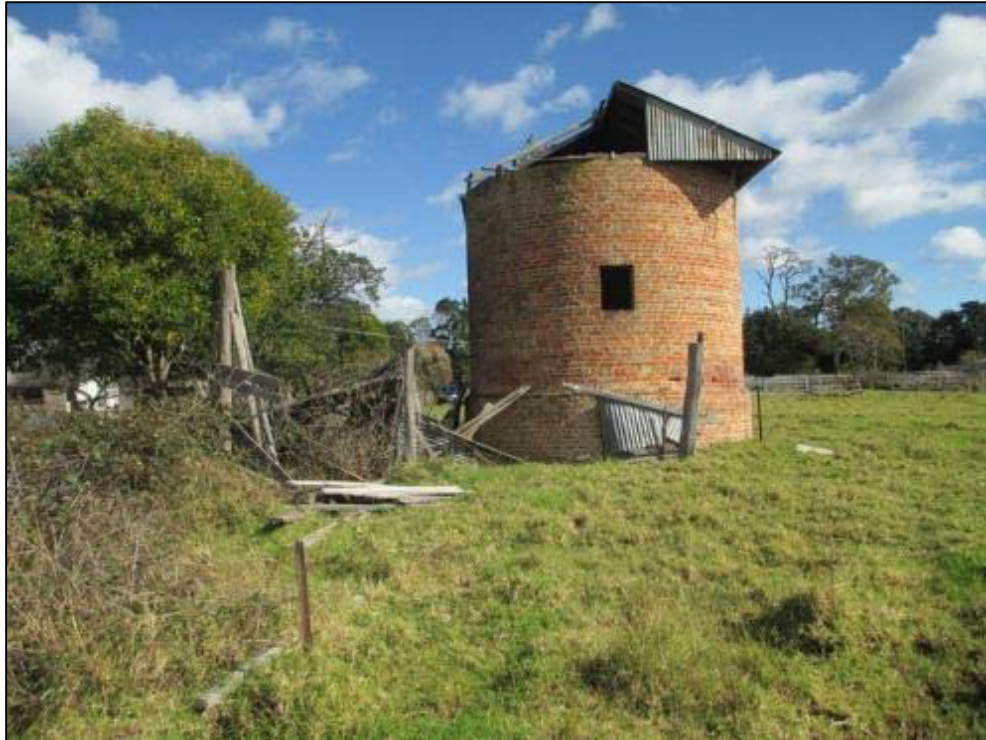
**Figure 18: A photograph taken in 2015 shows the gabled roof over the brick silo.**
