# Wastewater Assessment: Proposed subdivision application of 95 Great Southern Road, Bargo, NSW

P1504741JR07V01  
November 2016

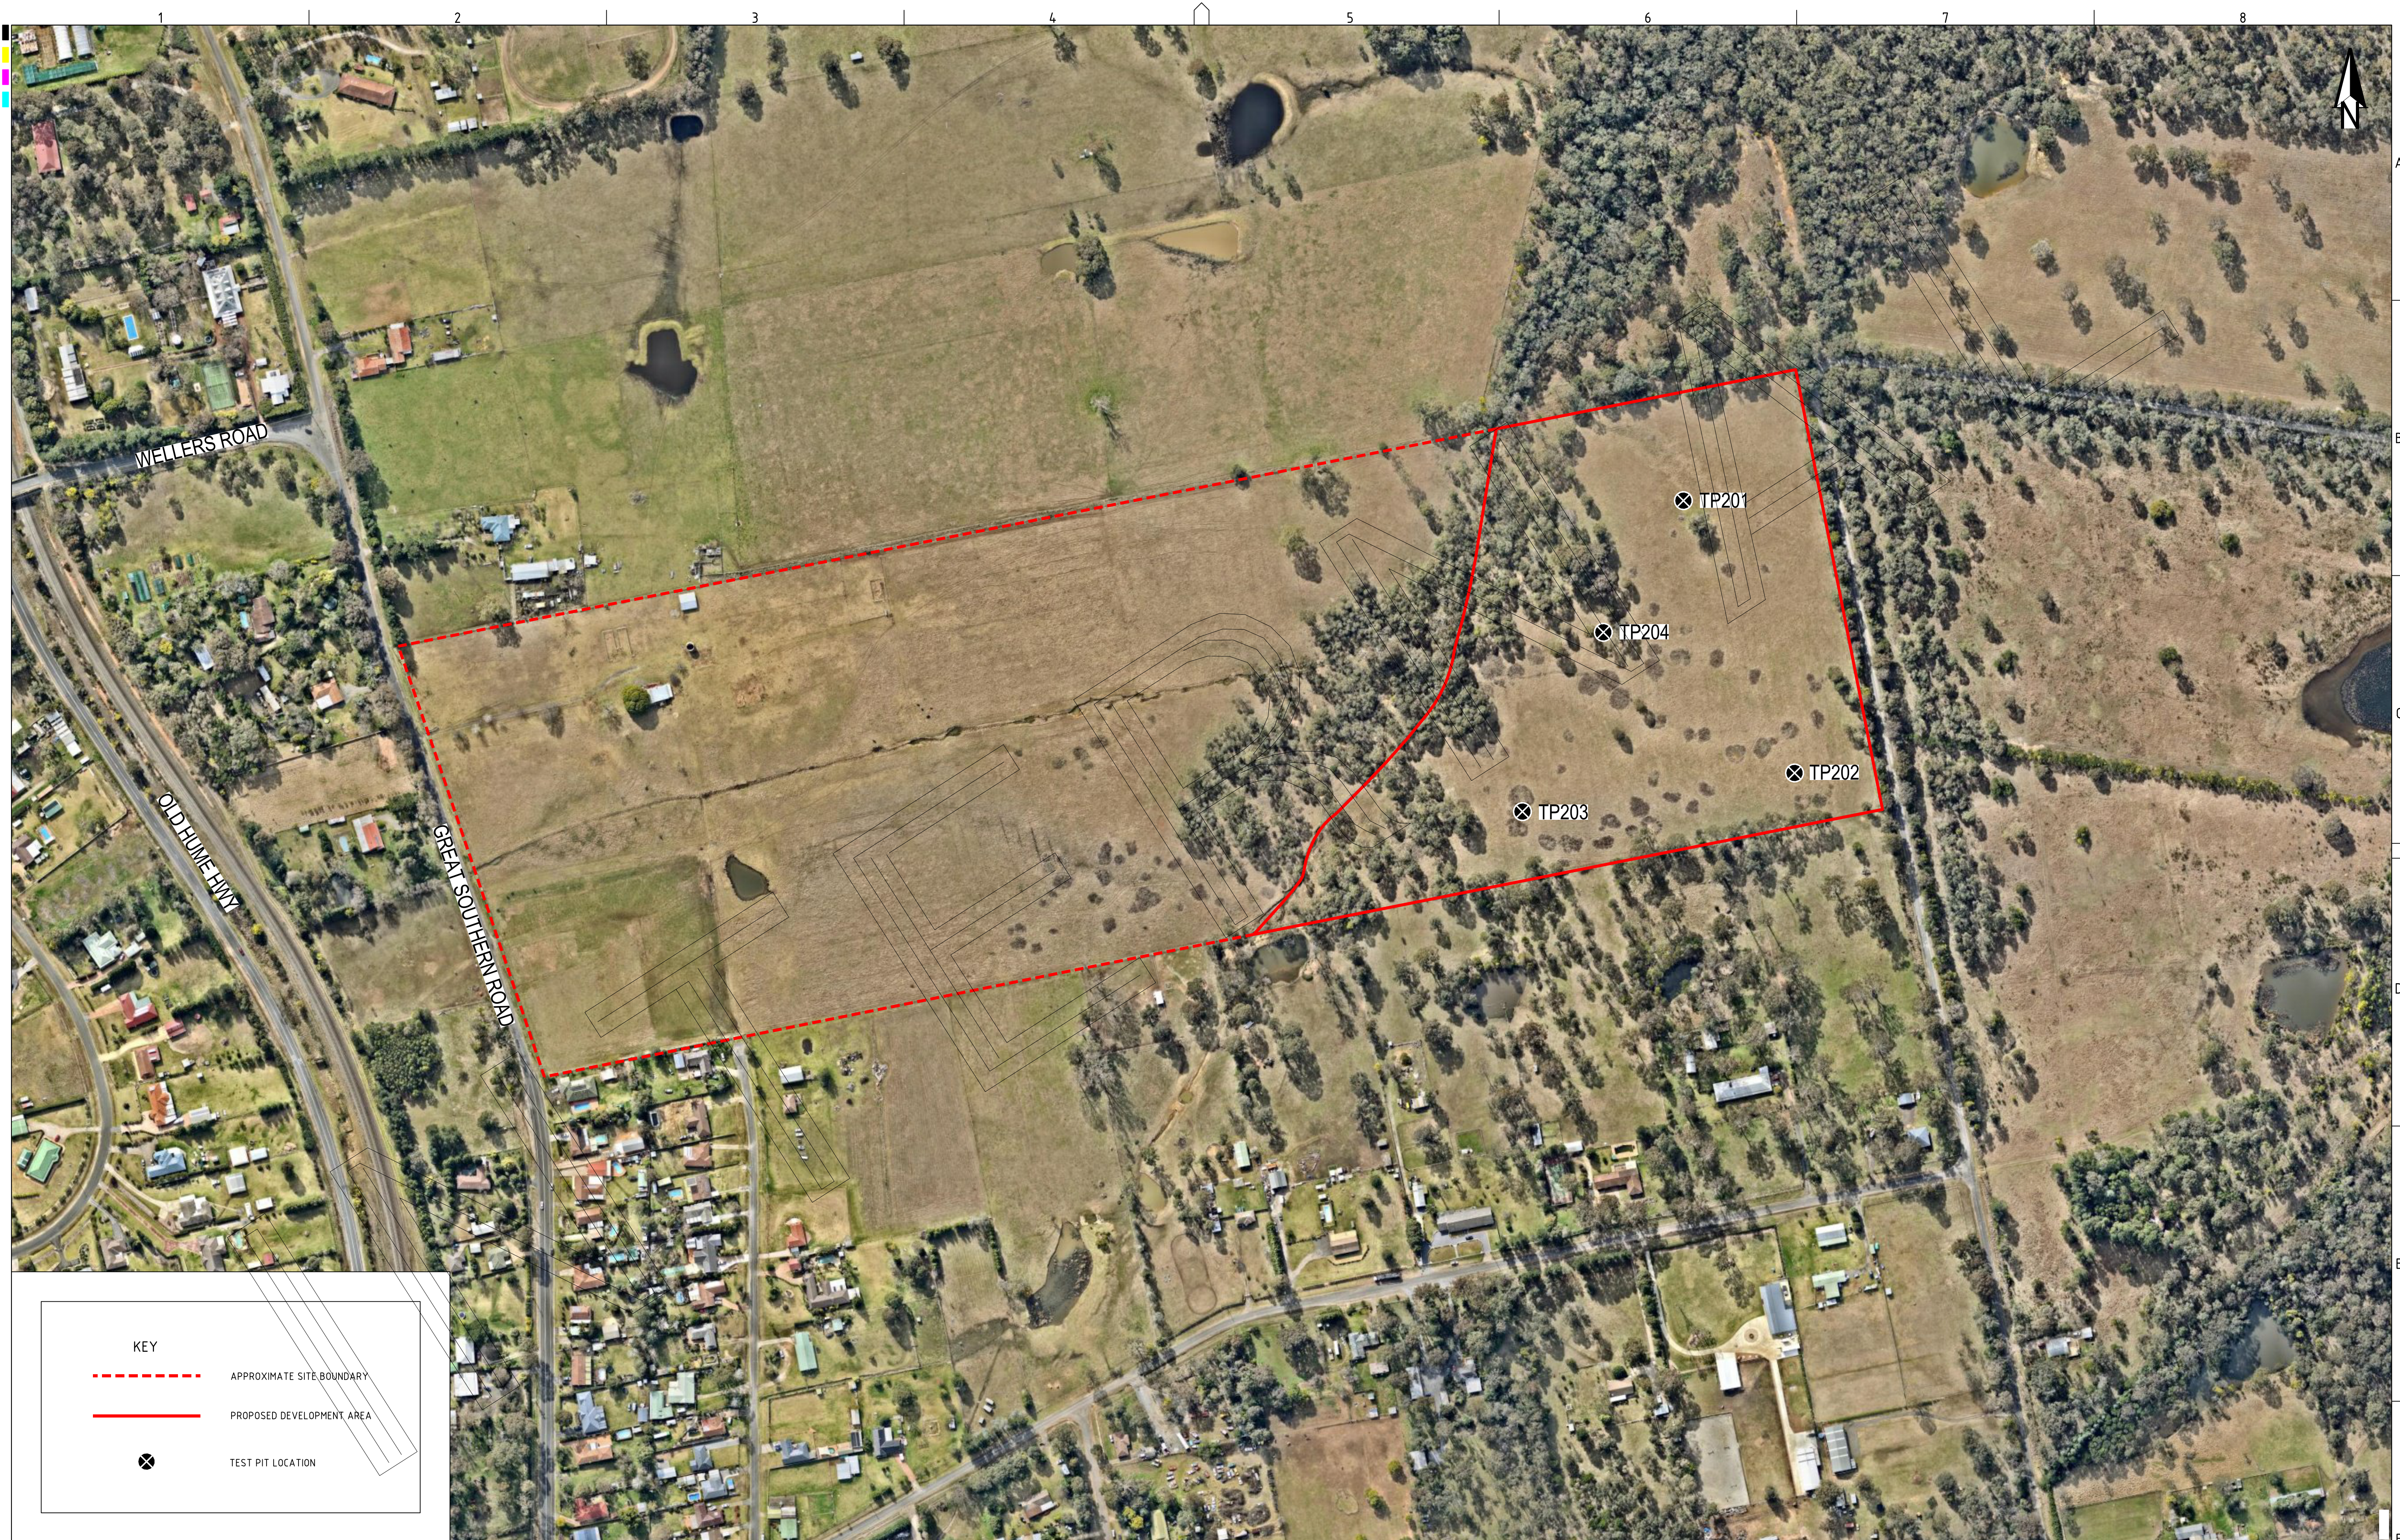
ZONING CONCEPT PLAN

CONCEPT ZONING PLAN OVER  
LOT 1 DP 996286

Martens & Associates has prepared this wastewater assessment to support an application for a proposed subdivision at 95 Great Southern Road, Bargo, NSW. This report documents a proposed on-site wastewater management strategy for the large lot (>5,000m<sup>2</sup>) portion of the proposed subdivision, located on the eastern part of the site, as shown in the Zoning Concept Plan in Attachment A.
