Salinity Assessment:  
Lot 1 DP 996286,  
95 Great Southern Road, Bargo, NSW

P1504741JR02V01  
July 2016

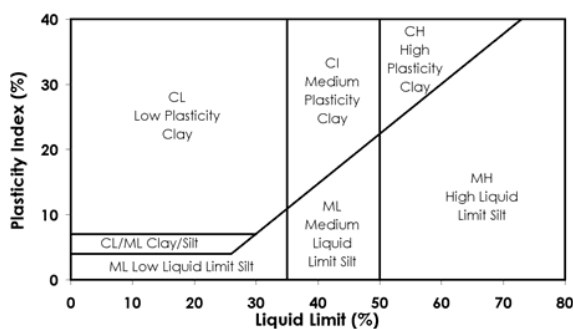
### Plasticity Properties

Plasticity properties can be assessed either in the field by tactile properties, or by laboratory procedures.
