Limited Detailed Site Investigation

26 Kissing Point Road and 266 Victoria Road  
Parramatta Planning Proposal  
Parramatta, NSW

Project 85556.00  
November 2016

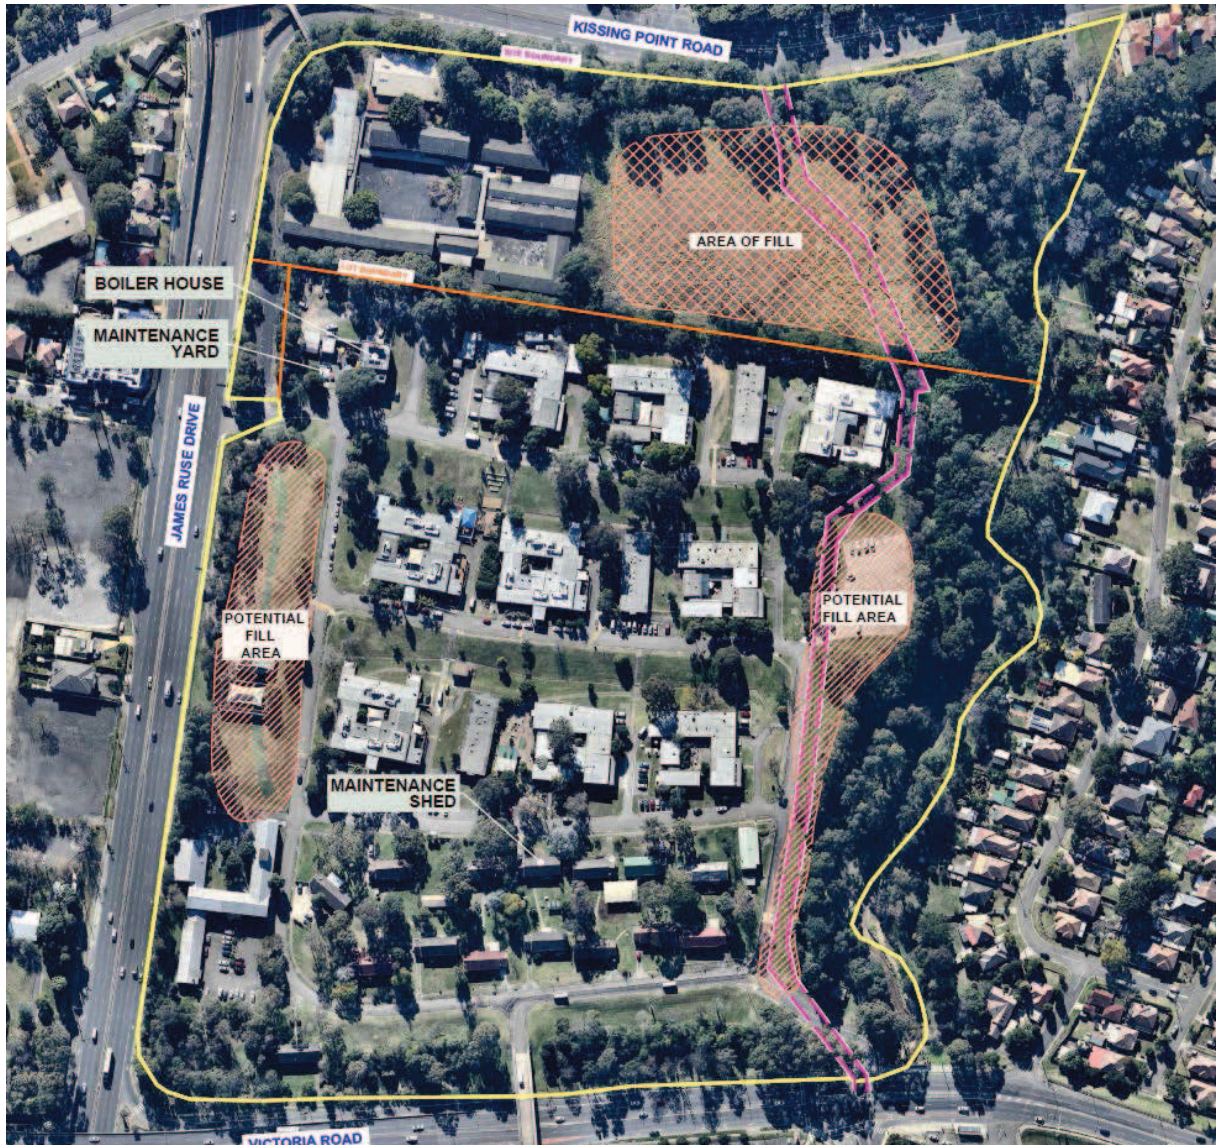
Figure 1: Site features

A high pressure liquid petroleum products pipeline (the 'high pressure pipeline' or 'oil pipeline') and associated easement, located to the west of Vineyard Creek, transects the site from north to south.

Key site features are shown on Drawing 1, Attachment 1 of DP (2016) in Appendix B. The drawing is reproduced in Figure 1, below.

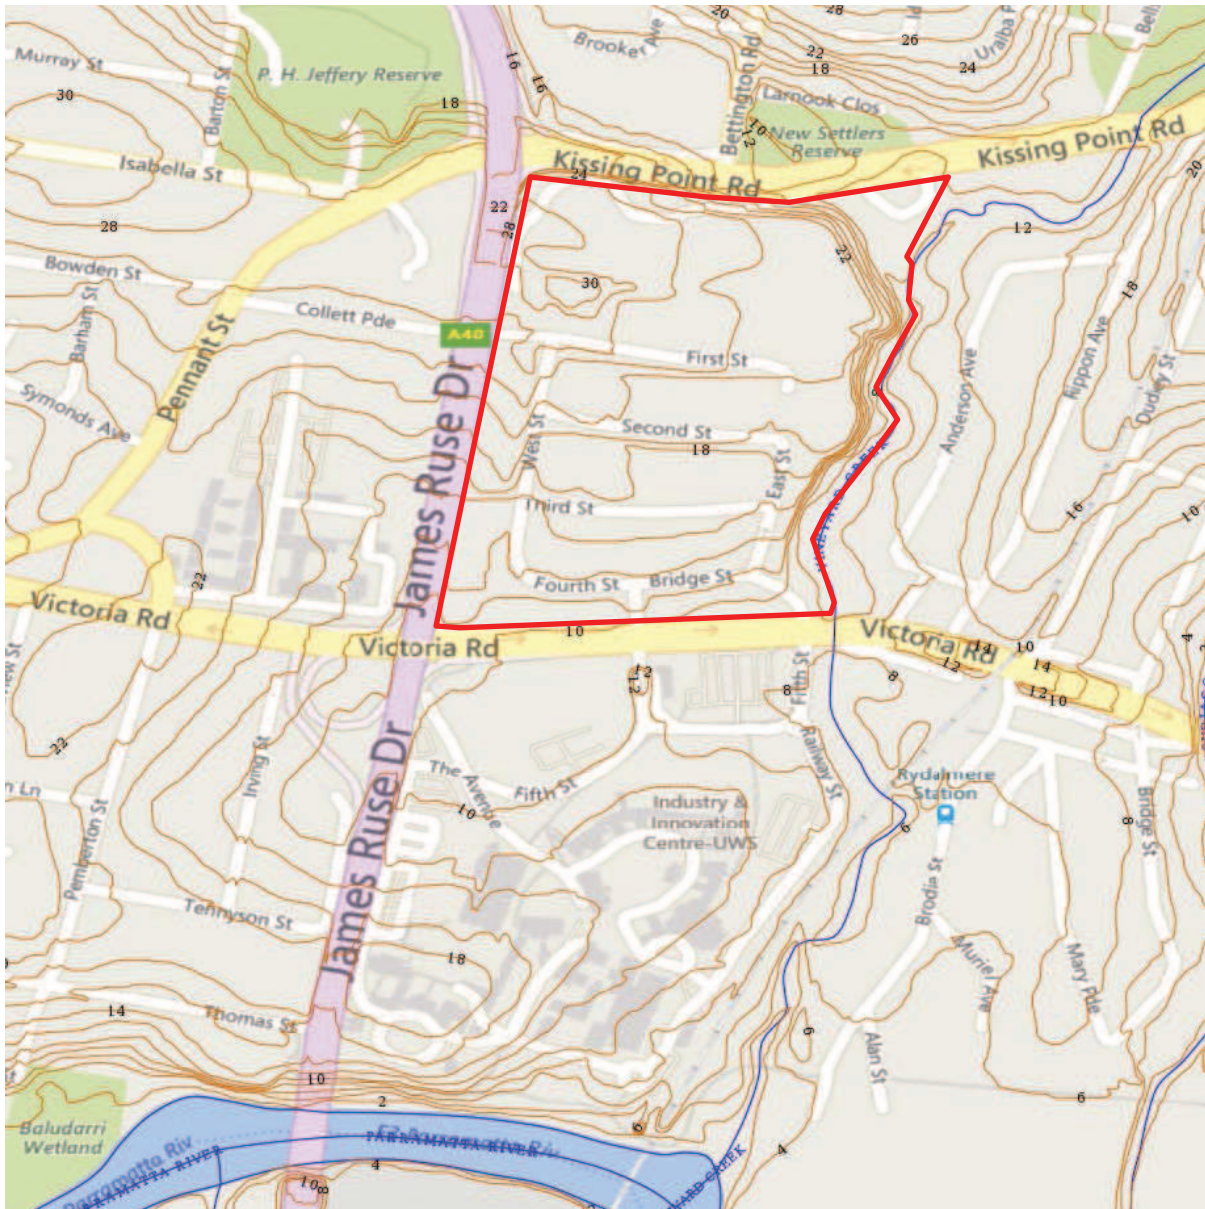
**Figure 3: Regional Topography (2 m contour intervals, AHD) (approximate site area outlined shown in red)**

The regional topography, shown with 2 m surface level contours based on data supplied by the NSW Department of Lands in April 2009, is shown on Drawing 3. The contours show levels at the site sloping either in a generally southerly direction towards Parramatta River or in a generally easterly direction towards Vineyard Creek. The contours indicate that the site has been levelled to the current land profile, and that the slope becomes steeper closer to Vineyard Creek. Surface water is expected to flow into Vineyard Creek (which discharges into the Parramatta River) or overland into the Parramatta River.

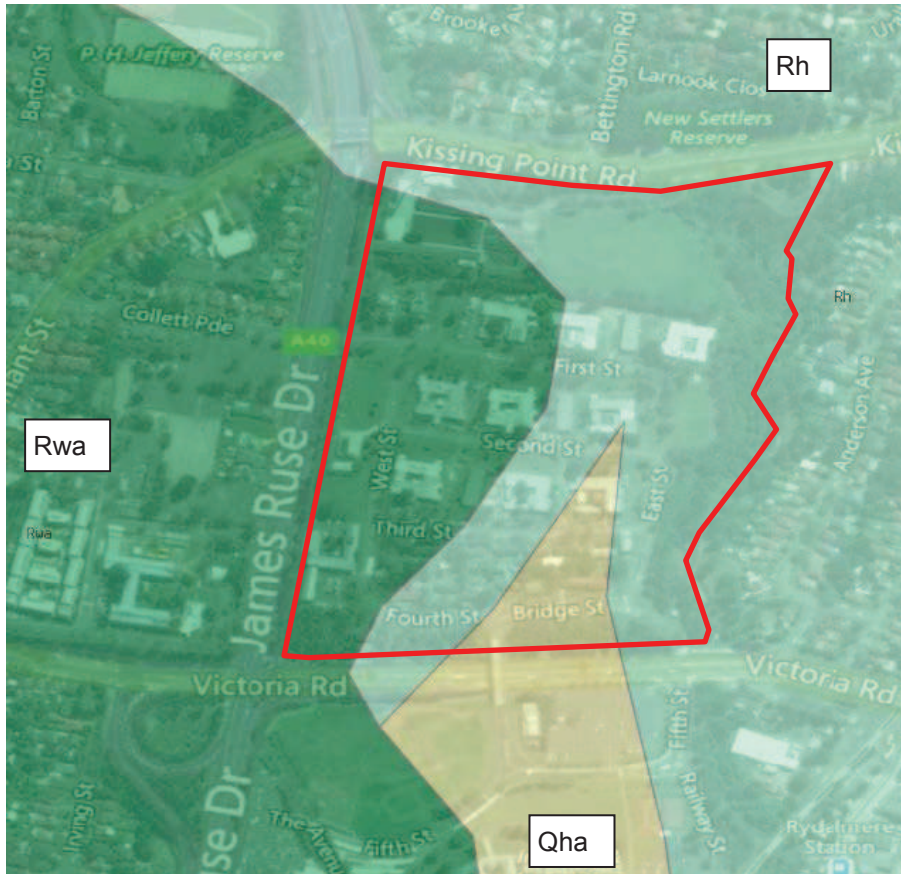
**Figure 4: Regional Geology (approximate site area outlined shown in red)**

Based on a review of the NSW Department of Mineral Resources, Geological Series Sheet 9130, the site is underlain by:

- Hawkesbury Sandstone (denoted Rh) of Triassic age generally comprising a lithology of medium to coarse grained quartz sandstone with very minor shale and laminite lenses – north-eastern and eastern portion of the site;
- Ashfield Shale (denoted Rwa) of Triassic age of the Wianamatta Group generally comprising a lithology of black to dark-grey shale and laminate – western portion of the site;
- Alluvial and estuarine sediment (denoted Qha) of Quaternary age generally comprising a lithology of silty to peaty quartz sand, silt, and clay with ferruginous and humic cementation in places and common shell layers – southern portion of the site.

The regional geological mapping is shown in Figure 4, below.

- **SHALE** – light grey and/ or red-grey shale was observed in 11 of the test locations from depths of between 0.1 m and 4.4 m. The areas where shale was encountered were generally consistent with the areas of mapped Ashfield Shale (refer to Section 6);

- **SANDSTONE** – white, light grey, orange, red, pink and/ or purple sandstone with some clay banding was observed in seven of the test locations from depths of between 0.05 m and 2.5 m. The areas where shale was encountered were generally consistent with the areas of mapped Hawkesbury Sandstone (refer to Section 6).

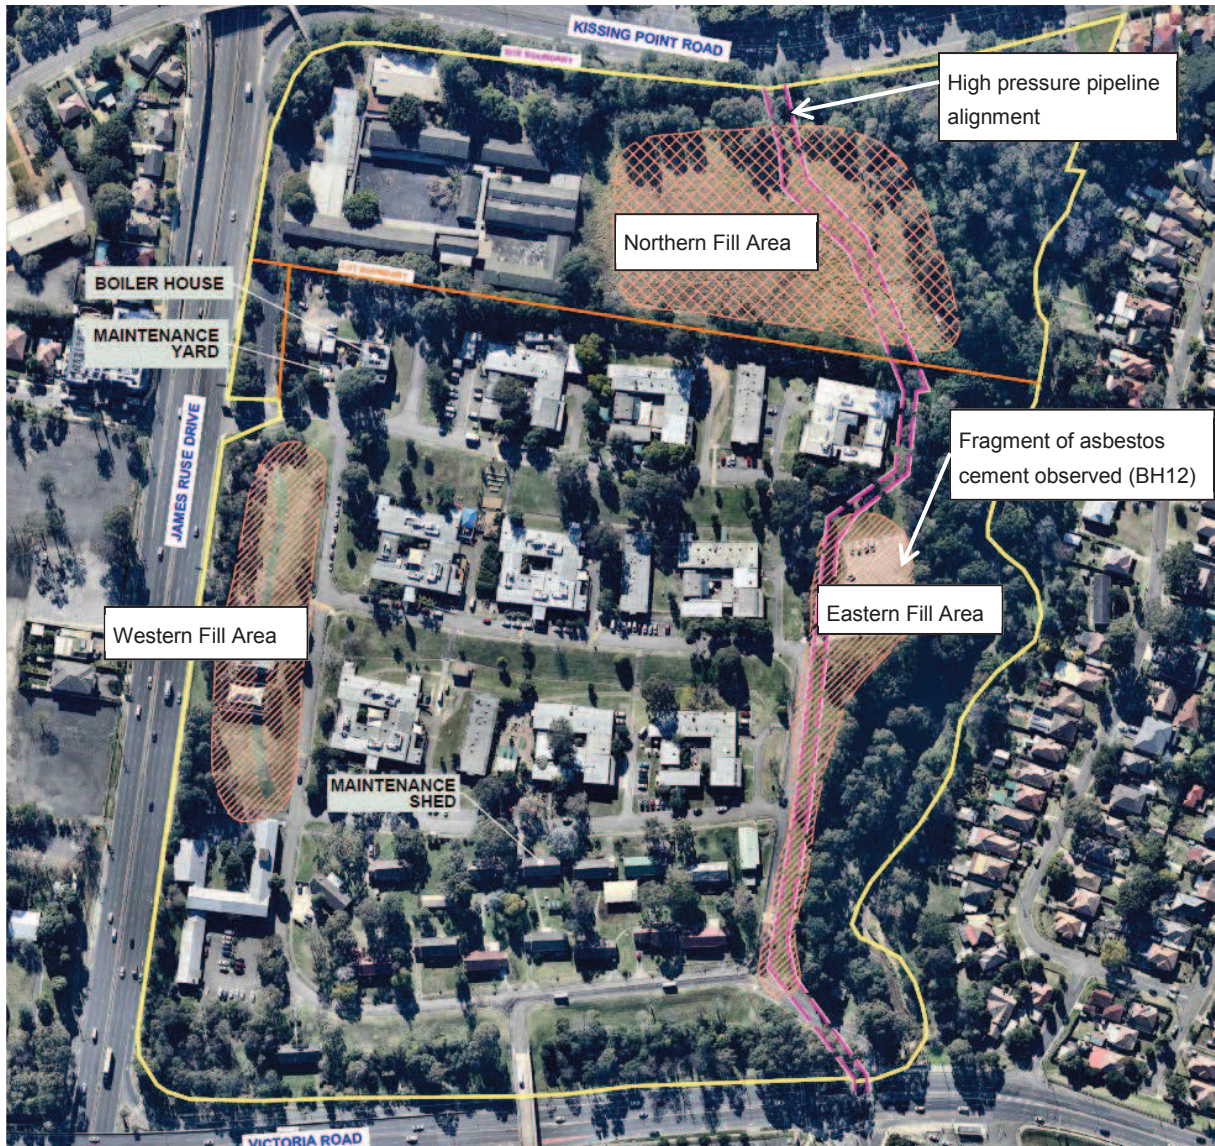
Figure 5: Summary of Fill Area

The current investigation, which comprised intrusive investigation in the ADHC portion of the site (noting the MBHS portion was inaccessible at the time of investigation) (refer to Figure 5, below for areas) found the following:

- Identified a fragment of asbestos cement in one location in the Eastern Fill Area, with a low asbestos concentration in soil (below the laboratory reporting limit) also identified by the laboratory at this location (BH12). Inclusions of building debris was observed in other test locations, and can be associated with asbestos contamination;

- Identified benzo(a)pyrene in filling above the ecological-based investigation levels at two locations (BH11 and TP10). Statistical analysis indicated that these concentrations are not statistically significant for the entire filling dataset, however given the proposed mixed use the actual locations and potential impacts should be considered when detailed development plans are confirmed; and

- Recorded concentration of potential groundwater contaminants in one location (BH14) (note other well locations either not accessible for well installation or were dry at the time of sampling). All results were within the adopted GIL with the exception of zinc. Zinc was above the adopted ecological-based investigation level, however is within background levels often recorded in urban Sydney areas. As such the detected zinc concentrations are not considered to be of concern.

- Additional investigations at the MBHS site with reference to the SAQP. The proposed scope may need to be modified depending on the site contamination impacts which may have been caused by the fire (e.g. asbestos, PFAS);
- Development of a suitable remediation action plan (RAP) that covers, *inter alia*, the decommissioning and management of any contamination associated with the boiler house, maintenance areas and other site structures, management of any contamination associated with the high pressure pipeline, remediation of asbestos contamination and any other contamination identified during the additional investigation and management of filling identified at the site.

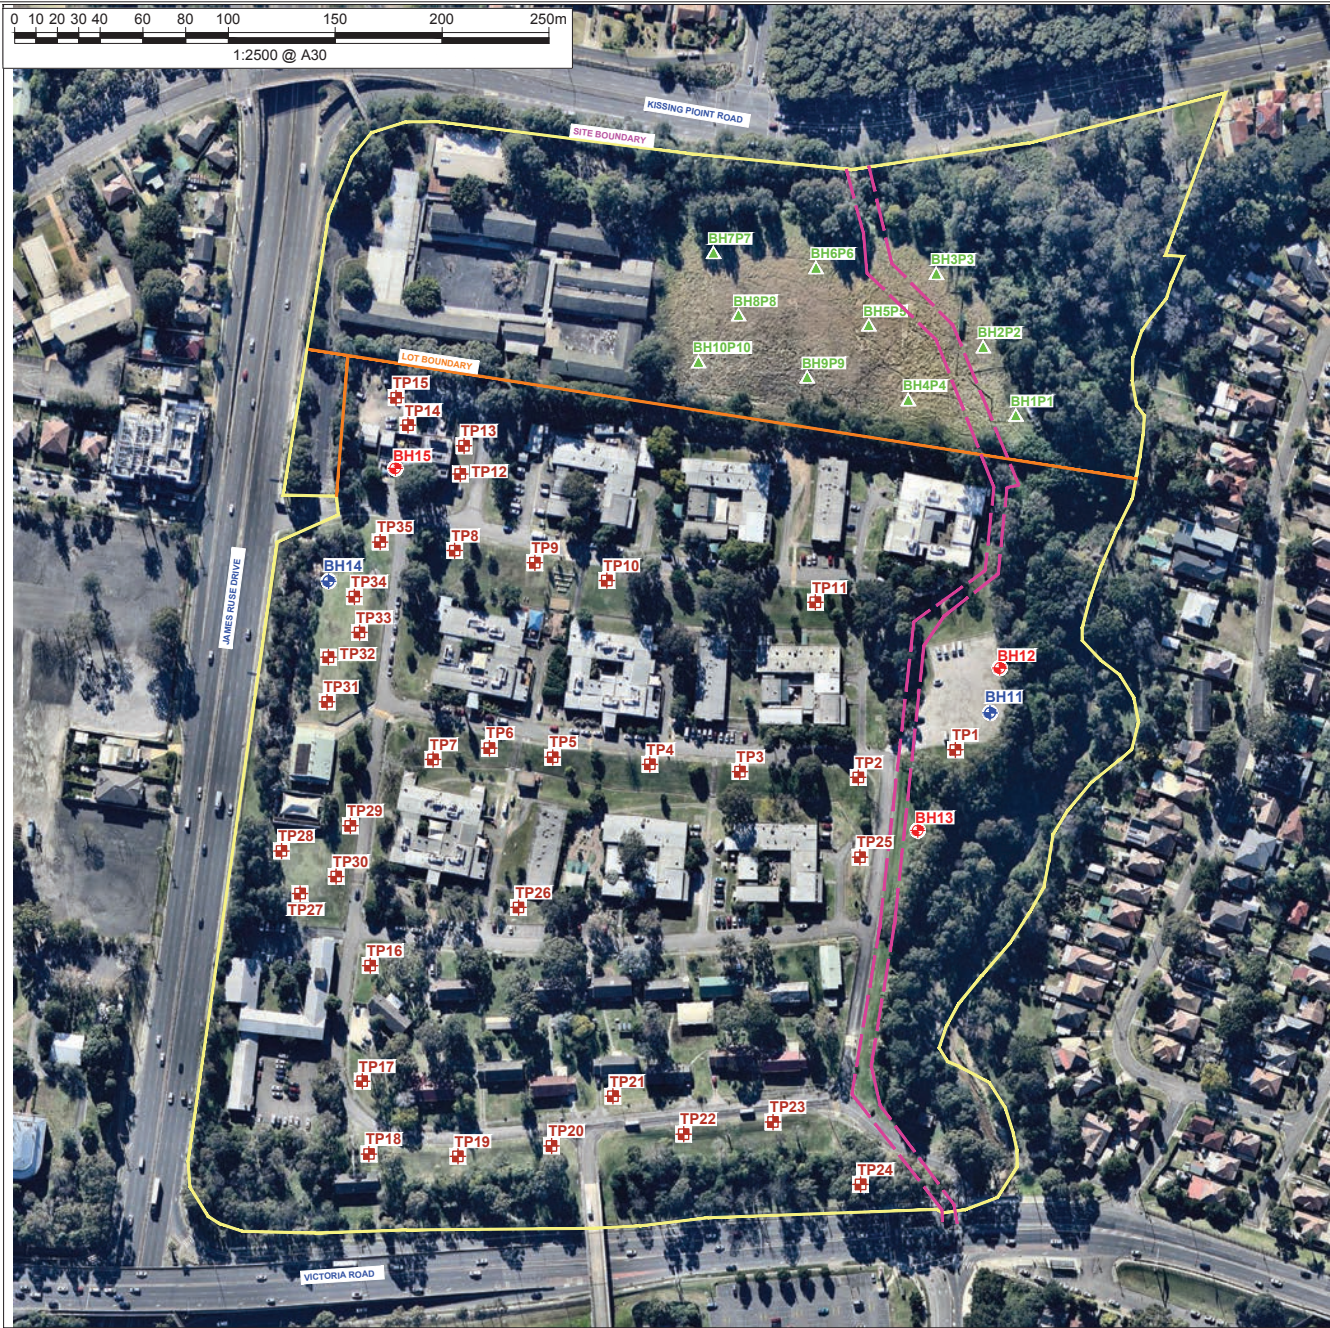
NOTE:  
 1: Base image from Nearmap.com  
 2: Test locations are approximate only and are shown with reference to existing features.

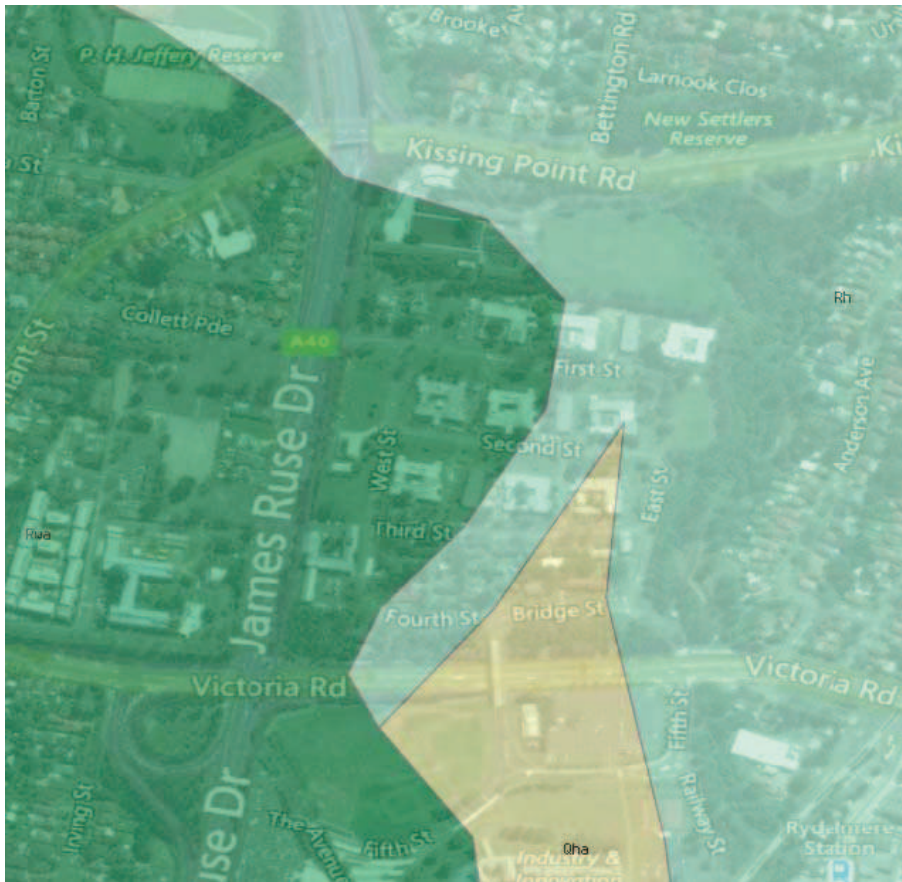
**Figure 1: Regional Geology**

- Hawkesbury Sandstone (denoted Rh) of Triassic age generally comprising a lithology of medium to coarse grained quartz sandstone with very minor shale and laminite lenses – north-eastern and eastern portion of the site;
- Ashfield Shale (denoted Rwa) of Triassic age of the Wianamatta Group generally comprising a lithology of black to dark-grey shale and laminate – western portion of the site;
- Alluvial and estuarine sediment (denoted Qha) of Quaternary age generally comprising a lithology of silty to peaty quartz sand, silt, and clay with ferruginous and humic cementation in places and common shell layers – southern portion of the site.

The regional geological mapping is shown in Figure 1, below.

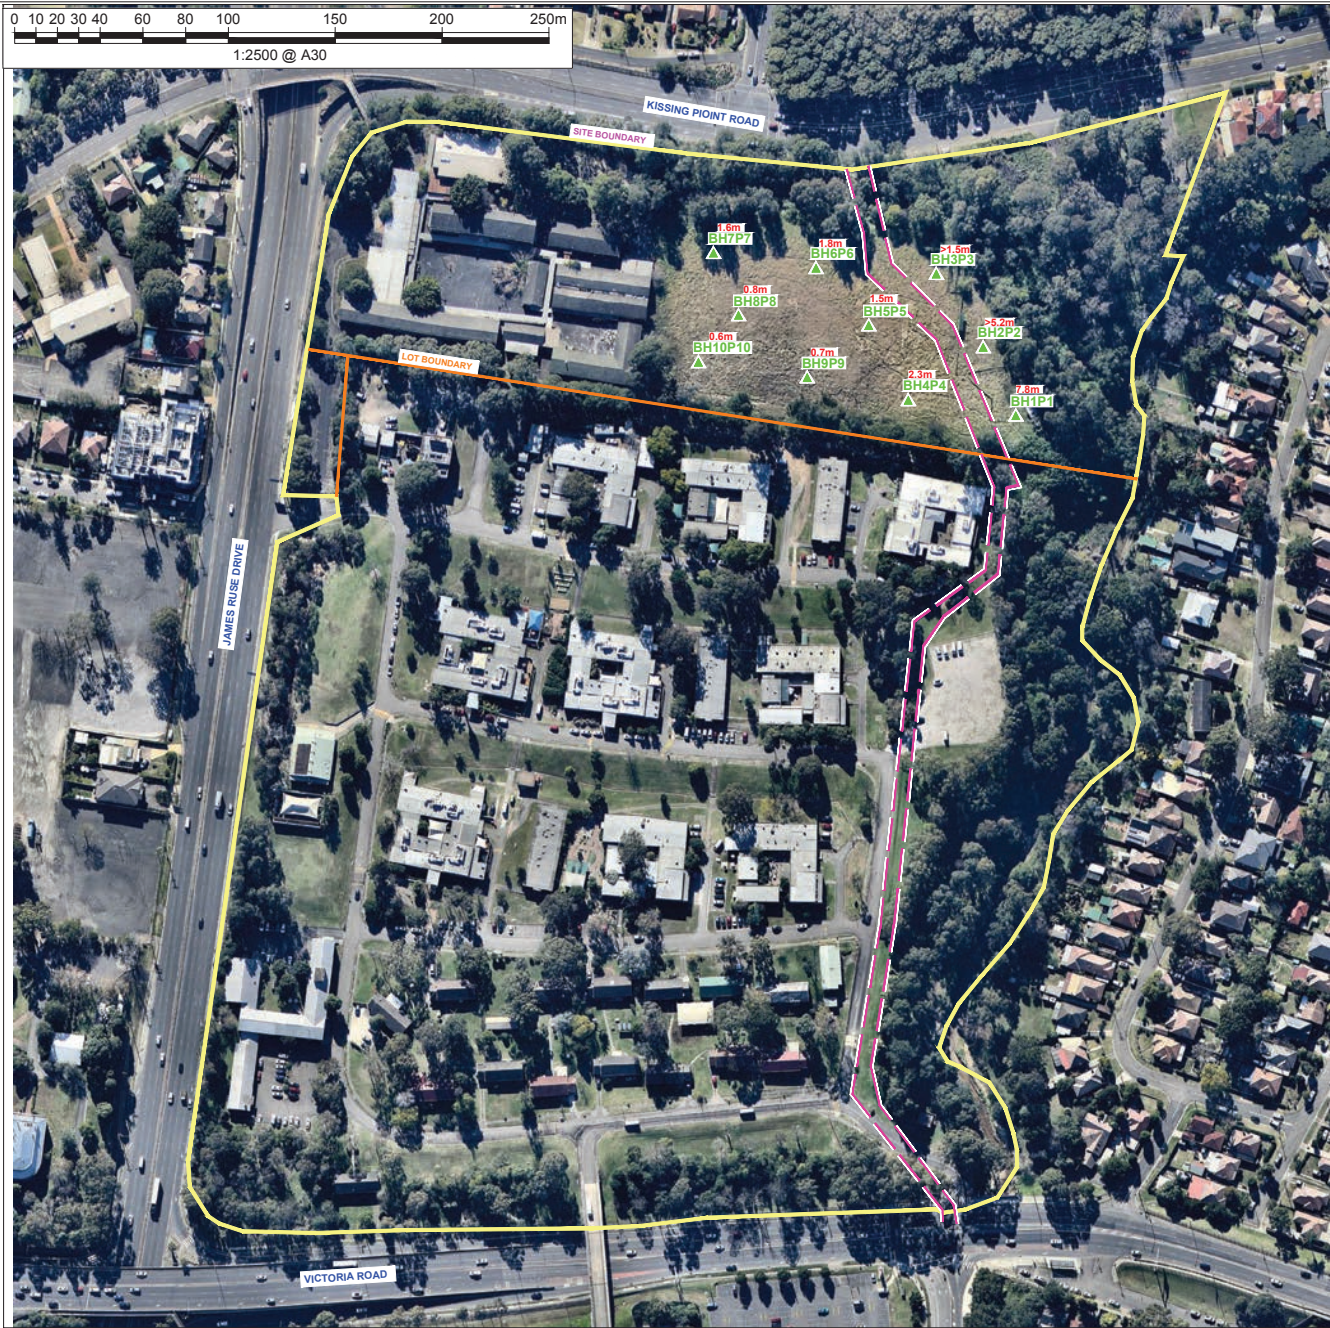
PROJECT No: 85556.00  
 DRAWING No: 2  
 REVISION: 0

NOTE:  
 1: Base image from Nearmap.com  
 2: Test locations are approximate only and are shown with reference to existing features.

The test locations and depth of fill are shown on Drawing 2, Attachment 1 of DP (2016) in Appendix B. The drawing is reproduced (in part) in Figure 2, below.

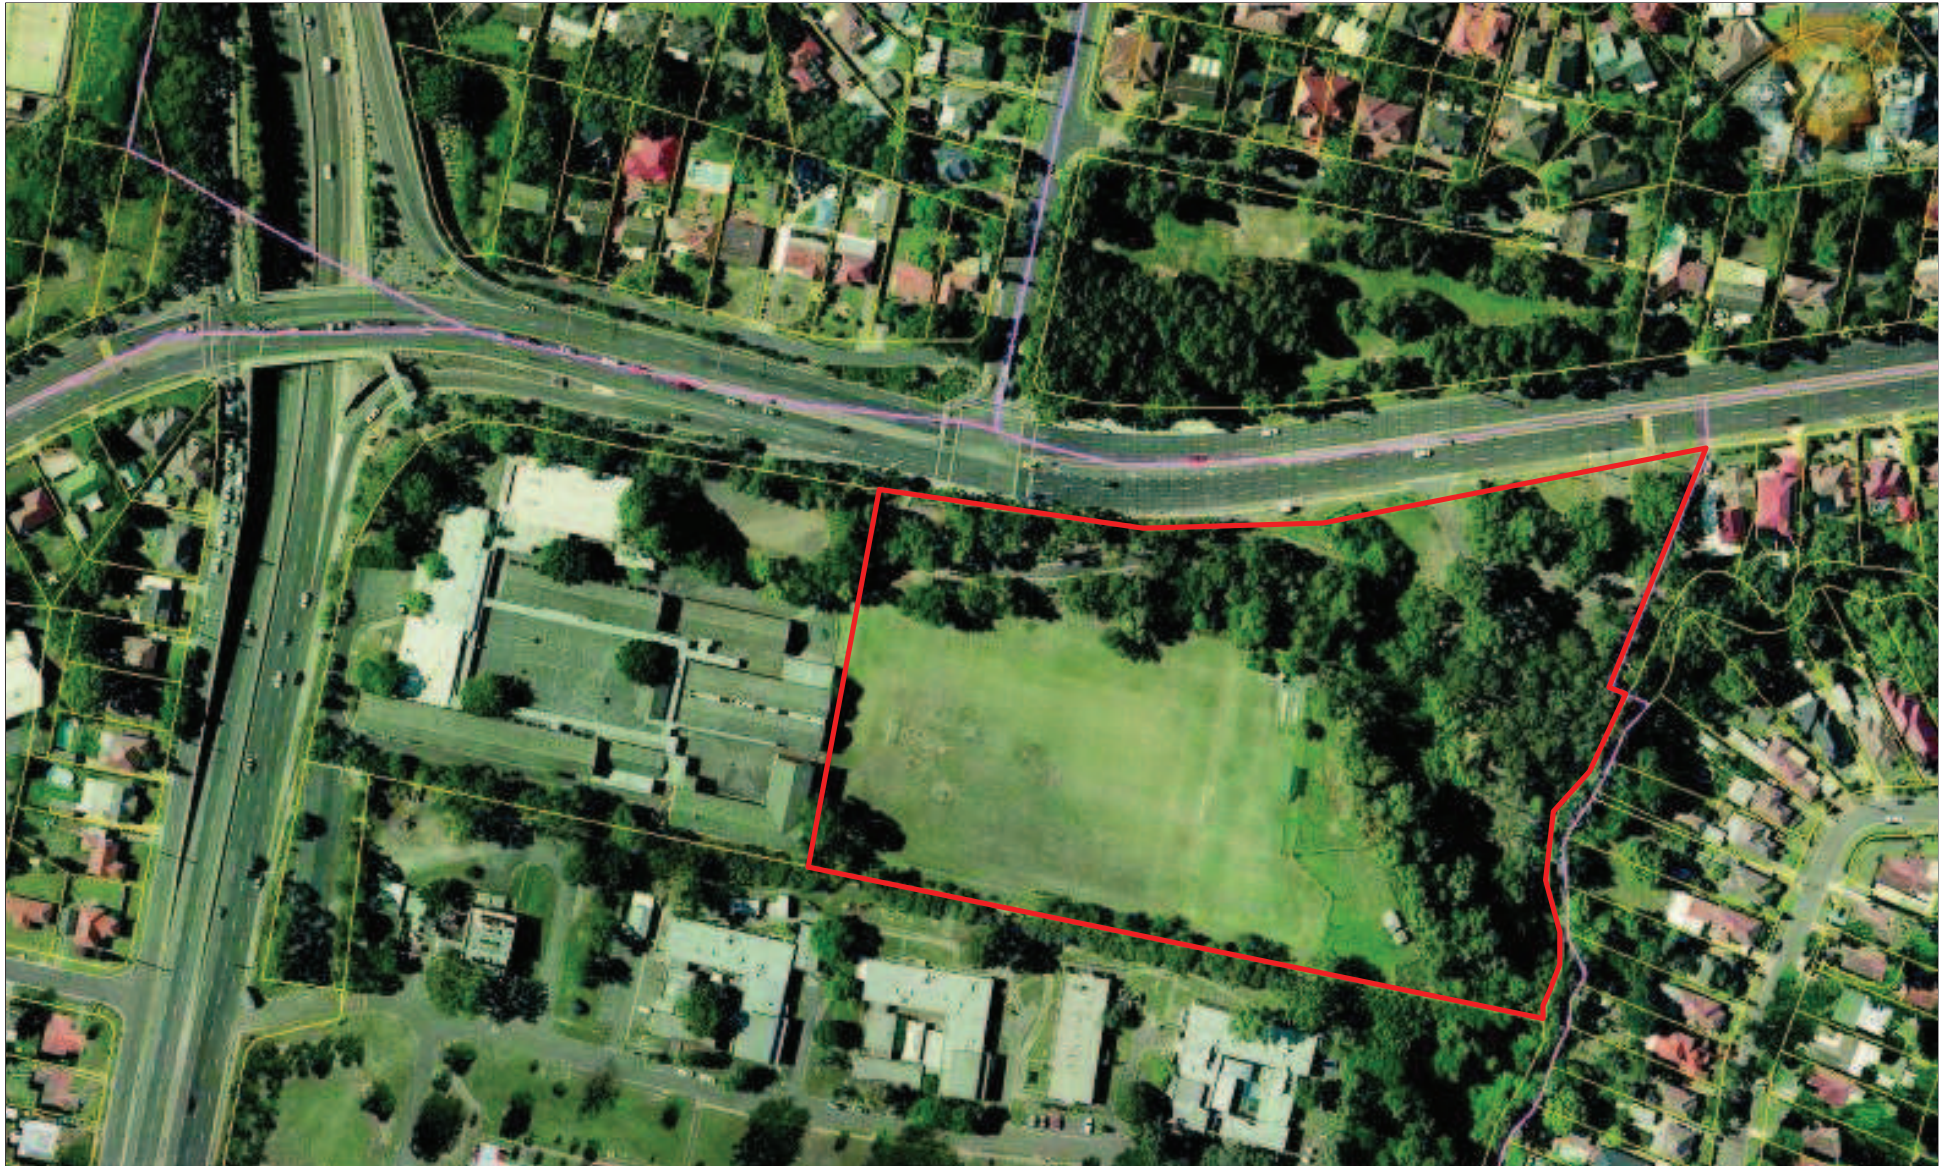
**Figure 2 – Site Layout**

Approximate boundary
