**Update of limited preliminary site investigation carried out in November 2010 for Inghams Processing Plant, Tahmoor, NSW.**

**Limited preliminary environmental site assessment of Inghams Processing Plant, Tahmoor, NSW.**

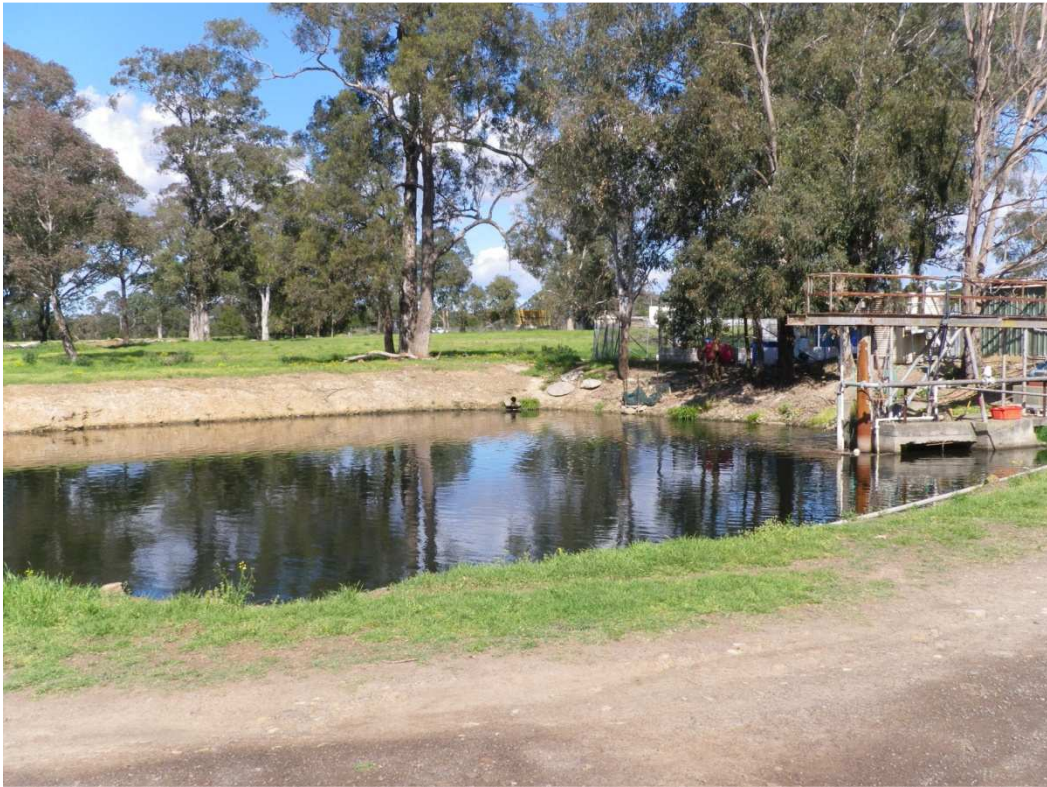
Six irrigation ponds exist at the site for both anaerobic and aerobic treatment of the waste water from the processing plant. Water enters Pond 1 (Photo Plate 3) directly from the plant and is treated anaerobically, from here it flows through Pond 2 (anaerobic) and then into Ponds 3, 4, 5 and 6 which are aerobic treatment ponds. Treated water from Pond 6 is used for irrigation of the paddock areas.

**Plate 3 -** Irrigation Pond

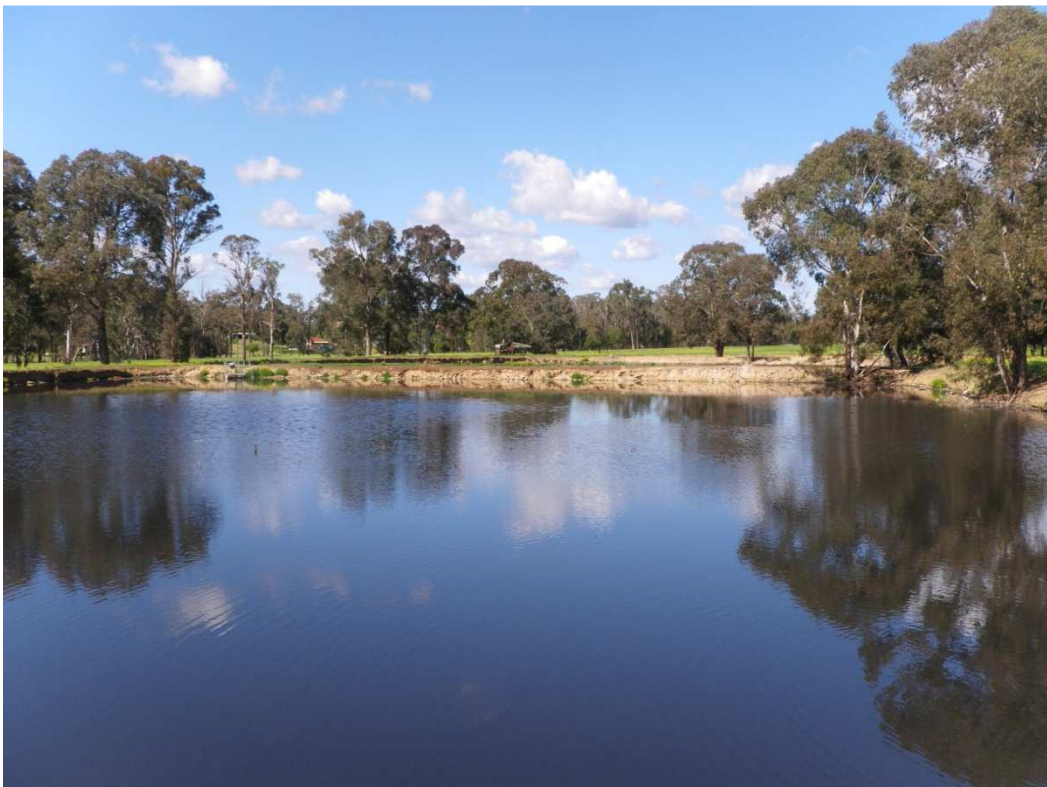
**Plate 4 -** Irrigation Pond

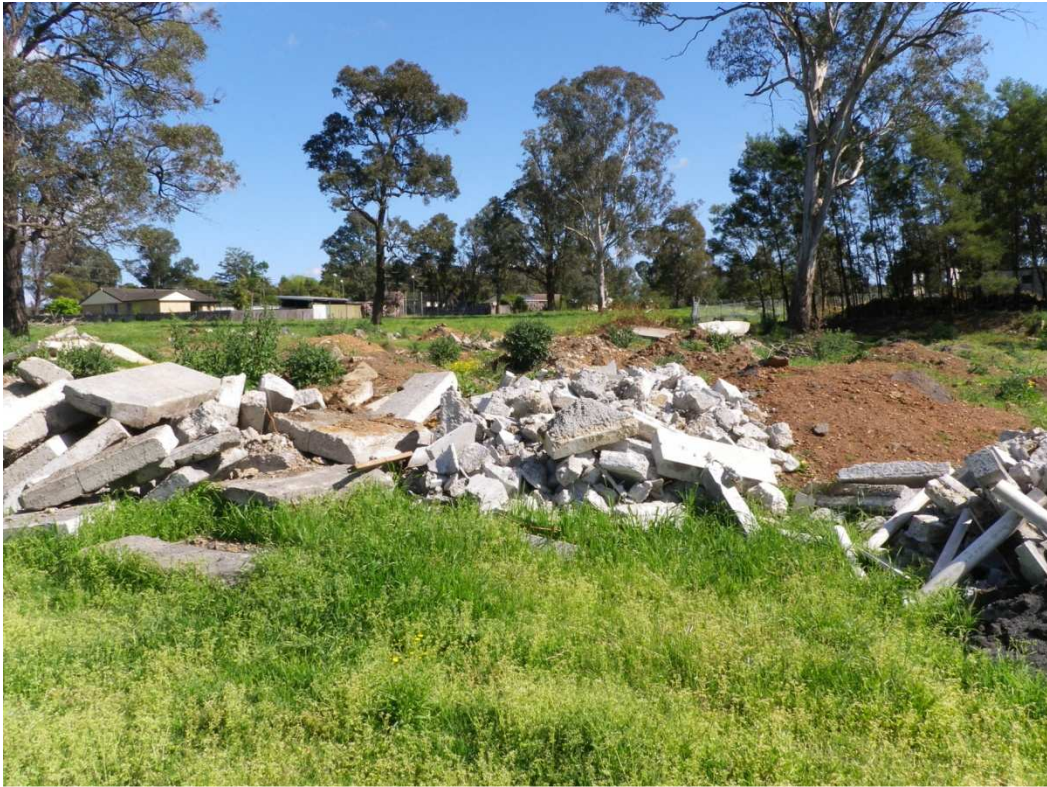
Some small stockpiles of concrete and excavated topsoil and bitumen material were noted to the west of the irrigation ponds (Photo Plates 5 - 6). There was no evidence of illegal dumping of waste. The rest of the "Processing Plant" area comprised wooded areas and paddocks which are grazed by cattle, dirt tracks intersect the wooded areas for access to the site. All vegetation appeared to be healthy and did not appear distressed.

**Plate 5 -** Concrete stockpiles

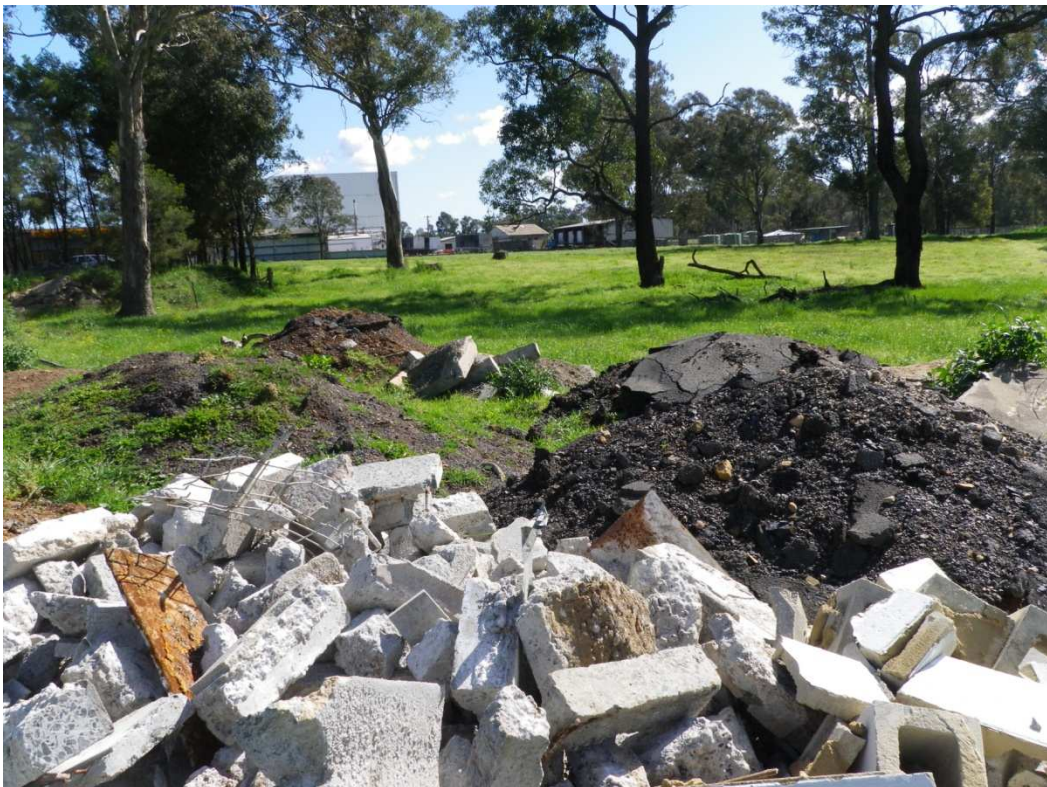
**Plate 6 -** Concrete and bitumen stockpiles

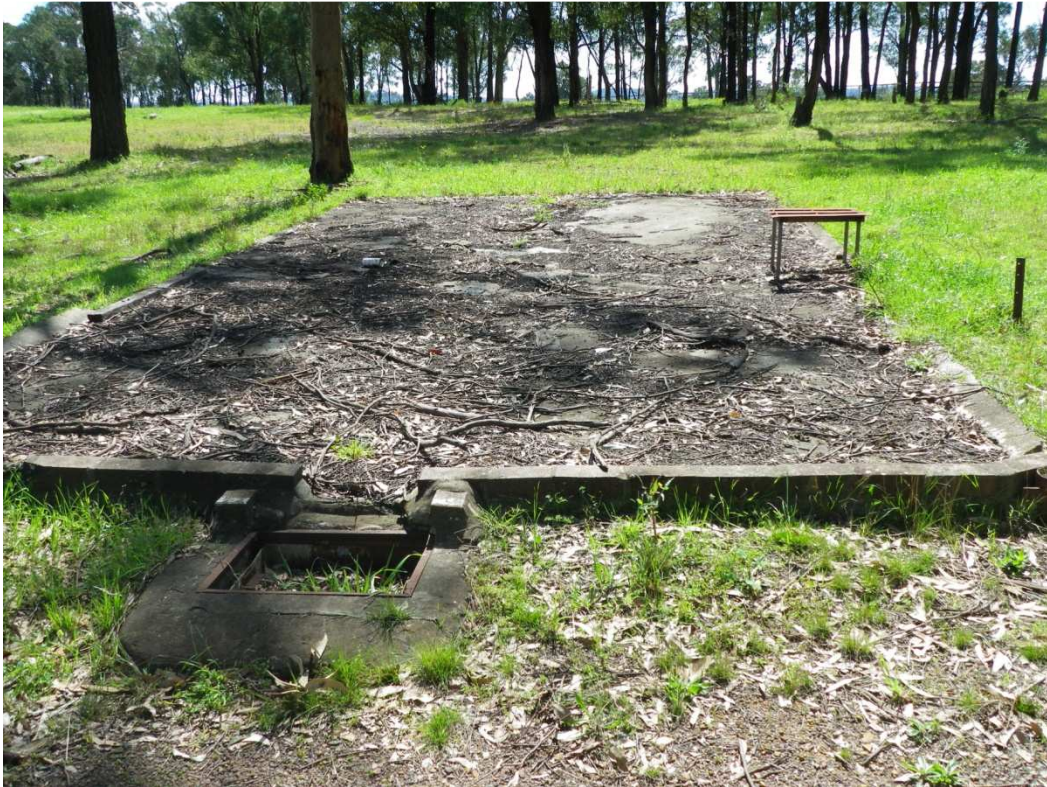
Within the wooded areas are concrete slabs and metal infrastructure (Photo Plate 7 - 8) associated with historical free range turkey farming which occurred at the site. To the north east of the site is a large shed used for storage of woodchips for use in the duck sheds, to the east of this are raised concrete footings associated with sheds which have since been demolished. Within the concrete footings some fragments of fibro sheeting (likely to have been from the roofs of the sheds) were noted along with rusted metal fencing panels and other metal pieces (Photo Plate 9 - 10).

**Plate 7 -** Concrete footings in “Old Duck Farm”

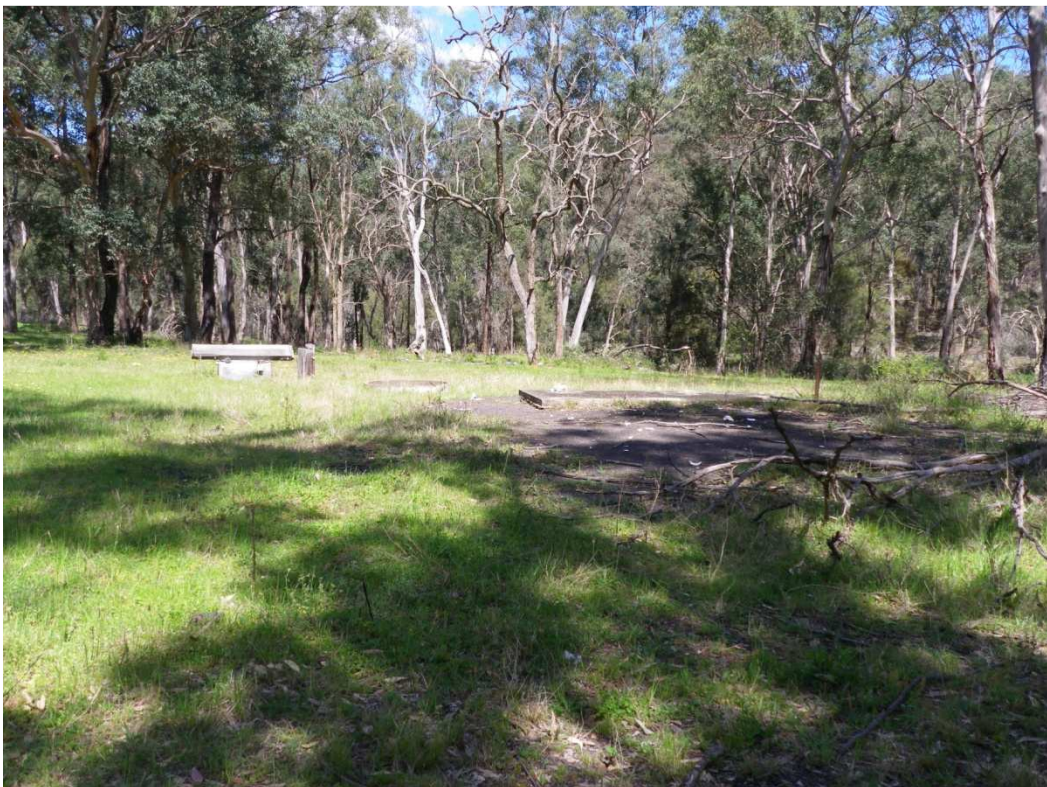
**Plate 8 -** Concrete footings in “Old Duck Farm”

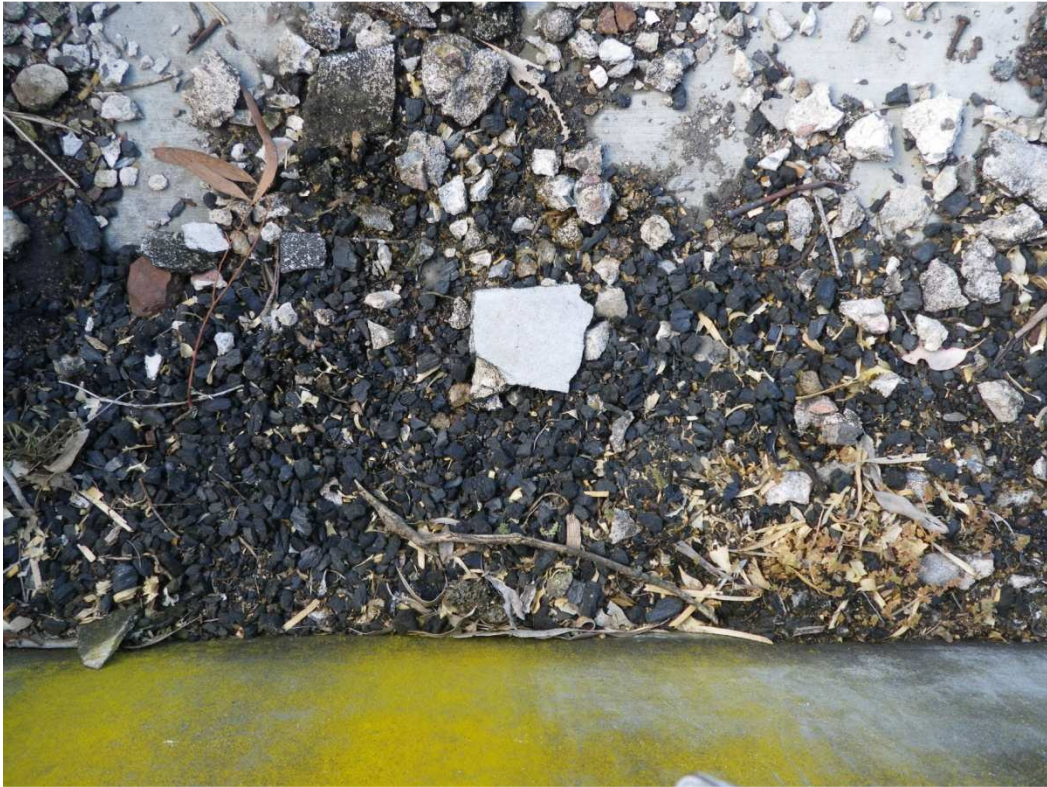
During the site investigation some fragments of fibro sheeting were noted on the concrete footings at the east of the “Old Duck Farm” area, no signs of visual or olfactory evidence were noted at the site however intrusive investigation was not part of the scope of works for this investigation.

**Plate 9** - Fibro fragments noted in old footings in “Old Duck Farm”

As fragments of fibro sheeting were noted during the investigation, Environmental Earth Sciences NSW consider it prudent to undertake a targeted soil investigation in the area surrounding the footings at the east of the woodchip storage shed in order to:

As fragments of fibro sheeting were noted during the investigation, Environmental Earth Sciences NSW consider it prudent to undertake a targeted soil investigation in the area surrounding the footings at the east of the woodchip storage shed in the “Old Duck Farm” portion of the site in order to:

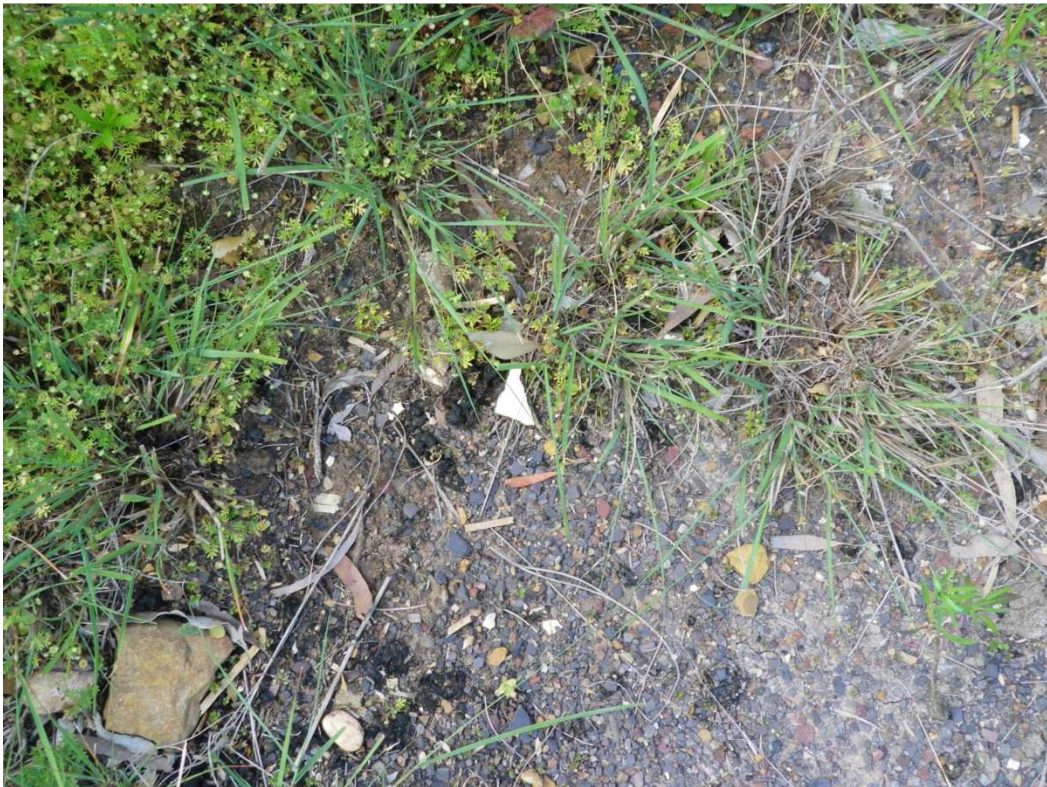
**Plate 10** - Fibro fragments noted in old footings in “Old Duck Farm”
