PRELIMINARY SITE INVESTIGATION

**77 OLD NARRANDERA ROAD &
9 RIVER ROAD
GOBBAGOMBALIN NSW**

JUNE 2019

REPORT NO. 5797

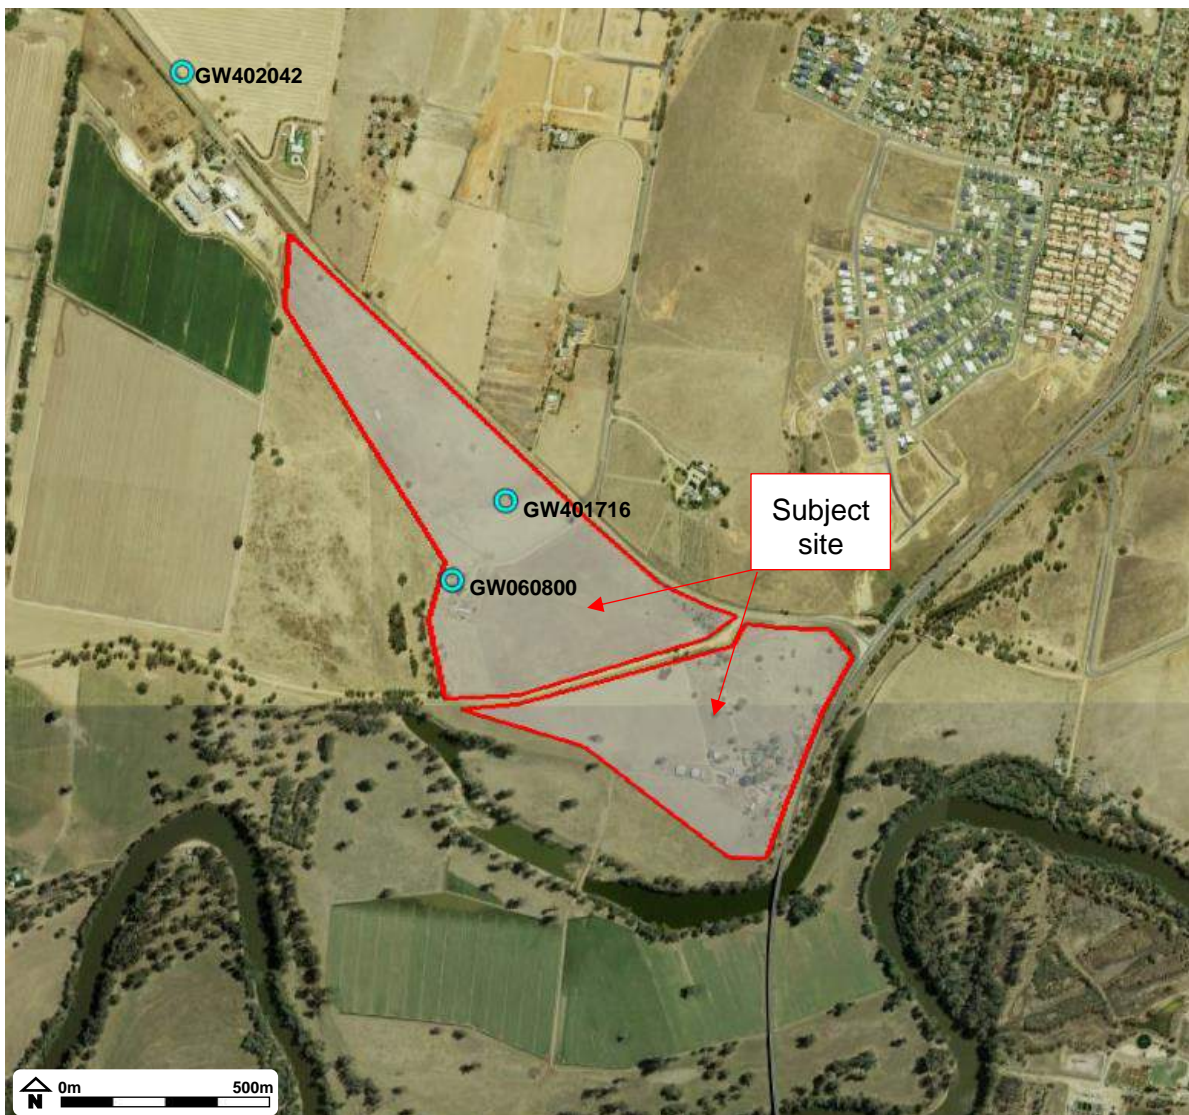
Figure 6: Registered groundwater bores within a 500m radius of the subject site

There are two registered groundwater bores on the subject site, and another bore within 500 meters of the site boundary, bore locations and details are recorded below, **Figure 6** and **Table 4**.

- Two groundwater bores exist on the site and are expected to be used for stock and domestic purposes. If significant soil contamination is found in the area, then groundwater analysis should be considered.

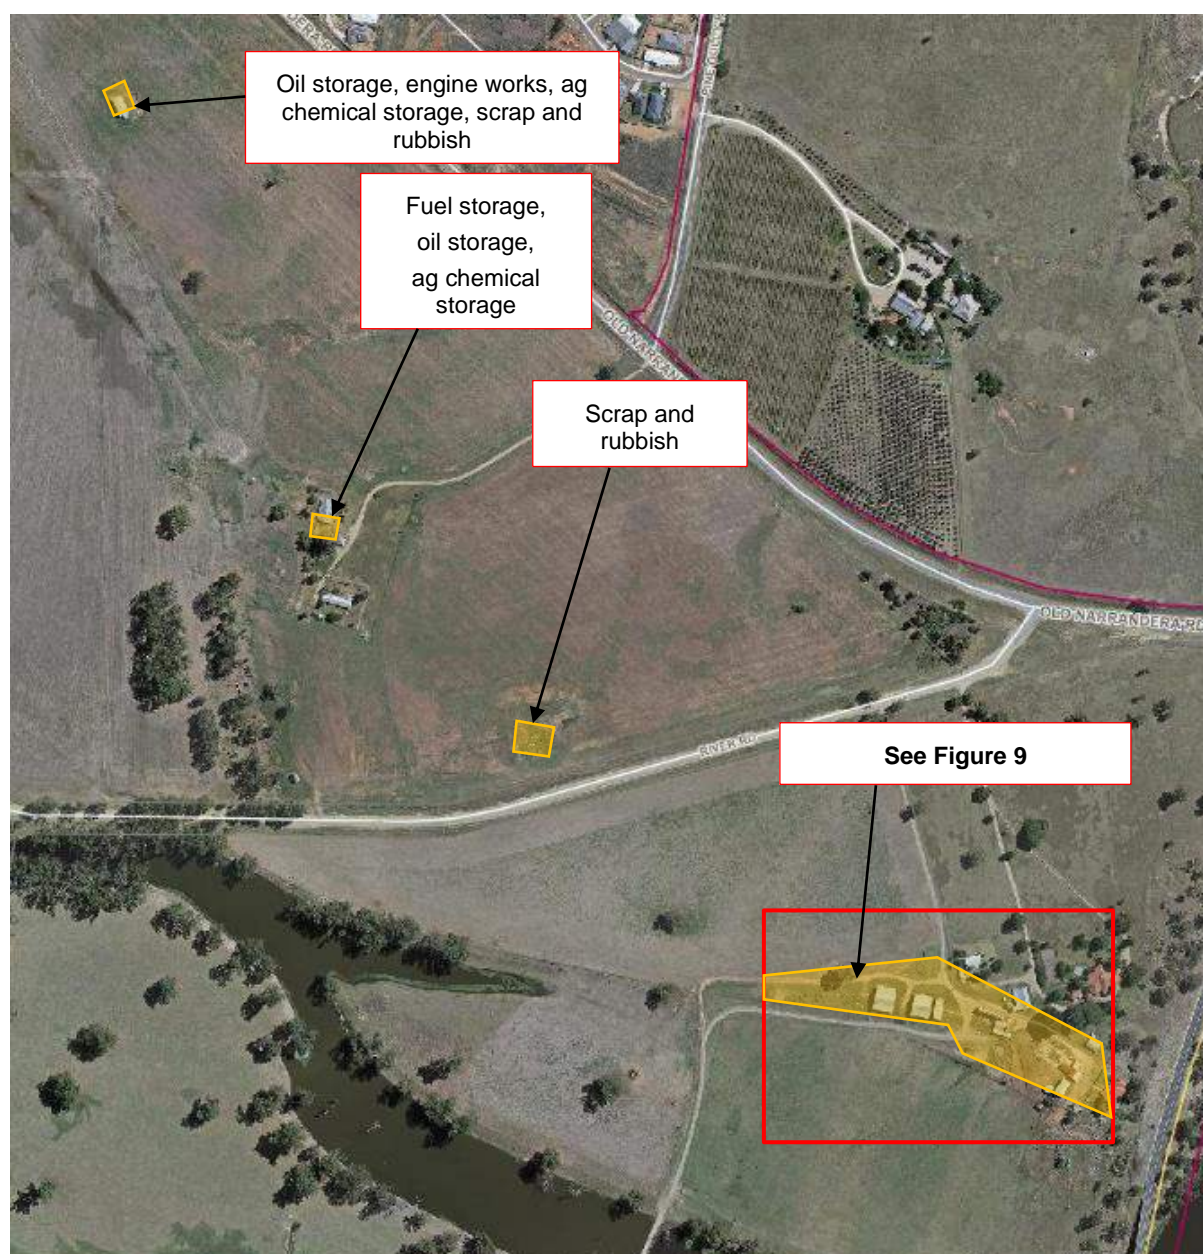
Figure 7: Areas of concern

The subject site as a whole is of concern due to broad scale application of agriculture-based chemicals. Further delineated areas of potential contamination include around the fuel tank onsite, as shown below, **Figures 7** and **Figure 8**.

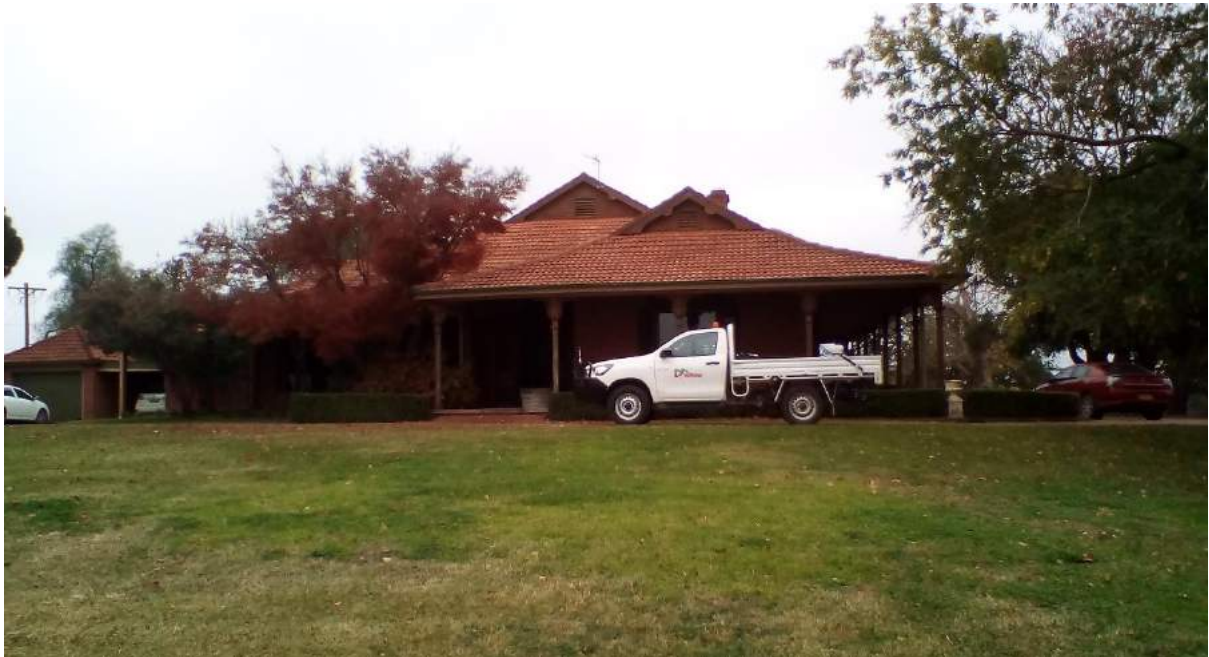
Photograph 1 shows the main house complex on the subject site, built from brick and timber framing atop a timber floor and clad with a ceramic tile roof.

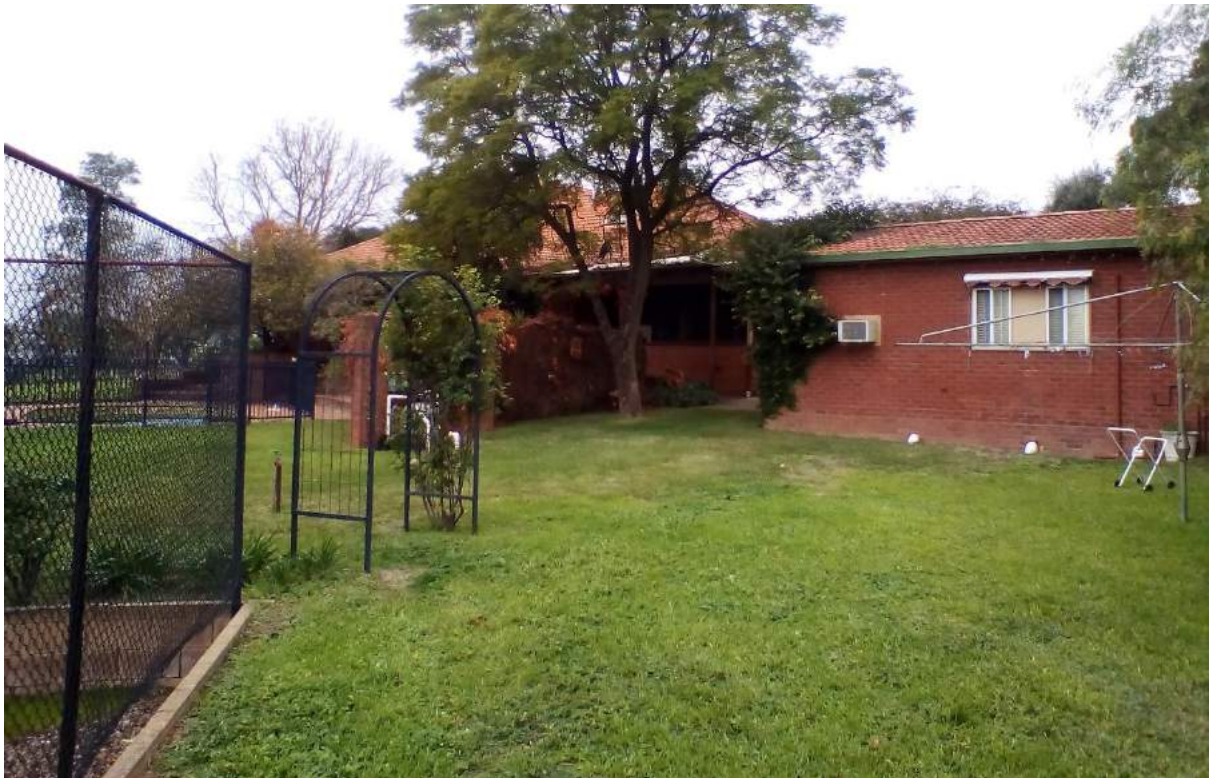
Photograph 2 shows the extent of the main house complex from a south western perspective with no suspect materials noticed.

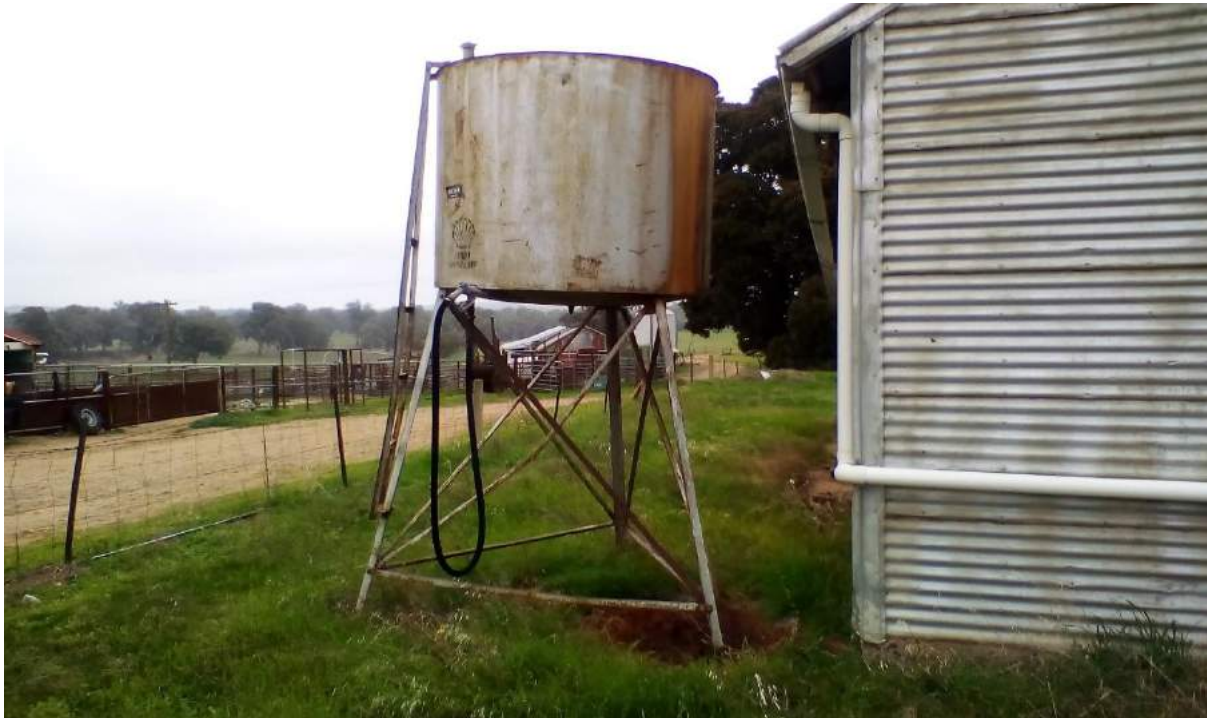
Photograph 3 shows the existing above ground diesel storage tank, some localised surface staining was noted on the ground surface under one of the legs.

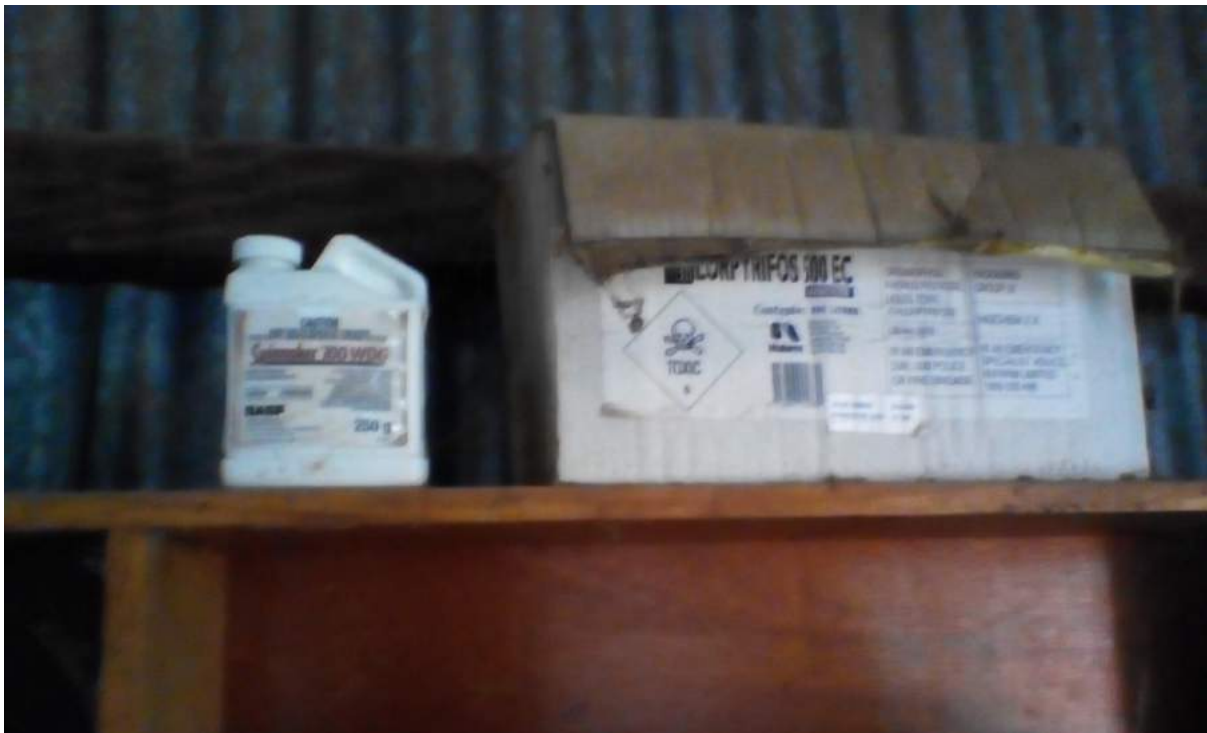
Photograph 4 shows stored chemicals within the workshop shed, chlorpyrifos is labelled on the box.

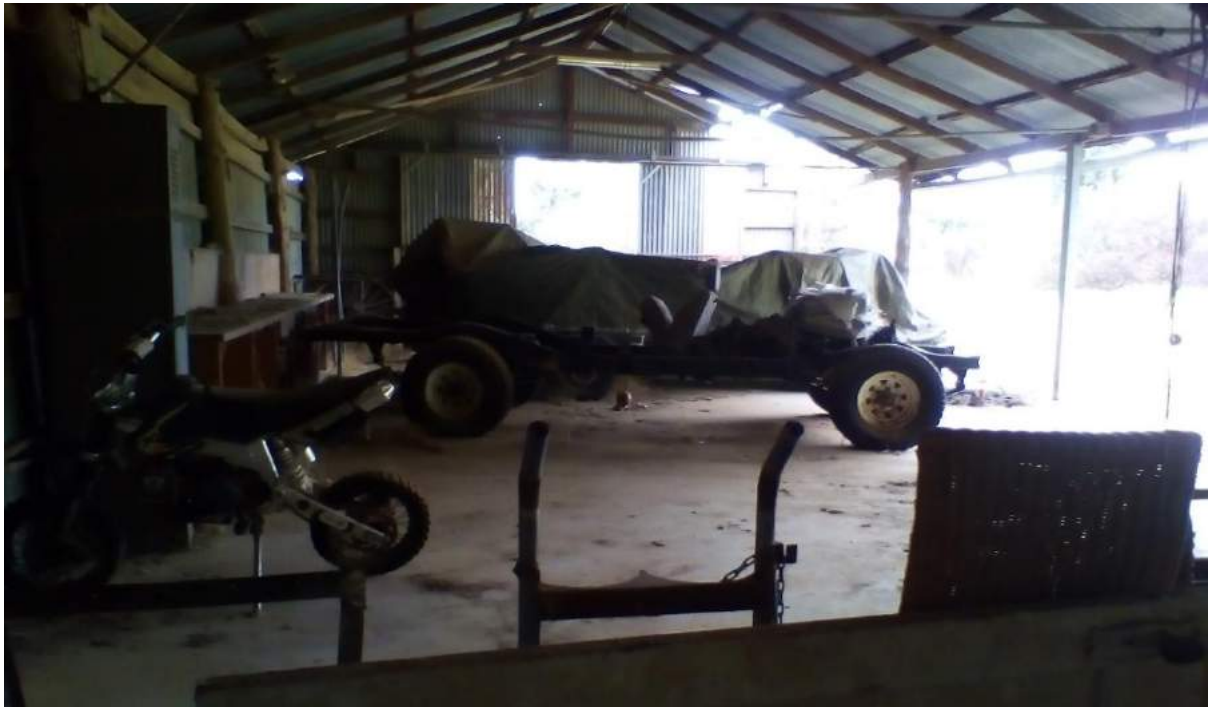
Photograph 5 shows stored vehicles on a sealed concrete surface within the existing workshop shed.

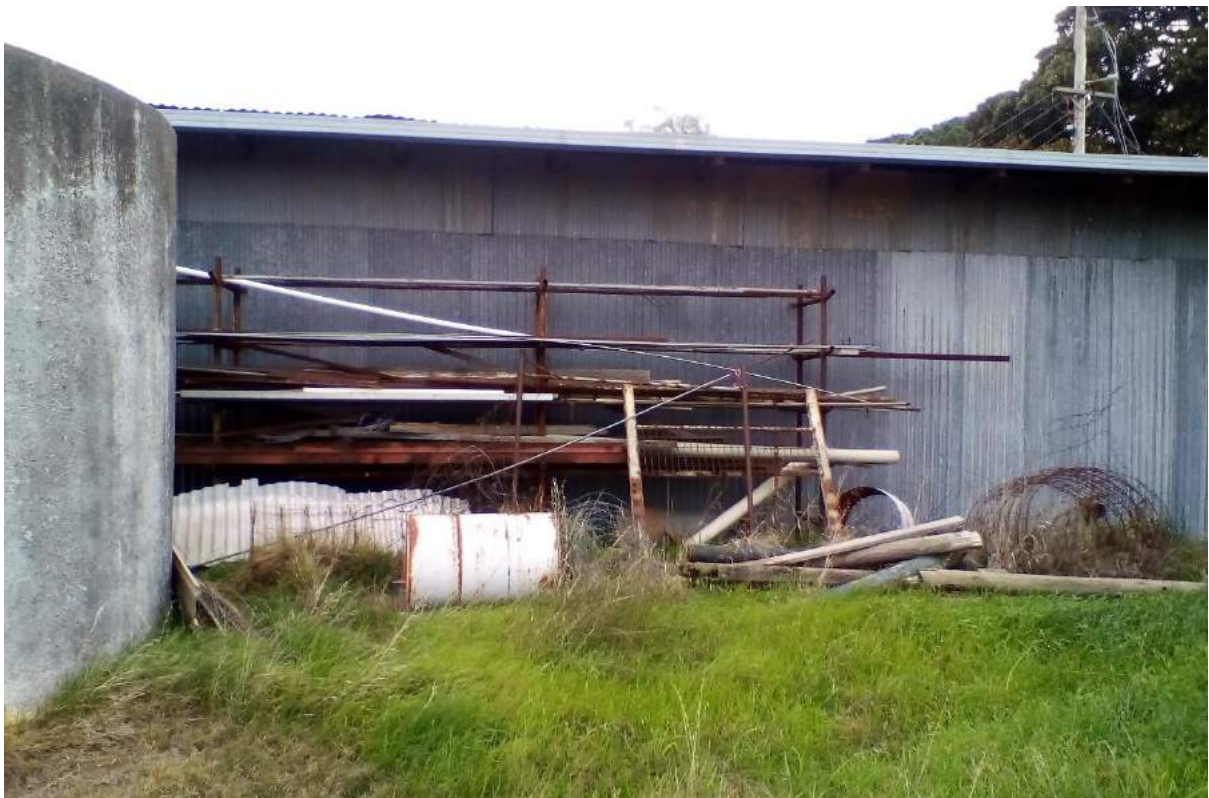
Photograph 6 shows stored material such as steel and wire out the rear of the existing workshop shed.

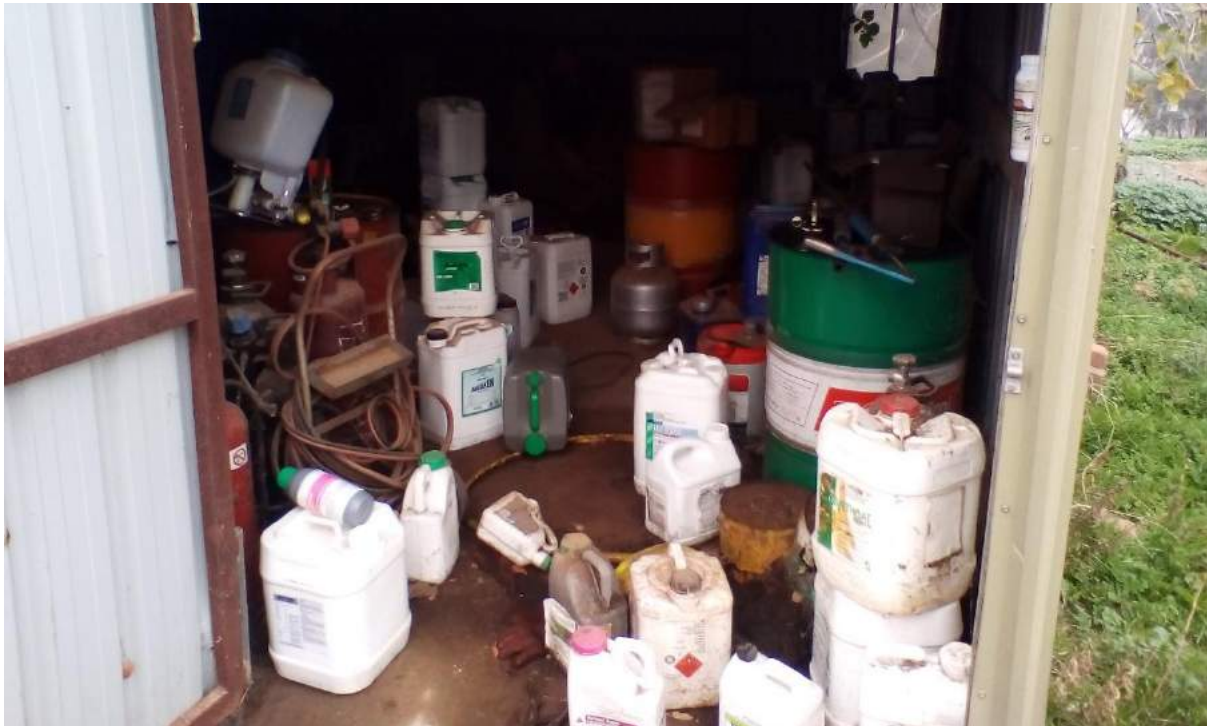
Photograph 7 shows the internal chemical drums and containers within the existing chemical storage shed. Localized staining of the concrete pad was noted during the inspection.

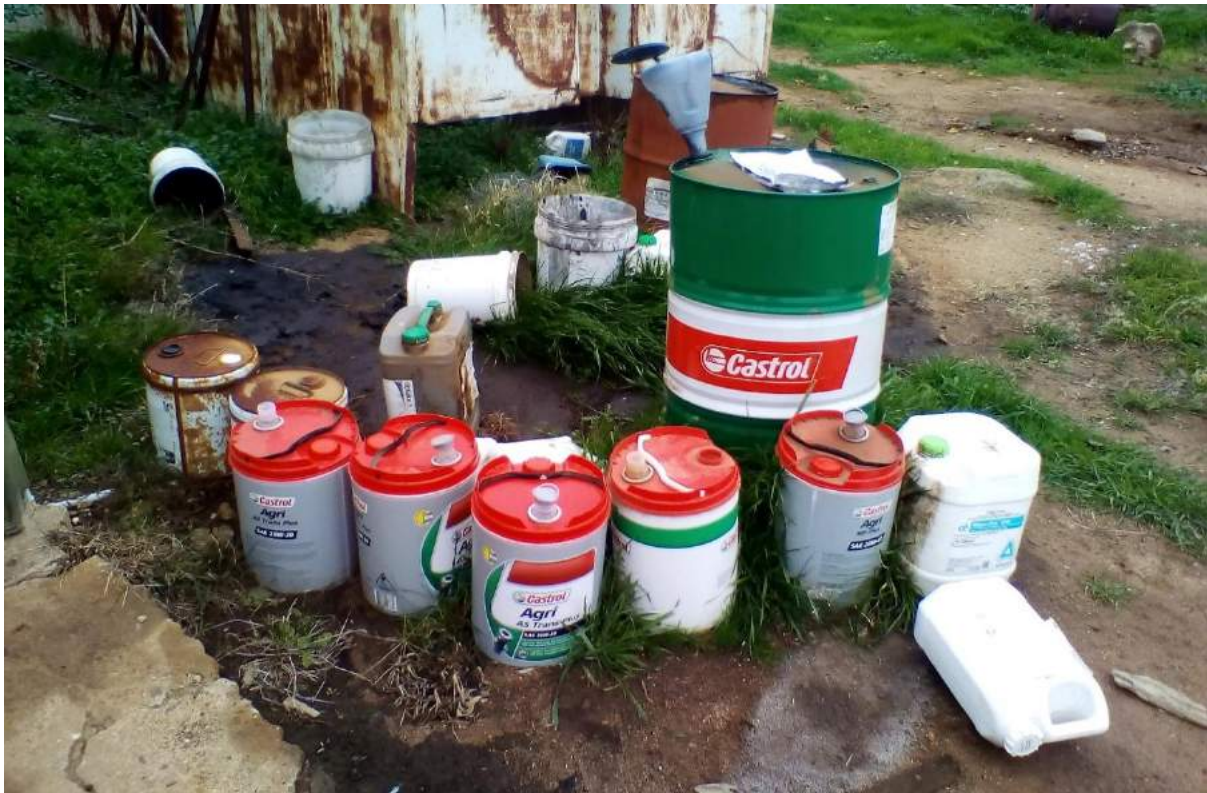
Photograph 8 shows stained ground surfaces around oil and spray drum storage adjacent to the chemical storage shed.

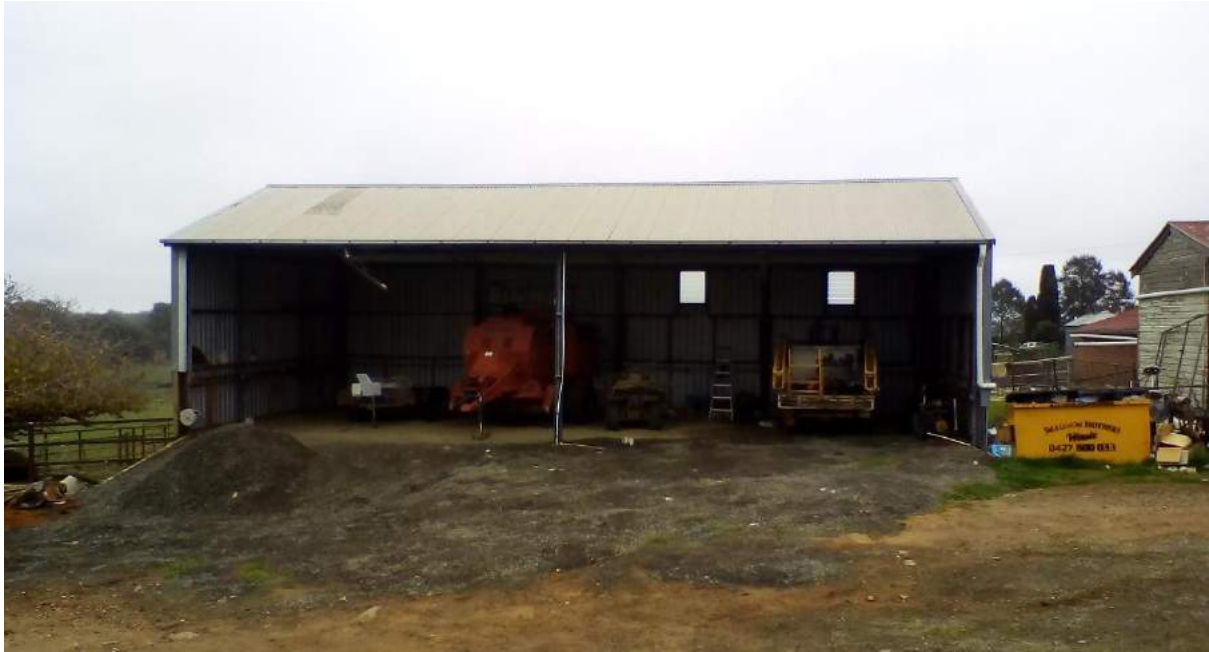
Photograph 9 shows machinery storage in one of the farm sheds on the subject site, the shed floor was hardstand with no evidence of significant oil staining from machinery. A small area of waste material can be seen on the right of the photograph.

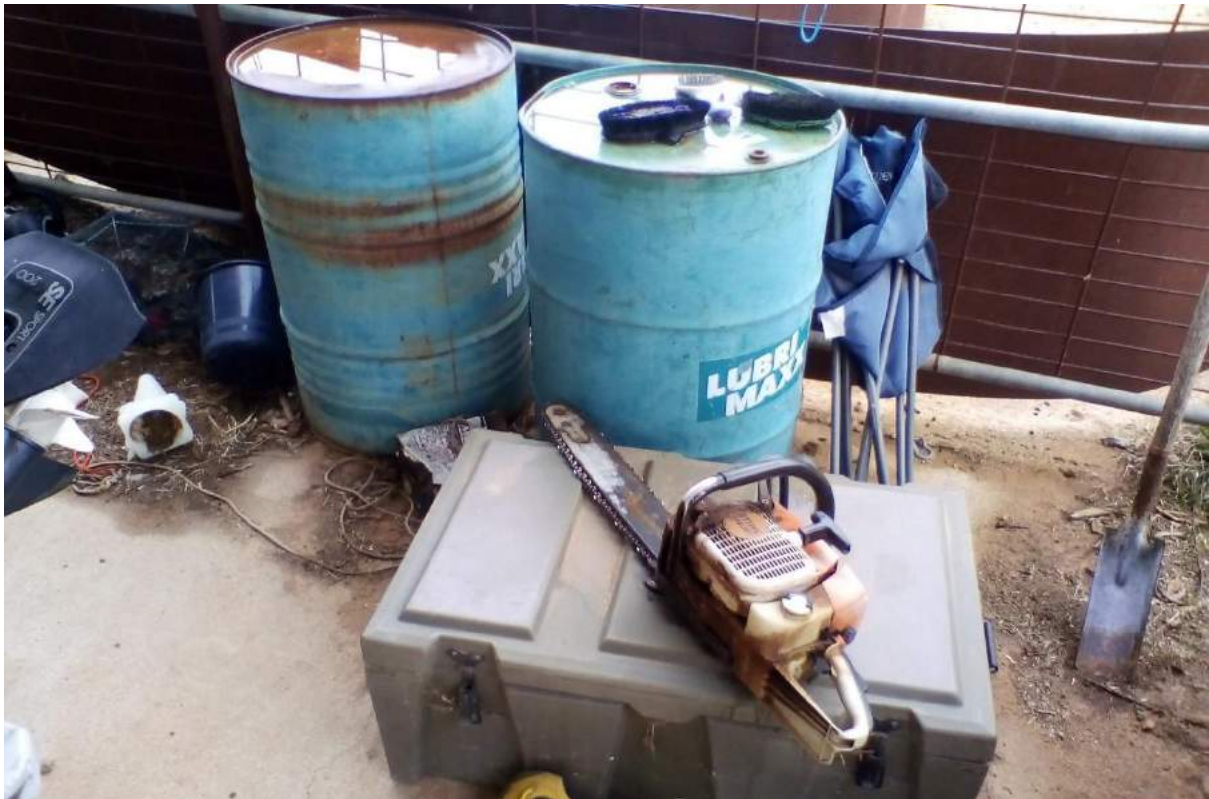
Photograph 10 shows large oil drums and stored items adjacent the stock yards, containers were observed in a good condition on a concrete surface.

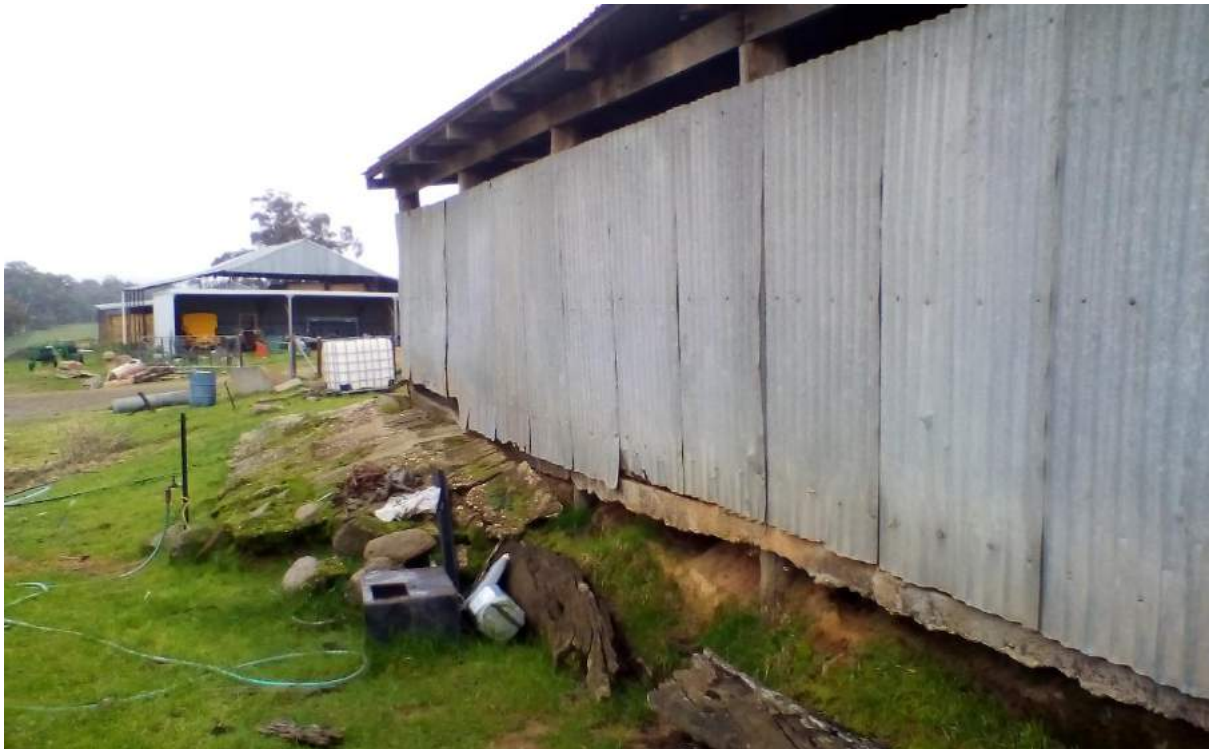
Photograph 11 shows one of the farm workshop sheds on the subject site with stored materials and waste in the background. Some livestock related chemical drums can also be seen in the foreground.

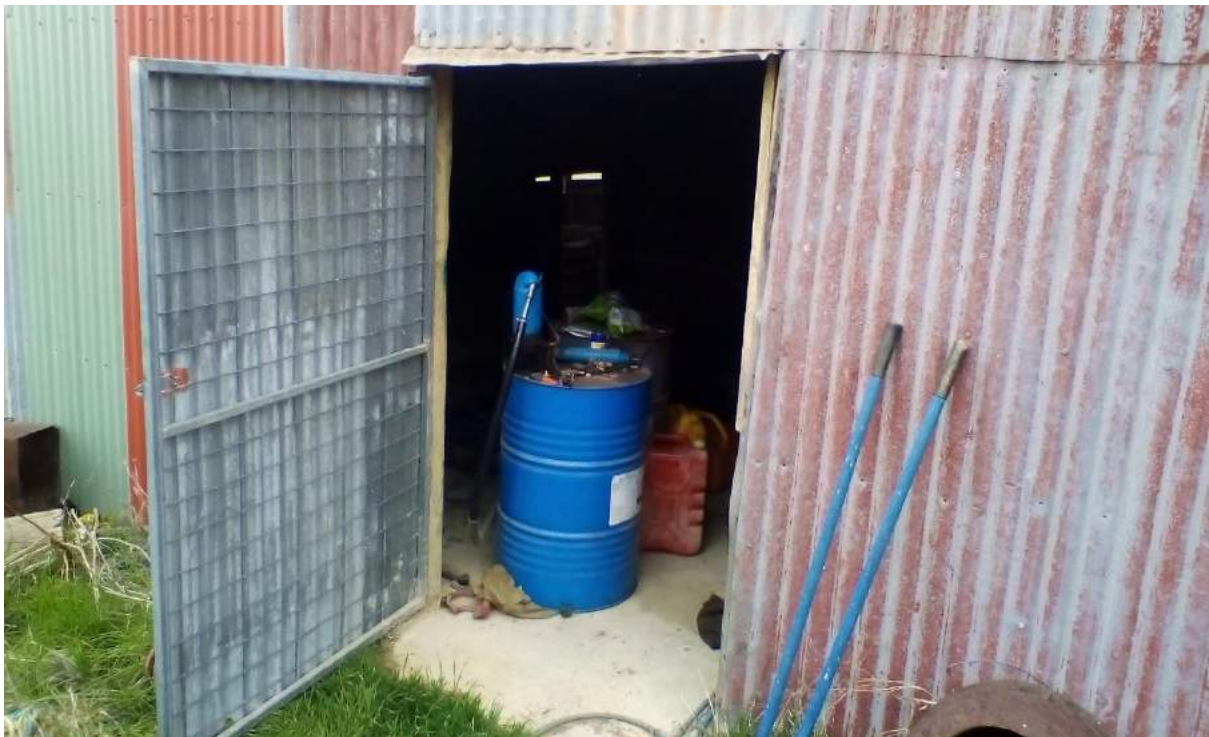
Photograph 12 shows the northern entry to one of the workshops on the subject site, fuel storage and stored materials can be seen within.

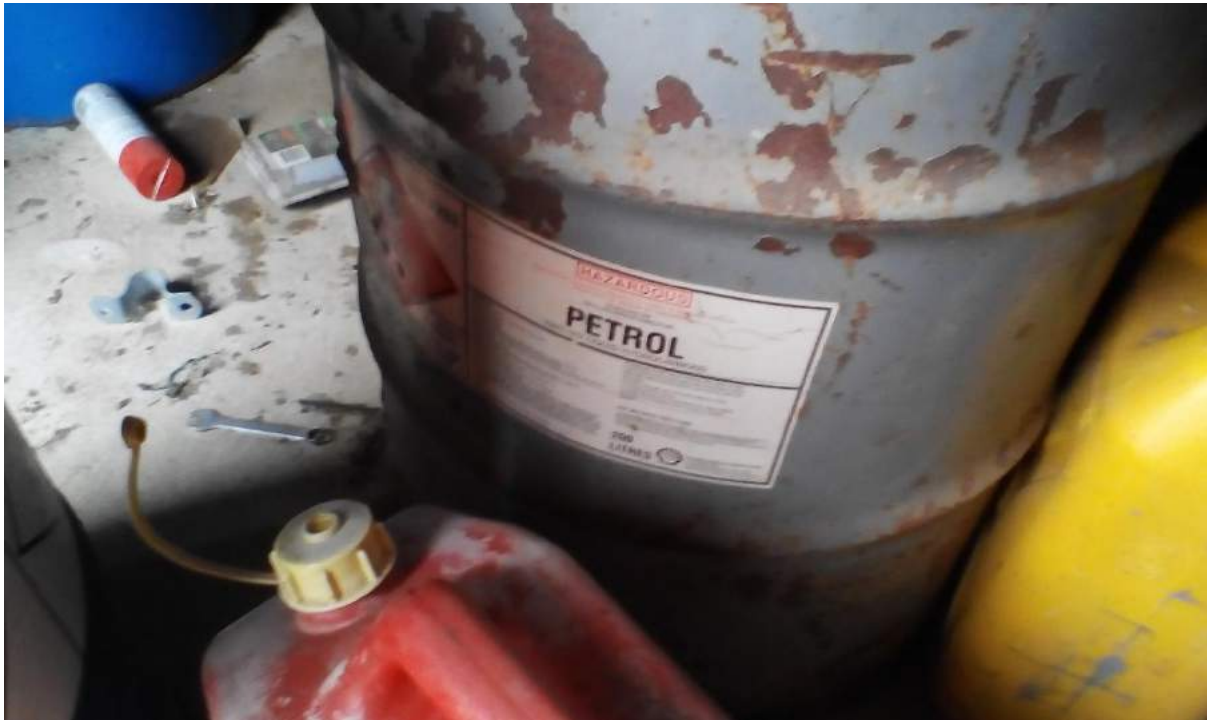
Photograph 13 shows more of the stored fuels and oils stored within one of the onsite workshop sheds.

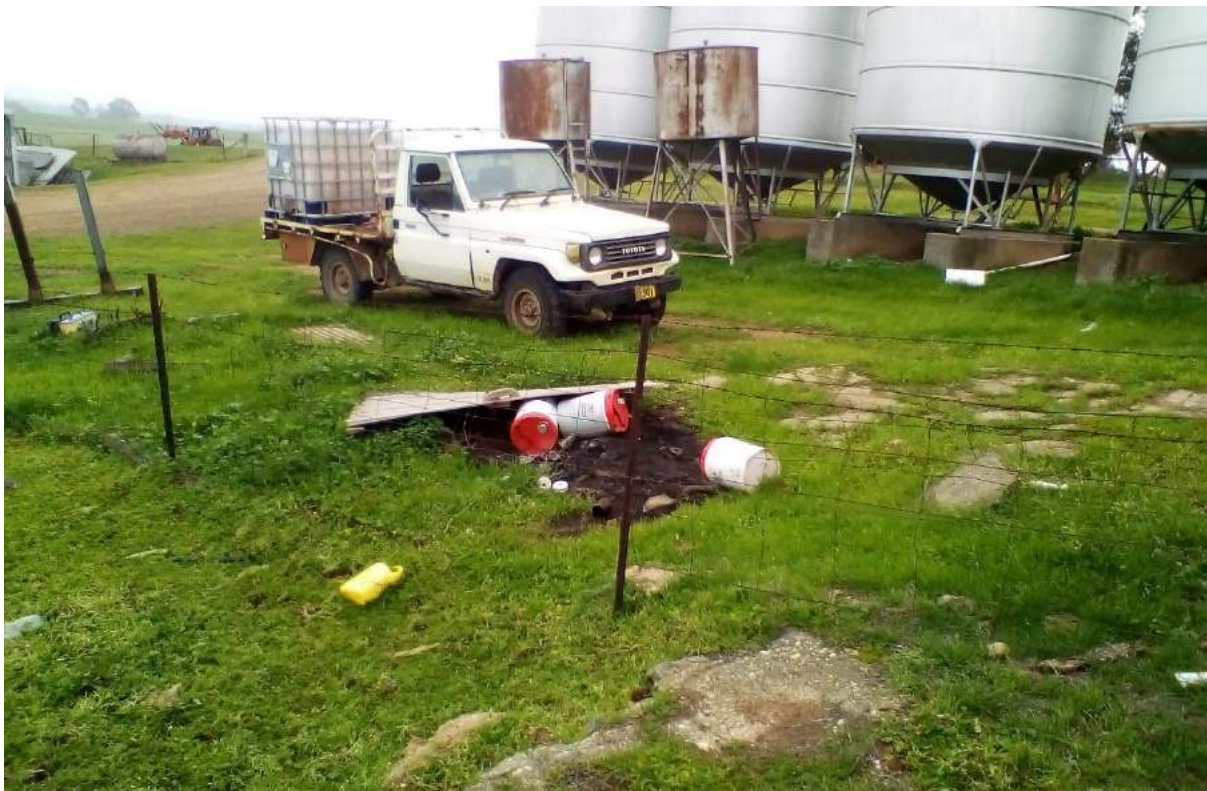
Photograph 14 shows the rear area behind the workshop shed. An old fire with oil drums and filters can be seen in the foreground, a vehicle with an IBC container can be seen in the centre with two Above ground fuel storage tanks seen in the background.

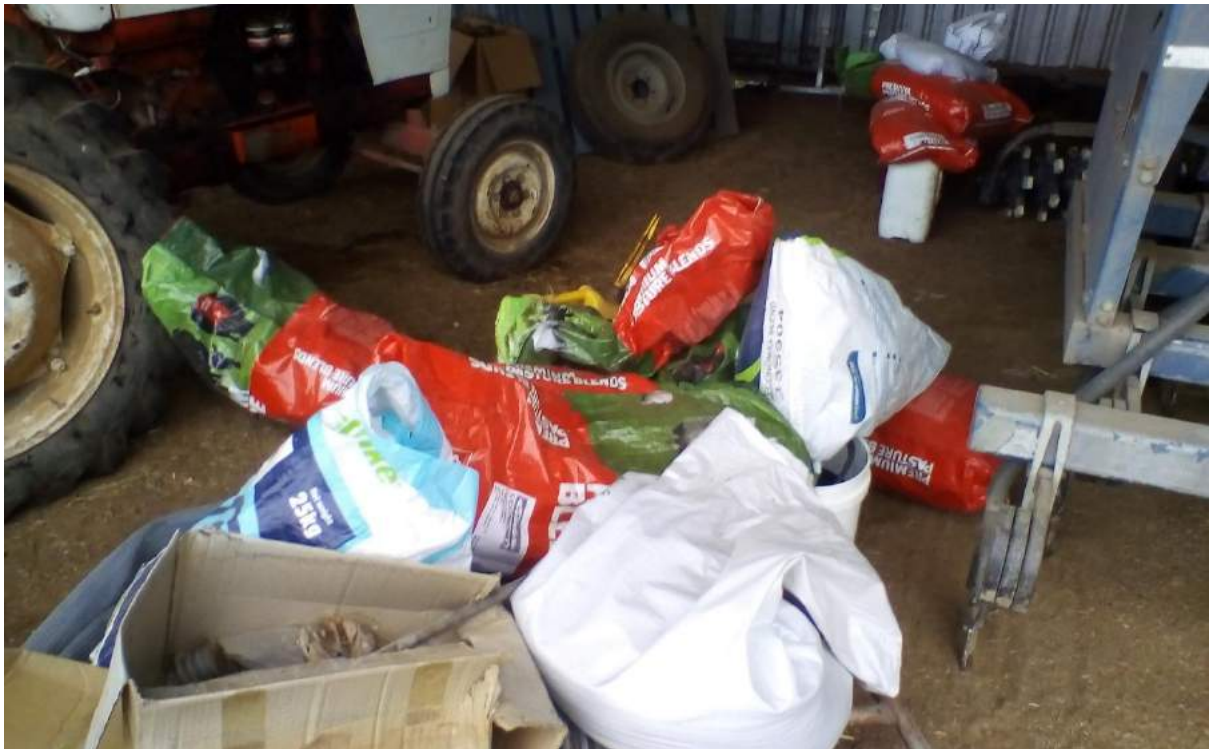
Photograph 15 shows more stored materials in one of the farm sheds including fertiliser and some spray drums. Farm machinery was also evident in the shed with some surface staining noted.

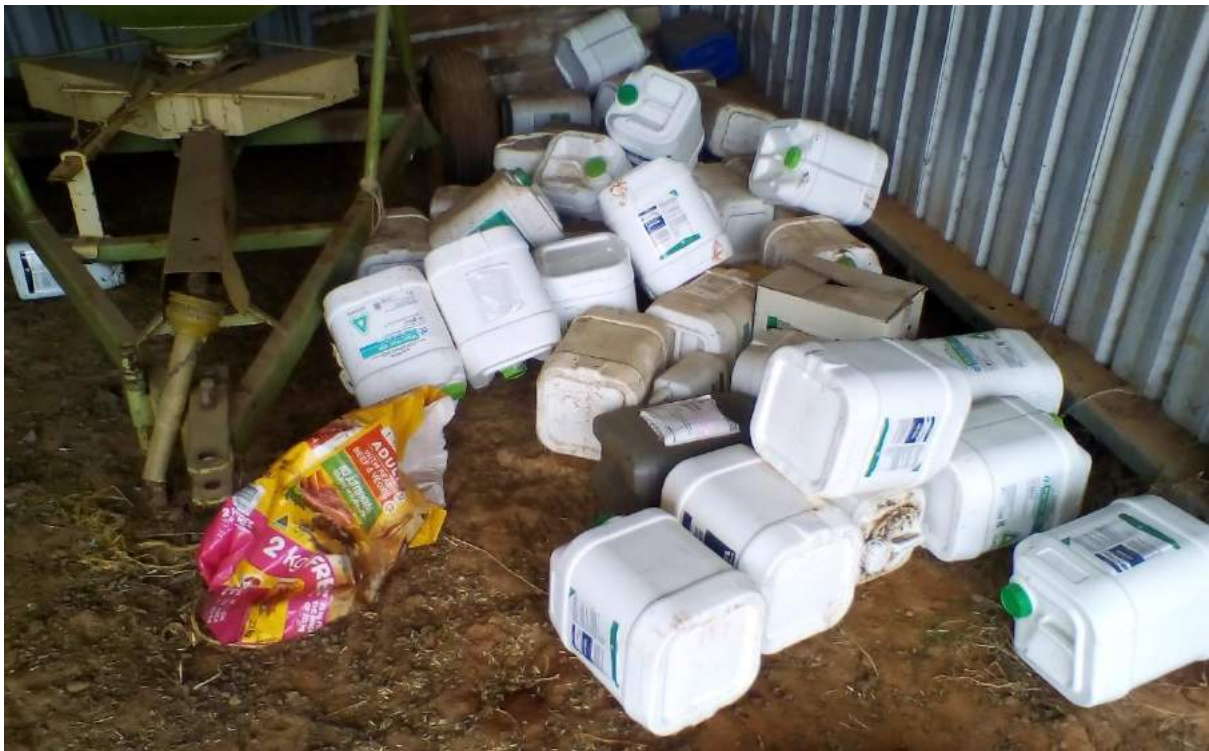
Photograph 16 shows a pile of used spray drums in one of the farm sheds.

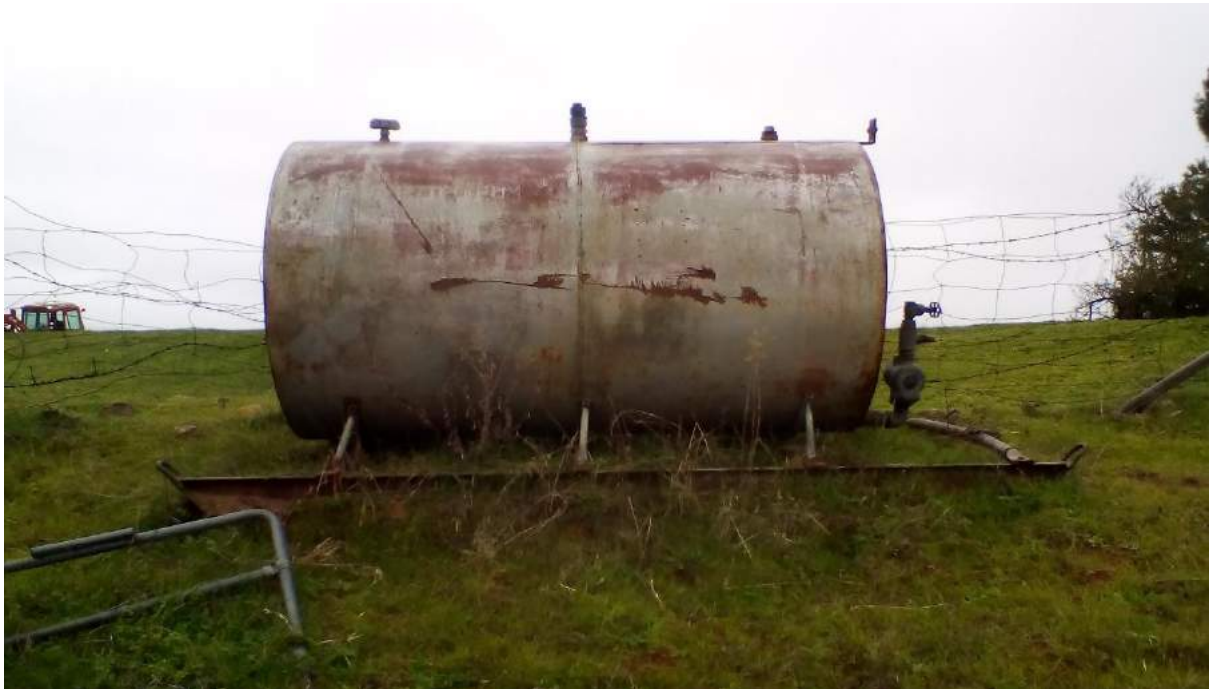
Photograph 17 shows another above ground fuel tank welded to a steel frame for transport, no staining was noted on the soil surface around the fuel tank.

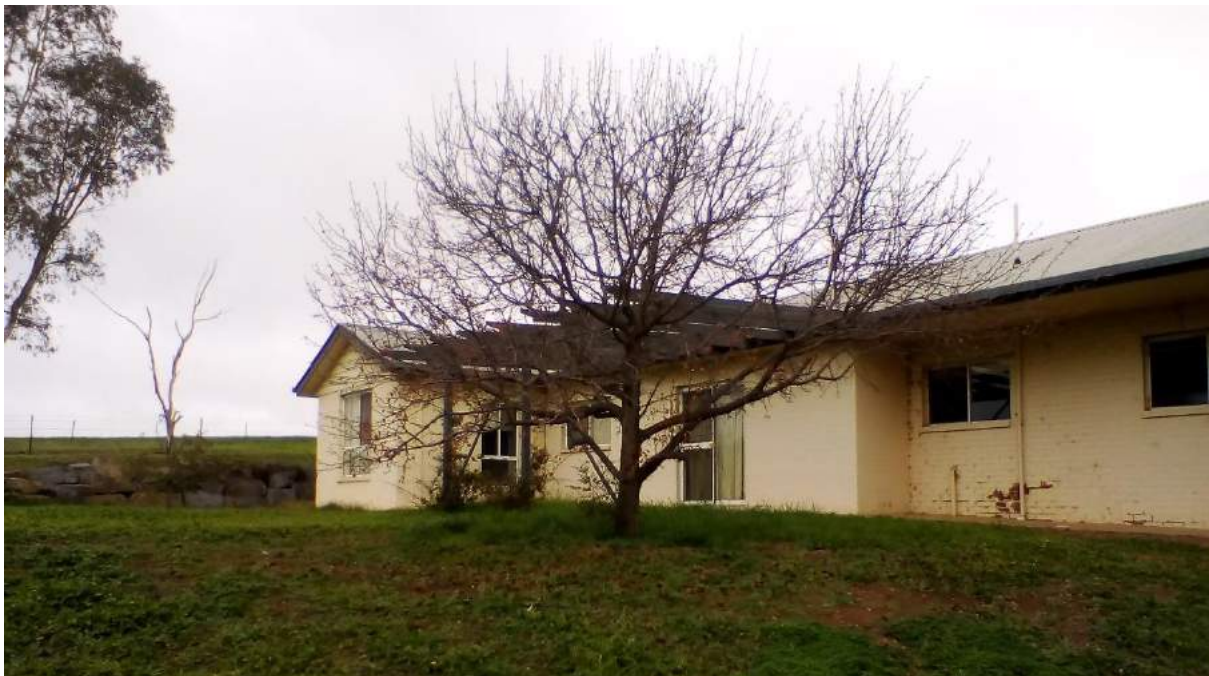
Photograph 18 shows the former dairy residence, built from brick and timber framing and topped with a corrugated iron roof. No suspected ACM material was noted throughout.

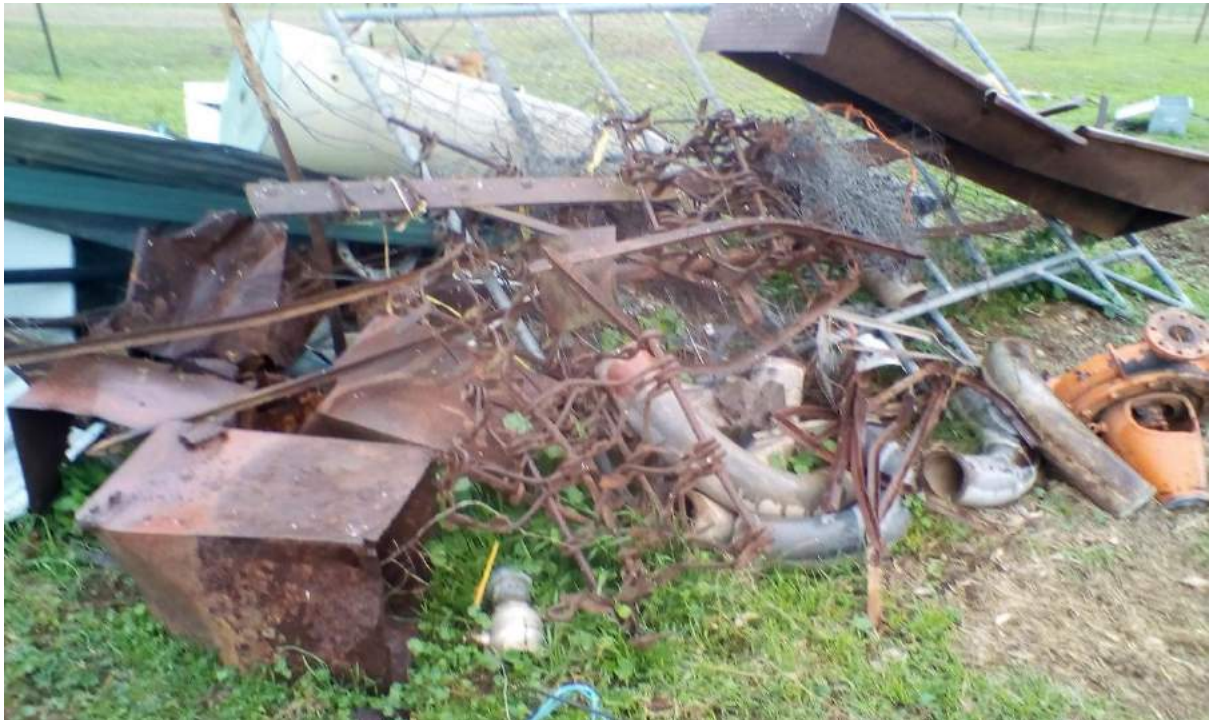
Photograph 19 shows more stored scrap and rubbish materials on the subject site with contents including steel, vehicle parts and old farm equipment.

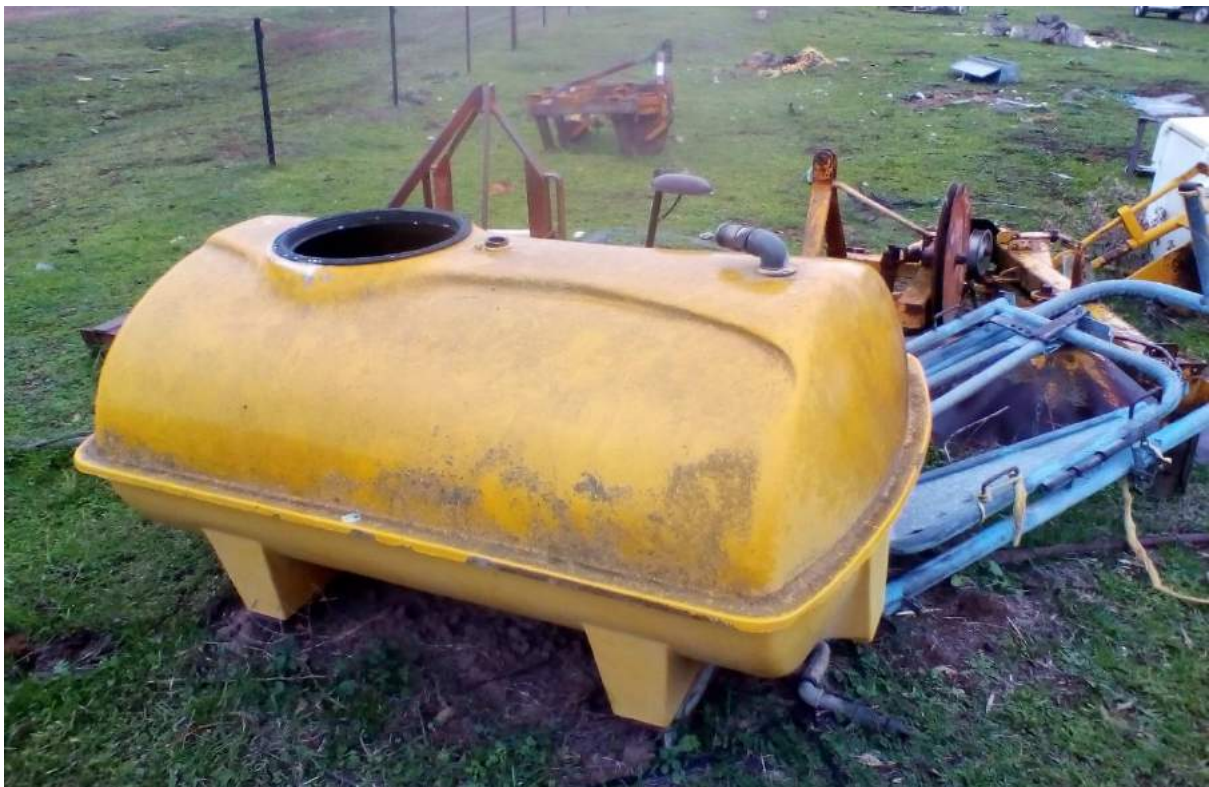
Photograph 20

Photograph 4 shows an old spray rig container stored on site and some old farming equipment in the background. No obvious staining or deleterious material was noted in the area.

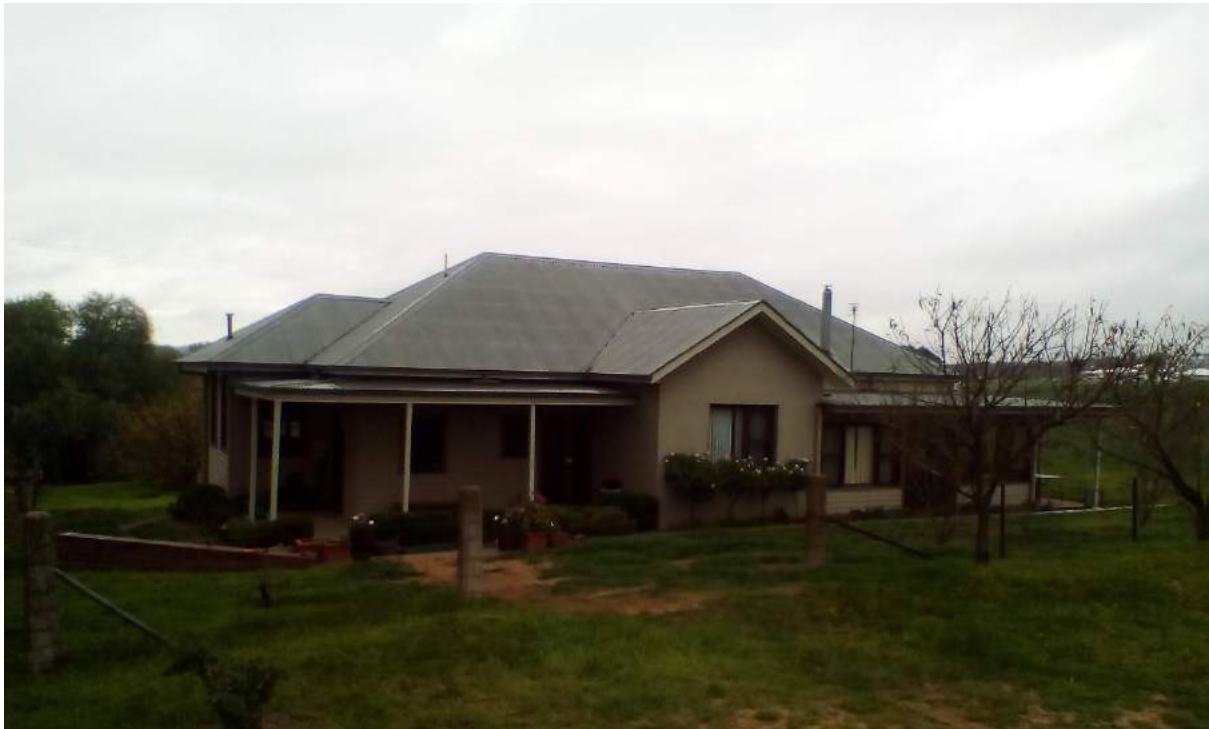
Photograph 21 shows the last residence property on the subject site built from timber flooring framing and cladding with a corrugated iron roof.
