PRELIMINARY SITE INVESTIGATION

**77 OLD NARRANDERA ROAD &
9 RIVER ROAD
GOBBAGOMBALIN NSW**

JUNE 2019

REPORT NO. 5797

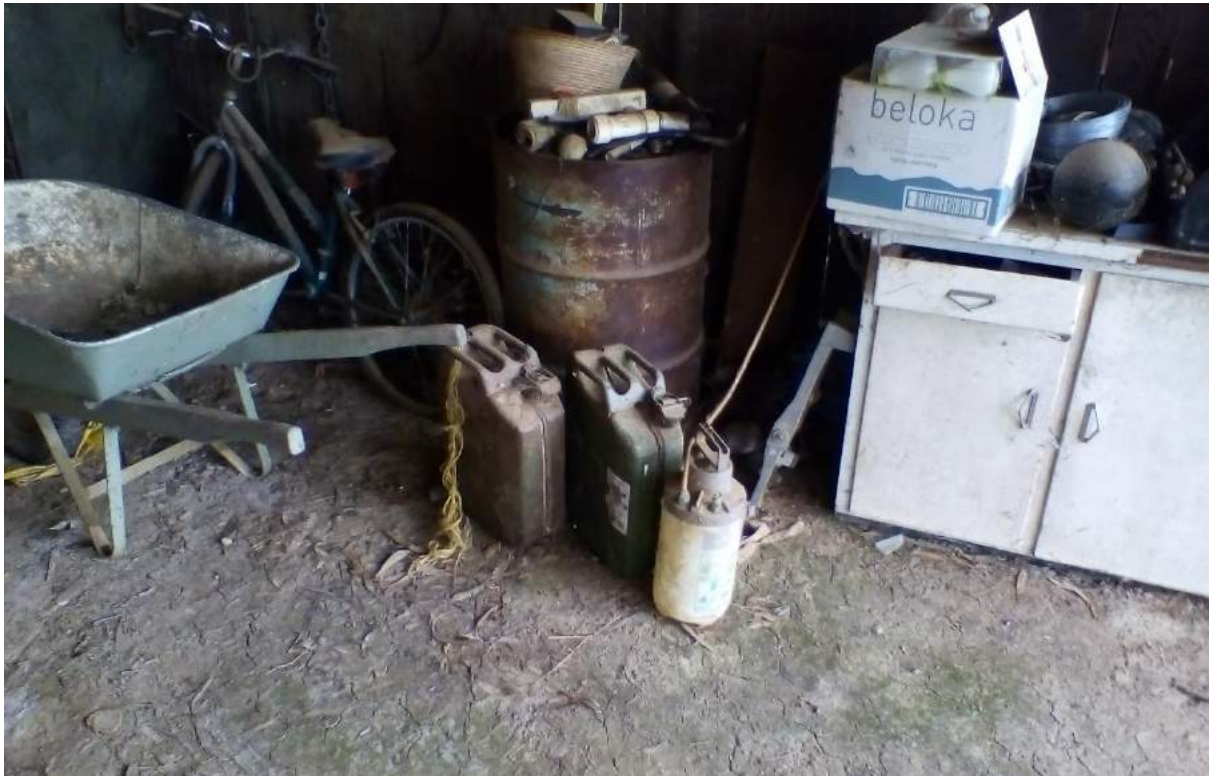
Photograph 22 shows some stored materials such as fuels and oils in the “Hawthorne” property garage.

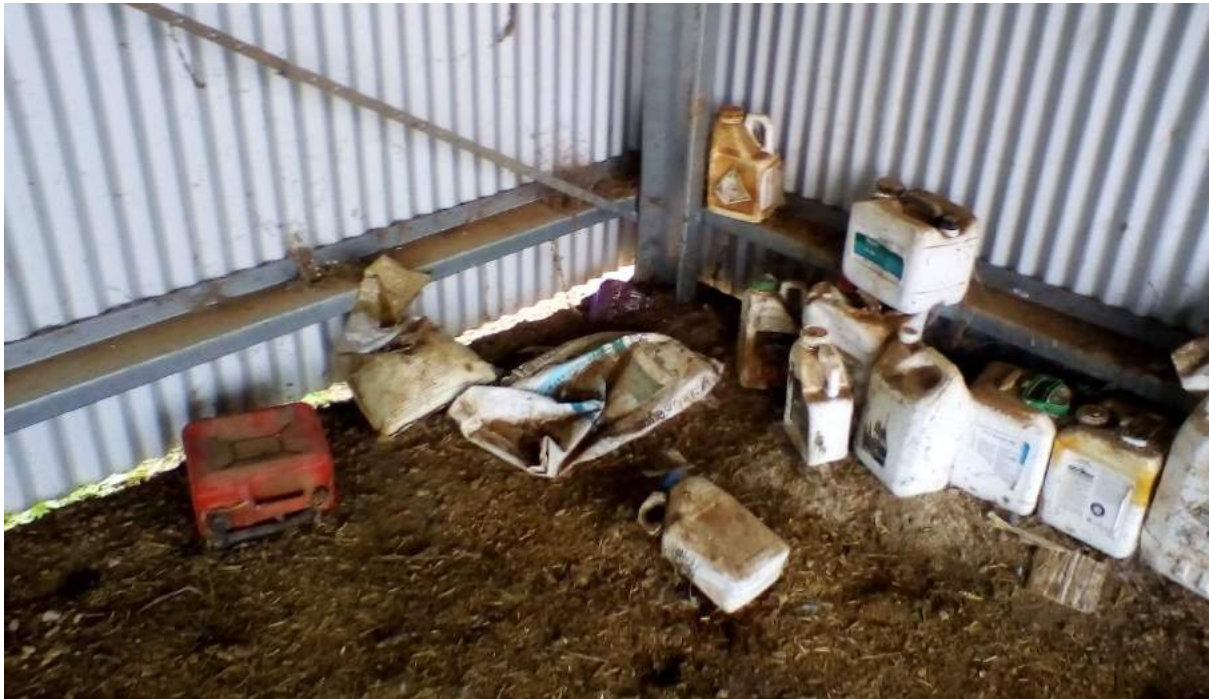
Photograph 23 shows some stored spray and chemical drums in the large farm shed on the “Hawthorne” property.

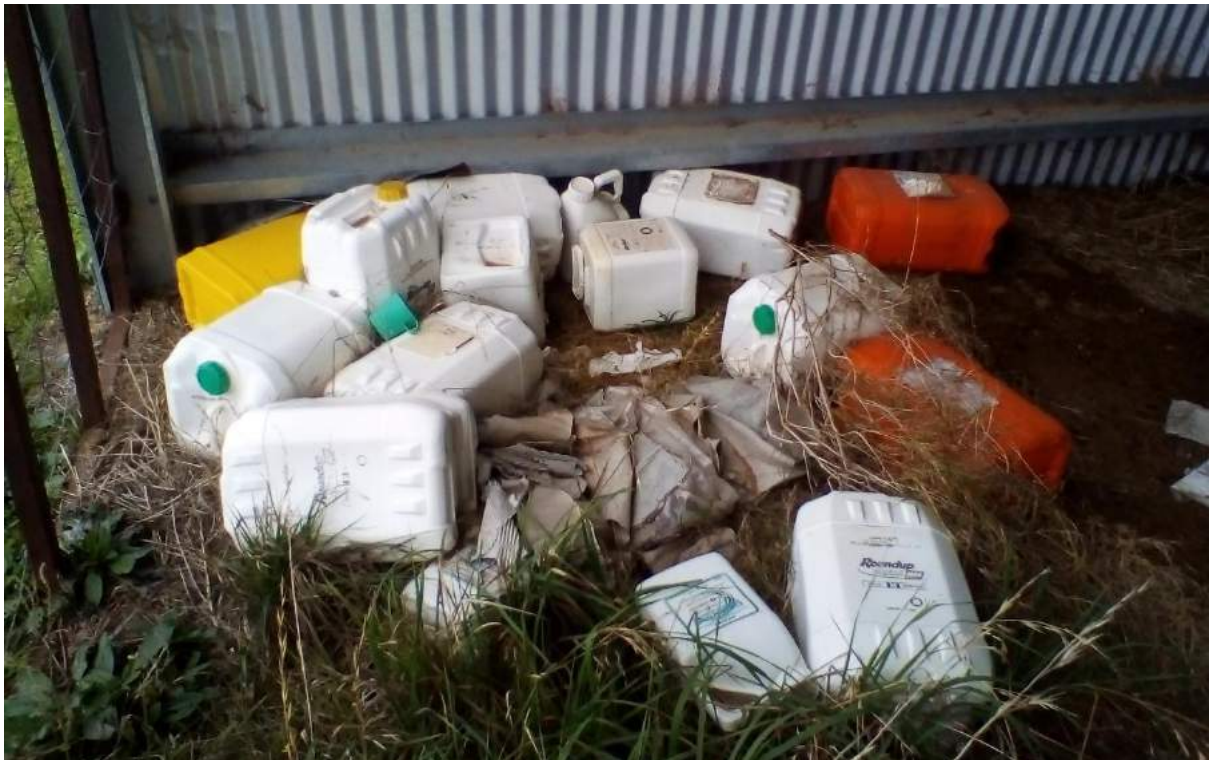
Photograph 24 shows more empty spray drums in the large farm shed on the “Hawthorne” property.

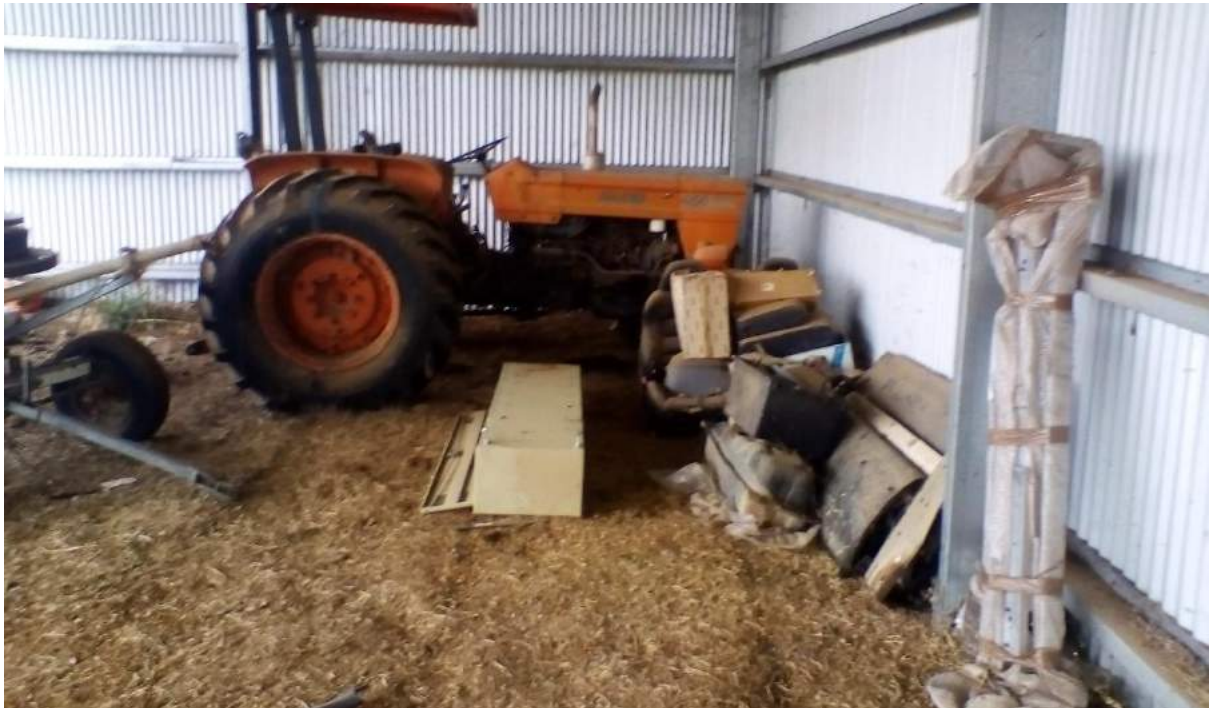
Photograph 25 shows a small tractor in the large farm shed on the “Hawthorne” property. Some staining of soils beneath the tractor was noted as a result of a leaking engine.

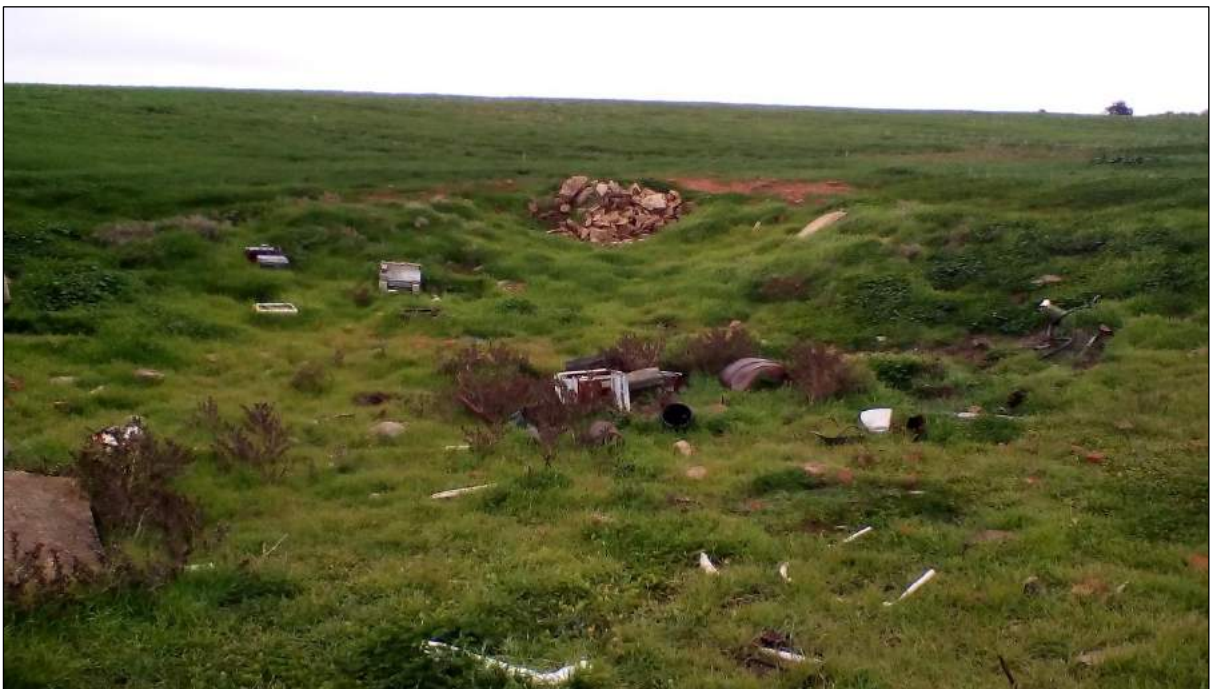
Photograph 26 shows an old rubbish and scrap storage pit towards the centre of the subject site. Materials noted within included metal, brick, tile, concrete, timber, rock and old appliances.
