Report Type: Preliminary Site Investigation
Site Address: 1400 – 1480 Elizabeth Drive, Cecil Park, NSW
Report Number: 2255/ER-1-1
Report Date: 12th May 2016

RE: PRELIMINARY SITE INVESTIGATION – 1400 – 1480 ELIZABETH DRIVE, CECIL PARK, NSW

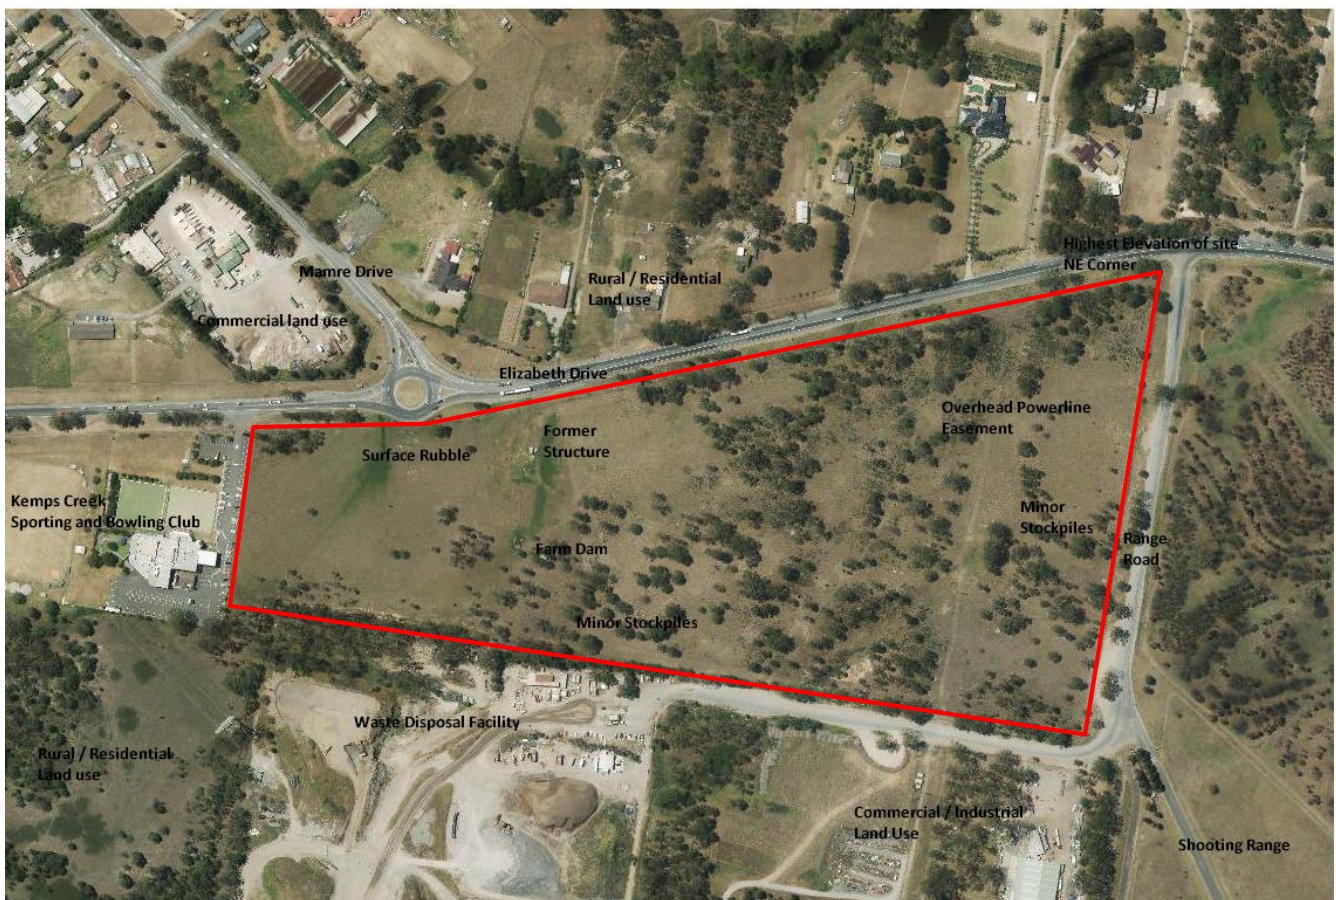
Figure 2: Site Layout and Features

At the time of the inspection, the site consisted of a large vacant area that was used for minor agricultural purposes (approximately 10 cows were observed). The site was relatively cleared with site vegetation including grasses and minor, localised pockets of trees. Other site features included minor soil stockpiles, two small temporary structures and footings of a former structure, dry creek lines and a small farm dam. The entire site was secured with a combination of locked gates, barbed wire and electric fencing around the perimeter. The site features are shown in **Figure 2** below and are discussed further in **Section 4**. Photographs taken during the site inspection are included in **Appendix A**.

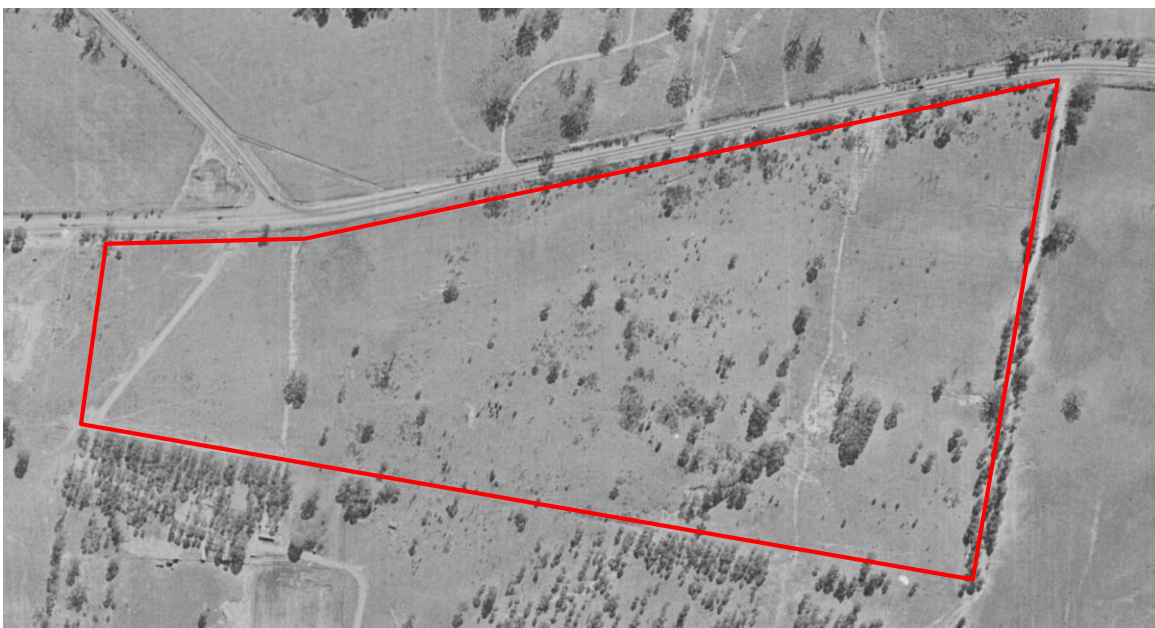
1965

The site use appeared similar to the previous aerial photograph except an unsealed road appeared to have been constructed between Elizabeth Drive and the property to the south and a number of the trees appeared to have increased in size. Further, two tracks were evident with one located on the western portion of the site and a second track located on the eastern portion of the site. This second track appears to be in the location of the current powerline easement and may indicate the construction of the powerline had recently occurred (an area of existing trees that intersected the alignment had been cleared). Quarrying activities appeared to have commenced at the property to the south of the site and the new road through the site was the point of ingress / egress for the quarry. The other surrounding properties appeared similar to the previous aerial photograph.

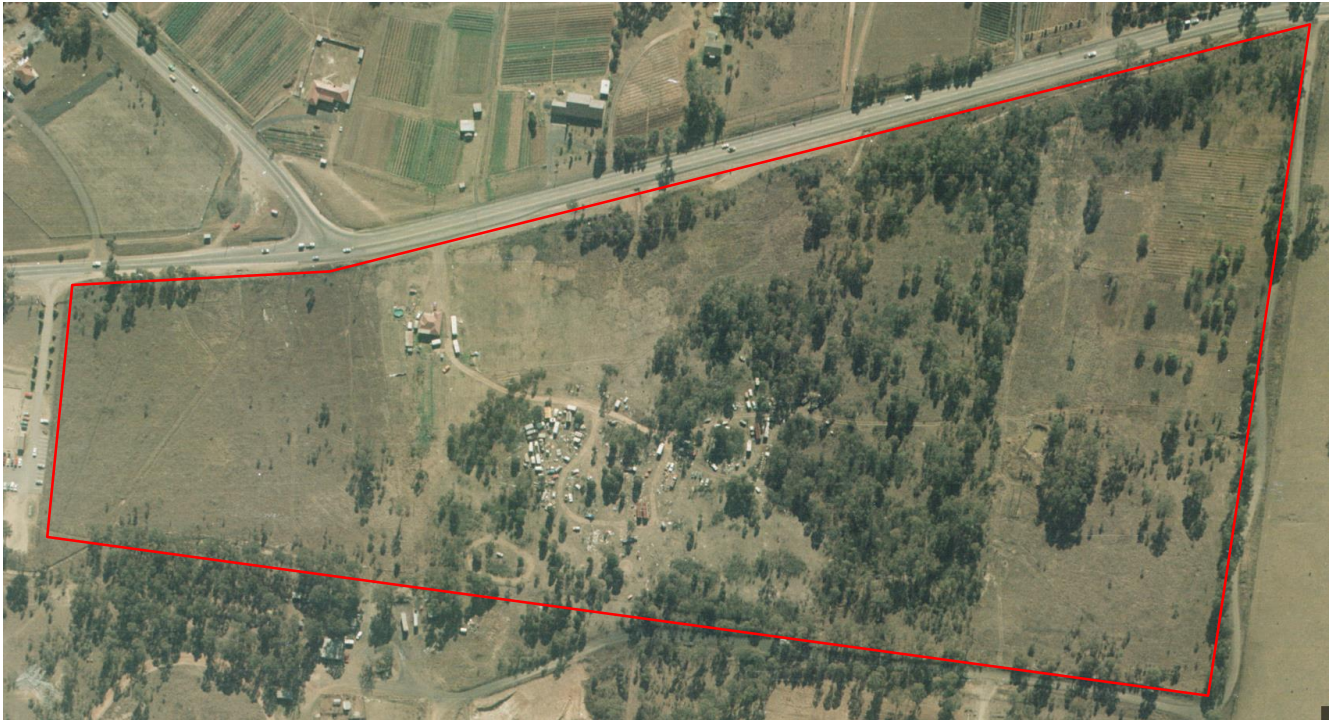
1986

The area to the south east of the site dwelling appeared to be used to store multiple cars, trucks, shipping containers and stockpiles of unknown materials. The north-eastern portion of the site appeared to continue to be used for cropping purposes. The former road that was used as the access point to the quarry in the 1965 photograph appeared to no longer be used and is partially overgrown.

The land use of the surrounding areas appeared similar to the previous aerial photograph.

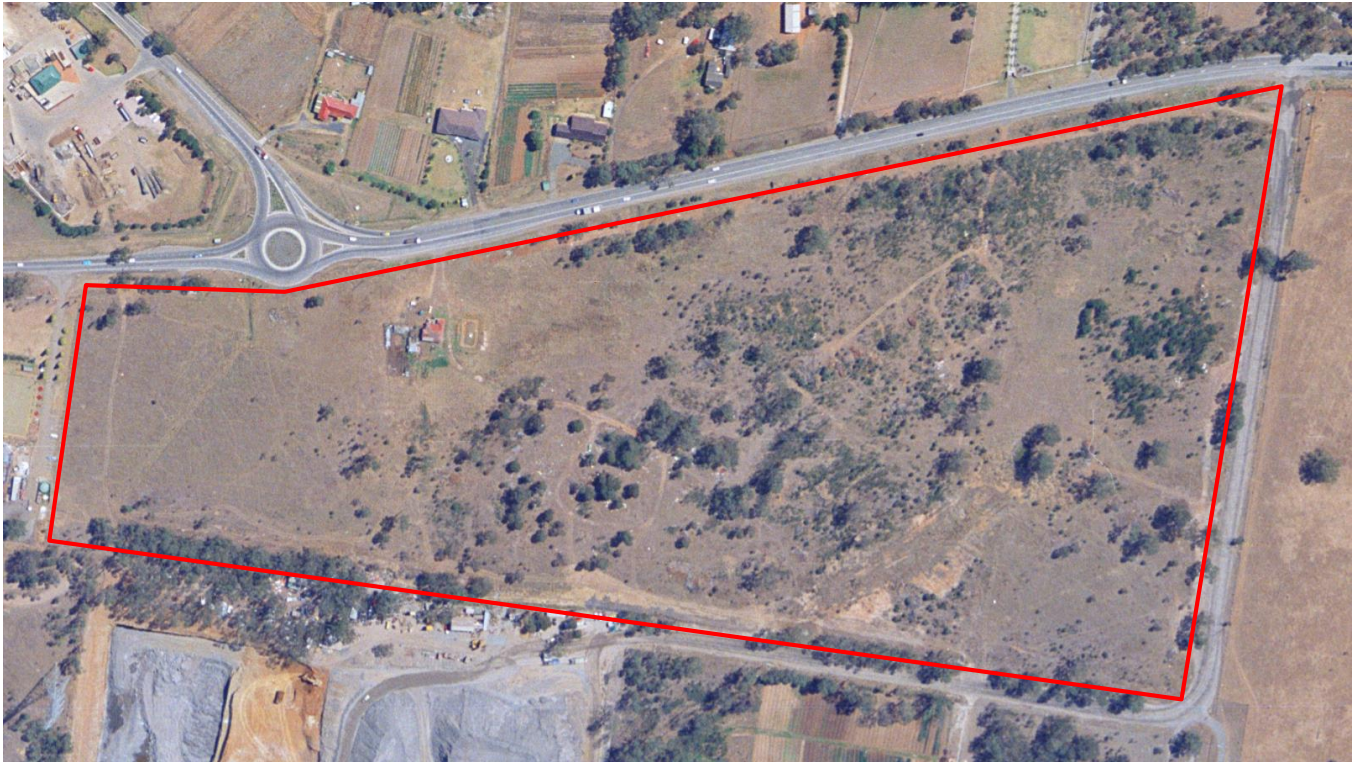
1994

The majority of the cars, trucks and other materials in the centre of the site that appeared in the previous aerial photograph appeared to have been removed, however, remnant objects were observed to remain. The site appeared to have ceased to be used for farming purposes with no cropping areas observed. Minor stockpiles and potential areas of fill/earthworks were observed. Minor alterations to the area surrounding the dwelling were also observed.

The property to the south appeared to have increased in production of quarried products. Elizabeth Drive appears to have undergone further improvements with a roundabout with Mamre Road now evident. What appears to be a commercial development (the location of the current landscaping supplies business) exist to the northwest of the roundabout. The remaining surrounding area appeared similar to the previous aerial photograph.

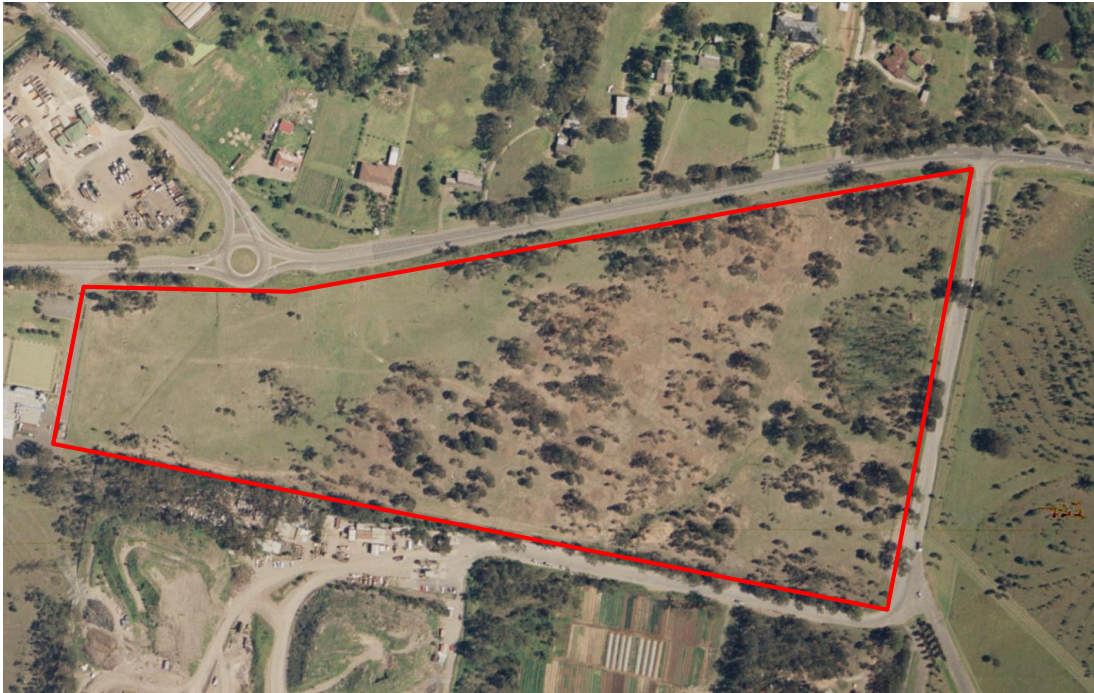
2005

The residential dwelling and all other structures / objects appeared to have been removed from the site. The central portion of the site appeared to have undergone earthworks with bare earth visible. The dam that was present at the site in the previous aerial photographs appeared to have been removed (filled). The land use of the surrounding areas appeared similar to the previous aerial photograph.

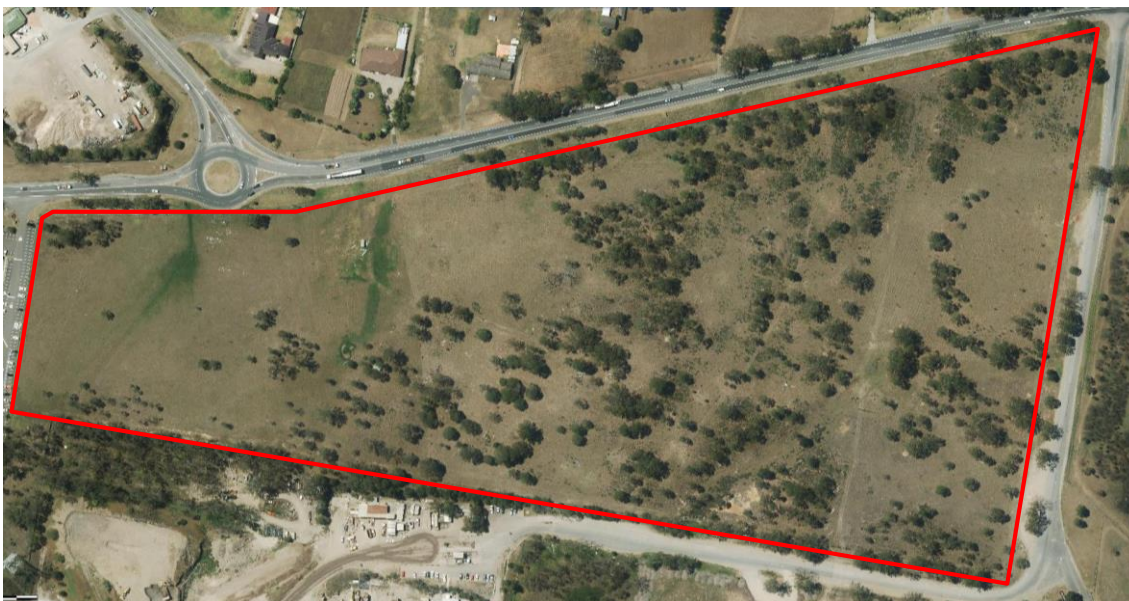
2015

The site and surrounding areas appeared similar to the previous aerial photograph except the site vegetation appeared to have re-grown across the whole site and two temporary structures appeared and minor objects had appeared on the surface in localised areas.

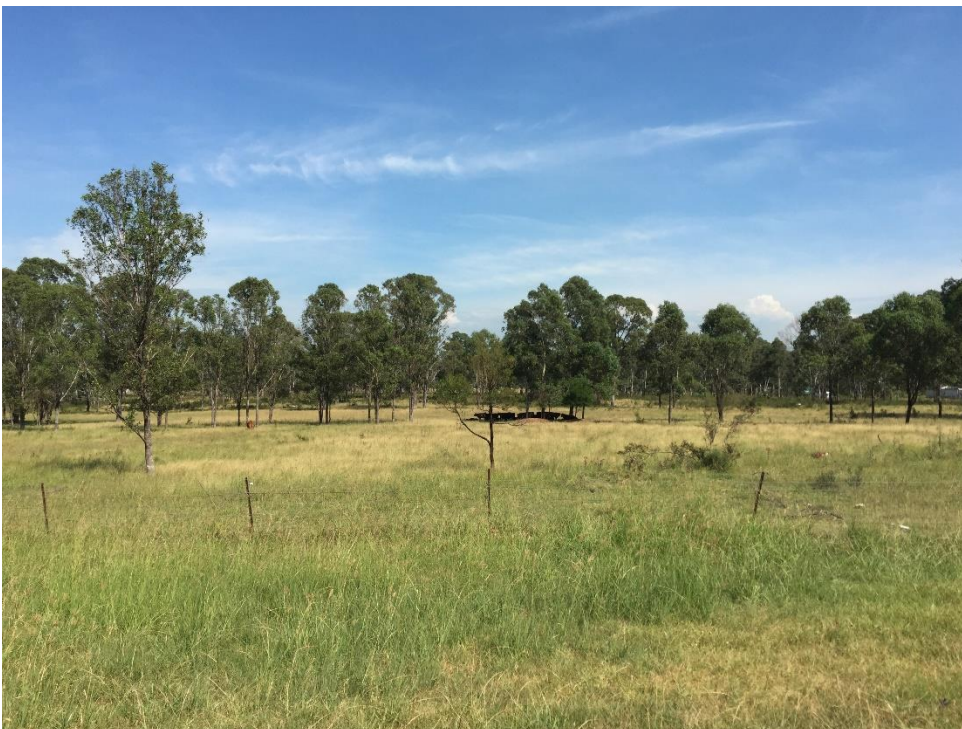
Photograph 2: Photograph was taken from the eastern site boundary, looking west. The majority of the site was grassed with minor trees and livestock grazing.

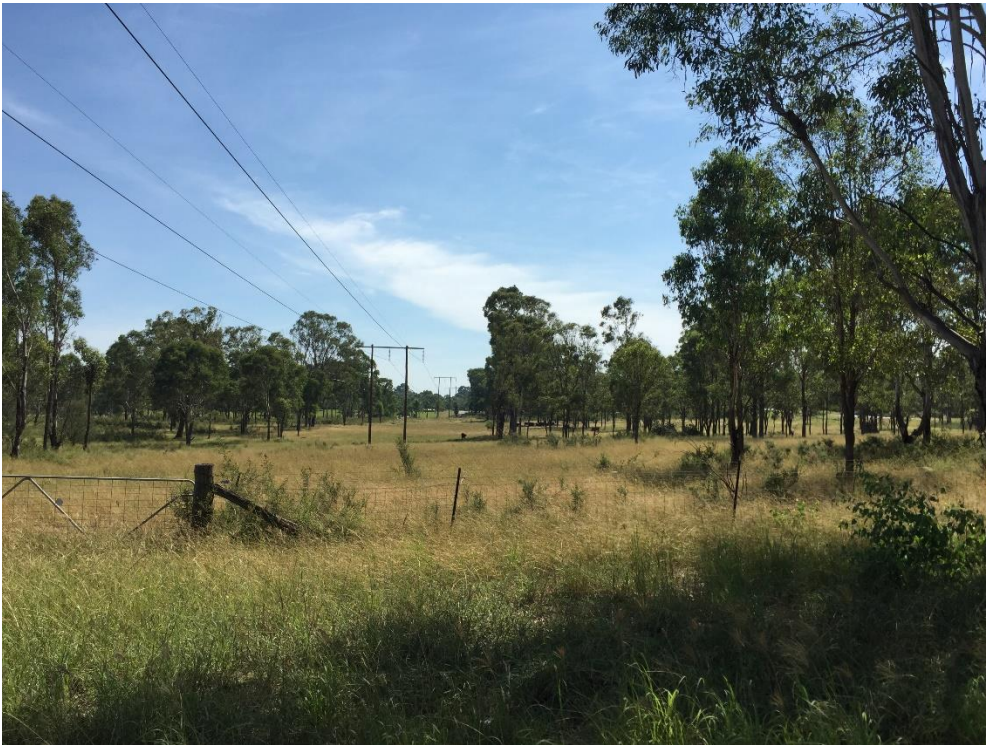
Photograph 3: The overhead powerline easement. This photograph was collected from the southern boundary, looking north.

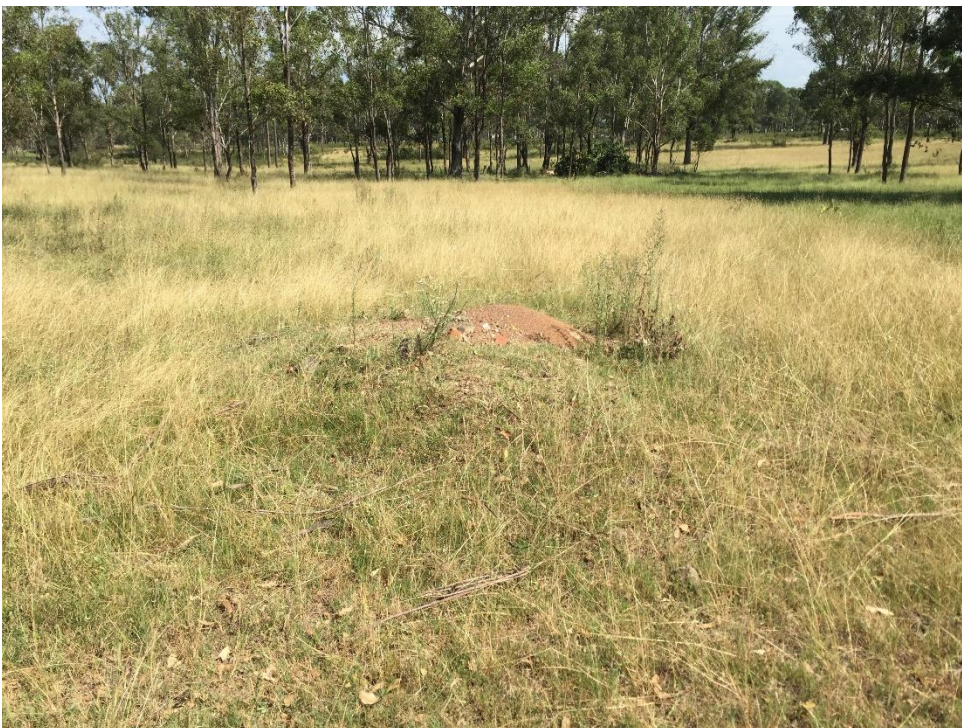
Photograph 4: A minor stockpile of fly-tipped soil in the southern portion of the site, looking north-west.

It is recommended that soil samples are collected to target the AECs and a Stage 2 Detailed Site Investigation should be completed to address the potential for contamination and to assess the suitability of the site for the proposed land use.

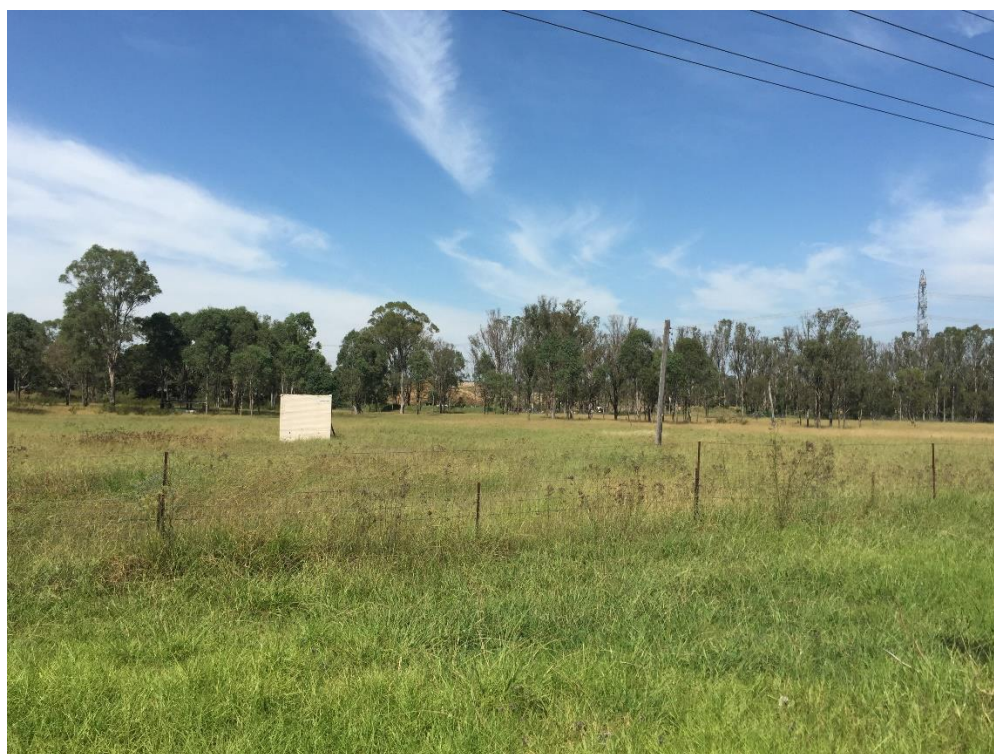
Photograph 5: A temporary site structure with the quarry in the background, looking south.
