Preliminary Wastewater Assessment:
Rezoning Application,
45 Noongah Street and 25 Gwynn
Hughes Street, Bargo, NSW

P1504816JR03V01
March 2017

DRAWING TITLE				
WASTEWATER CONSTRAINTS PLAN				
PROJECT NO.	PLANSET NO.	ISSUE NO.	DRAWING NO.	REVISION
P1504816	PS00	N/A	SK-A100	A

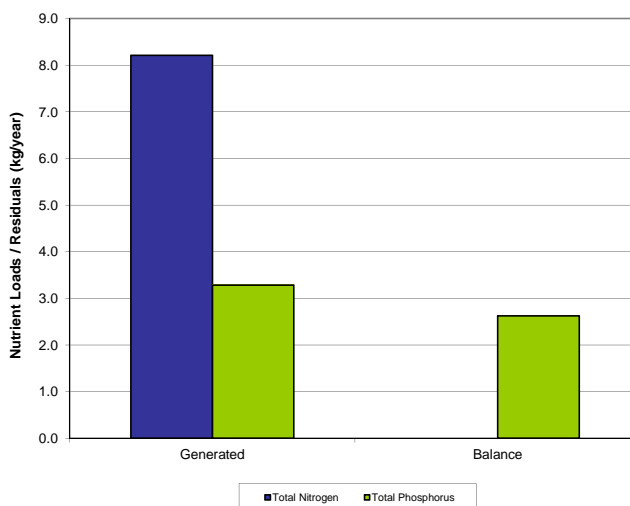
MINIMUM NUTRIENT ASSIMILATION AREA

Minimum Area	411	m ²
--------------	-----	----------------

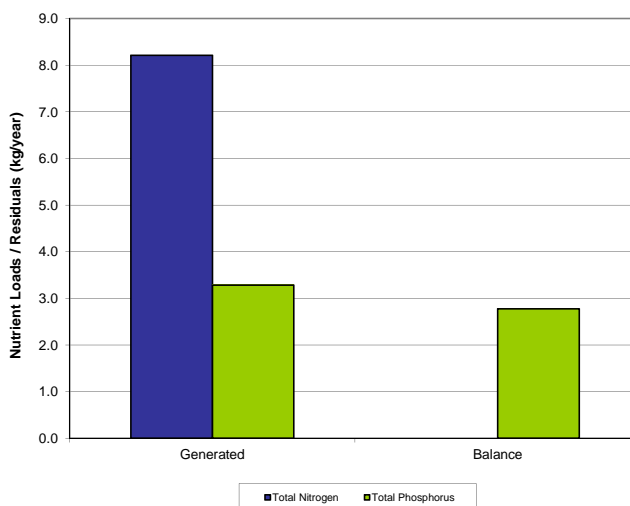
MINIMUM NUTRIENT ASSIMILATION AREA

Minimum Area	411	m ²
--------------	-----	----------------

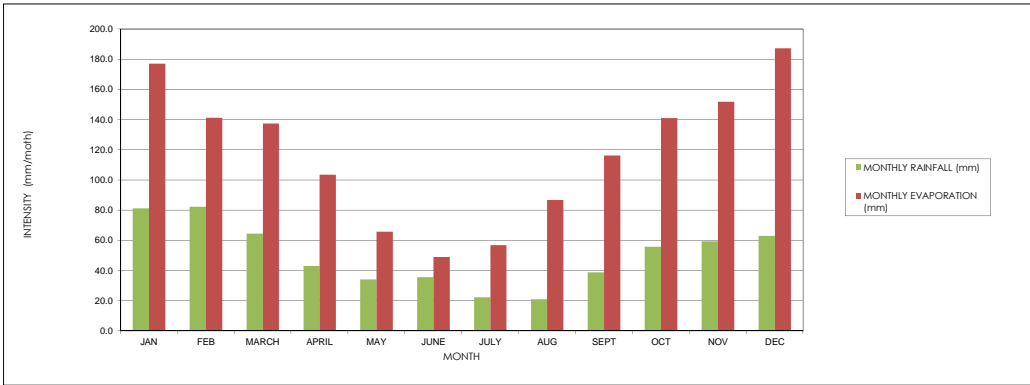
Source(s):	Evaporation data - Badgerys Creek McMasters Firestation (067068) 1967 - 1984
	Rainfall data - Buxton (Amaroo) NSW (068166) 1966 - 2013

MONTH	MONTHLY RAINFALL (mm)	MONTHLY EVAPORATION (mm)
	Enter Data	Enter Data
JAN	81.30	177.10
FEB	82.30	141.40
MARCH	64.40	137.40
APRIL	43.10	103.60
MAY	34.20	65.70
JUNE	35.60	49.00
JULY	22.20	56.80
AUG	21.00	86.80
SEPT	38.80	116.20
OCT	55.80	141.20
NOV	59.50	152.00
DEC	63.00	187.30
