HERITAGE IMPACT STATEMENT

34-72 Tallawong Road, Rouse Hill

May 2019 | J3537

**Weir
Phillips**
Heritage
and Planning

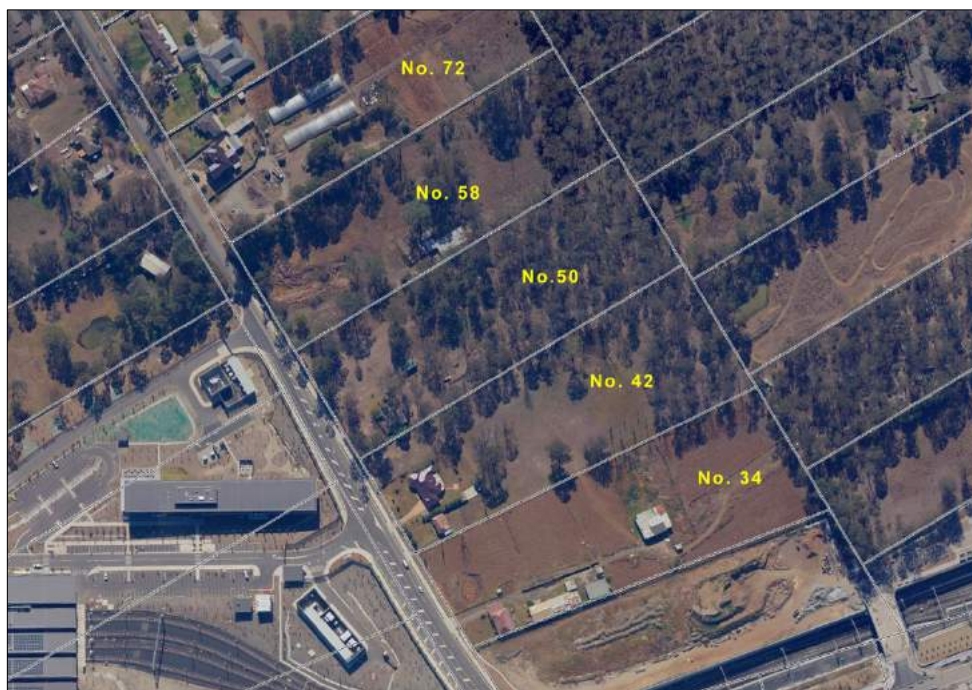
The site is approximately 7.5ha in size. The lots are partially cleared with scattered vegetation. Lot 67 is more heavily vegetated than the other lots comprising the site. There are a number of free standing dwellings (and their outbuildings) on the site. Refer to Figure 3.

Figure 3: Aerial Photograph over the site.

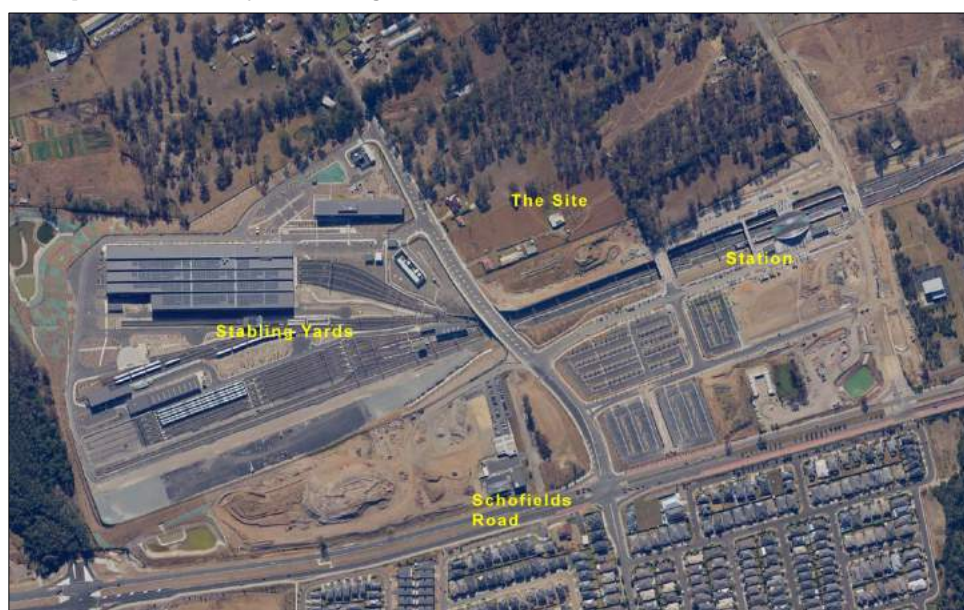
Figure 4: Aerial Photograph over the site and the surrounding area.

To the north, east and north west of the site lie similarly large lots with semi-rural uses. To the south lies the newly opened Tallawong Station on the Sydney Metro Northwest line and large parking areas. Further south lies Schofields Road, a four lane divided carriageway. To the south west lies the Sydney Metro Trains stabling and maintenance facility. Refer to Figure 4.

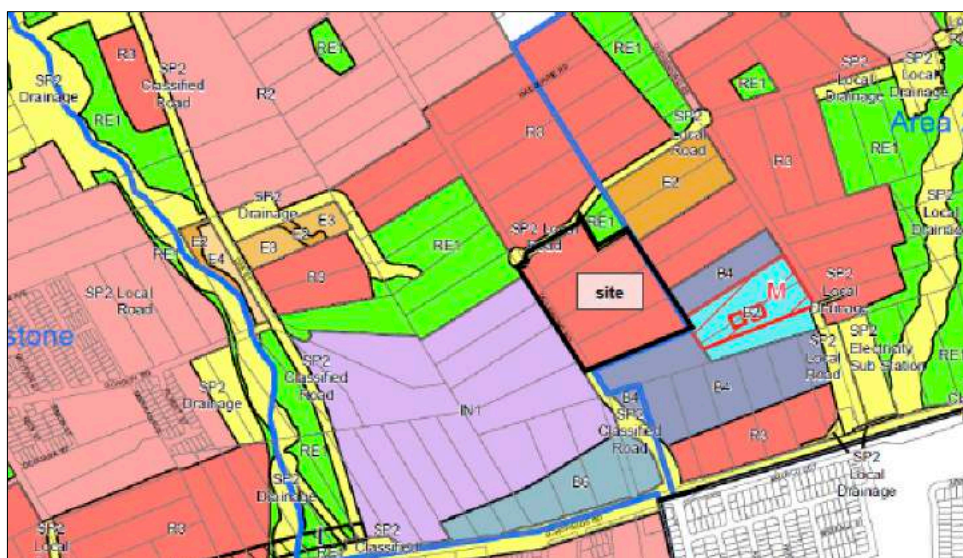
The site is currently zoned R3 medium density residential under *Sydney Region Growth Centre SEPP*. This provides a maximum building height of 16m. The site has a minimum residential density control of 45 dwellings per hectare. It is noted that the proposed building height of 26m is the same height that applies to land to the east of the site which is also zoned R3, adjacent to the local centre and the same distance from Tallawong Station. The minimum residential density control of 45 dwellings per hectare is consistent across the subject site, which as a 16m height limit and the adjoining land, which has a 26m height limit. There are no Floor Space Ratio Controls applicable to the site under the SEPP. Refer to Figures 5 and 6.

Figure 5: Detail of the Zoning Plan from *Sydney Region Grown Centre SEPP*.
Cited in the Gateway Determination Report.

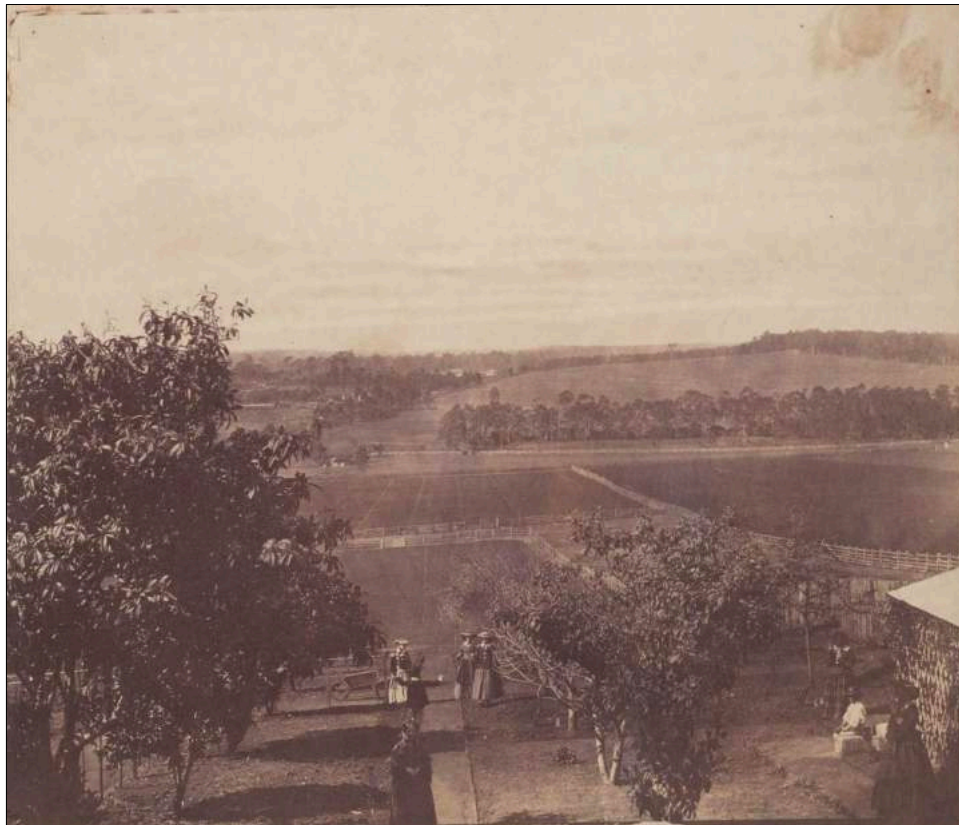
Figure 9: Thomas Wingate, *View from the upper floor of Rouse Hill House looking towards Second Ponds Creek*, c.1859. Note: This view is to the south east. The subject site is located to the south west.

Figure 9 provides a historic photograph of a view from Rouse Hill House in the mid nineteenth century, showing its rural setting. As set out below, preserving the understanding of this setting is critical to understanding the significance of Rouse Hill House.

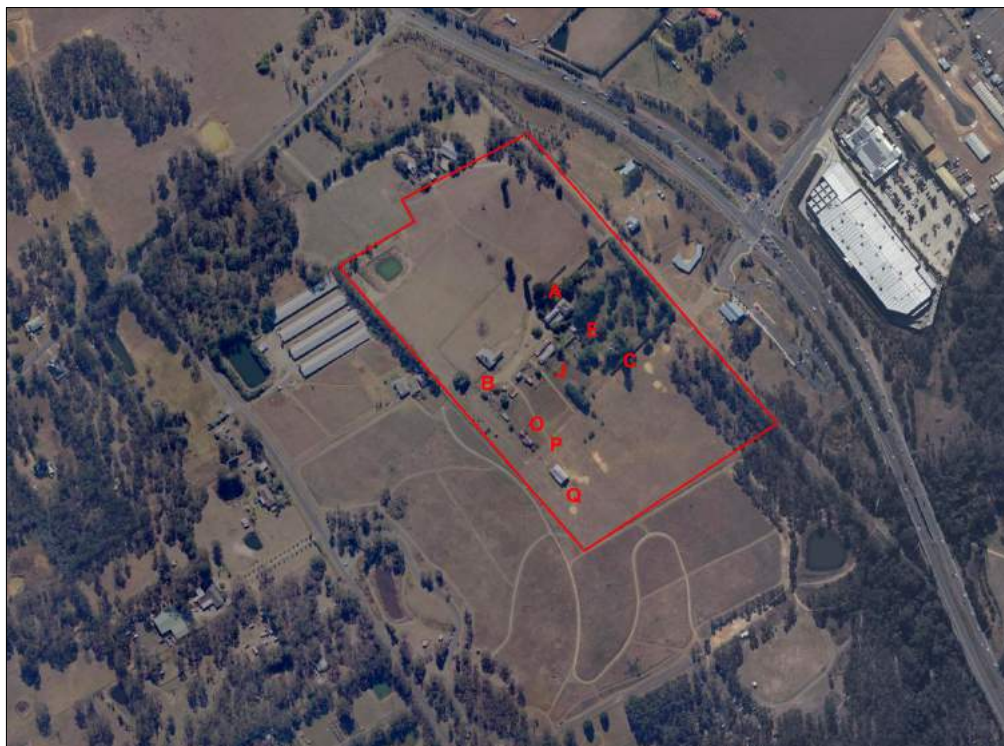
Figure 10: Recent Aerial Photograph Over the Site. Some of the larger structures labelled in Figure 10 below are labelled above for orientation purposes. Refer to Figure 10 below for the key.

Figure 10 provides a recent aerial photograph over Rouse Hill House and Estate. Figure 11 provides a diagram identifying the principal structures on the site. These images should be read in conjunction with the following site description.

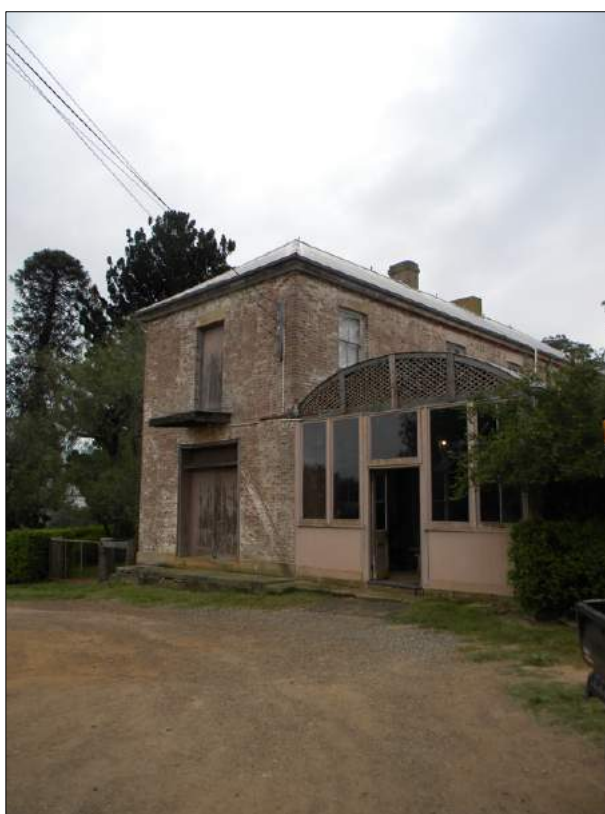
Figure 13:
Kitchen block and the servants
wing, comprising the south
western corner of Rouse Hill
House.

It is not the purpose of this statement to illustrate each of the items identified above. Figures 12 to 15 illustrate the house and the rear wings that comprise its south western corner, the stables and the area to the south west of the house, being the general line of site towards the subject site on Tallawong Road.

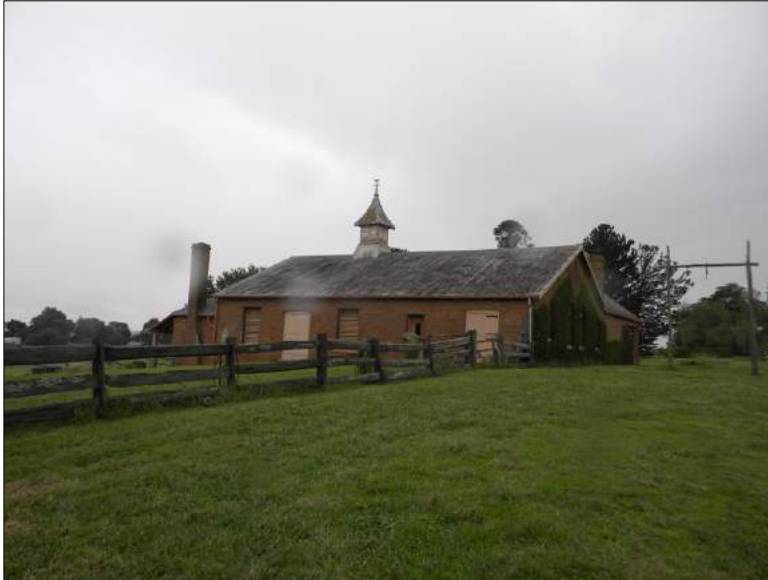
Note: Of the outbuildings, the most notable is the brick stables, not described above. The stables were designed by John Horbury Hunt. They are a large detached single storey face brick building with gabled roof (with vented cupola) forms clad in corrugated iron.

Figure 14:
Stables.

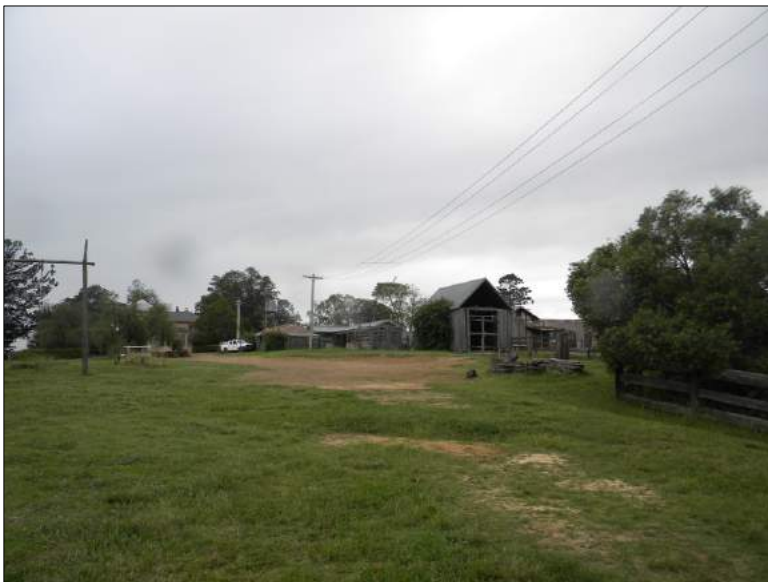
Figure 15:
View north
towards the rear
of the house,
showing
outbuildings and
water tank in the
foreground.

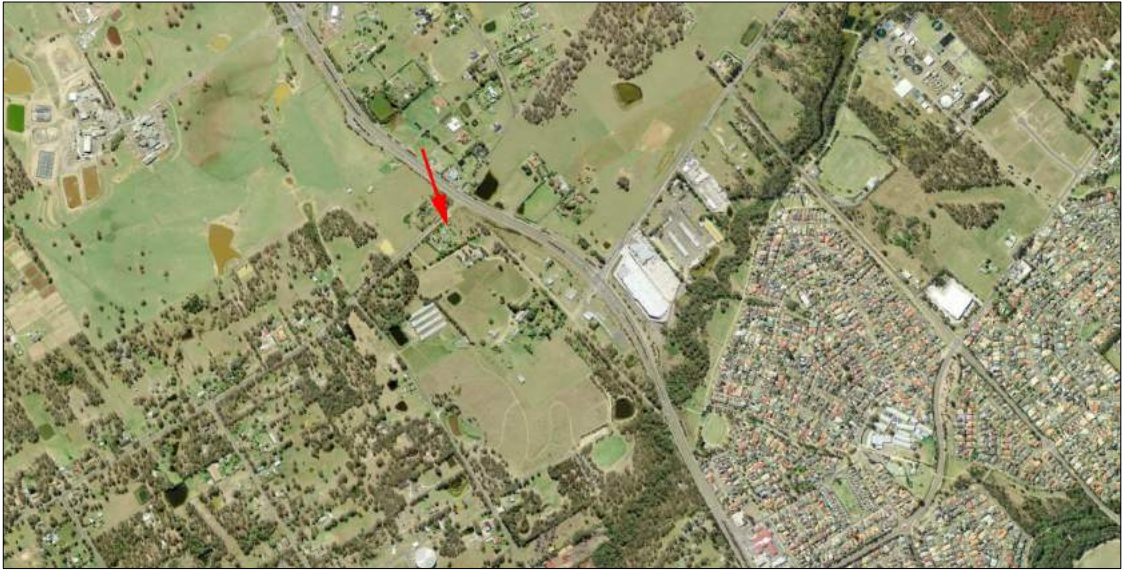
Figure 16: Aerial photograph over Rouse Hill House and Estate and the surrounding area.
SIX Maps; annotation by WP Heritage and Planning.

and native grass lands. Within this area lies the Second Ponds Creek (to the south east) and Killarney Chain of Ponds (to the west). Refer to Figure 16.

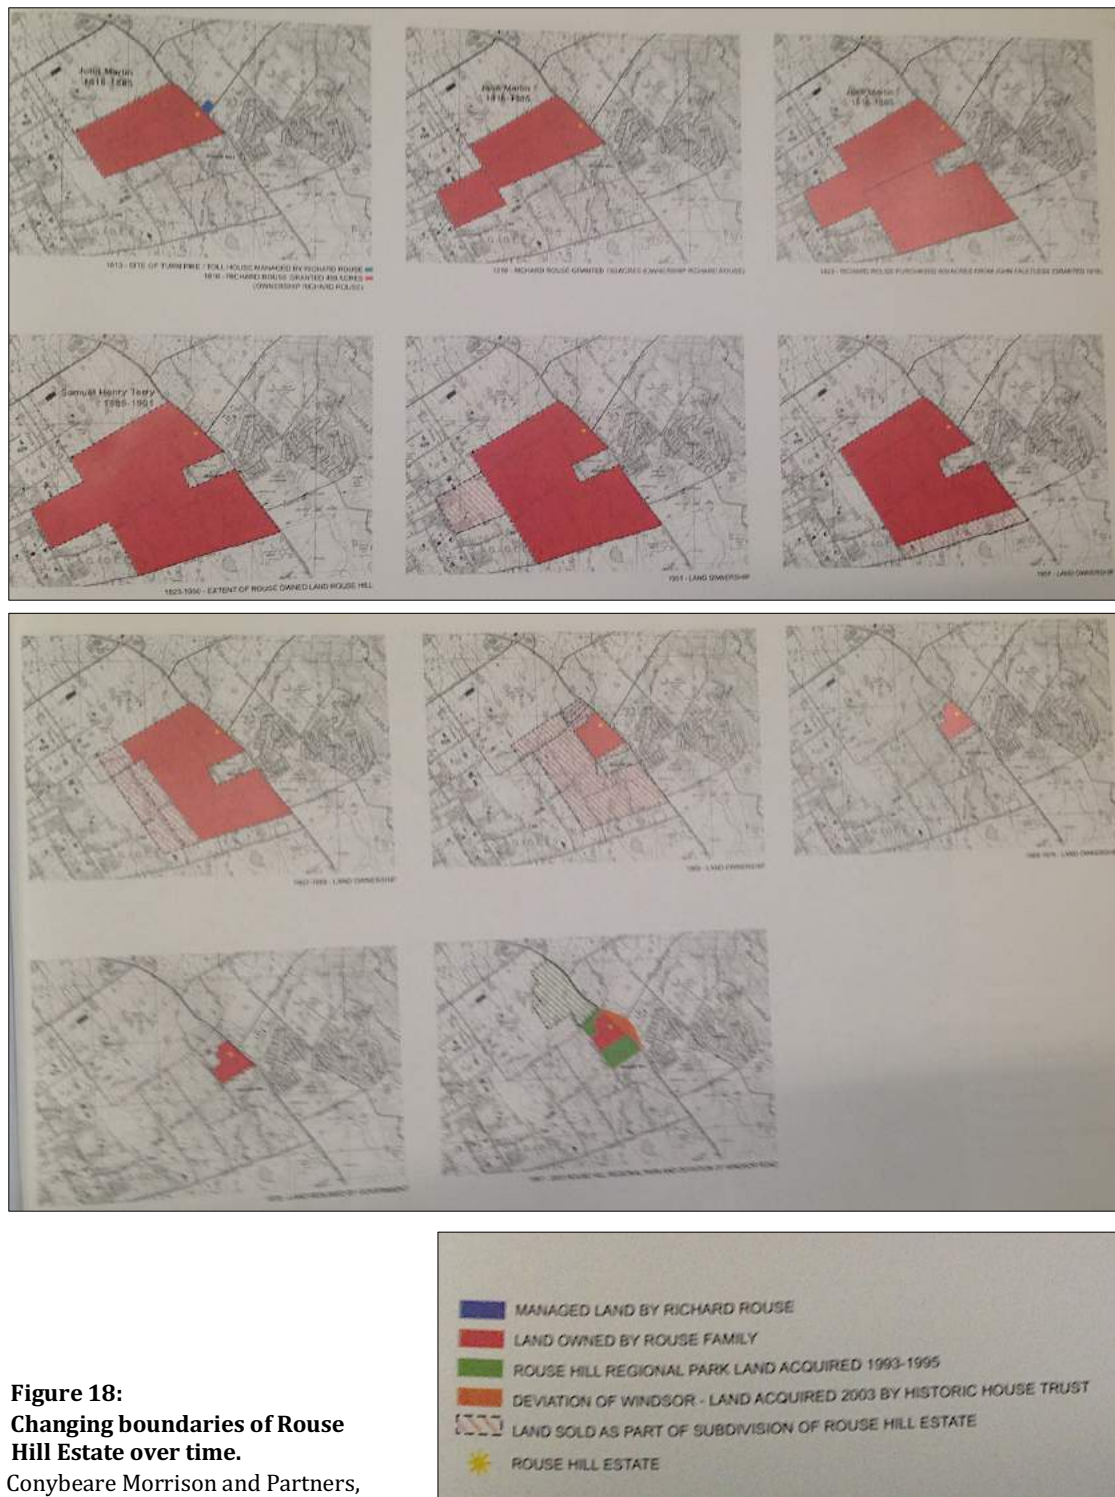
The boundaries associated with Rouse Hill House have changed over time. These changes are set out in a graphic form in a visual curtilage study prepared by Conybeare Morrison and Partners in 2003. Refer to Figure 18. The existing site boundaries are substantially less than the original Estate boundaries.

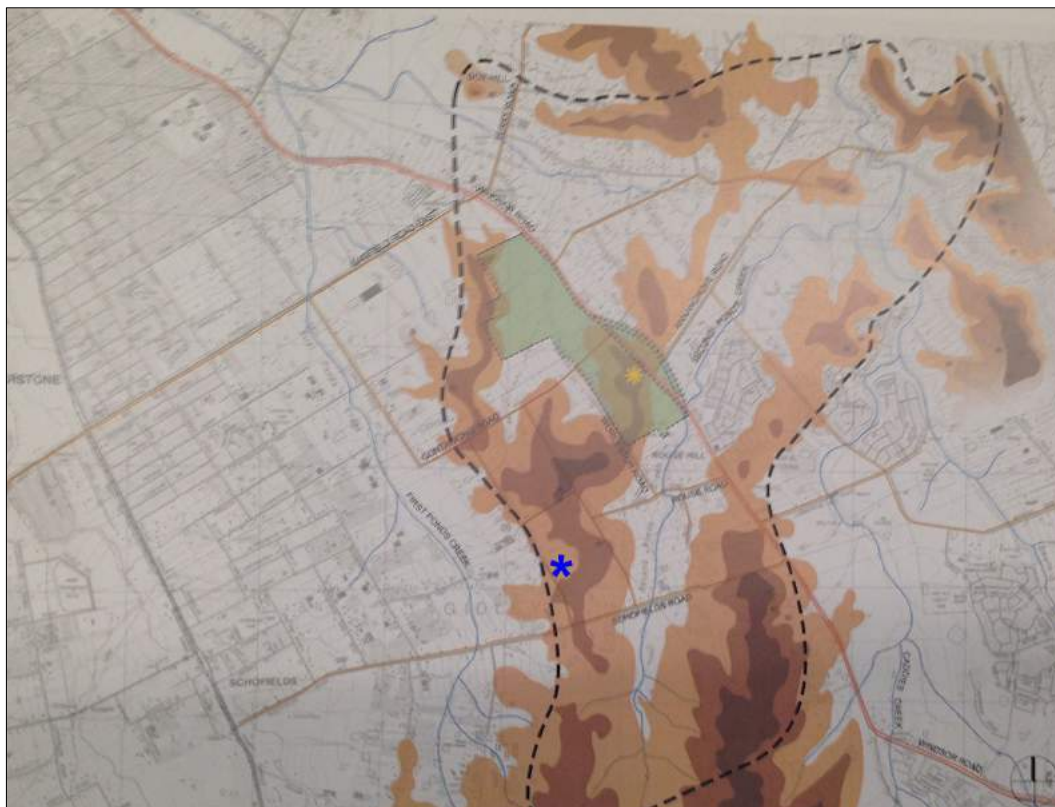
The above analysis gave rise to the following recommended expanded curtilage. In Figure 21, Rouse Hill House is marked with the yellow asterisk. The blue asterisk marks the approximate location of the site and has been added by Weir Phillips Heritage and Planning. The black line marks the curtilage.

Figure 21: Recommended Vistas from the Rouse Hill House Estate.
