Preliminary Site Investigation

Proposed Rezoning (Area 1) and Georges Cove
Marina (Area 2)
146 Newbridge Road, Moorebank

Prepared for
Mirvac Homes NSW Pty Ltd and Tanlane Pty Ltd

Project 71459.10
May 2018

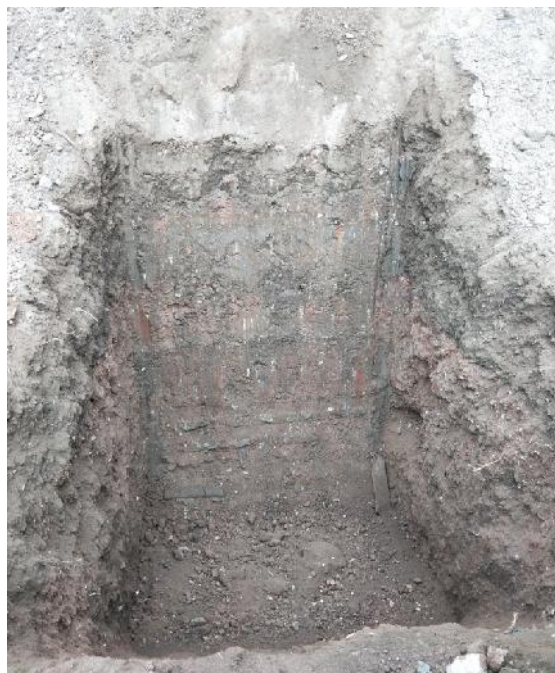
Fragments of fibre cement (potential bonded asbestos containing material (ACM)) were observed in TP101 and TP 102. This is consistent with other areas of the property and the observed presence of building waste in the fill.

Photo 8 - TP101 (typical filling profile)
