Report on  
Preliminary Site Investigation with Limited Sampling

Proposed Residential Rezoning  
Part 1675 The Northern Road, Luddenham, NSW

Project 92207.00  
March 2017

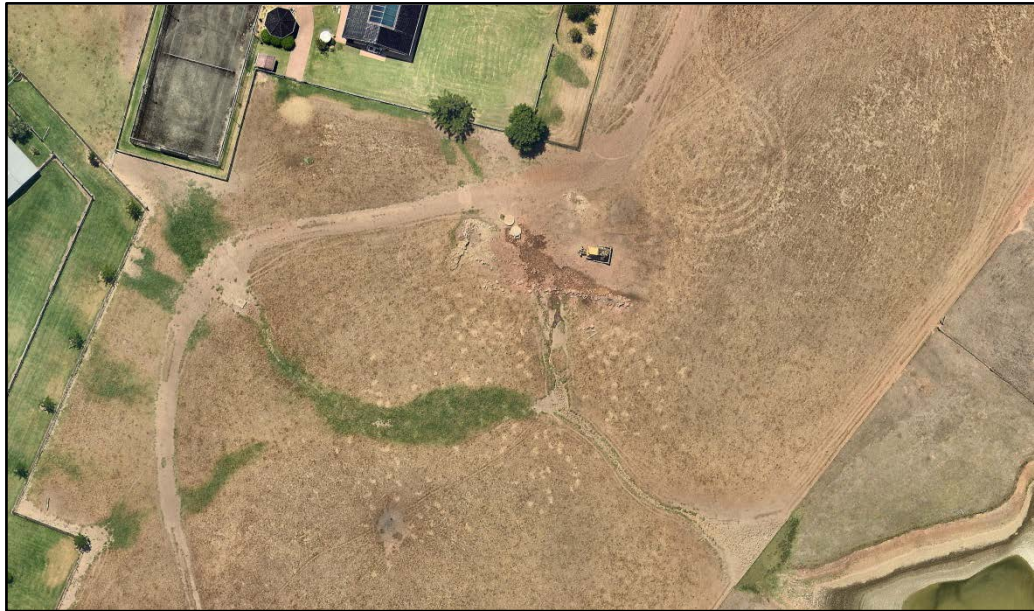
**Figure 1: Nearmap image (23 January 2017) showing filled drainage channel and the access road.**

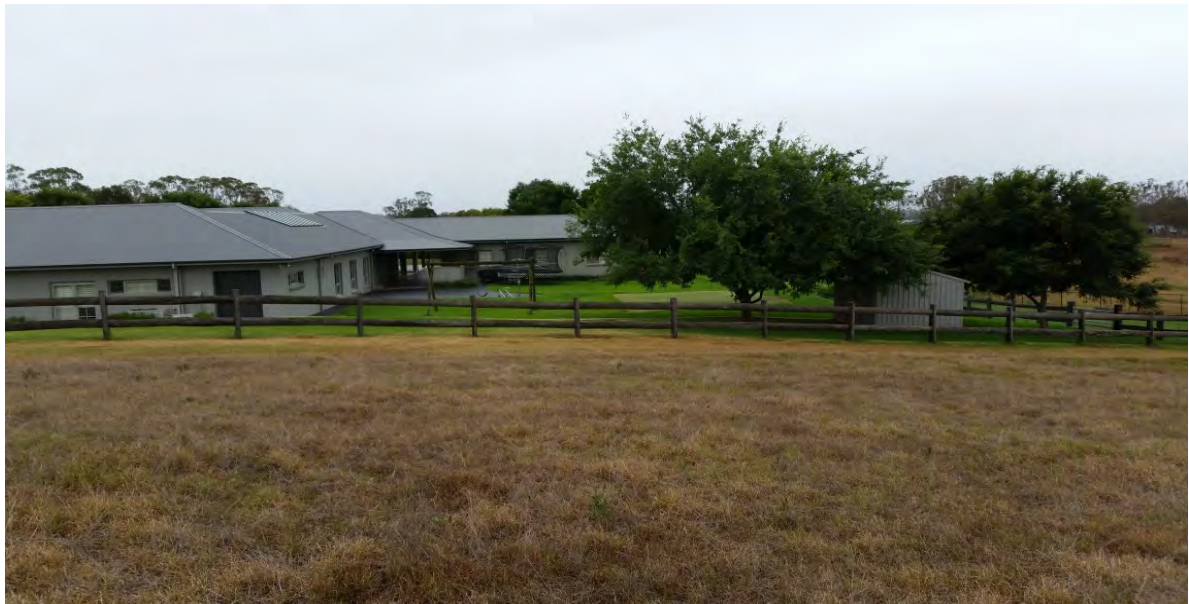
- Dairy cattle were grazing within the non-residential areas of the site;
- The two residential properties and adjacent fenced areas appeared to be in well - kept and good condition (Photographs 1 and 2);

Photograph 1 - View facing north towards residential property 1

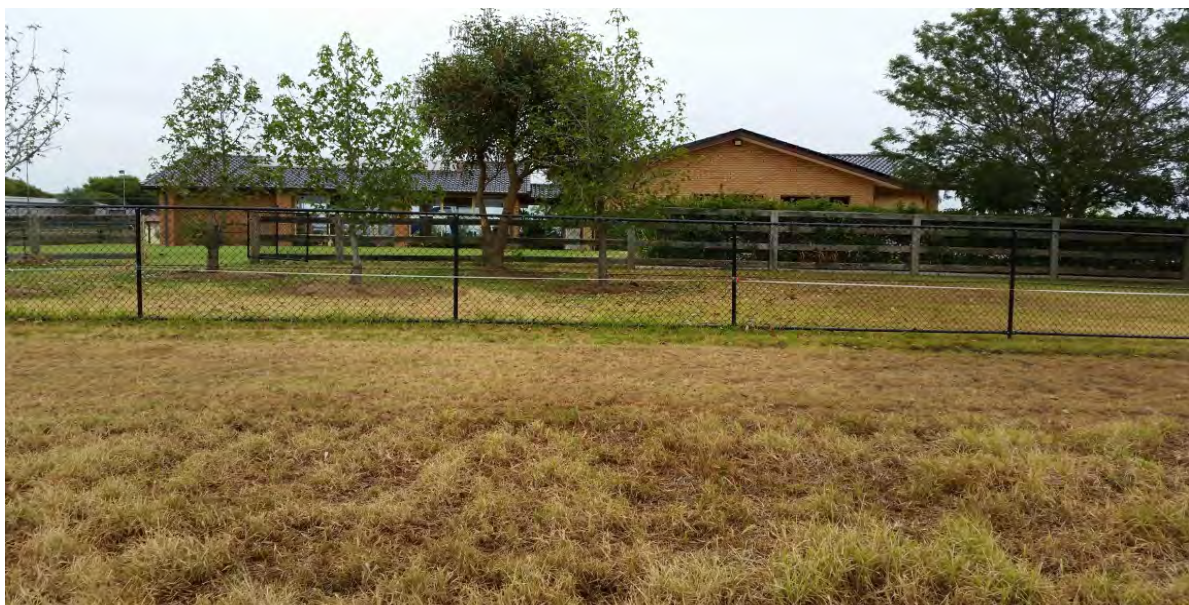
Photograph 2 - View facing west toward residential property 2

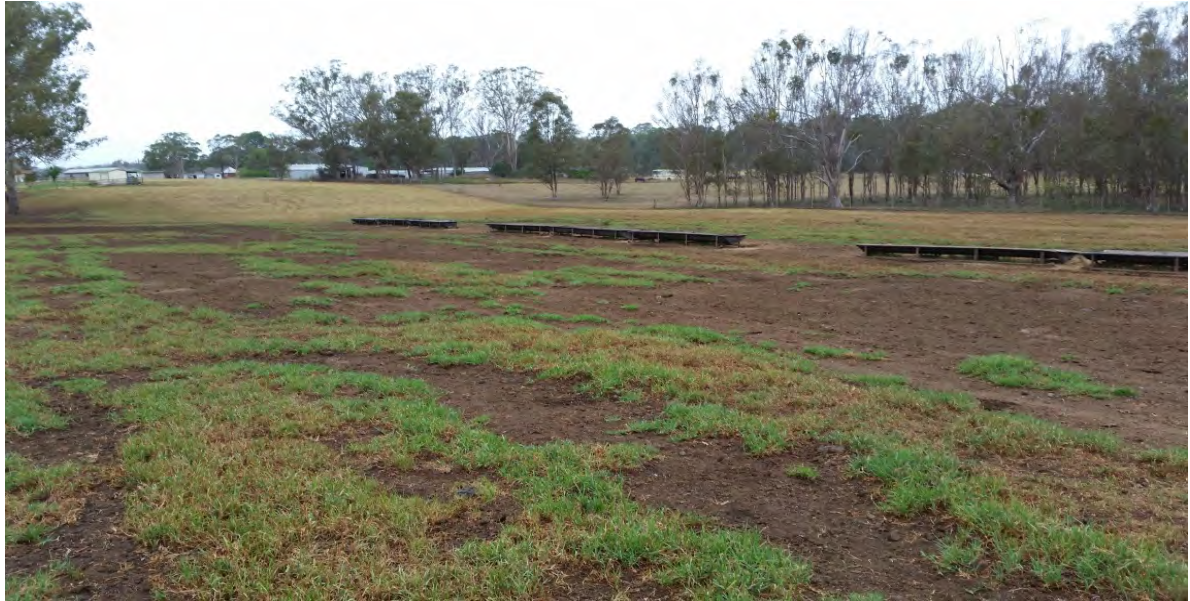
- Evidence of the cattle lots present in the 1961 aerial photographs was not observed during the walkover;
- Cattle feed troughs were present in the north eastern portion of the site. Ground disturbance surrounding the troughs appeared to be associated with cattle access (Photograph 3);

Photograph 3 - View facing east towards the cattle troughs

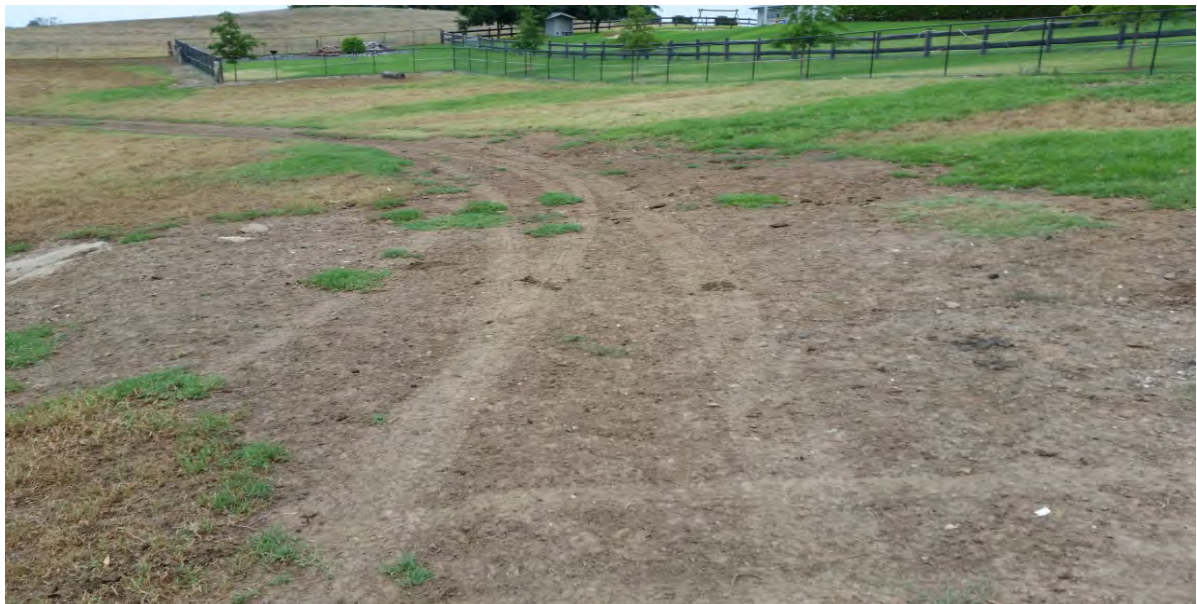
Photograph 4 - View facing south west toward Area A

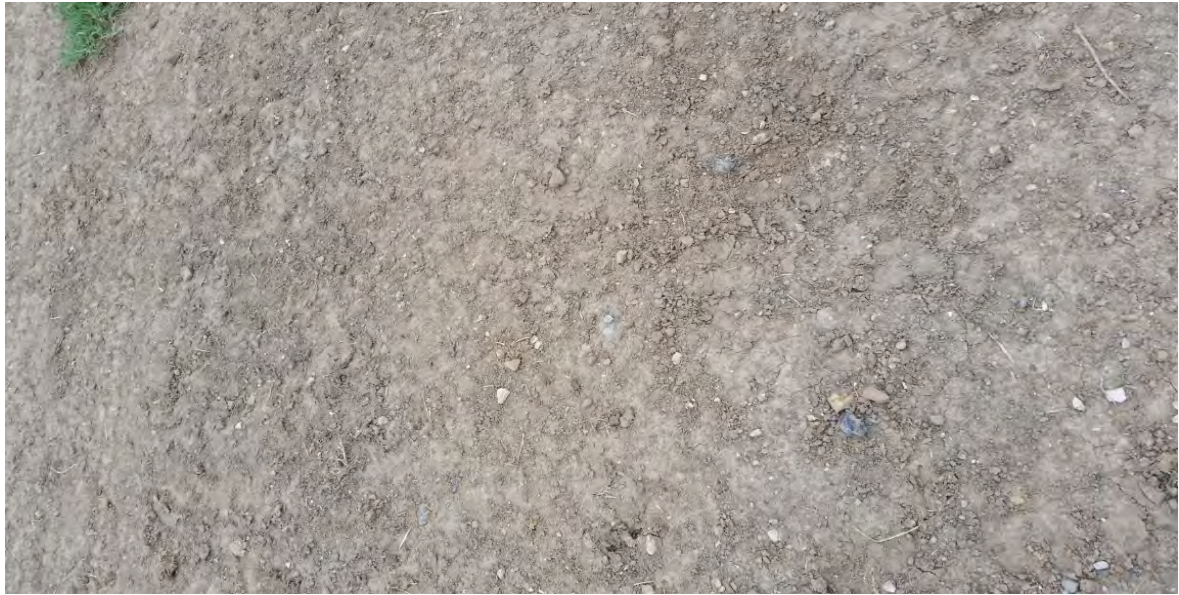
Photograph 5 - View looking at Area A filling

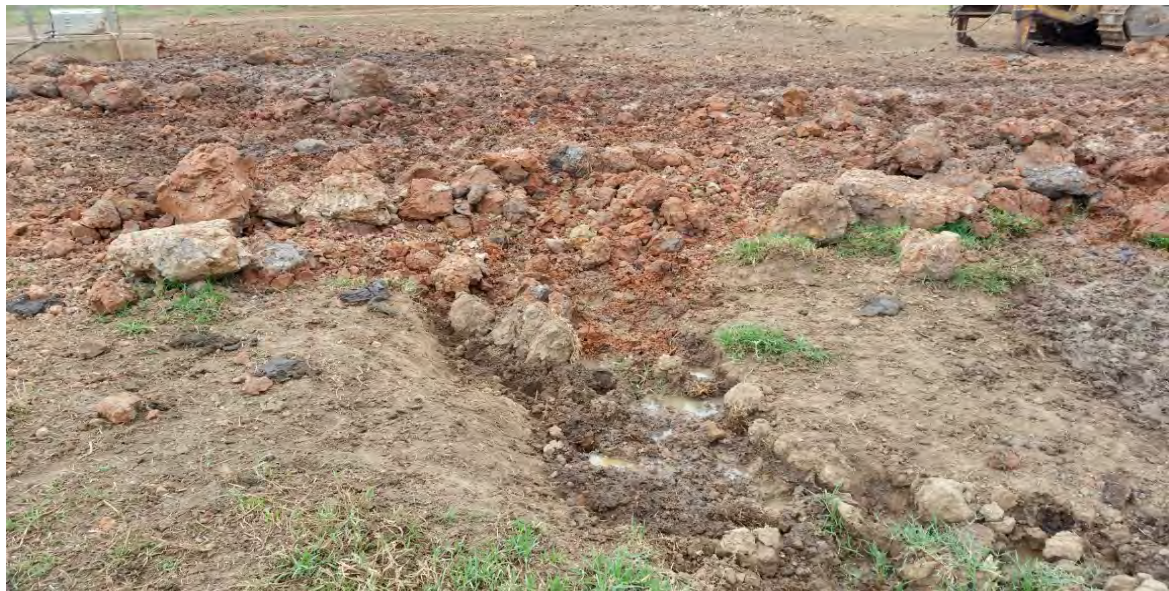
- Two in-ground concrete effluent tanks were observed to the south of the residential properties in one of the drainage channels. Fill was also observed down gradient of the tanks (Area B - refer Photograph 6). The fill appeared to comprise reworked locally derived soil.

Photograph 6 - View north toward Area B filling

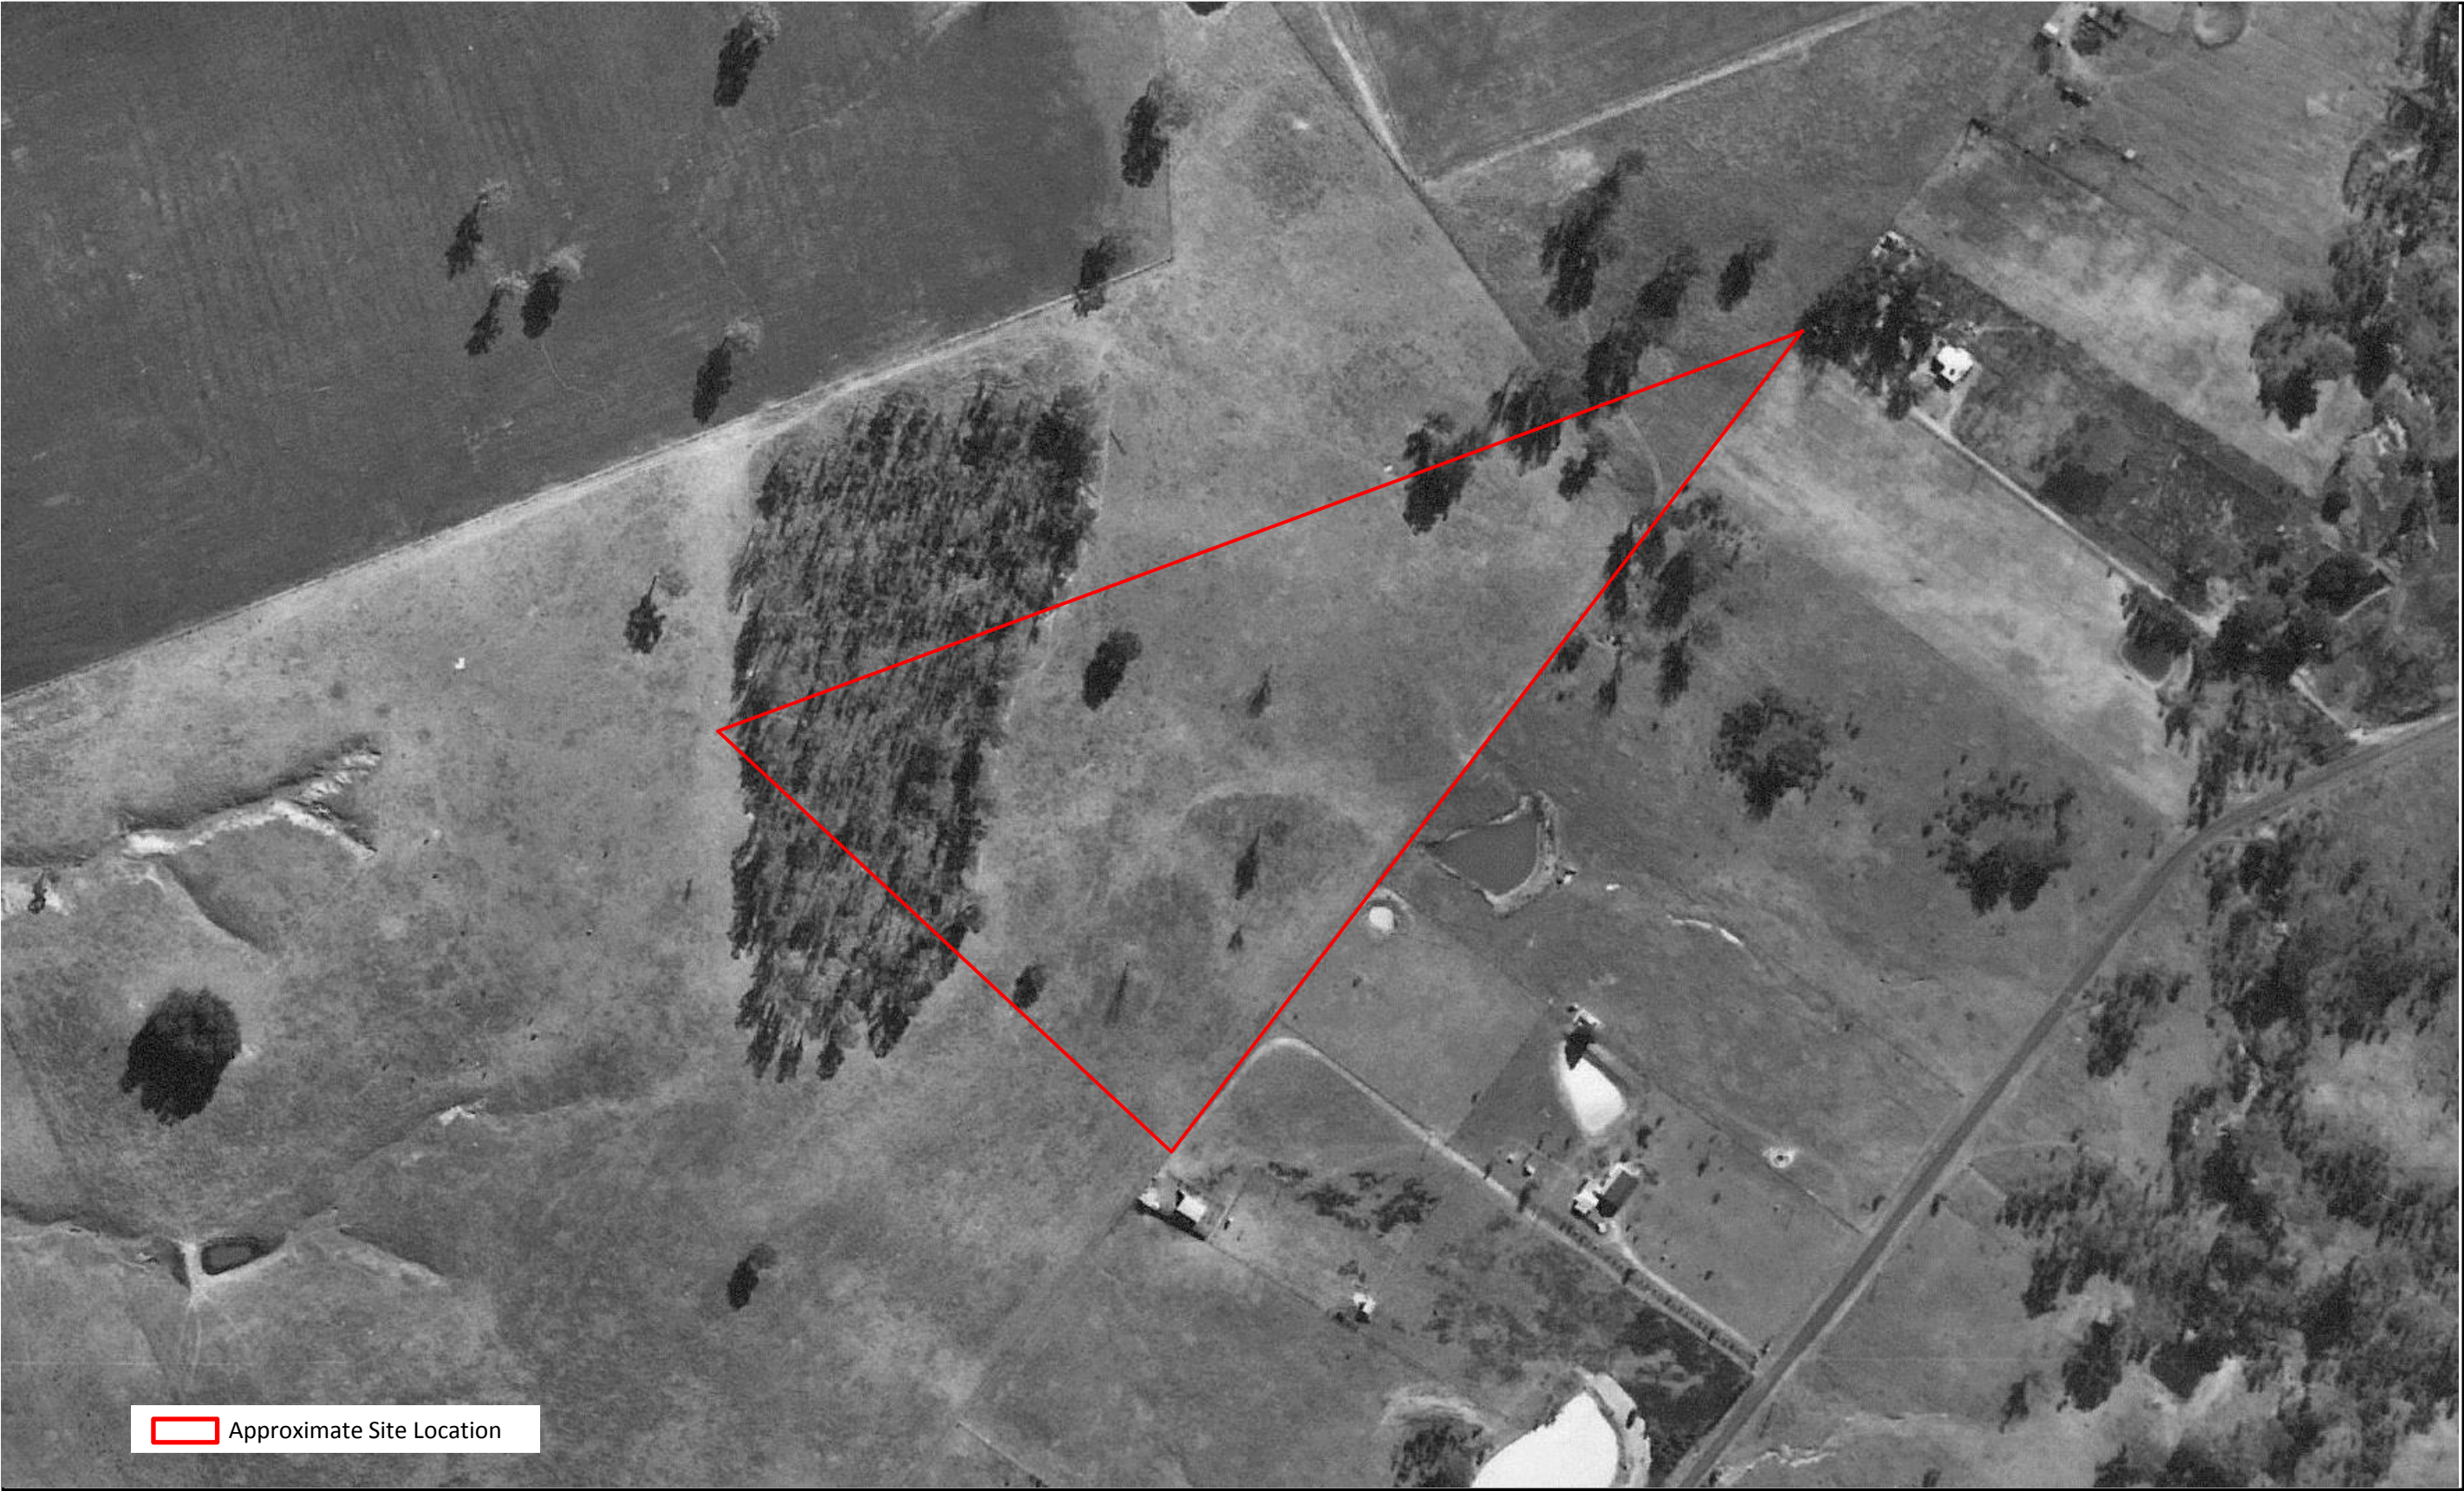
| | Office: Macarthur | Drawn by: MG | | Drawing No. 4 |

**1970:** The site appears relatively unchanged since the 1961 aerial photograph, with the exception that the livestock enclosure is no longer evident. The land to the north of the site still appears to be used for agricultural use, while the land to the north - east, east and south is observed to have undergone further rural residential and agricultural development.

| | Client: Greenfields Development Company Pty Ltd | | Aerial Photograph - 1970<br>Preliminary Site Investigation with Limited Sampling<br>Proposed Residential Rezoning | Project No. 92207.00 |
