“Coruisk” (later “Lansdowne”)

3 ANDERSON STREET

HERITAGE ASSESSMENT

AUGUST 2015

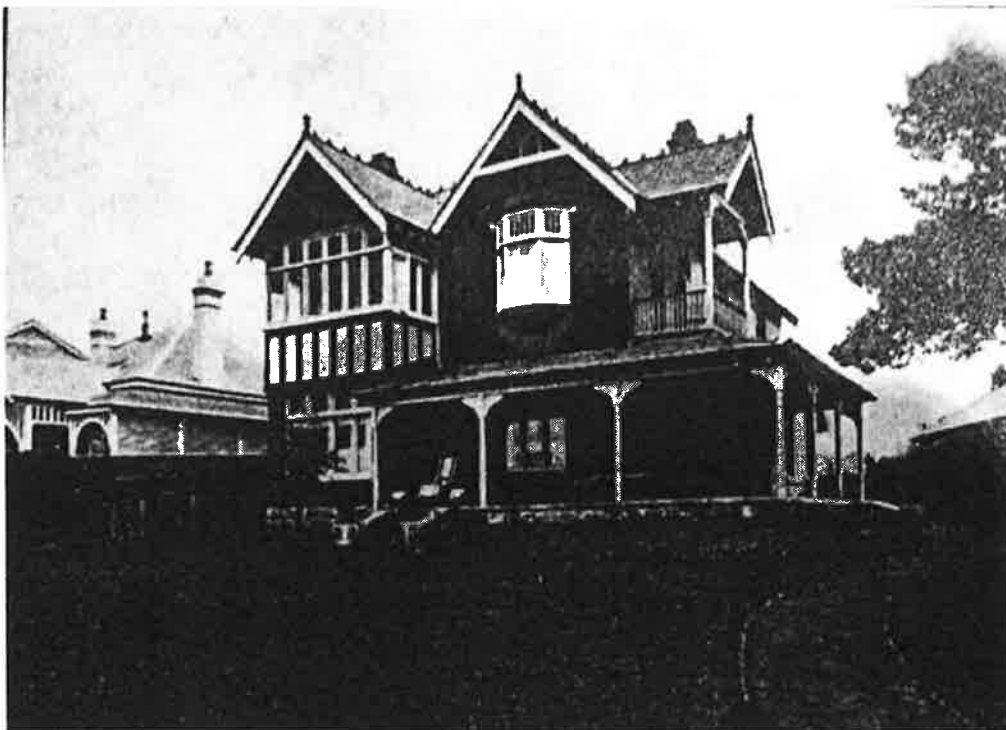
Figure 5: 1919 photo of the south (original front) and east elevations of "Coruisk" (later "Lansdowne") at No. 3 Anderson Street, Neutral Bay Source: Properties & Premises 1 September 1919, reproduced from Figure 9 of the GML Heritage Report on 3 Anderson Street, June 2014

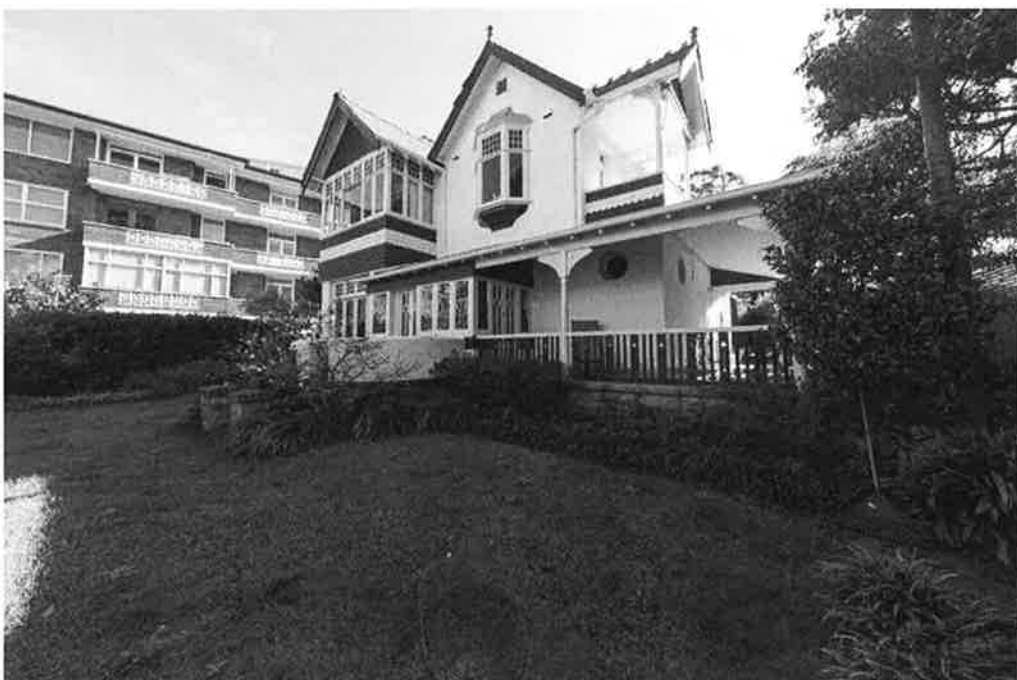
Figure 6: The south elevation of the house now, showing few alterations (sunroom to ground floor verandah, new timber shingling to apron to the original first floor sunroom. Source: photo by Nathanael Hughes, Aperture Photography, July 2015

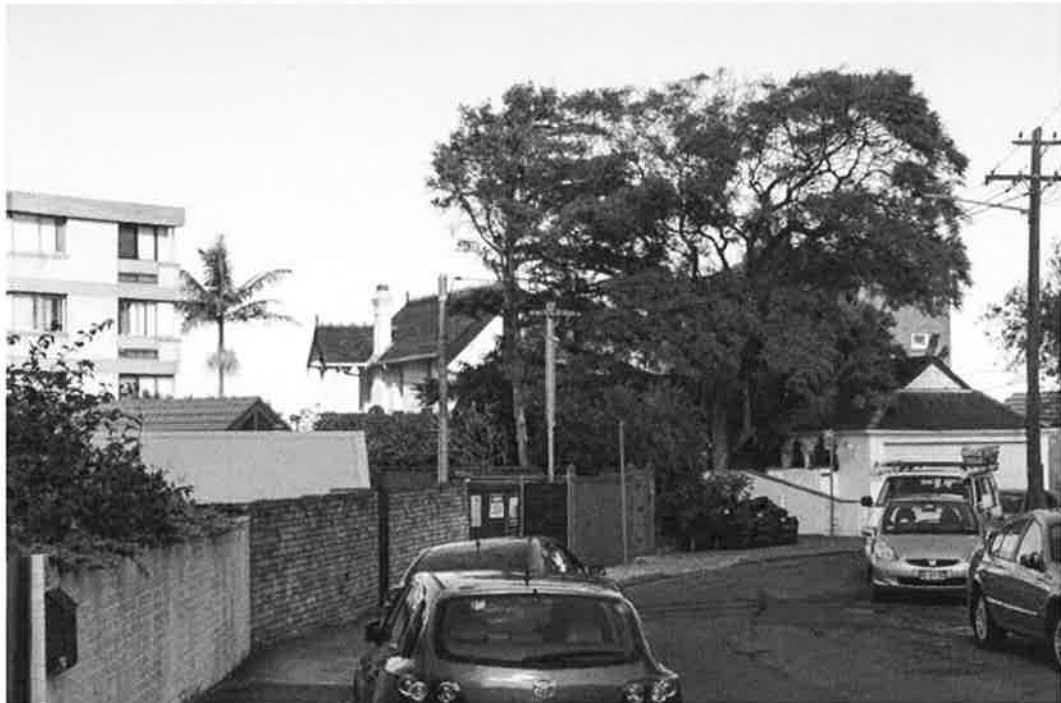
Figure 7: View of "Lansdowne" with east and north elevations visible (centre, slate roofed house to the left of the trees) from the east in Anderson Street. This view also shows the context in Anderson Street.

To the ground floor the brick walls (originally face brickwork) are painted, to the first floor roughcast stuccoed. The complex gabled roof form is slate clad with terracotta ridge capping and finials and some hidden flashings, and features four tall roughcast stuccoed brick chimneys with terracotta chimney pots. Windows and French doors are timber framed, and many feature spectacular stained glass.

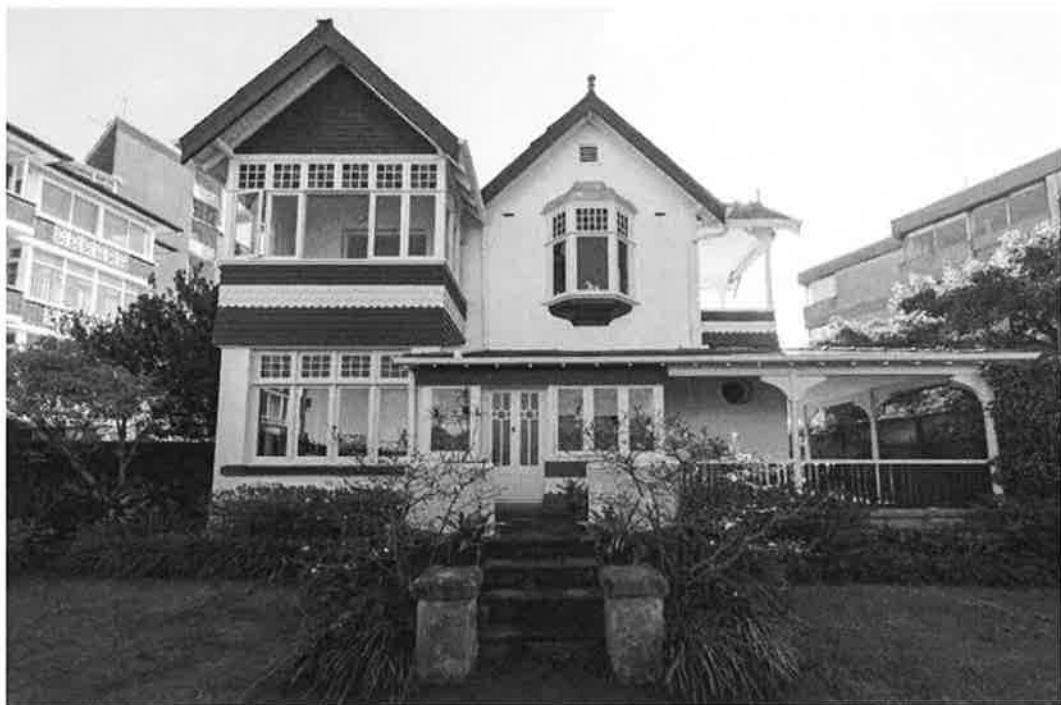
Figure 8: South elevation "Lansdowne". Note pair of gables, one roughcast with oriel window below (at right), the other timber shingled with 2-storey bay window below. Central sunroom to the ground floor is an inter-war period enclosure of part of the verandah.

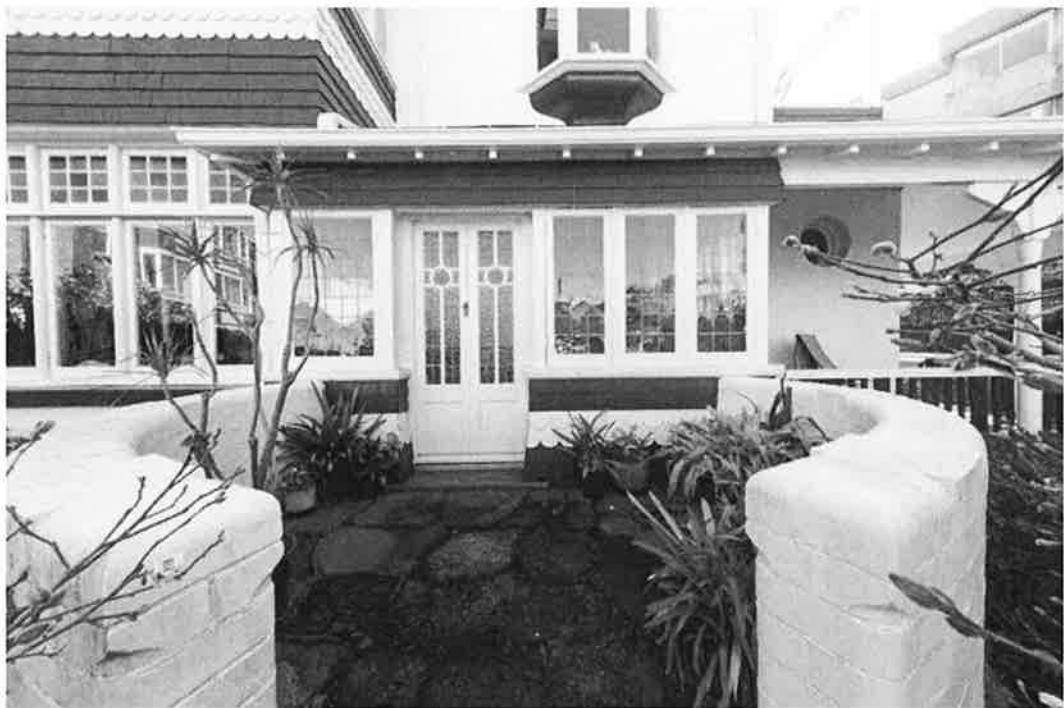
Figure 9: Detail of Inter-war period sunroom to ground floor (enclosing part of the original verandah) south elevation "Lansdowne"

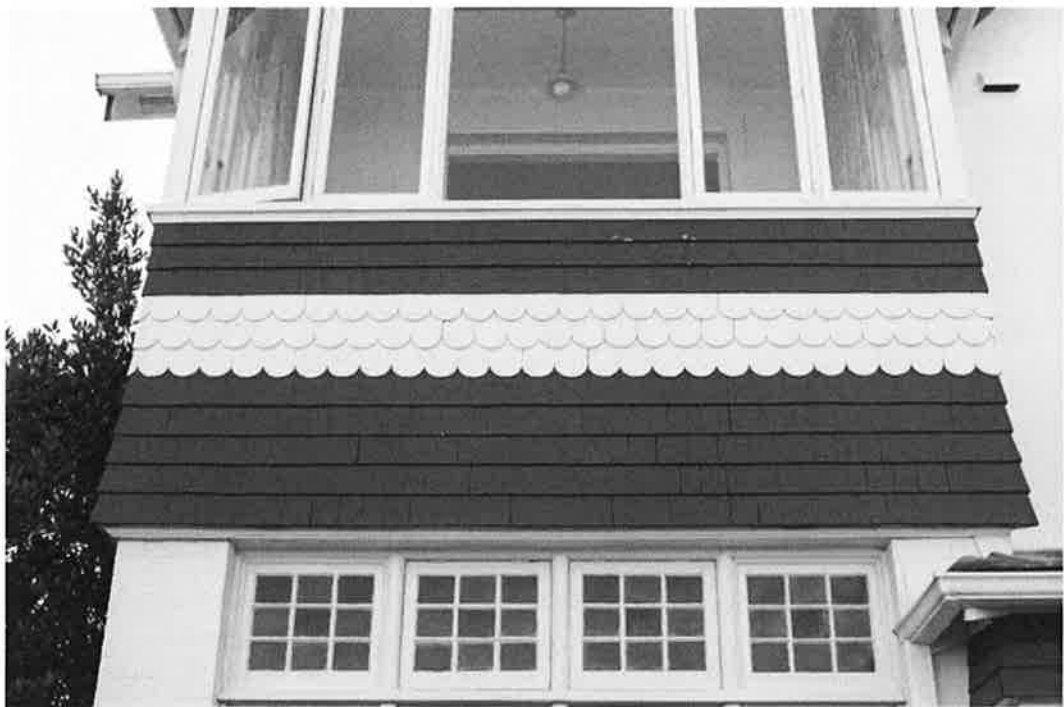
Figure 10: Detail of timber-shingled apron to first floor sunroom, south elevation "Lansdowne"

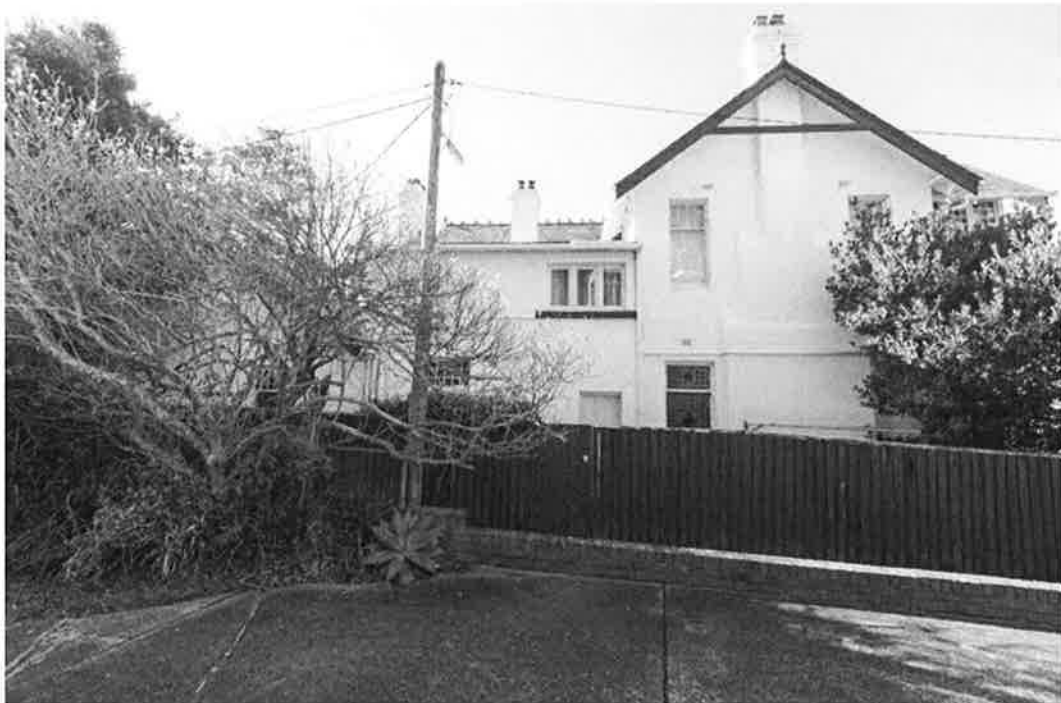
Figure 11: West elevation "Lansdowne" from adjacent property. Note public pedestrian pathway between the low brick wall and the timber side fence of the subject property.

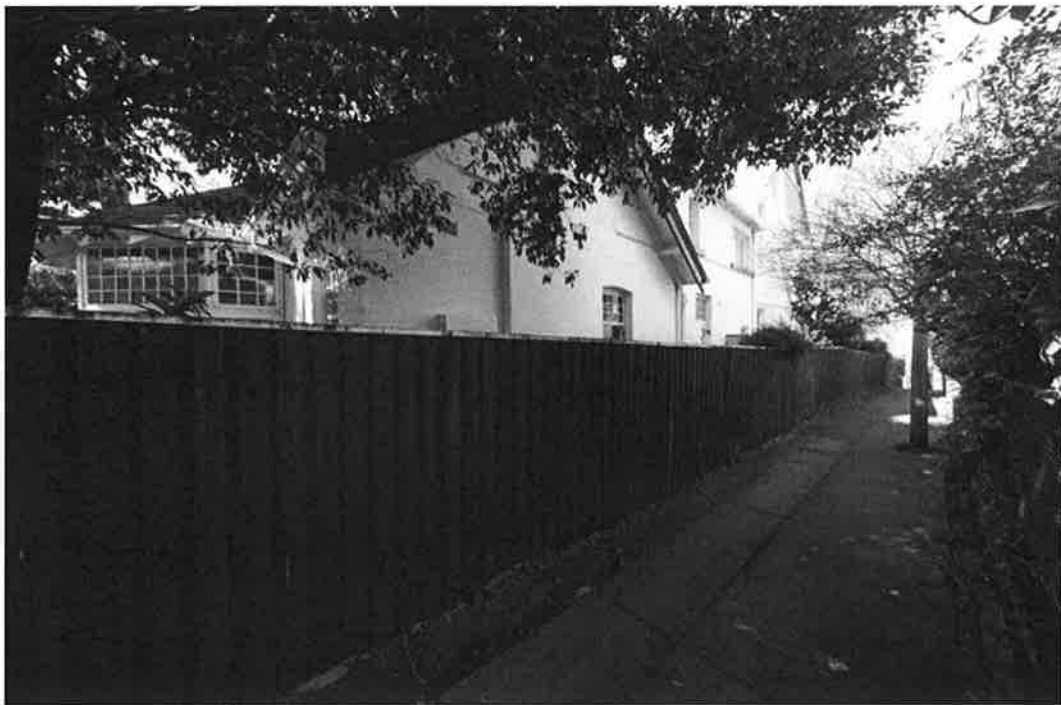
Figure 12: West elevation "Lansdowne" from adjacent public pedestrian laneway

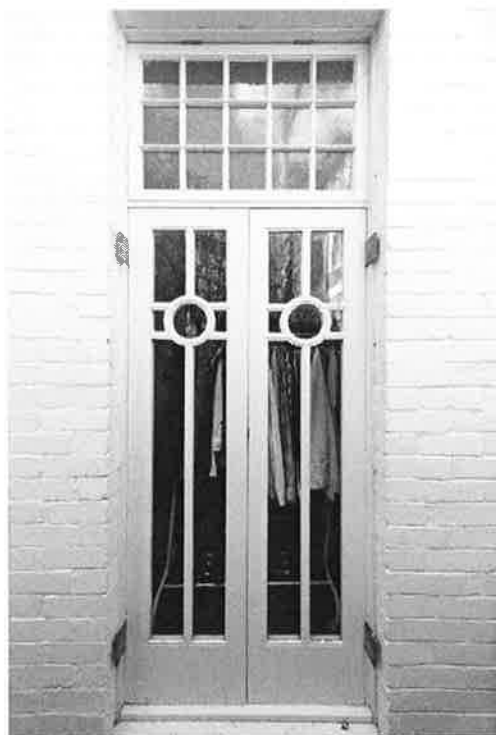
Figure 13: (Left) Detail of Inter-war period French doors with original 1890s fanlight to west elevation

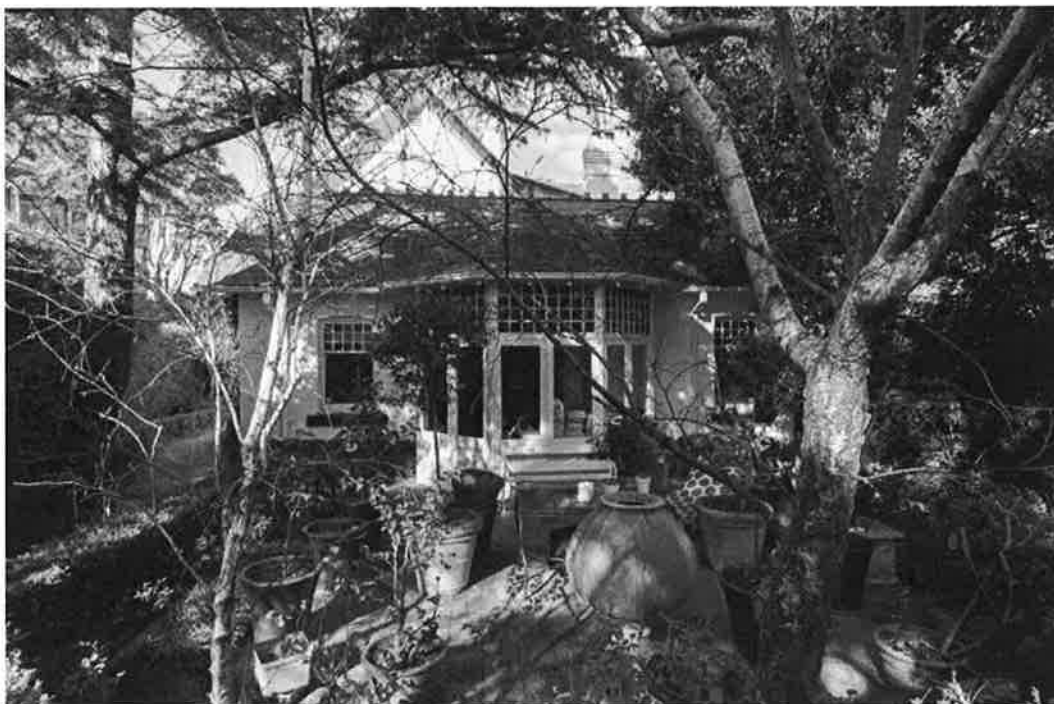
Figure 14: North elevation "Lansdowne"

To the north (rear) elevation of the house there is a single storey section containing the kitchen, which features a slate roof with hidden flashings.

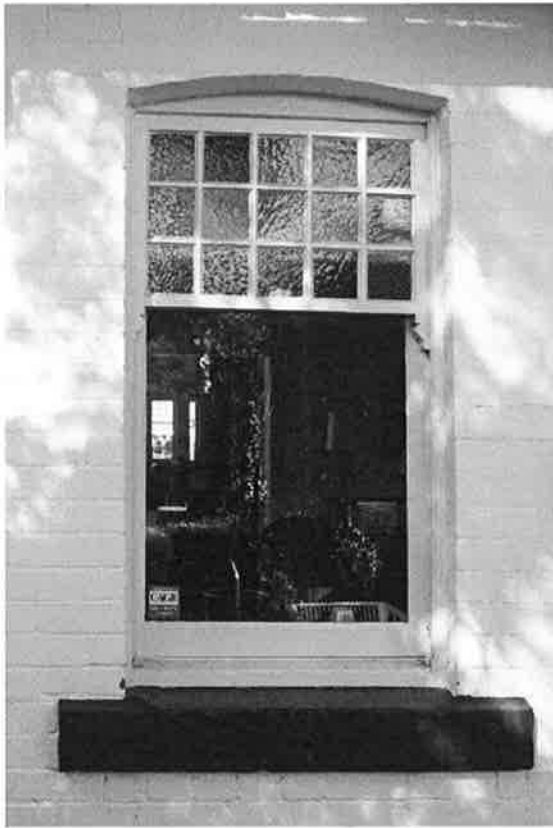
Figure 15: (Left) typical timber framed double hung window, "Lansdowne"

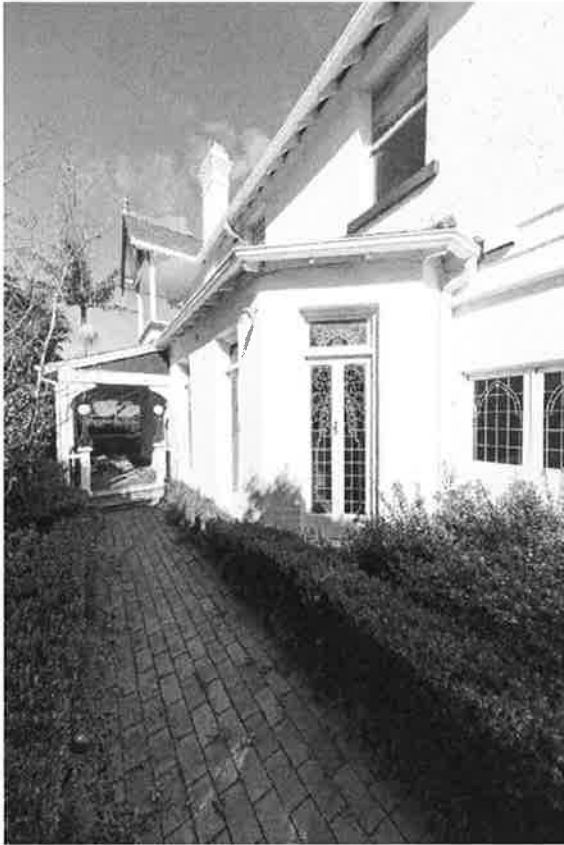
Figure 16: (Left) East elevation "Lansdowne", looking south, with east verandah and balcony in distance, bay window in foreground

The verandah extends around to the south end of the eastern elevation, with the main entry door on the eastern elevation accessed via the verandah. This main entry door has a semi-circular fanlight above with stained glass and the door itself features a large stained glass panel.

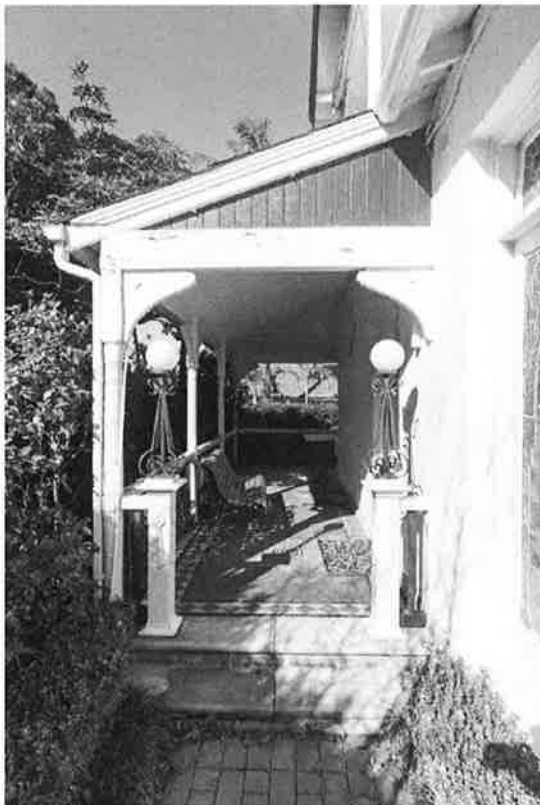
Figure 19: (Left) Detail, northern end of east elevation verandah

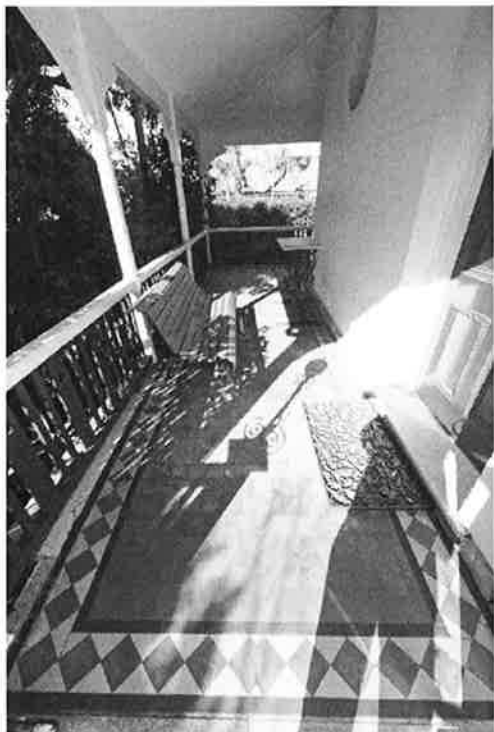
Figure 20: (Left) Detail, east elevation verandah

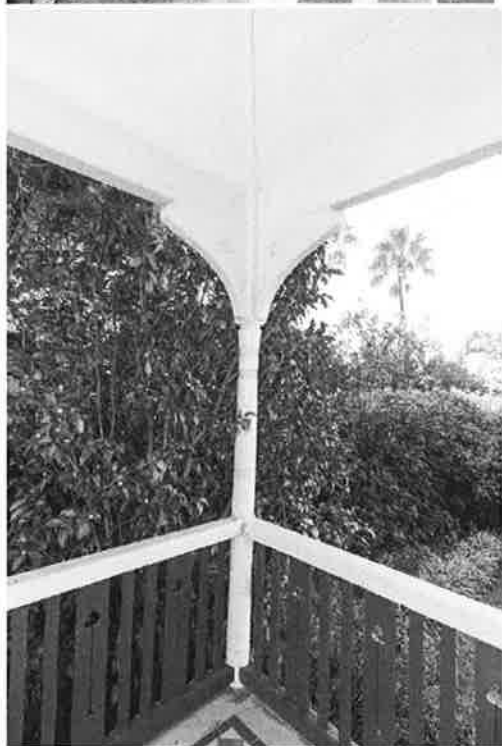
Figure 21: (Left) Detail, verandah bracket to south-east corner of the house

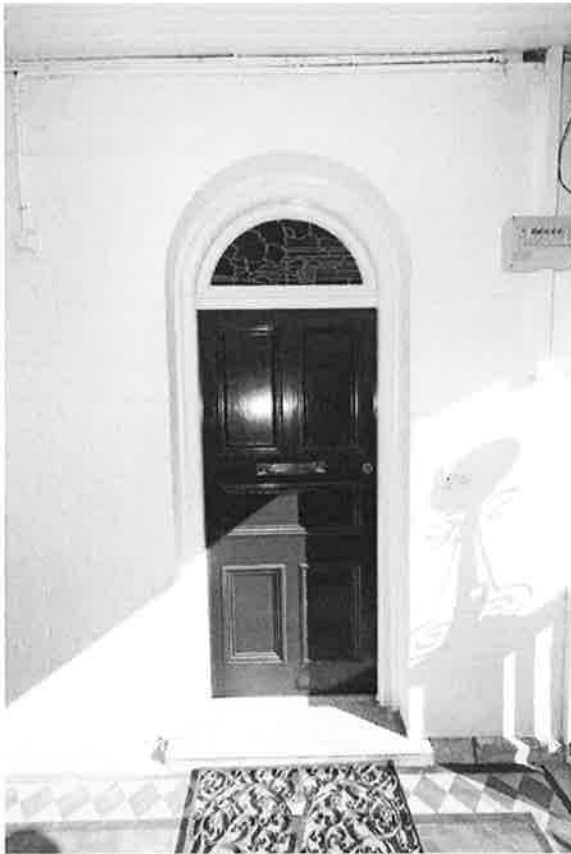
Figure 22: (Left) main entry door off the east verandah, Note semicircular leadlight fanlight.

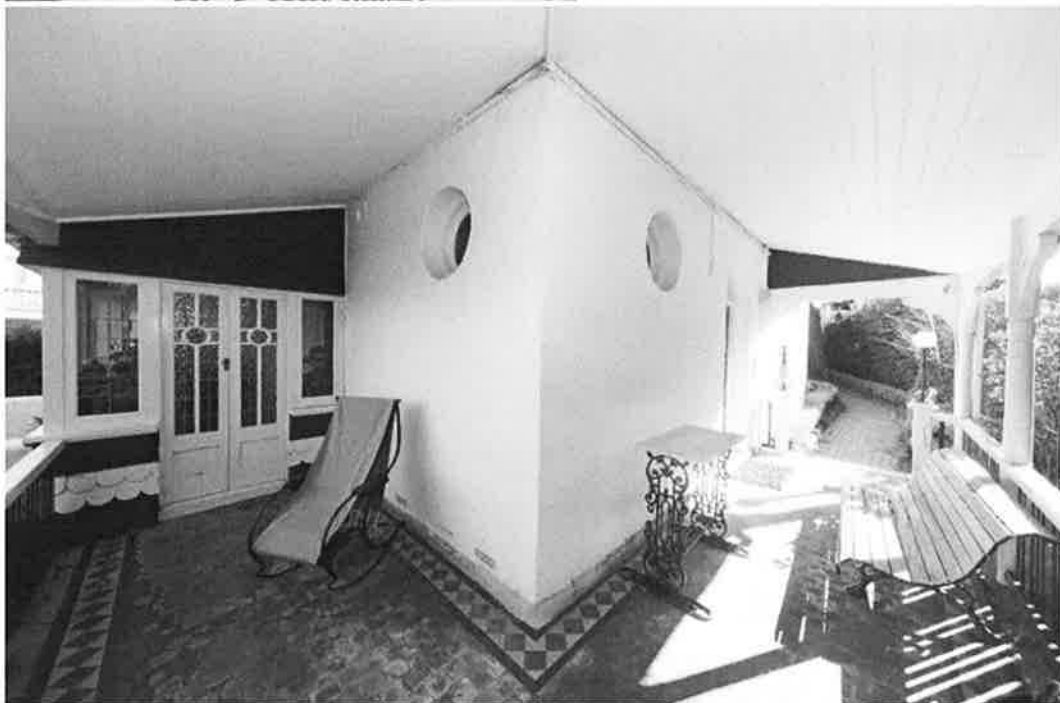
Figure 23: The south-east corner of "Lansdowne" within the verandah, with two bullseye windows and (left) the east elevation of the inter-war period sunroom enclosure of part of the south verandah.

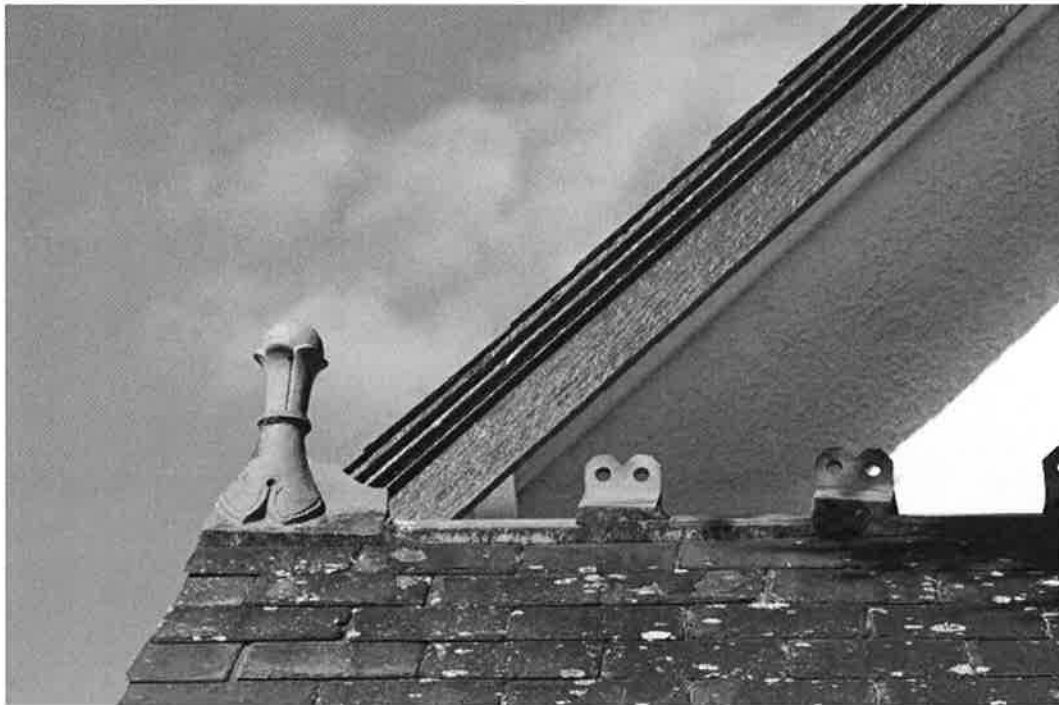
Figure 24: Ridge capping detail "Lansdowne"

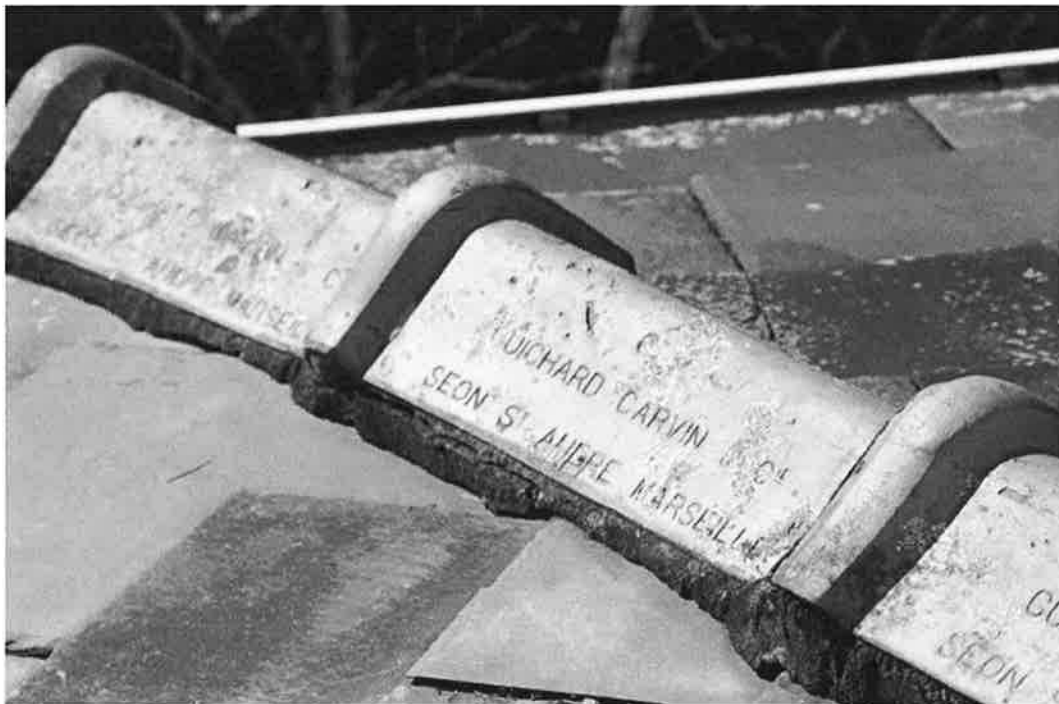
Figure 25: Terracotta ridge capping detail, "Lansdowne" with the Marseille (France) manufacturer's name

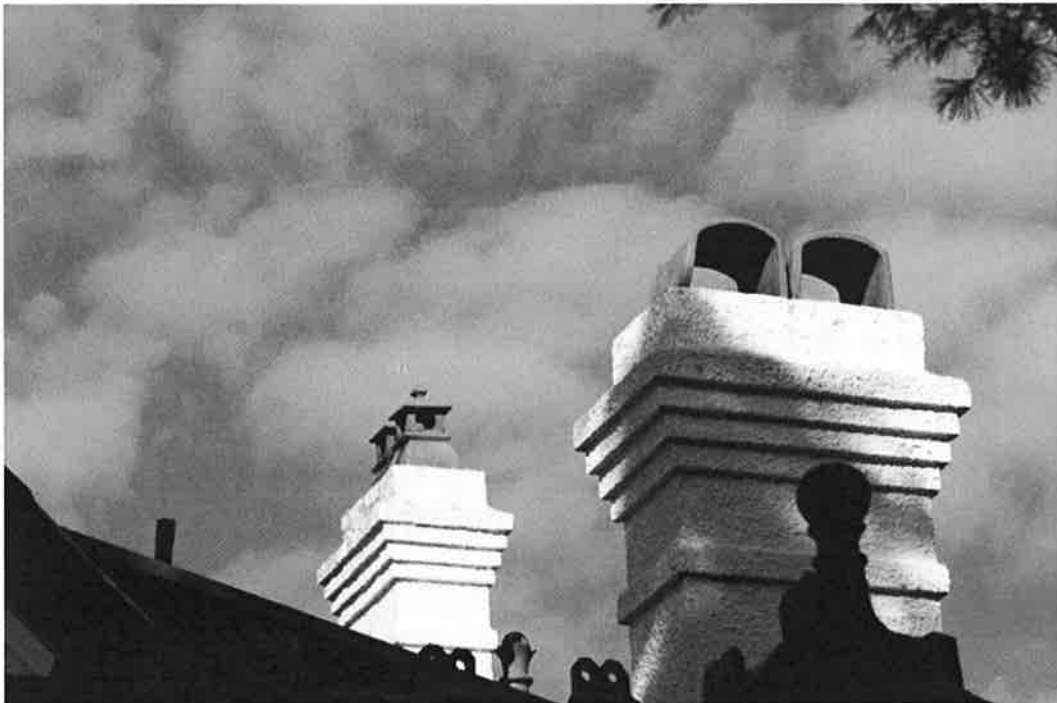
Figure 26: Chimney detail, "Lansdowne" (note two different styles of terracotta chimney pots)

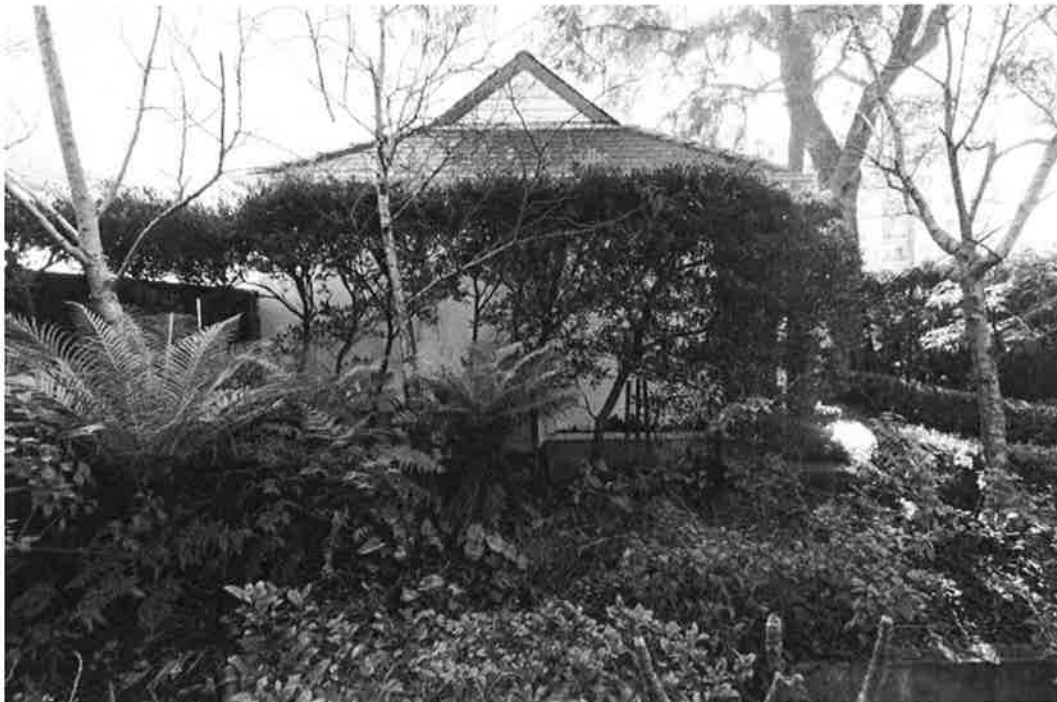
Figure 27: South elevation of the garage from within the garden, "Lansdowne"

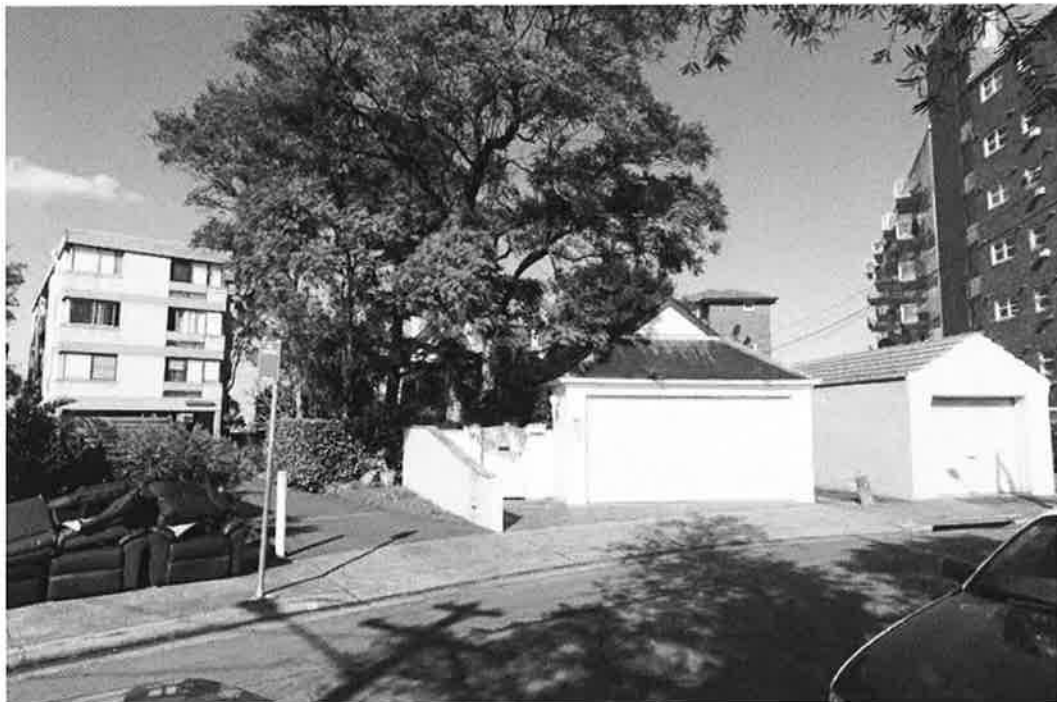
Figure 29: The slate-roofed garage (centre) with entry gate from Anderson Street at left. From this angle the house is obscured by trees. This view also shows the context in Anderson Street.

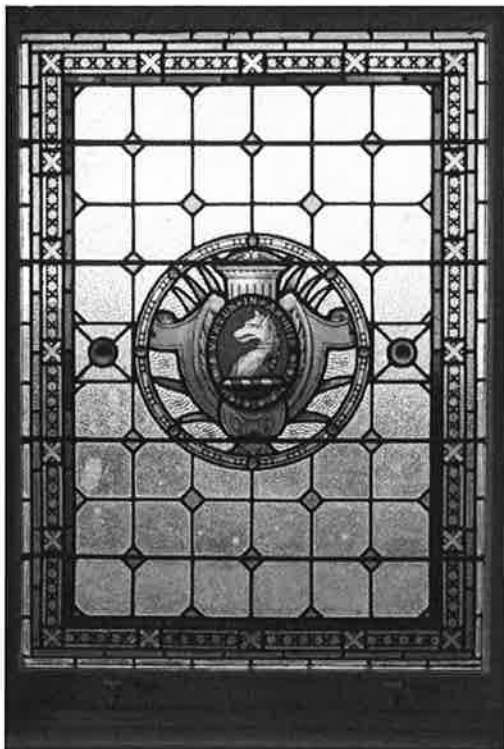
Figure 33: (Left) Detail of west window to ground floor living room

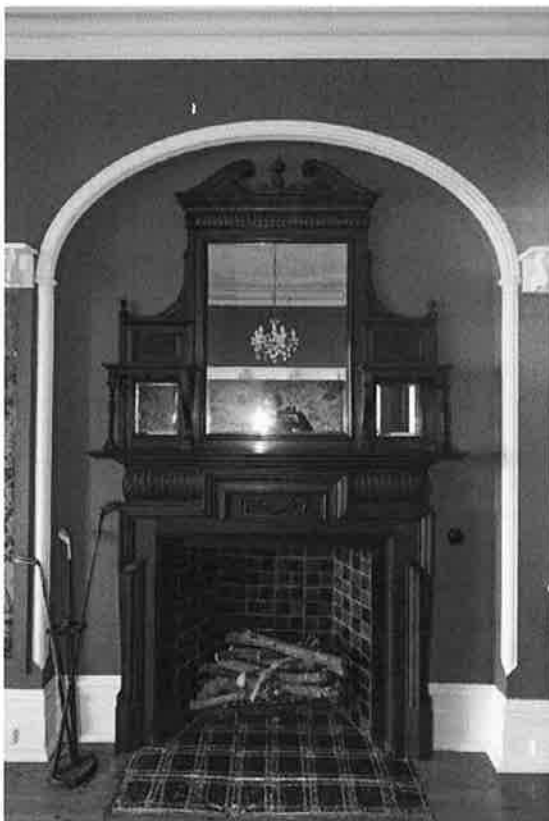
Figure 35: (Left) Detail of fireplace, ground floor living room

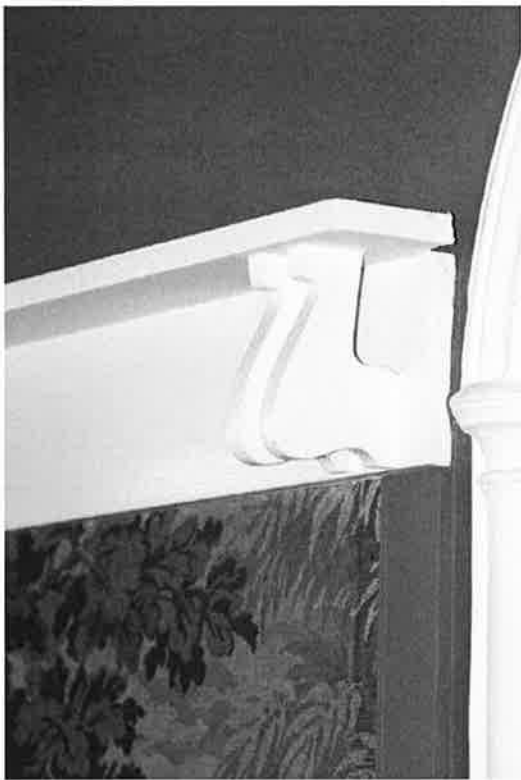
Figure 36: (Left) Detail of inter-war period plaque rail to ground floor living room

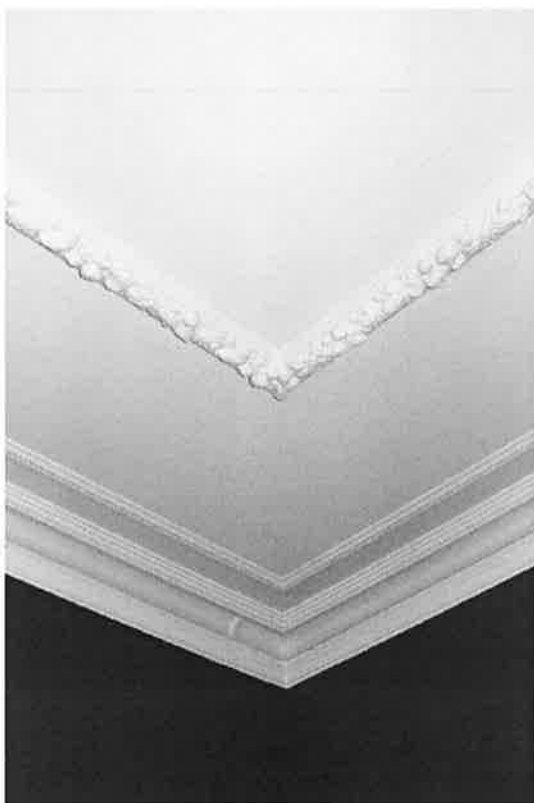
Figure 37: (Left) Cornice and ceiling detail, ground floor living room

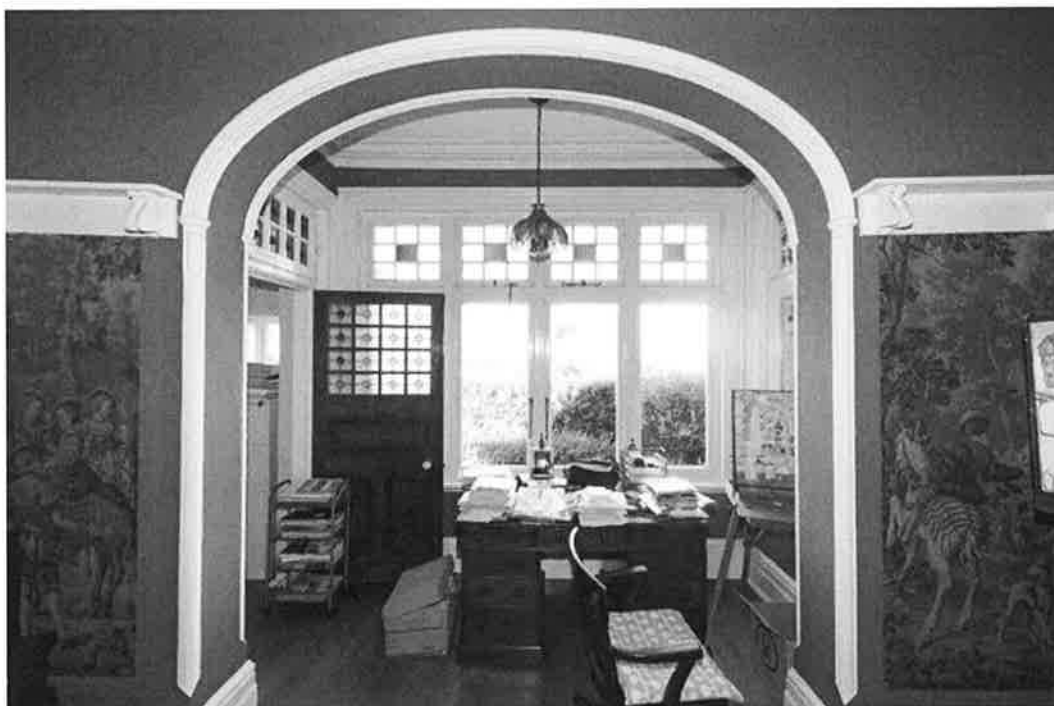
Figure 38: View into bay window (south elevation) from ground floor living room. Note open door at left leads to the inter-war period sunroom.

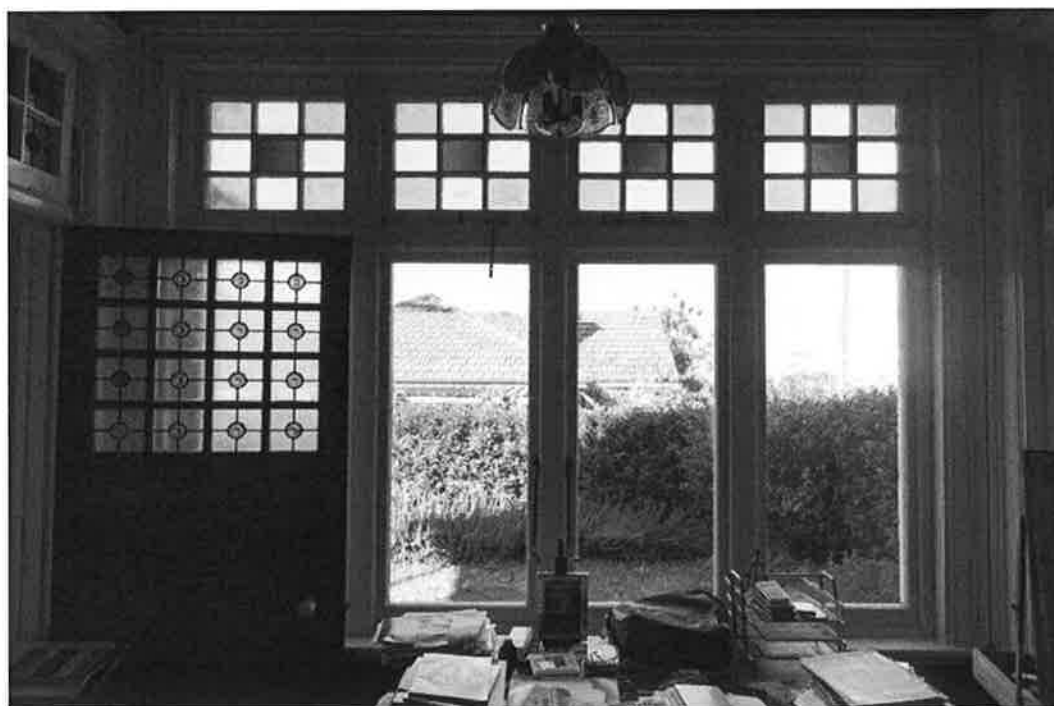
Figure 39: Detail of sunroom (south elevation)

The interwar period alterations evident do not detract from the overall composition of the house – for example the interwar period sunroom to the ground floor south elevation (enclosing part of the original verandah) features high quality detailing including 1920s style painted glass with oriental scenes.

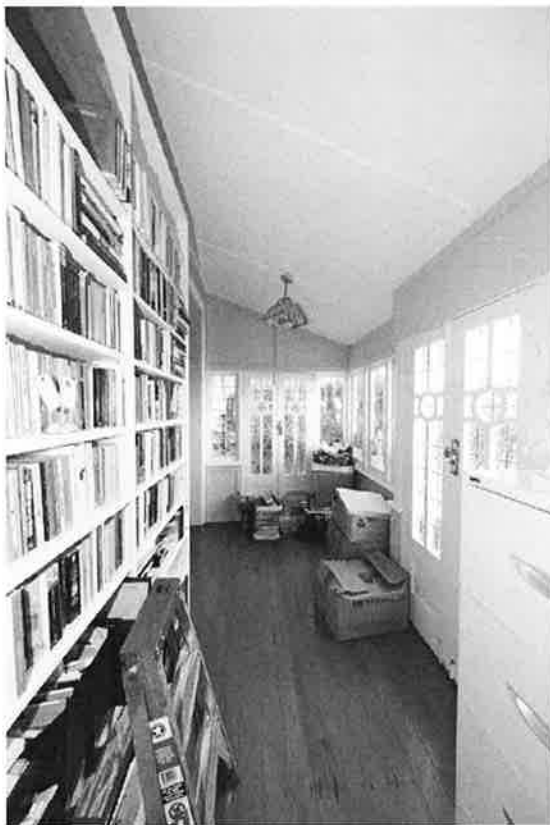
Figure 40: (Left) Interior of inter-war period sunroom, (south elevation)

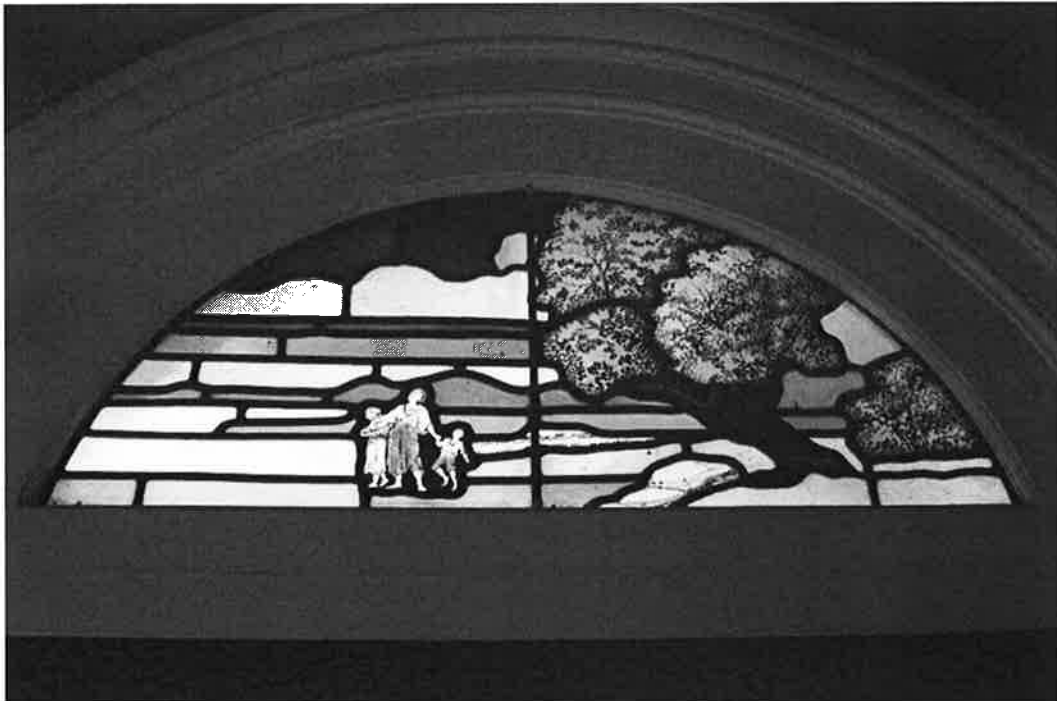
Figure 44: Detail, leadlight fanlight over main entry door, east elevation

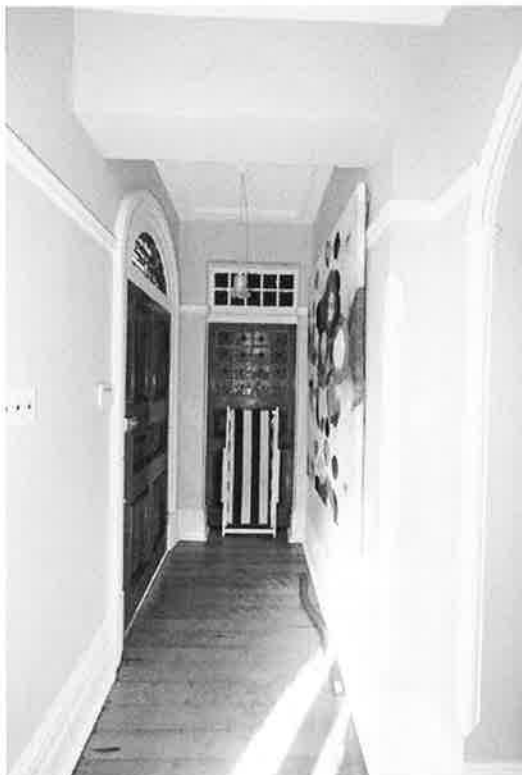
Figure 45: (Left) Entry hall, east elevation ground floor with main entry door with semi circular arched fanlight above at left. Note evidence for removal of a small wall in this area.

The internal layout to both ground and first floors is largely intact, with only minor modifications (for example the removal of a small wall near the main eastern entry door). Extensive original joinery remains, although some 1920s French doors are evident later additions. Some fireplace mantelpieces have been replaced with interwar period mantelpieces and the rear bedroom (north-east corner) to the first floor has a chimneybreast but no fireplace, indicating possible past removal of a fireplace. The staircase is an original timber staircase.

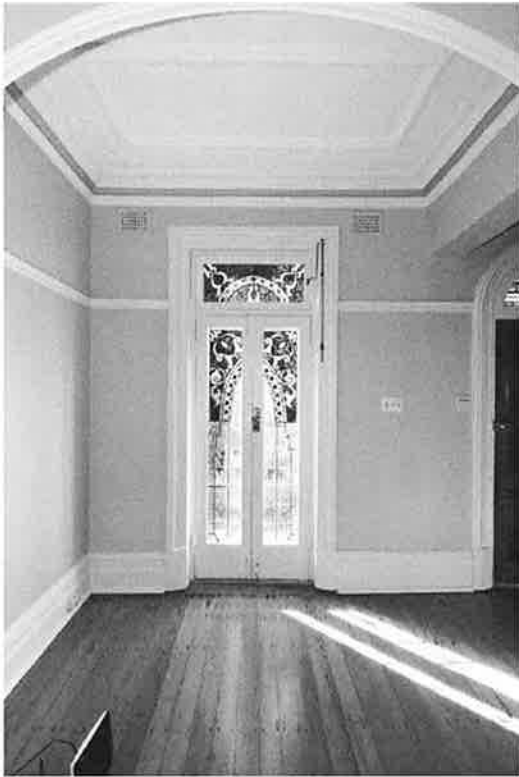
Figure 46: (Left) stained glass and leadlight fanlight and French doors (north of the main entry door, east elevation)

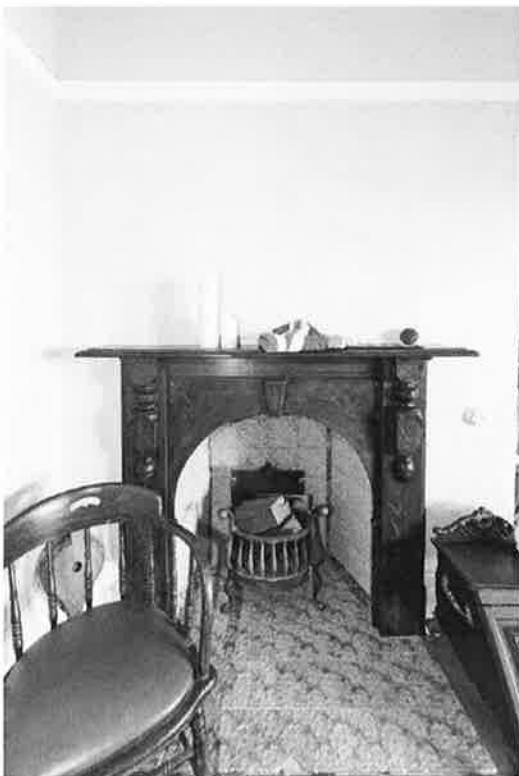
Figure 47: (Left) Fireplace detail, ground floor dining room

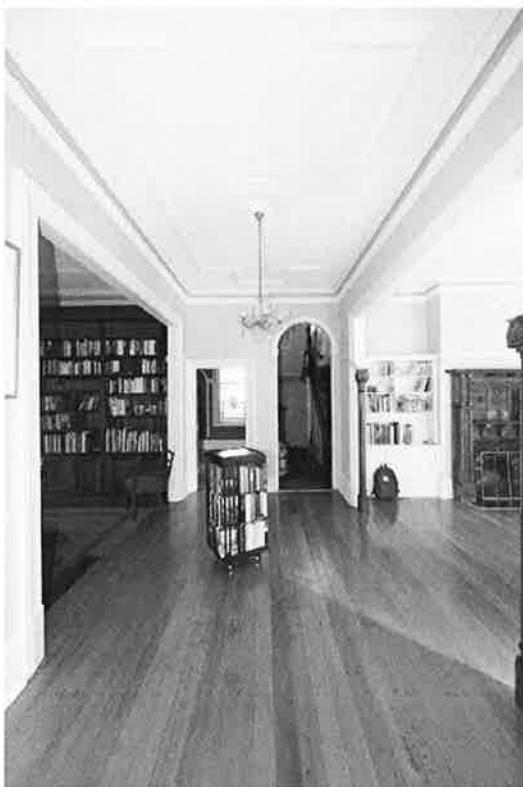
Figure 49: (Left) looking west towards the stair hall, ground floor. Note original New Zealand Kauri pine floor

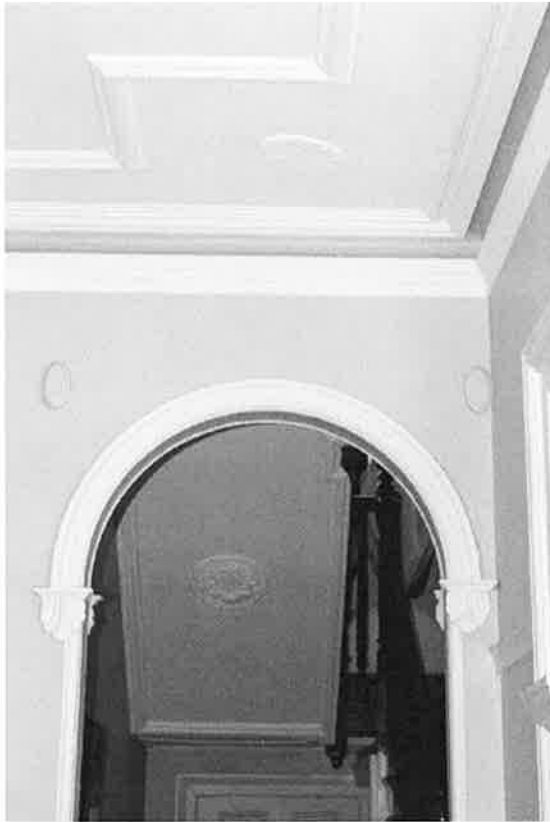
Figure 50: (left) Ground floor - arch to stairwell flanked by circular wooden blocks for mounting gas light fittings

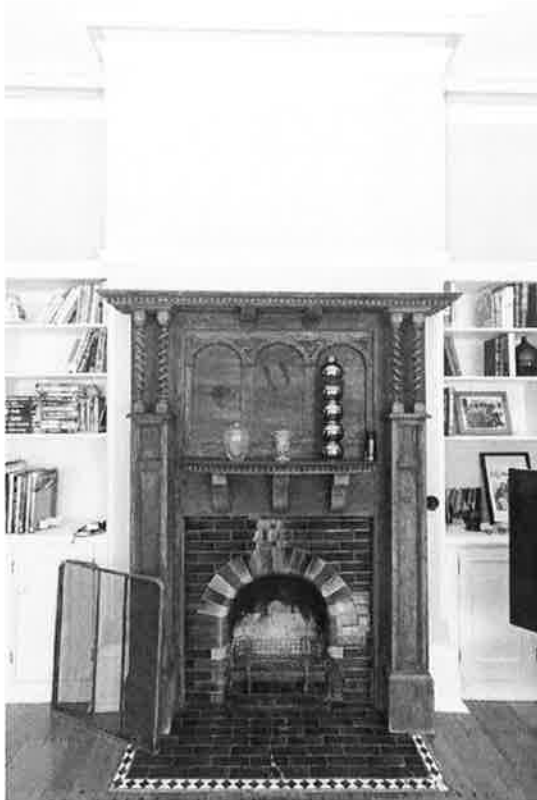
Figure 54: (Left) Detail of fireplace, west wall of lounge room, ground floor

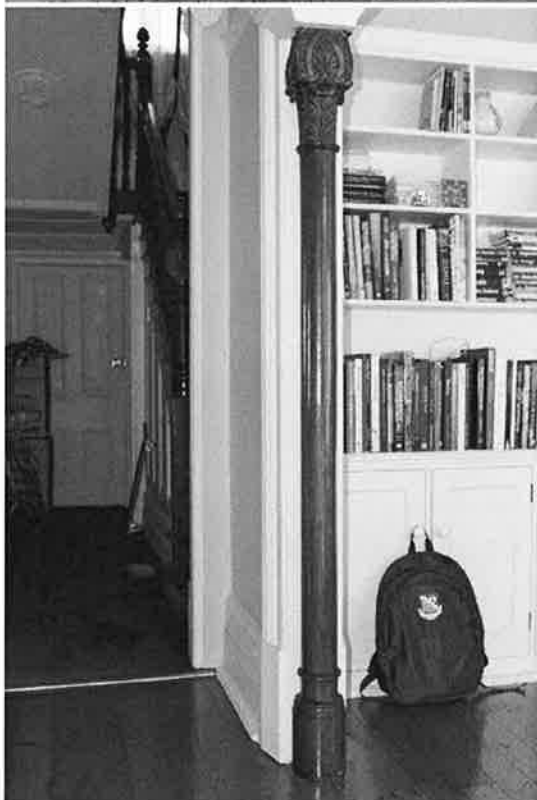
Figure 55: (Left) Detail of one of the carved pilasters dividing the lounge room from the stair hall area

The house exhibits fine detailing including very high quality stained glass windows, timber pilasters to the ground floor living area, and large rooms with high ceilings.
