“Coruisk” (later “Lansdowne”)

3 ANDERSON STREET

HERITAGE ASSESSMENT

AUGUST 2015

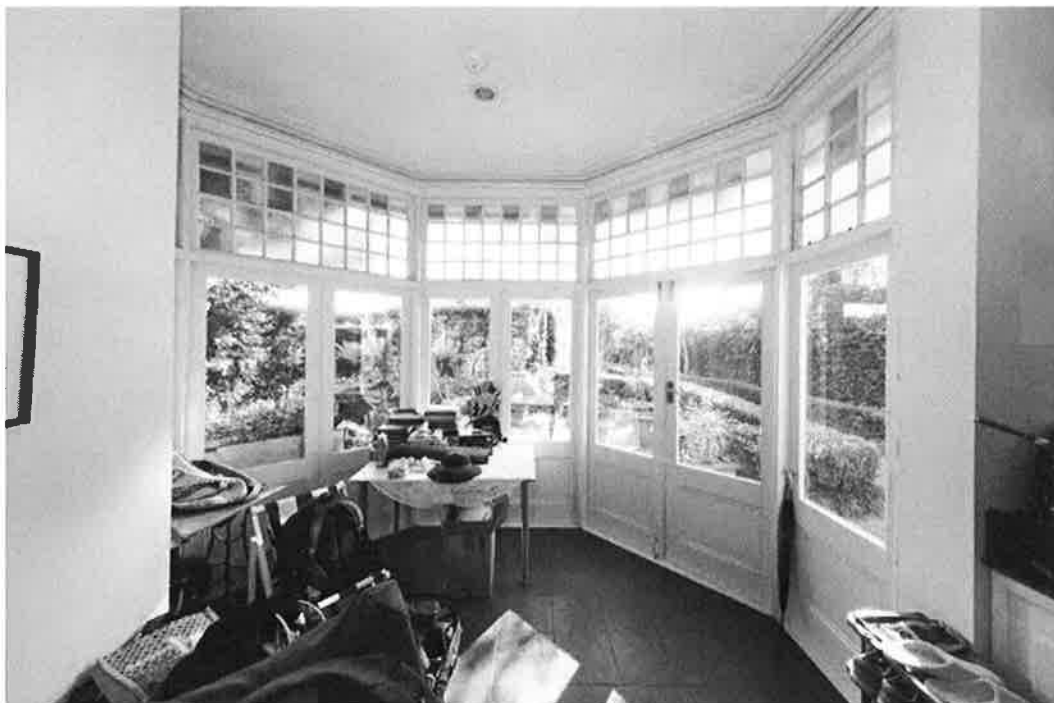
Figure 58: Bay window to kitchen, ground floor north elevation of the house.

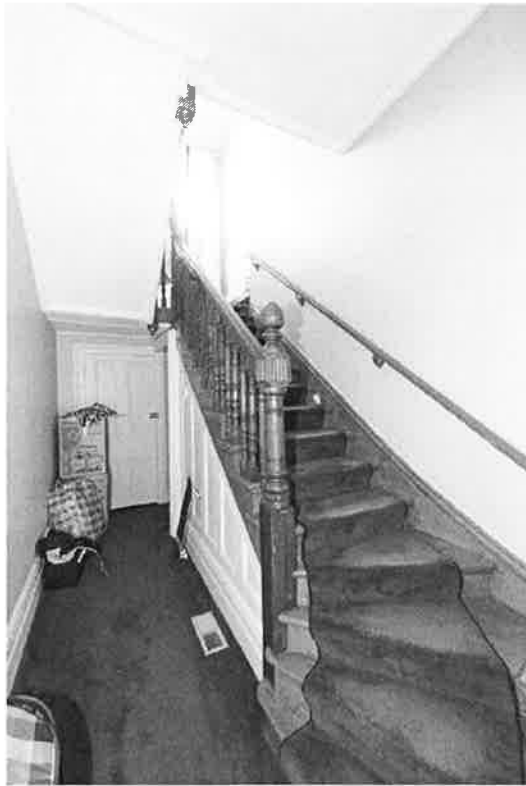
Figure 62: (Left) The stair hall, ground floor, with original timber staircase. Note door to left of stair opens onto the west elevation of the house.

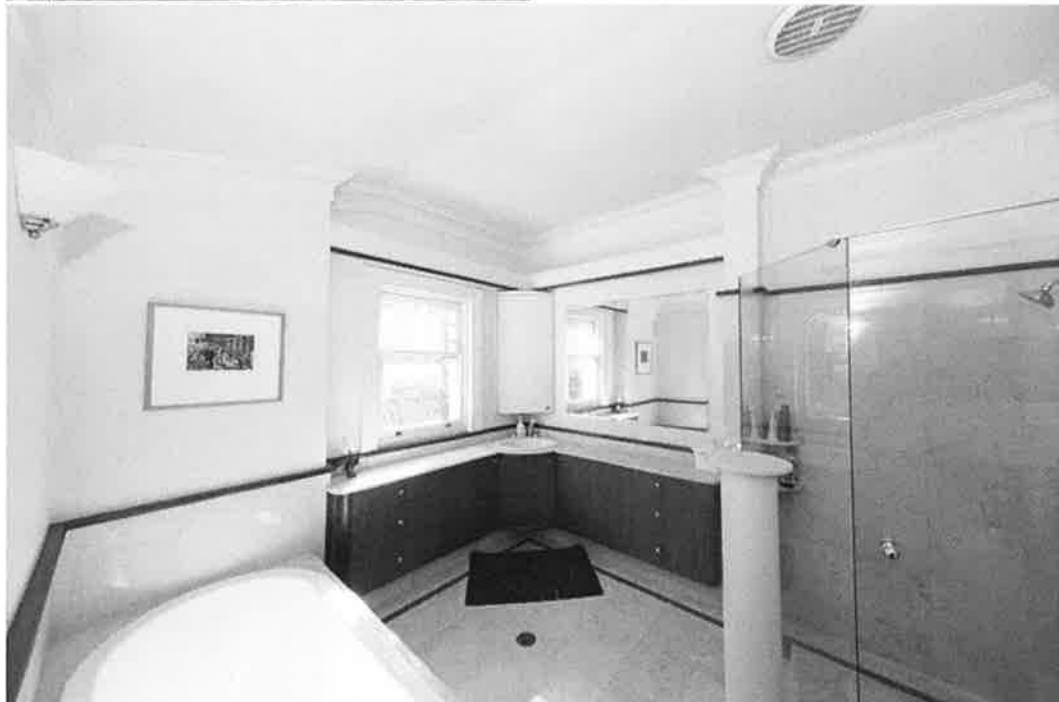
Figure 63: Bathroom within a mezzanine level accessed off a stair landing (note: this area is above the maid's room, laundry and bathroom area to the ground floor level of the house)

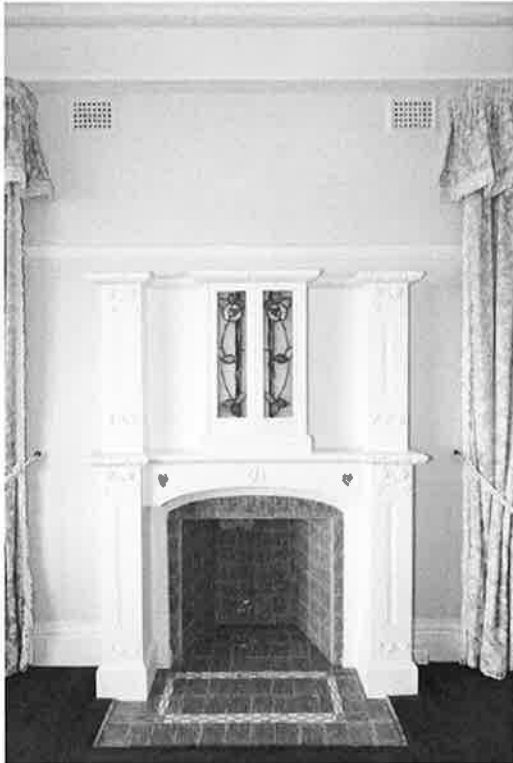
Figure 70: (Left) Detail, fireplace to first floor bedroom to the south-west corner of the house,

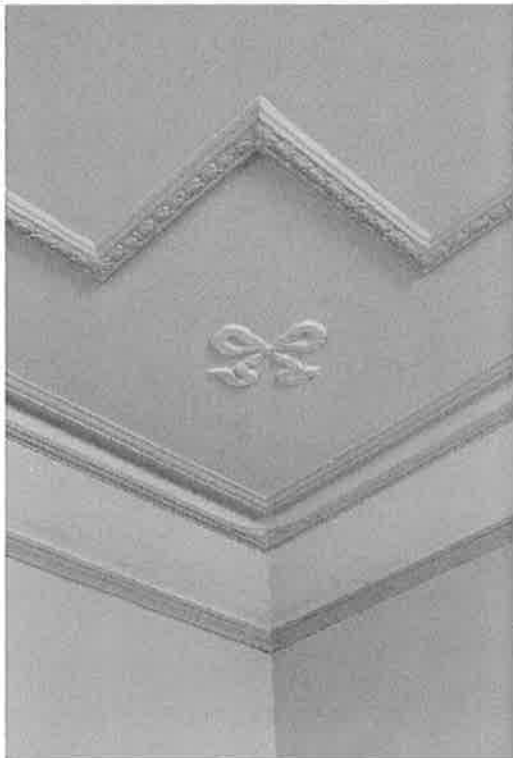
Figure 71: (Left) cornice and ceiling detail, first floor bedroom to the south-west corner of the house

Ceilings are variously original (original deeply moulded cornices remain in most rooms of the house) or have been replaced in the interwar period.

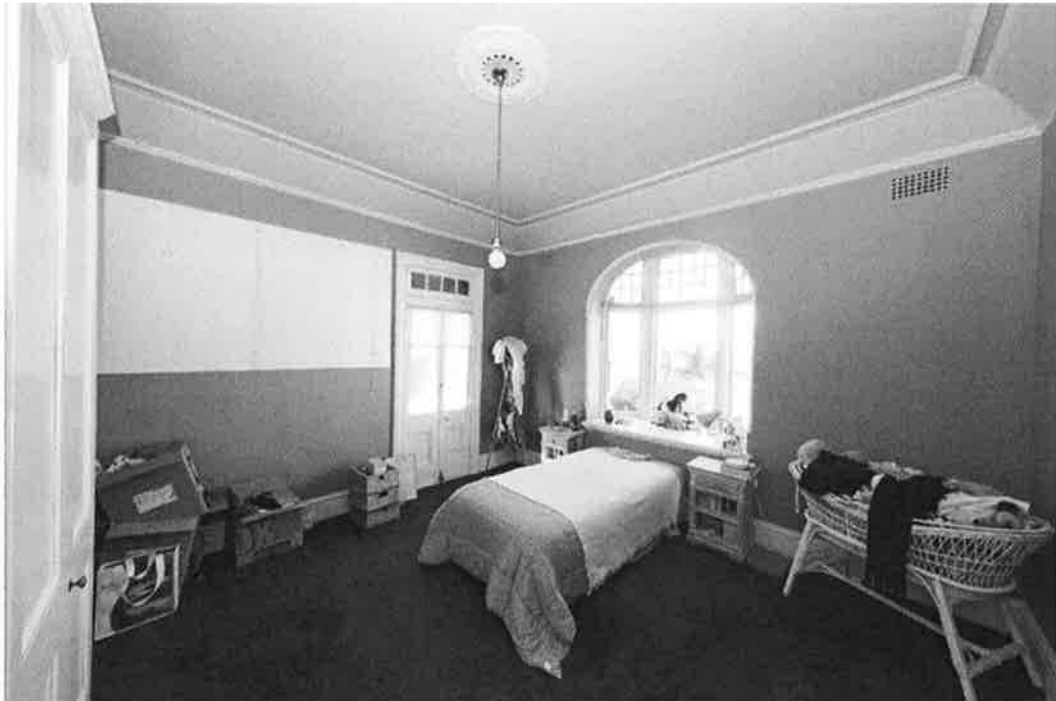
Figure 72: First floor bedroom to the south-east corner of the house, with interior of oriel window at right, doors to eastern balcony at left

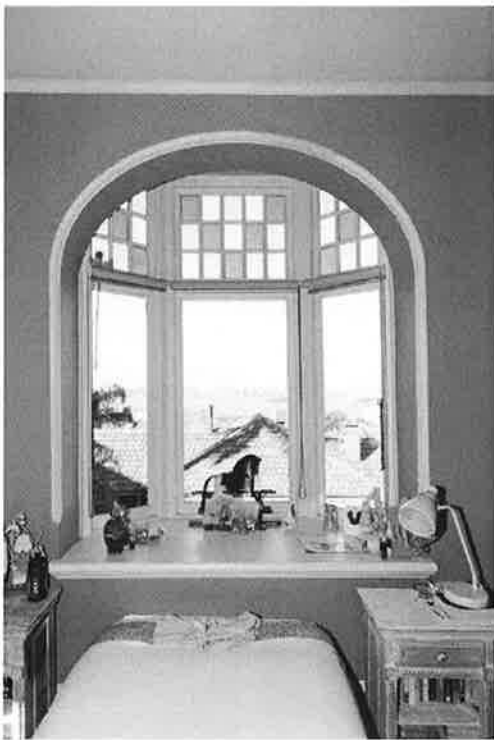
Figure 73: (Left) Detail, interior of oriel window

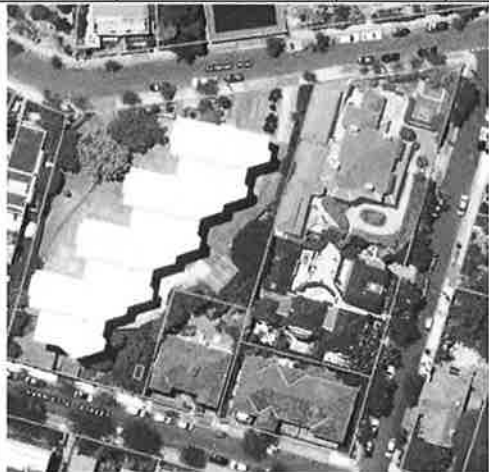
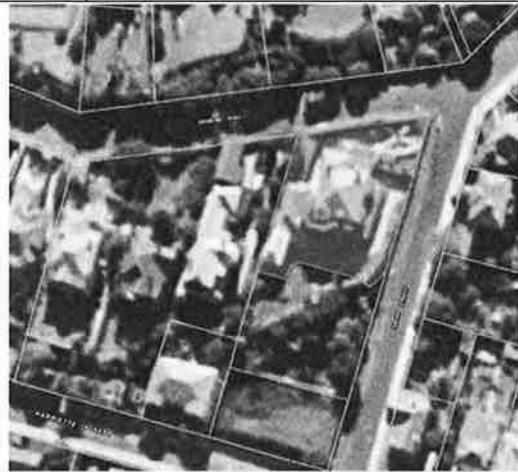
| Heritage item name | Address | LGA | Heritage Listing/Date | Comment |
|---|---|---|---|---|
| Figure 77: 22 Thrupp Street today, with the current allotment/heritage listing curtilage shaded yellow, and buildings to the south on land subdivided from the original site. Source: NSW Land & Property Information Six Maps | | Figure 78: 22 Thrupp St in 1943, showing the current allotment/heritage listing curtilage shaded yellow and the garden to the south of the house extending down to Harriette Street. Source: NSW Land & Property Information Six Maps | | |

| Heritage item name | Address | LGA | Heritage Listing/Date | Comment |
|---|---|---|---|---|
| "Nazareth" (aka St Ronan's, house constructed 1889) | 22 Thrupp Street, Neutral Bay (corner Raymond Road) | North Sydney | Listed in the North Sydney LEP 2013 – Heritage item No. I0714 | The property originally had three street frontages – to Raymond Road, Thrupp Street and Harriette Street. Two allotments have been created via a subdivision to the south of the house (originally a garden area), and later buildings constructed. The house is now part of a Strata Plan development. This site is in proximity of the subject site at 3 Anderson Street. |

It should also be noted that the house "Nazareth" at 22 Thrupp Street is in close proximity to the subject property at 3 Anderson Street, and "Nazareth" was also built only a few years earlier (1889) than the subject house (built circa 1893). "Nazareth" is also in close proximity to multi storey residential flat buildings, particularly the flat building at No. 10-12 Raymond Road.

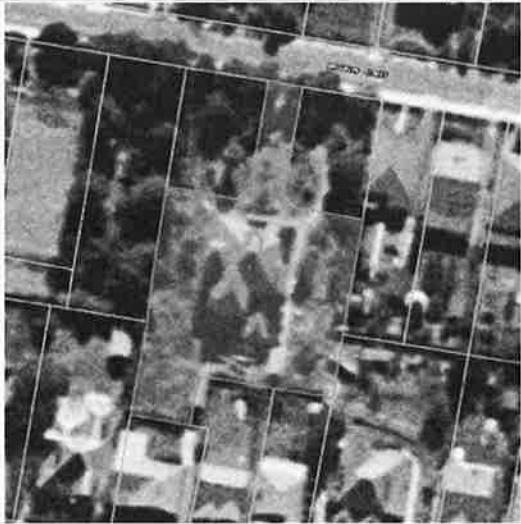
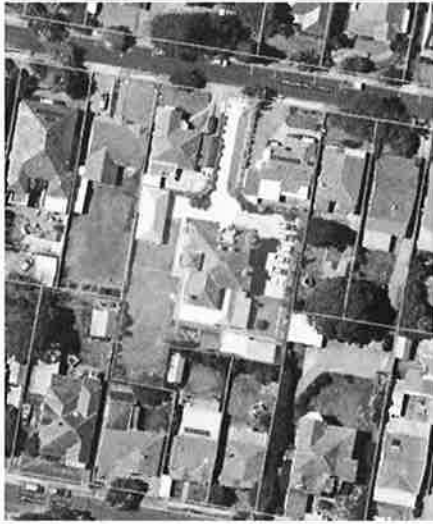
| Heritage item name | Address | LGA | Heritage Listing/Date | Comment |
|---|---|---|---|---|
| <p>Figure 79: 16 Brooklyn Street in 1943, showing the current allotment and heritage listing boundary (shaded yellow), with a circular carriage drive to the north, in front of the house.<br/>Source: NSW Land &amp; Property Information Six Maps</p> <p>Figure 80: The current allotment and heritage listing boundary for No. 16 Brooklyn Street, Burwood, showing only a narrow driveway onto Brooklyn Street, where originally the house had extensive frontage to Brooklyn Street.<br/>Source: NSW Land &amp; Property Information Six Maps</p> | | | | |

| Heritage item name | Address | LGA | Heritage Listing/Date | Comment |
|---|---|---|---|---|
| Federation period house | 16 Brooklyn Street, Burwood | Burwood | Listed in the Burwood LEP 2012 and previously in the 1989 Burwood LEP | The LEP heritage listing covers the current allotment, however it is clear that this a remnant of a larger portion of land. Two later houses have been built in front of the heritage item, however the house (a large 2 storey Federation period house) is still visible from Brooklyn Street. |

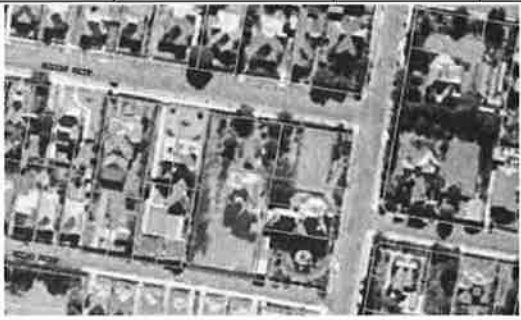
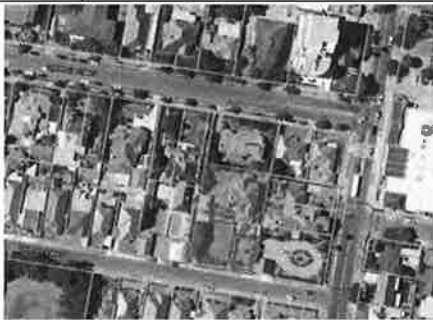
| Heritage item name | Address | LGA | Heritage Listing/Date | Comment |
|---|---|---|---|---|
| <p>Figure 81: "Athole", No.1 Church Street Burwood in 1943, showing the current allotment (shaded yellow) with the front garden (since subdivided off) facing Clarence Street to the north.<br/>Source: NSW Land &amp; Property Information Six Maps</p> <p>Figure 82: No. 1 Church Street, Burwood today, showing a modern house to the north of the current allotment of "Athole".<br/>Source: NSW Land &amp; Property Information Six Maps</p> | | | | |

| Heritage item name | Address | LGA | Heritage Listing/Date | Comment |
|---|---|---|---|---|
| "Athole" (house built in 1887) | 1 Church Street, Burwood | Burwood | Listed in the Burwood LEP 2012 and previously in the 1989 Burwood LEP | Built for a well-known local retailer, originally the site ran through from Clarence Street to Church Street, with the house and front garden facing Clarence Street. A mid 20 <sup>th</sup> century subdivision resulted in a new house built circa 1960s in what was the front garden addressing Clarence Street (this house since replaced in the 1990s with a new dwelling). The heritage listed house is addressed 1 Church Street, with the original rear of the house facing Church Street |

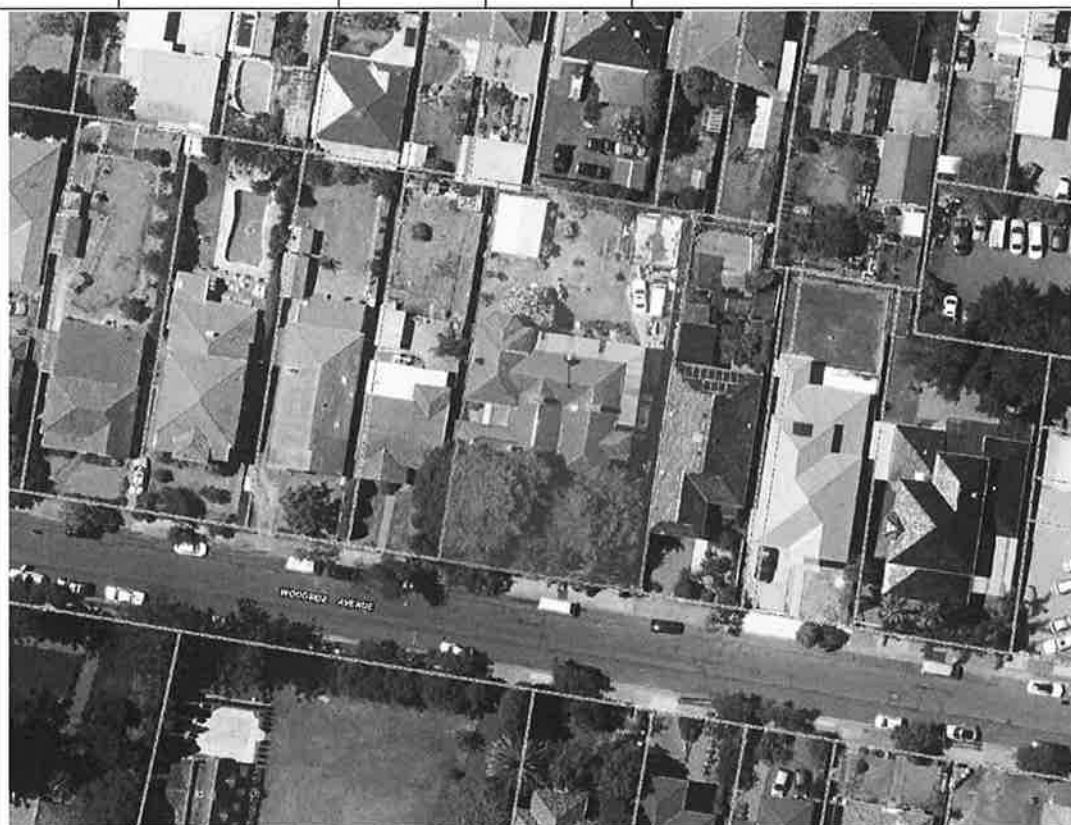
Figure 83: Recent satellite photo showing the heritage listing boundary for "Luscombe", 7 Woodside Ave, Burwood (highlighted yellow, outlined in red), which reflects the current allotment boundaries, with the bay window and verandah to the north elevation of the house, now facing the backyard. Source: NSW Land & Property Information Six Maps

| Heritage item name | Address | LGA | Heritage Listing/Date | Comment |
|---|---|---|---|---|
| "Luscombe"<br>(circa 1860s house) | 7 Woodside Avenue East, Burwood | Burwood | Listed in the Burwood LEP 2012 and previously in the 1989 Burwood LEP | The property including the house Luscombe originally encompassed extensive land. The house was designed to face north. The property was subdivided in the 1920s and the Burwood Fire Station (built 1925, also LEP heritage listed) and other buildings built to the north of the house along Livingstone Street. The property retains a street frontage to Woodside Avenue East to the south. The rear elevation of the house Luscombe now faces the street and the original northern front elevation of the house with its bay window and expansive verandah faces what is now the backyard. The original 1989 LEP heritage listing and the recent 2012 LEP heritage listing covers the property with its modern lot boundaries and Woodside Avenue street address. |

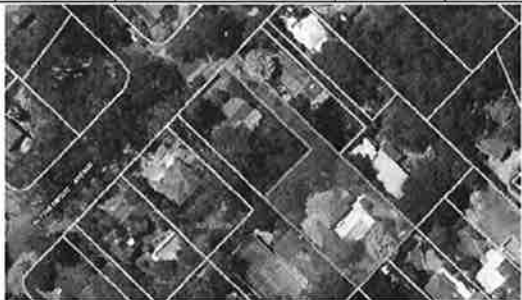
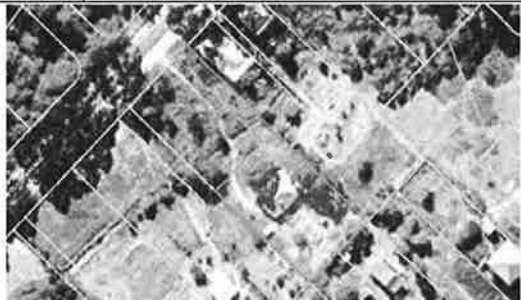
| Heritage item name | Address | LGA | Heritage Listing/Date | Comment |
|---|---|---|---|---|
| Figure 84: The site of 22 Blytheswood Avenue Warrawee today, on a battle-axe allotment (shaded yellow). Source: NSW Land & Property Information Six Maps | | Figure 85: The site of 22 Blytheswood Avenue Warrawee in 1943 (shaded yellow). The driveway access to the house across land at the front of the house since subdivided off is apparent in this photo. Source: NSW Land & Property Information Six Maps | | |

| Heritage item name | Address | LGA | Heritage Listing/Date | Comment |
|---|---|---|---|---|
| Dwelling house | 22 Blytheswood Avenue, Warrawee | Ku-ring-gai | Listed in the Ku-ring-gai LEP 2015 (Item No. I1027) | Now on a battle-axe allotment, the house site originally included land fronting Blytheswood Avenue. |

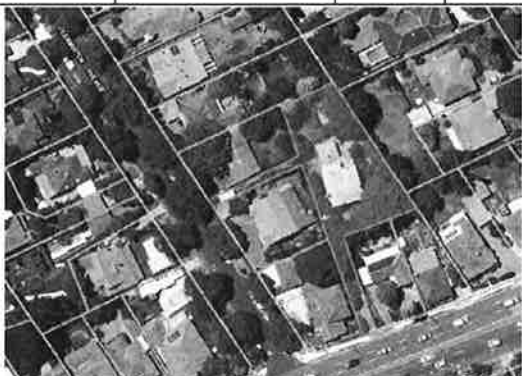
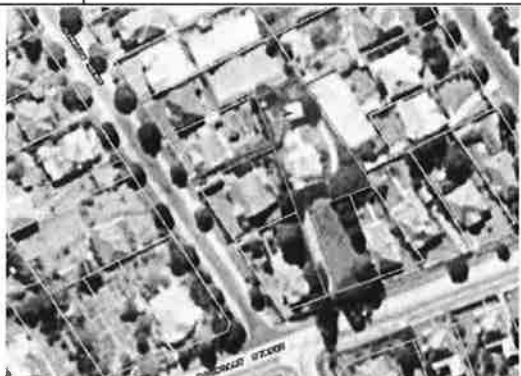
| Heritage item name | Address | LGA | Heritage Listing/Date | Comment |
|---|---|---|---|---|
| Figure 86: "Clermiston" today on its battle-axe allotment with driveway access to two streets. Source: NSW Land & Property Information Six Maps | | Figure 87: "Clermiston" in 1943, already hemmed in with surrounding development. Source: NSW Land & Property Information Six Maps | | |

| Heritage item name | Address | LGA | Heritage Listing/Date | Comment |
|---|---|---|---|---|
| Clermiston | 79 Boundary Street Roseville | Ku-ring-gai | Listed in the Ku-ring-gai LEP 2015 (Item No. I671) | The house "Clermiston" predates surrounding development and was already hemmed in with later development by 1943. The house has no street presence at all. |

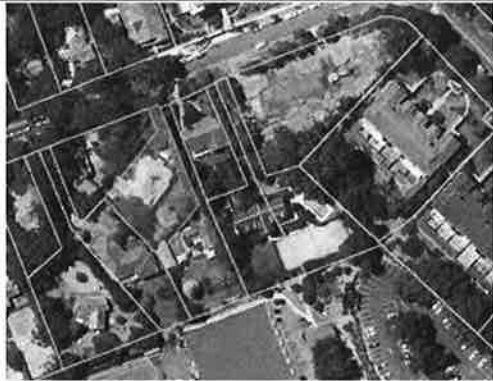
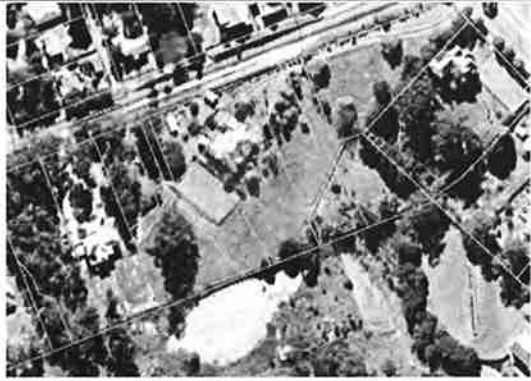
| Heritage item name | Address | LGA | Heritage Listing/Date | Comment |
|---|---|---|---|---|
| Figure 88: The site of 10 Buckingham Road, Killara today (shaded yellow), a battle-axe allotment off Buckingham Road. Source: NSW Land & Property Information Six Maps | | Figure 89: 1943 aerial photo of 10 Buckingham Road, Killara with the current site shaded yellow, showing the extensive land holding with an access drive evident off the Pacific Highway, and the rear of the house and outbuildings facing Buckingham Road. Source: NSW Land & Property Information Six Maps | | |

| Heritage item name | Address | LGA | Heritage Listing/Date | Comment |
|---|---|---|---|---|
| Dwelling house | 10 Buckingham Road, Killara | Ku-ring-gai | Listed in the Ku-ring-gai LEP 2015 (Item No. I255) | The house, now on a battle-axe allotment, originally had an extensive land holding with an access drive from the Pacific Highway (evident on the 1943 aerial photo) |

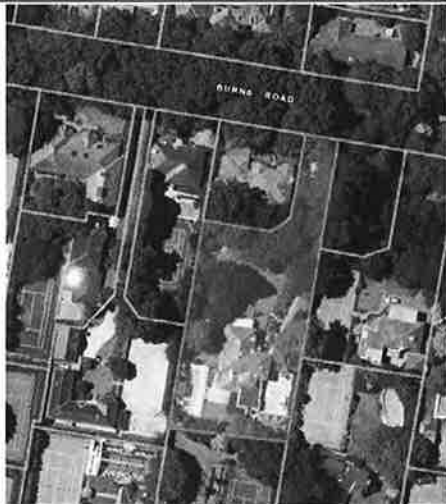
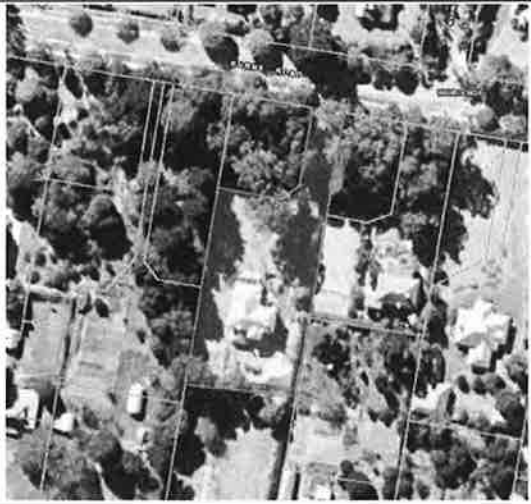
| Heritage item name | Address | LGA | Heritage Listing/Date | Comment |
|---|---|---|---|---|
| Figure 90: The site today of 53 Burns Road (shaded yellow), with a new dwelling in front. Source: NSW Land & Property Information Six Maps | | Figure 91: 1943 aerial photo of the site of 53 Burns Road (shaded yellow), Source: NSW Land & Property Information Six Maps | | |

| Heritage item name | Address | LGA | Heritage Listing/Date | Comment |
|---|---|---|---|---|
| Dwelling house (Circa 1930s) | 53 Burns Road, Wahroonga | Ku-ring-gai | Listed in the Ku-ring-gai LEP 2015 (Item No. I872) | The house, now on a battle-axe allotment, appears to have always been obscured from Burns Road by dense trees (see 1943 aerial photo below) |

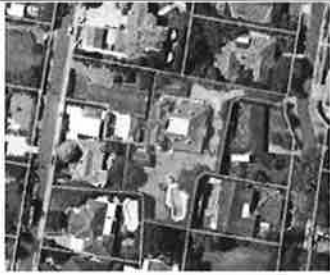
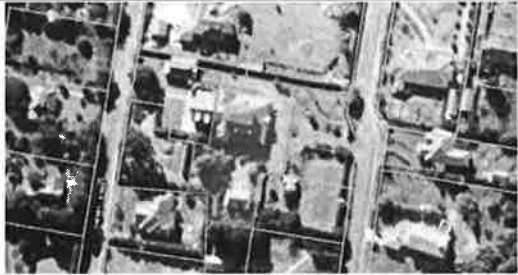
| Heritage item name | Address | LGA | Heritage Listing/Date | Comment |
|---|---|---|---|---|
| Figure 92: The site of 20 Harrington Avenue, Warrawee today as a battle-axe allotment (shaded yellow). Source: NSW Land & Property Information Six Maps | | Figure 93: 1943 aerial photo showing the site of 20 Harrington Avenue, Warrawee, with the current site shaded yellow. The landscaping and tennis court on the Harrington Avenue frontage are evident, along with rear wing and rear outbuildings facing Cherry Street on the western side of the house. Source: NSW Land & Property Information Six Maps | | |

| Heritage item name | Address | LGA | Heritage Listing/Date | Comment |
|---|---|---|---|---|
| Dwelling house | 20 Harrington Avenue, Warrawee | Ku-ring-gai | Listed in the Ku-ring-gai LEP 2015 (Item No. I1036) | The house was originally part of an extensive land holding which fronted Harrington Avenue and extending through to Cherry Street at the rear (evident on the 1943 aerial photo). The site has since 1943 been subdivided to create a battle-axe allotment. The subdivision appears to have resulted in the loss of a rear wing to the house, outbuildings and tennis court and extensive landscaped setting |

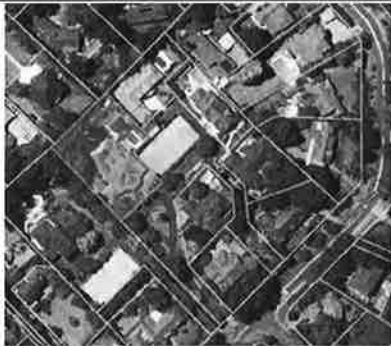
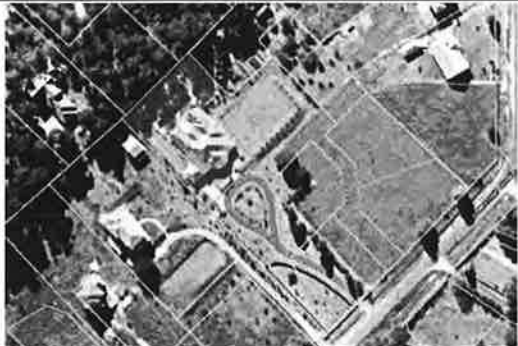
| Heritage item name | Address | LGA | Heritage Listing/Date | Comment |
|---|---|---|---|---|
| Figure 94: The site of the house at 75 Livingstone Avenue Pymble today (shaded yellow) Source: NSW Land & Property Information Six Maps | | Figure 95: 1943 aerial photo of the site of the house at 75 Livingstone Avenue Pymble (shaded yellow). The extent of the original land holding associated with the house is evident in this photo. Source: NSW Land & Property Information Six Maps | | |

| Heritage item name | Address | LGA | Heritage Listing/Date | Comment |
|---|---|---|---|---|
| Dwelling house | 75 Livingstone Road, Pymble | Ku-ring-gai | Listed in the Ku-ring-gai LEP 2015 (Item No. I562) | This house was once part of an extensive site with tennis court and a driveway ending in a teardrop shape. Subsequent subdivision has resulted in development of modern housing around the original house. Some of the original landscaping, notably the teardrop driveway and tennis court, is protected as a separate listed heritage item. This house would have no street presence in Livingstone Avenue due its distance from the Avenue. |
