Report on
Preliminary Site Investigation (Contamination)

Proposed Rezoning
Webber Circuit, Bardia, NSW

Project 202007.00
April 2021

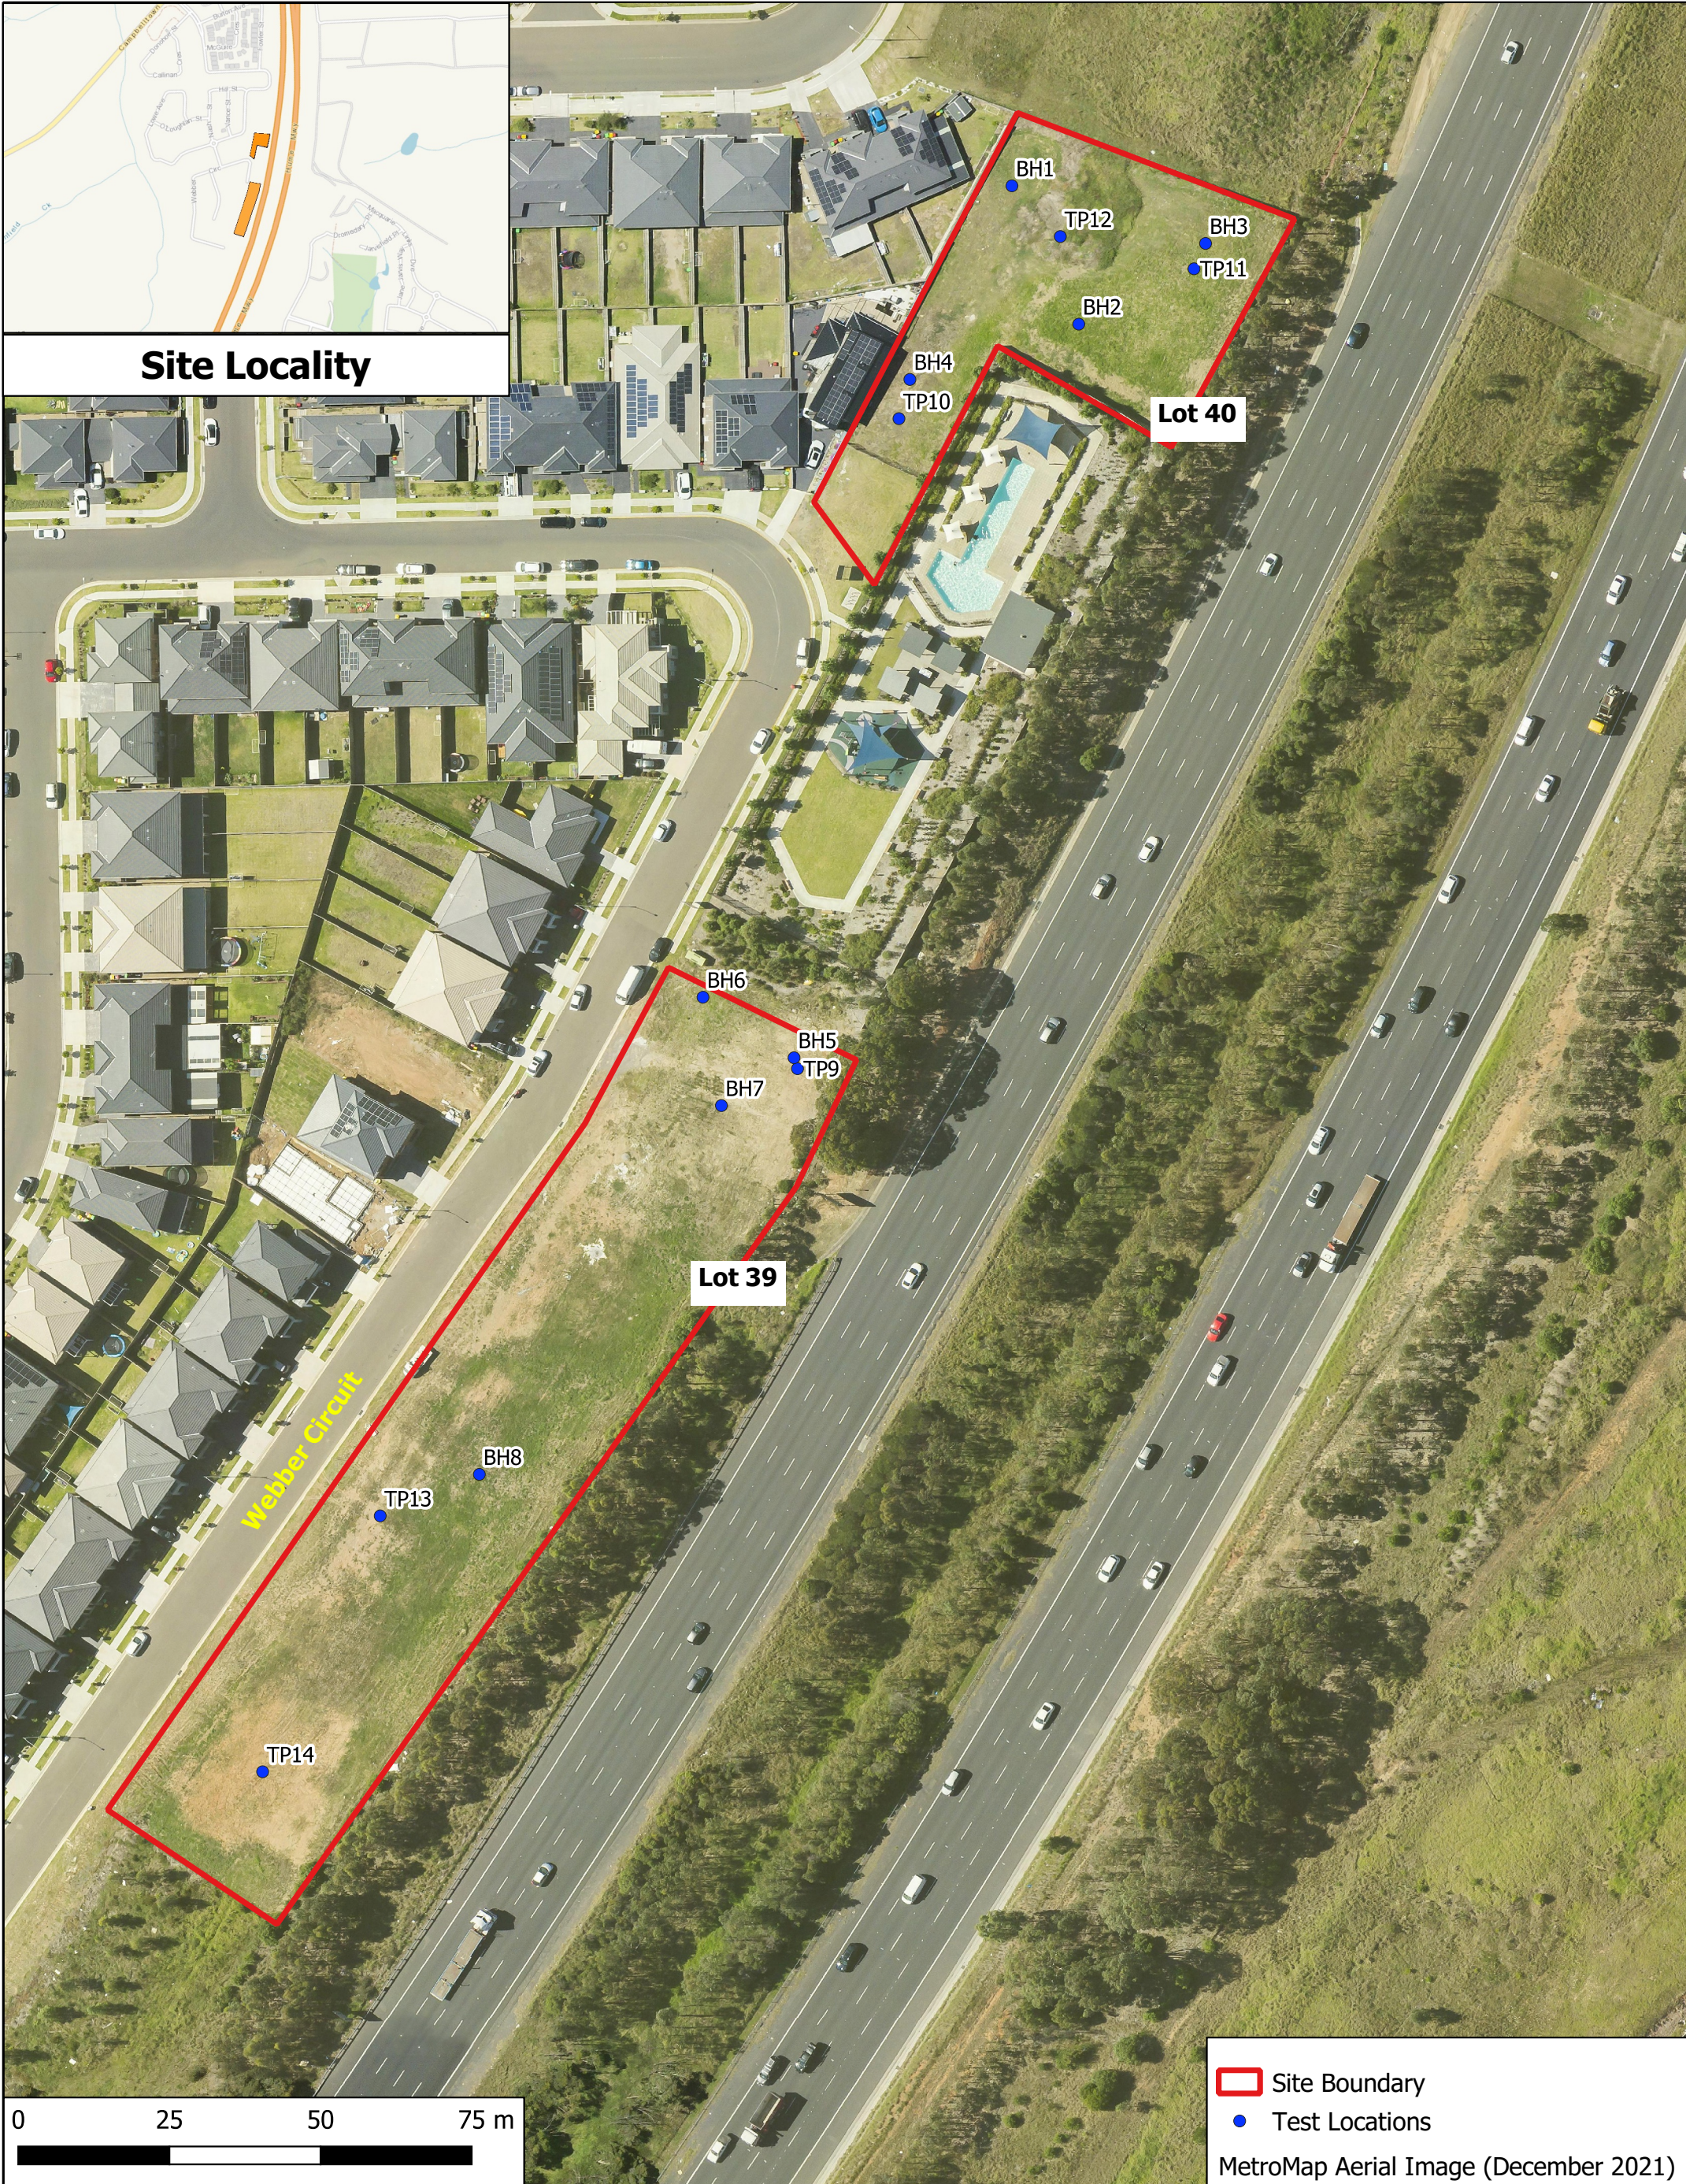
Drawing 1

Site Boundary

Test Locations

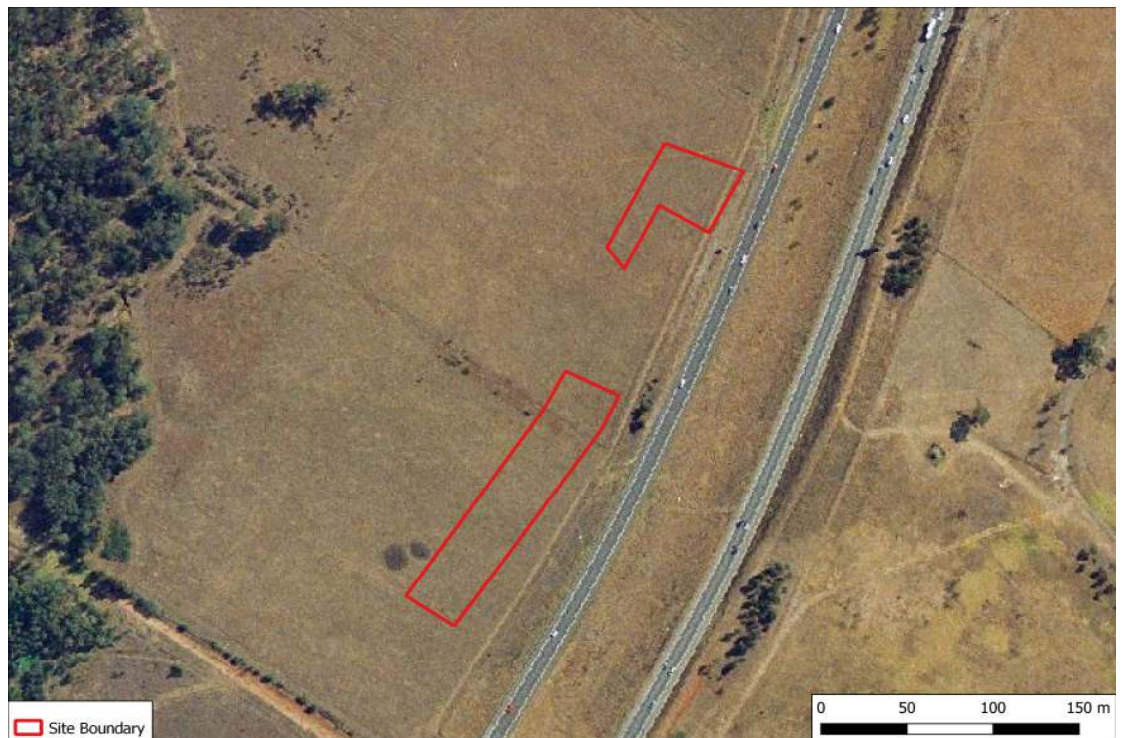
Drawing C5 - 1994

1994 – Drawing C5	The site and surrounding land use appeared consistent with the previous photograph	
2005 – Drawing C6	The site appeared relatively unchanged from the previous photograph	The construction of roads associated with the adjacent subdivisions has begun to the northwest and southeast.
2016 – No drawing provided	Ground disturbances (tracks) were observed through the site likely associated with the adjacent subdivision works	Bulk earthworks and road construction was in progress for the adjacent subdivision (to the northwest).
2018 – Drawing C7	The site was being utilised for the stockpiling of soils and building materials associated with the adjacent subdivision. The area to the north of Lot 39, and Lot 40 appeared to be covered in aggregate/temporary hardstand for a potential site compound. Shipping containers and potential site sheds were present in Lot 40	House and road construction was in progress for the adjacent subdivision (to the northwest).

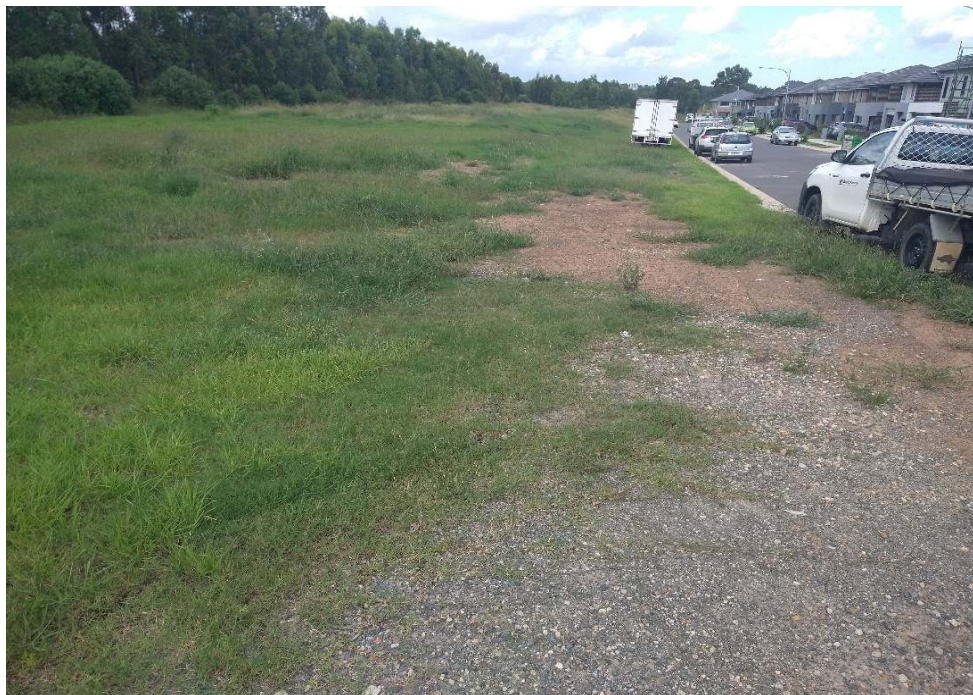
- Areas of exposed fill were observed in four locations across the site. Trace non-soil aggregate and demolition waste (brick, porcelain and terracotta tile, glass and concrete) were also observed (Photograph 1);
- The stockpile in the north (Lot 40) comprised of multiple soil stockpiles. The stockpile area measured approximately 16 m x 13 m 1 m (LxWxH). The stockpiles contained soil, demolition waste (bricks, tile, glass and concrete) and woodchips;
- Apart from demolition waste on the surface, no other obvious signs of potential contamination (i.e. staining, odours or potential asbestos-containing materials (PACM)) were observed; and
- Long grass prevented the inspection of the ground surface in multiple locations.

Photo 1 - View of exposed fill and trace remenant gravel in the north of Lot 40 (facing south)

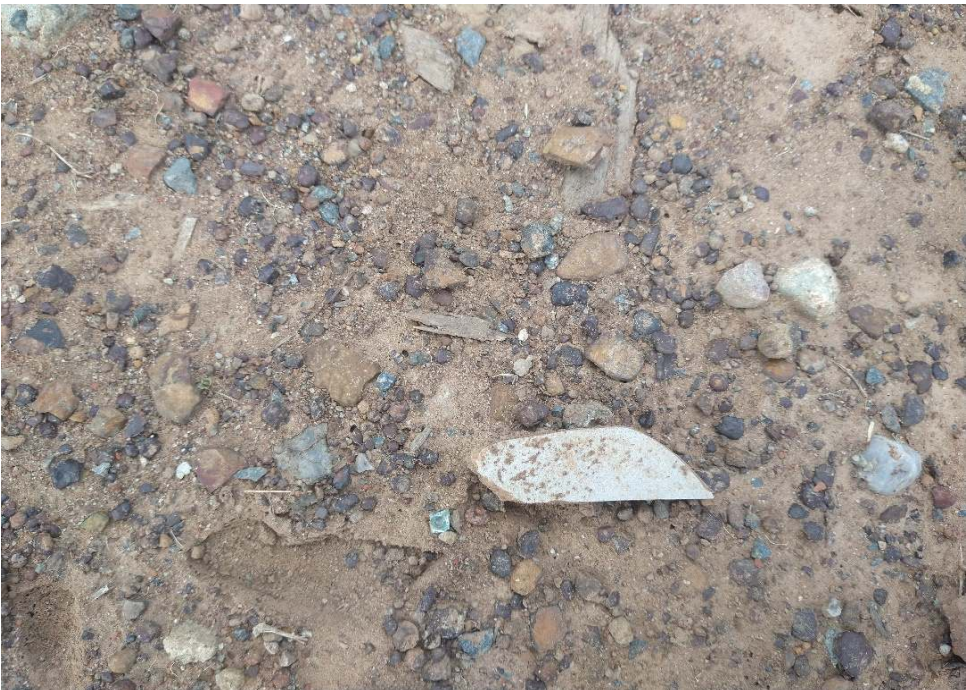
Photo 2 - Trace demolition waste (tile) observed on the surface of exposed fill areas

DP recommends the preparation and implementation of an unexpected finds protocol (UFP) to manage any potential contamination (such as asbestos, or malodorous or discoloured soils) which may be encountered during any future development of the site.

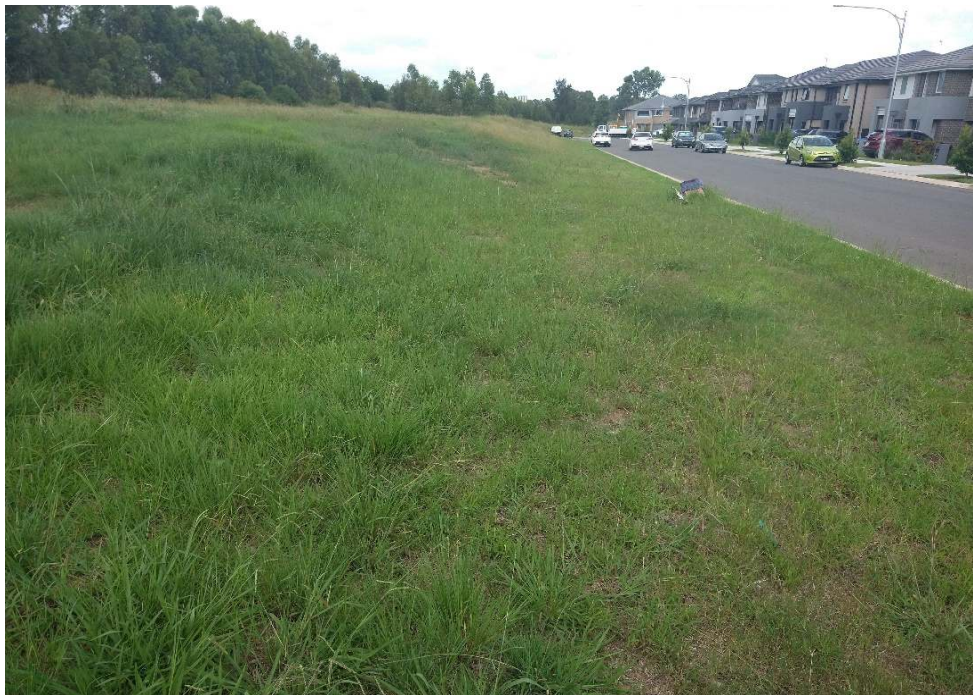
Photo 3 - Long grass preventing the inspection of the ground surface in Lot 40 (facing south)

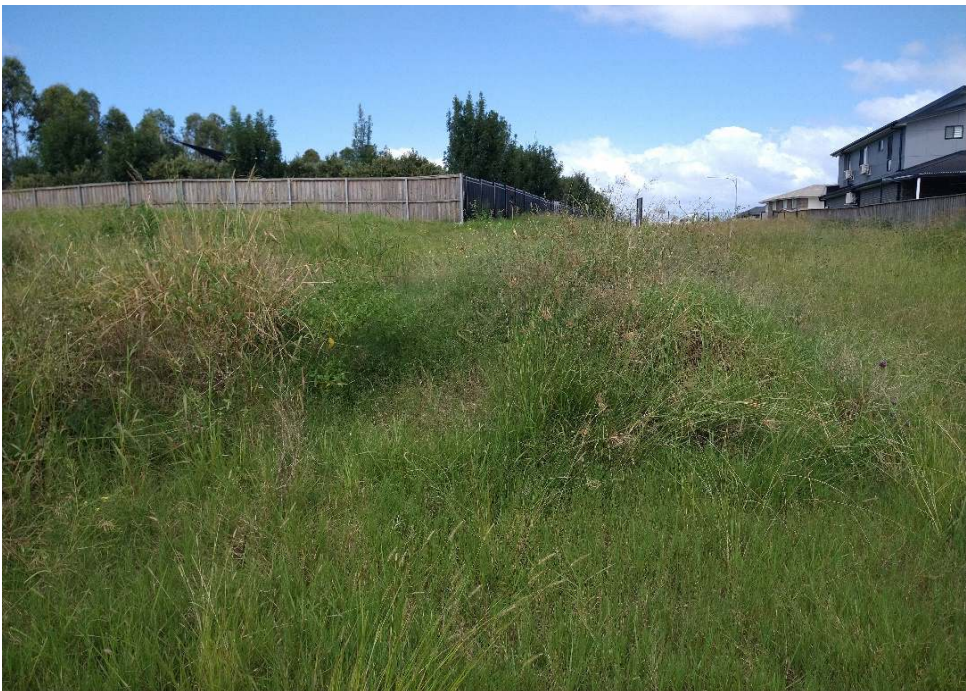
Photo 4 - Stockpiled materials located in the north (Lot 39).

Given that it is understood, based on discussions with ACOR, the current stockpiled materials present on the northern portion of Lot 39 are to be disposed off-site, no sampling and analysis of these materials were undertaken as a part of this assessment. Notwithstanding, further assessment of this material will be required for the purposes of disposal (i.e. to waste classify the materials). If the materials are to remain on site, they must be assessed for their suitability to remain. If considered suitable to remain, given the presence of oversized materials observed during field works, the stockpiled materials may not be suitable to remain at the surface at the conclusion of works, from an aesthetic perspective. Additionally, the geotechnical suitability will also need to be assessed if the material is to remain on site.
