ACID SULFATE SOIL ASSESSMENT & MANAGEMENT PLAN

Proposed Rezoning for Future Residential Subdivision and Development

Lot 100 DP 1201719
Hills Road, Rileys Hill

October 2020

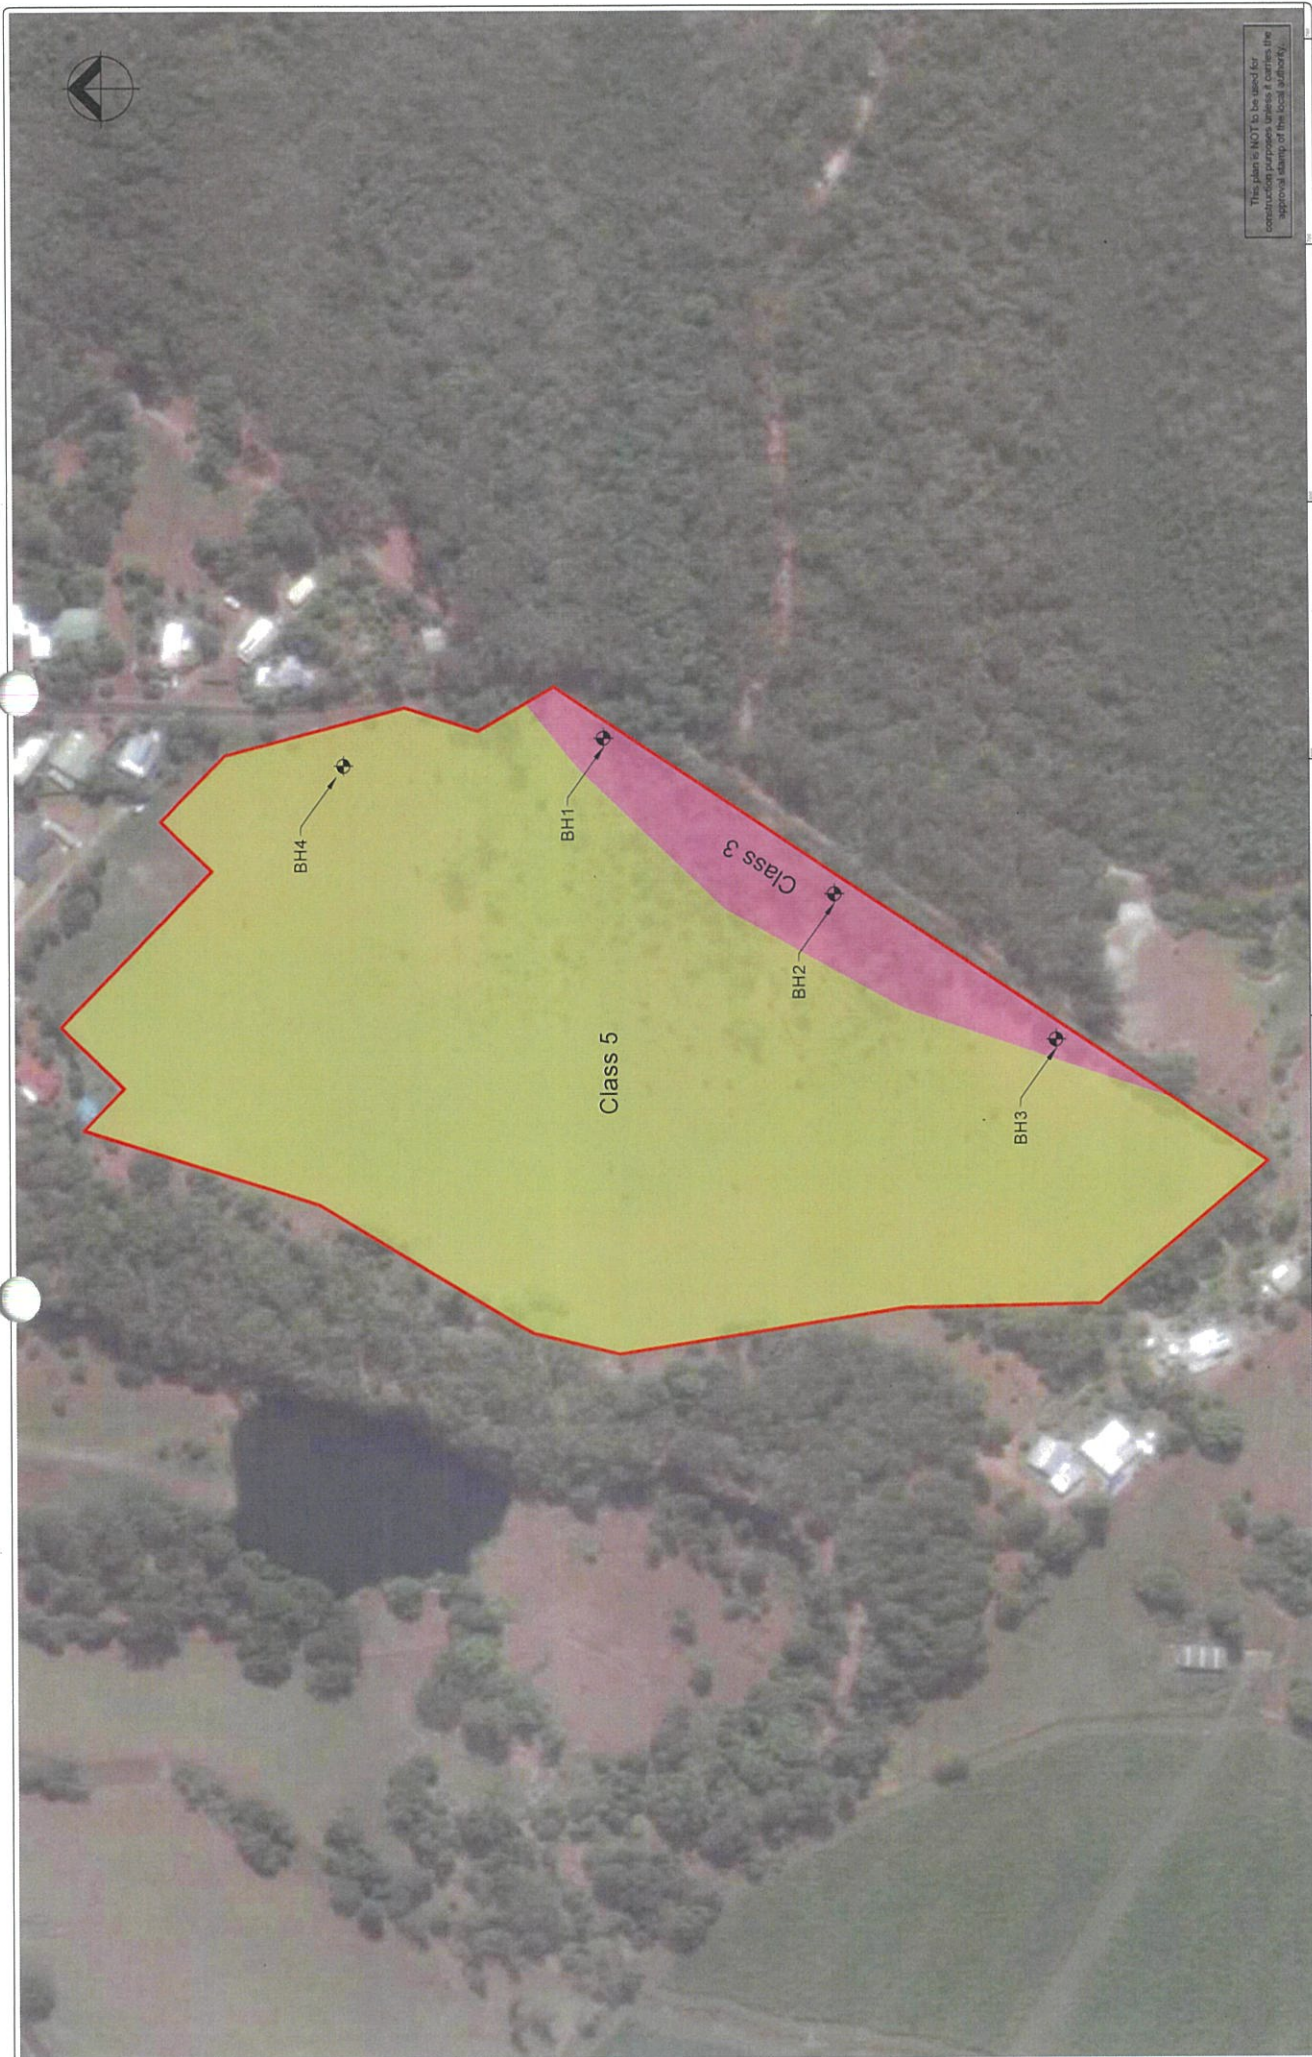
SITE PLAN & TEST LOCATIONS

1 Borehole Location

1 Test Pit Location

The borehole locations are included in Attachment 1.

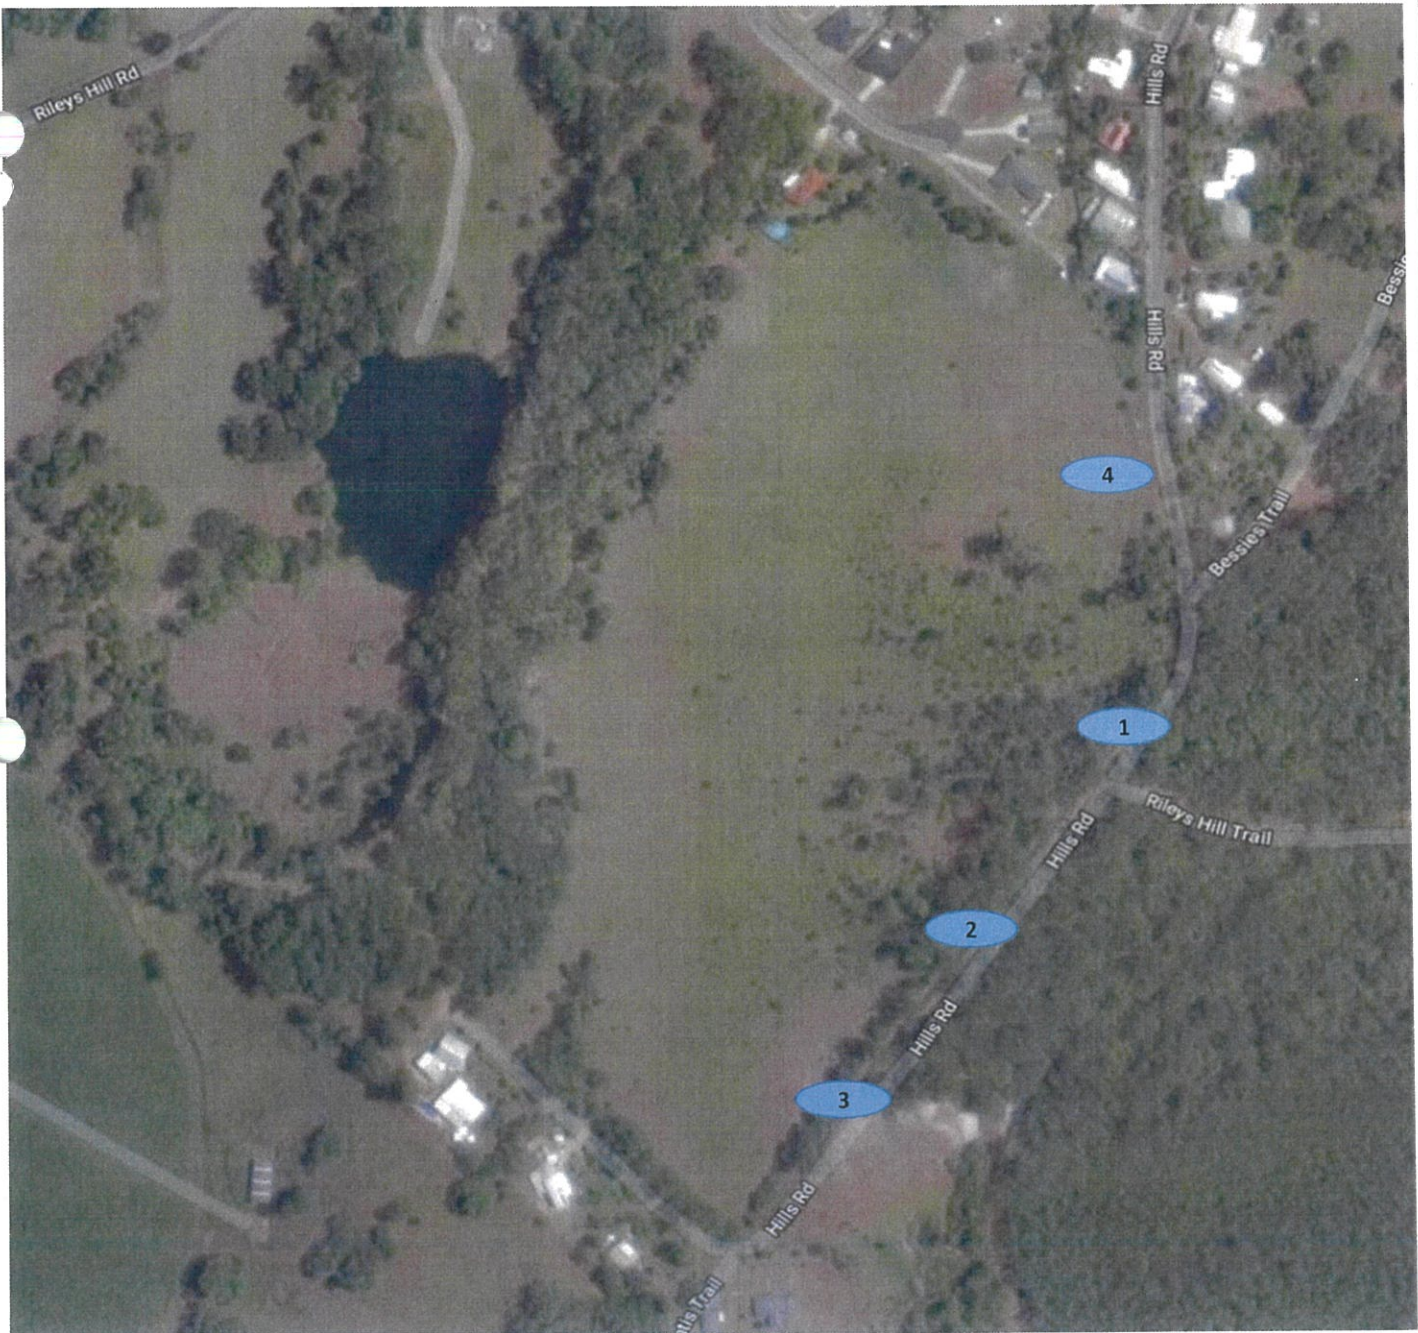
BOREHOLE LOG SHEET - 1

<i>Cone Tip</i>							
0.0		SM	SILTY SAND, NATURAL: black, non plastic, fine to medium grained sand, moist.			Disturbed	
0.1							
0.2							
0.3		SP	SAND, NATURAL: grey and brown, non plastic, fine to medium grained sand, moist.			Disturbed

0.4							
0.5							
0.6							
0.7							
0.8							
0.9			SP	SAND, NATURAL: grey, non plastic, fine to medium grained sand, moist.			Disturbed
1.0							
1.1

Sub-surface conditions within the investigation area were found to be generally uniform. The lower portion is characterised by silty sand underlain by fine to medium grained grey sand. The higher portions of the site to the north-west are characterised by silty sand underlain by silty clay and silty sand to 2m bgl where weathered sandstone was discovered. Engineering logs provided by ASCT are included in Attachment 1.
