# Moore Point Precinct Review Study Part 1: Contamination, Acid Sulfate Soils & Remedial Strategy

Newbridge & Bridges Roads, Liverpool, NSW

**Report No:** E22882.E09\_Rev1

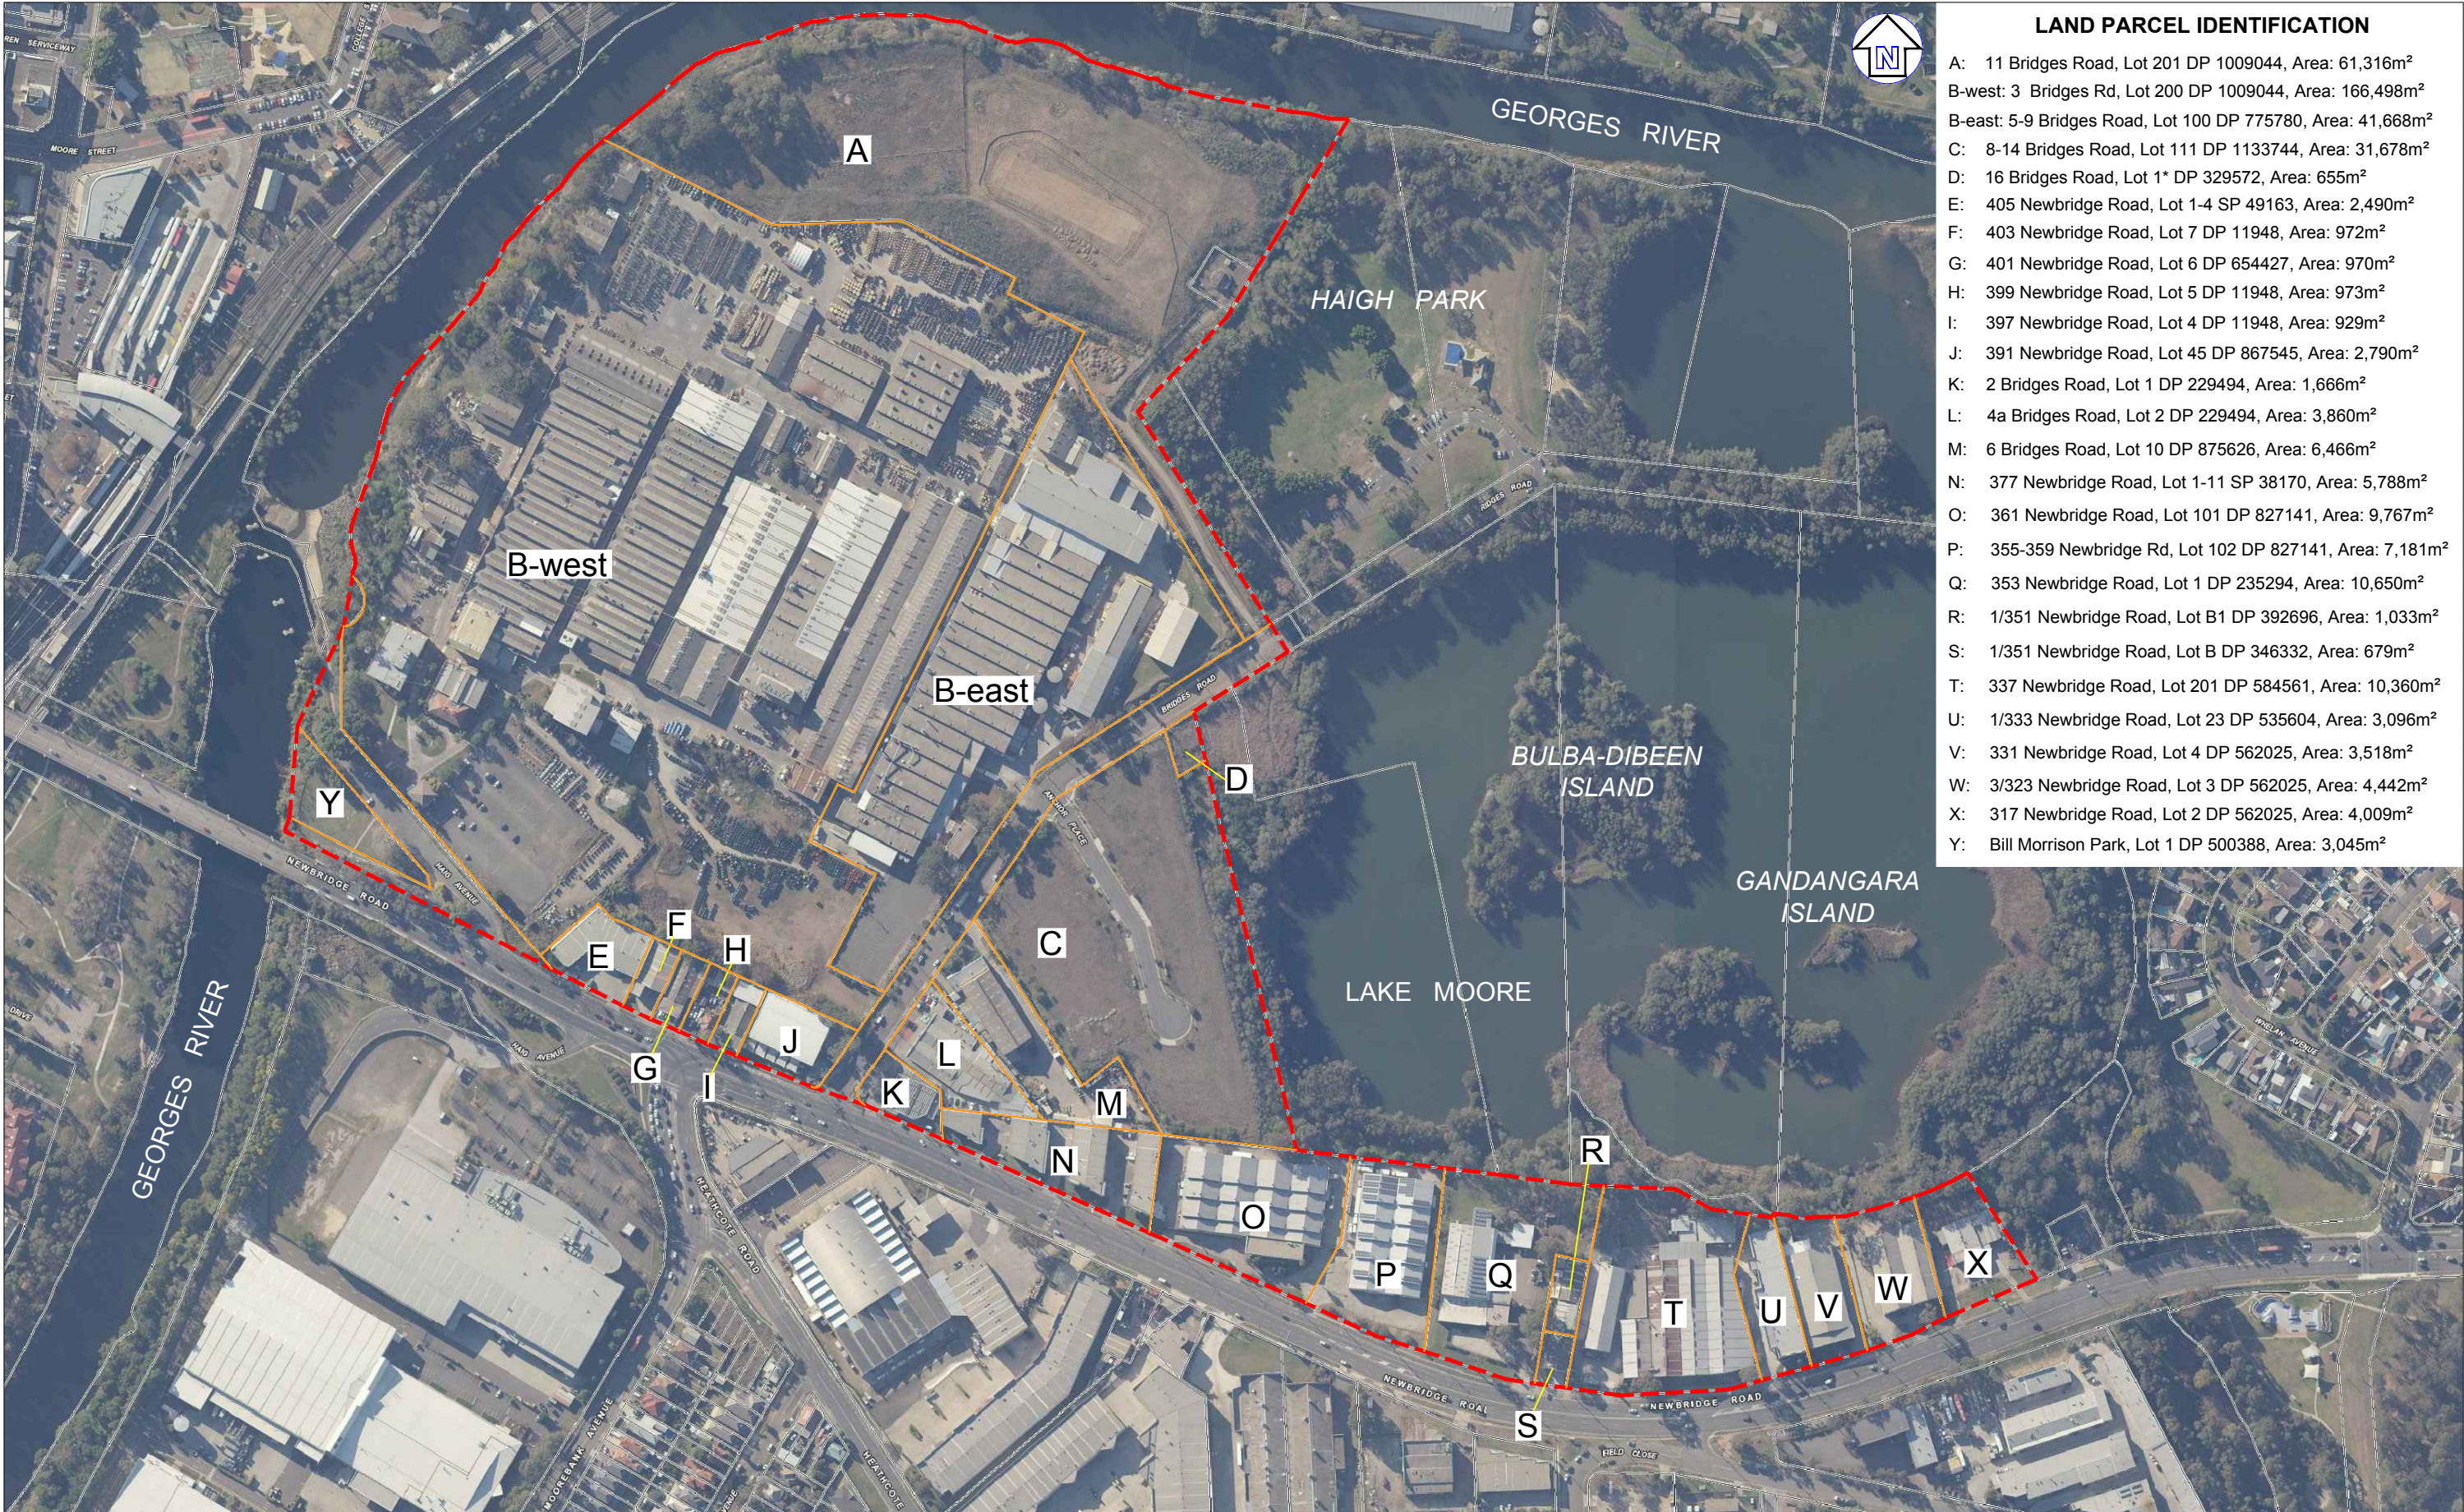
LAND PARCEL IDENTIFICATION

- A: 11 Bridges Road, Lot 201 DP 1009044, Area: 61,316m<sup>2</sup>  
B-west: 3 Bridges Rd, Lot 200 DP 1009044, Area: 166,498m<sup>2</sup>  
B-east: 5-9 Bridges Road, Lot 100 DP 775780, Area: 41,668m<sup>2</sup>  
C: 8-14 Bridges Road, Lot 111 DP 1133744, Area: 31,678m<sup>2</sup>  
D: 16 Bridges Road, Lot 1\* DP 329572, Area: 655m<sup>2</sup>  
E: 405 Newbridge Road, Lot 1-4 SP 49163, Area: 2,490m<sup>2</sup>  
F: 403 Newbridge Road, Lot 7 DP 11948, Area: 972m<sup>2</sup>  
G: 401 Newbridge Road, Lot 6 DP 654427, Area: 970m<sup>2</sup>  
H: 399 Newbridge Road, Lot 5 DP 11948, Area: 973m<sup>2</sup>  
I: 397 Newbridge Road, Lot 4 DP 11948, Area: 929m<sup>2</sup>  
J: 391 Newbridge Road, Lot 45 DP 867545, Area: 2,790m<sup>2</sup>  
K: 2 Bridges Road, Lot 1 DP 229494, Area: 1,666m<sup>2</sup>  
L: 4a Bridges Road, Lot 2 DP 229494, Area: 3,860m<sup>2</sup>  
M: 6 Bridges Road, Lot 10 DP 875626, Area: 6,466m<sup>2</sup>

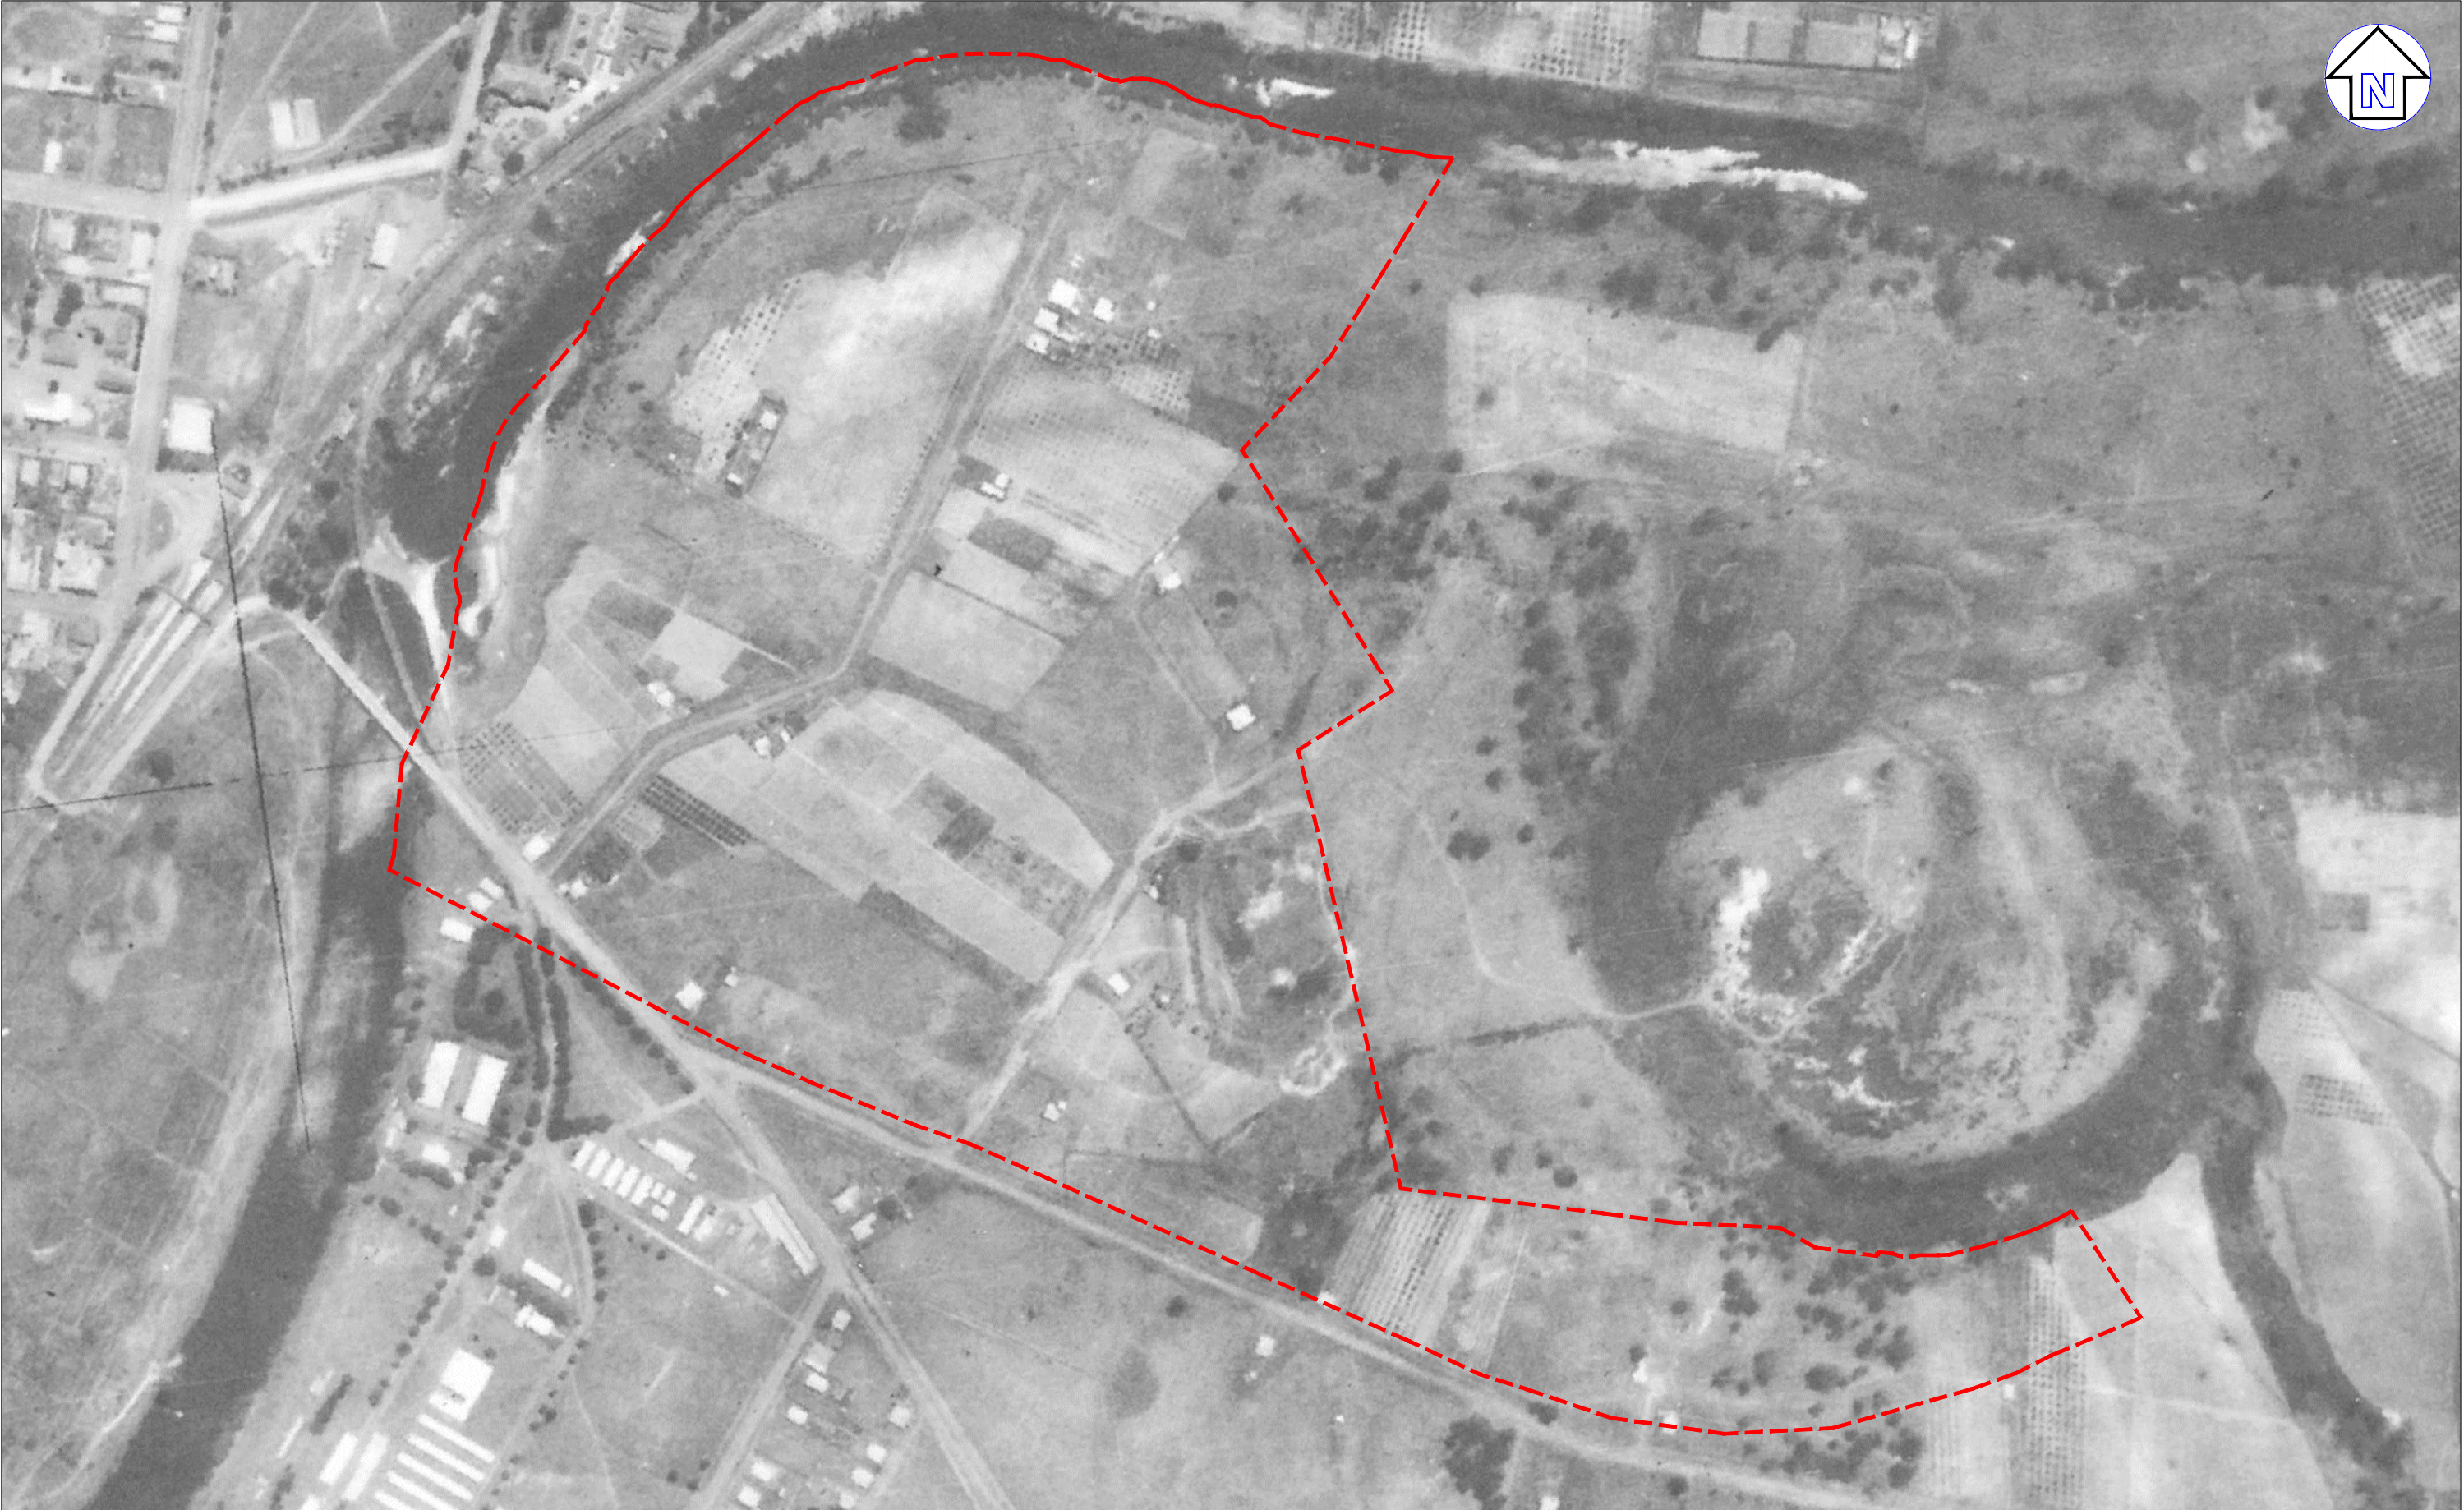
Photo year	Aerial photograph details	Historical land use description	Land use category
1930	Survey: Sydney NSW 3429, Run 24, Photo 797; Photo date: 10-2-1930; Source: Commonwealth of Aust., see <b>Figure C-1</b>	<p><b>Within the precinct:</b></p> <p>Although photo image resolution was low in quality, the whole of the precinct area appeared to be rural land with most parts showing evidence of cultivation, with occasional structures believed to be farm sheds and/or residences. Four residences were located in the southern part of parcel A.</p> <p>Two buildings were present in the southwest corner of the site (land <sup>1</sup> parcel Y) over present day Bill Morrison Park.</p> <p>Cleared, grazing land, with sparse trees was present over all or most of the smaller land parcels D, C, P, Q, R, S, T, U, the northern and western parts of parcel A.</p> <p>Bridges Rd. terminated at Haigh Park. The western end of Newbridge Road joined Heathcote Road, which extended over what is now Haigh Avenue, in the southwest corner of the precinct. A former road was also present running from Heathcote Road to the south through the centre of parcel B-west and terminating at parcel A.</p> <p><b>Surrounding Properties:</b></p> <p>An oxbow lake feature was located 150m east of parcels C and D and adjacent to the northern boundary of parcels T to X, over the eastern part of current day Lake Moore, which was fed by ANZAC Creek located 70 to 90m east of parcel X.</p> <p>Other off-Precinct areas south of Georges River were passive or cultivated rural land, with the exception of the land to the south of Heathcote and Newbridge Roads, and close to Georges River, which was partly covered by regular structures, indicating more intensive farming operations (e.g. dairy or poultry farming).</p> <p>A railway corridor was apparent to the west and north of Georges River, with the early Liverpool train station on eastern edge of Liverpool Town visible to the west of the rail line.</p>	<p>Rural: passive, cultivated and sparse residential</p> <p>Rural and town development</p>

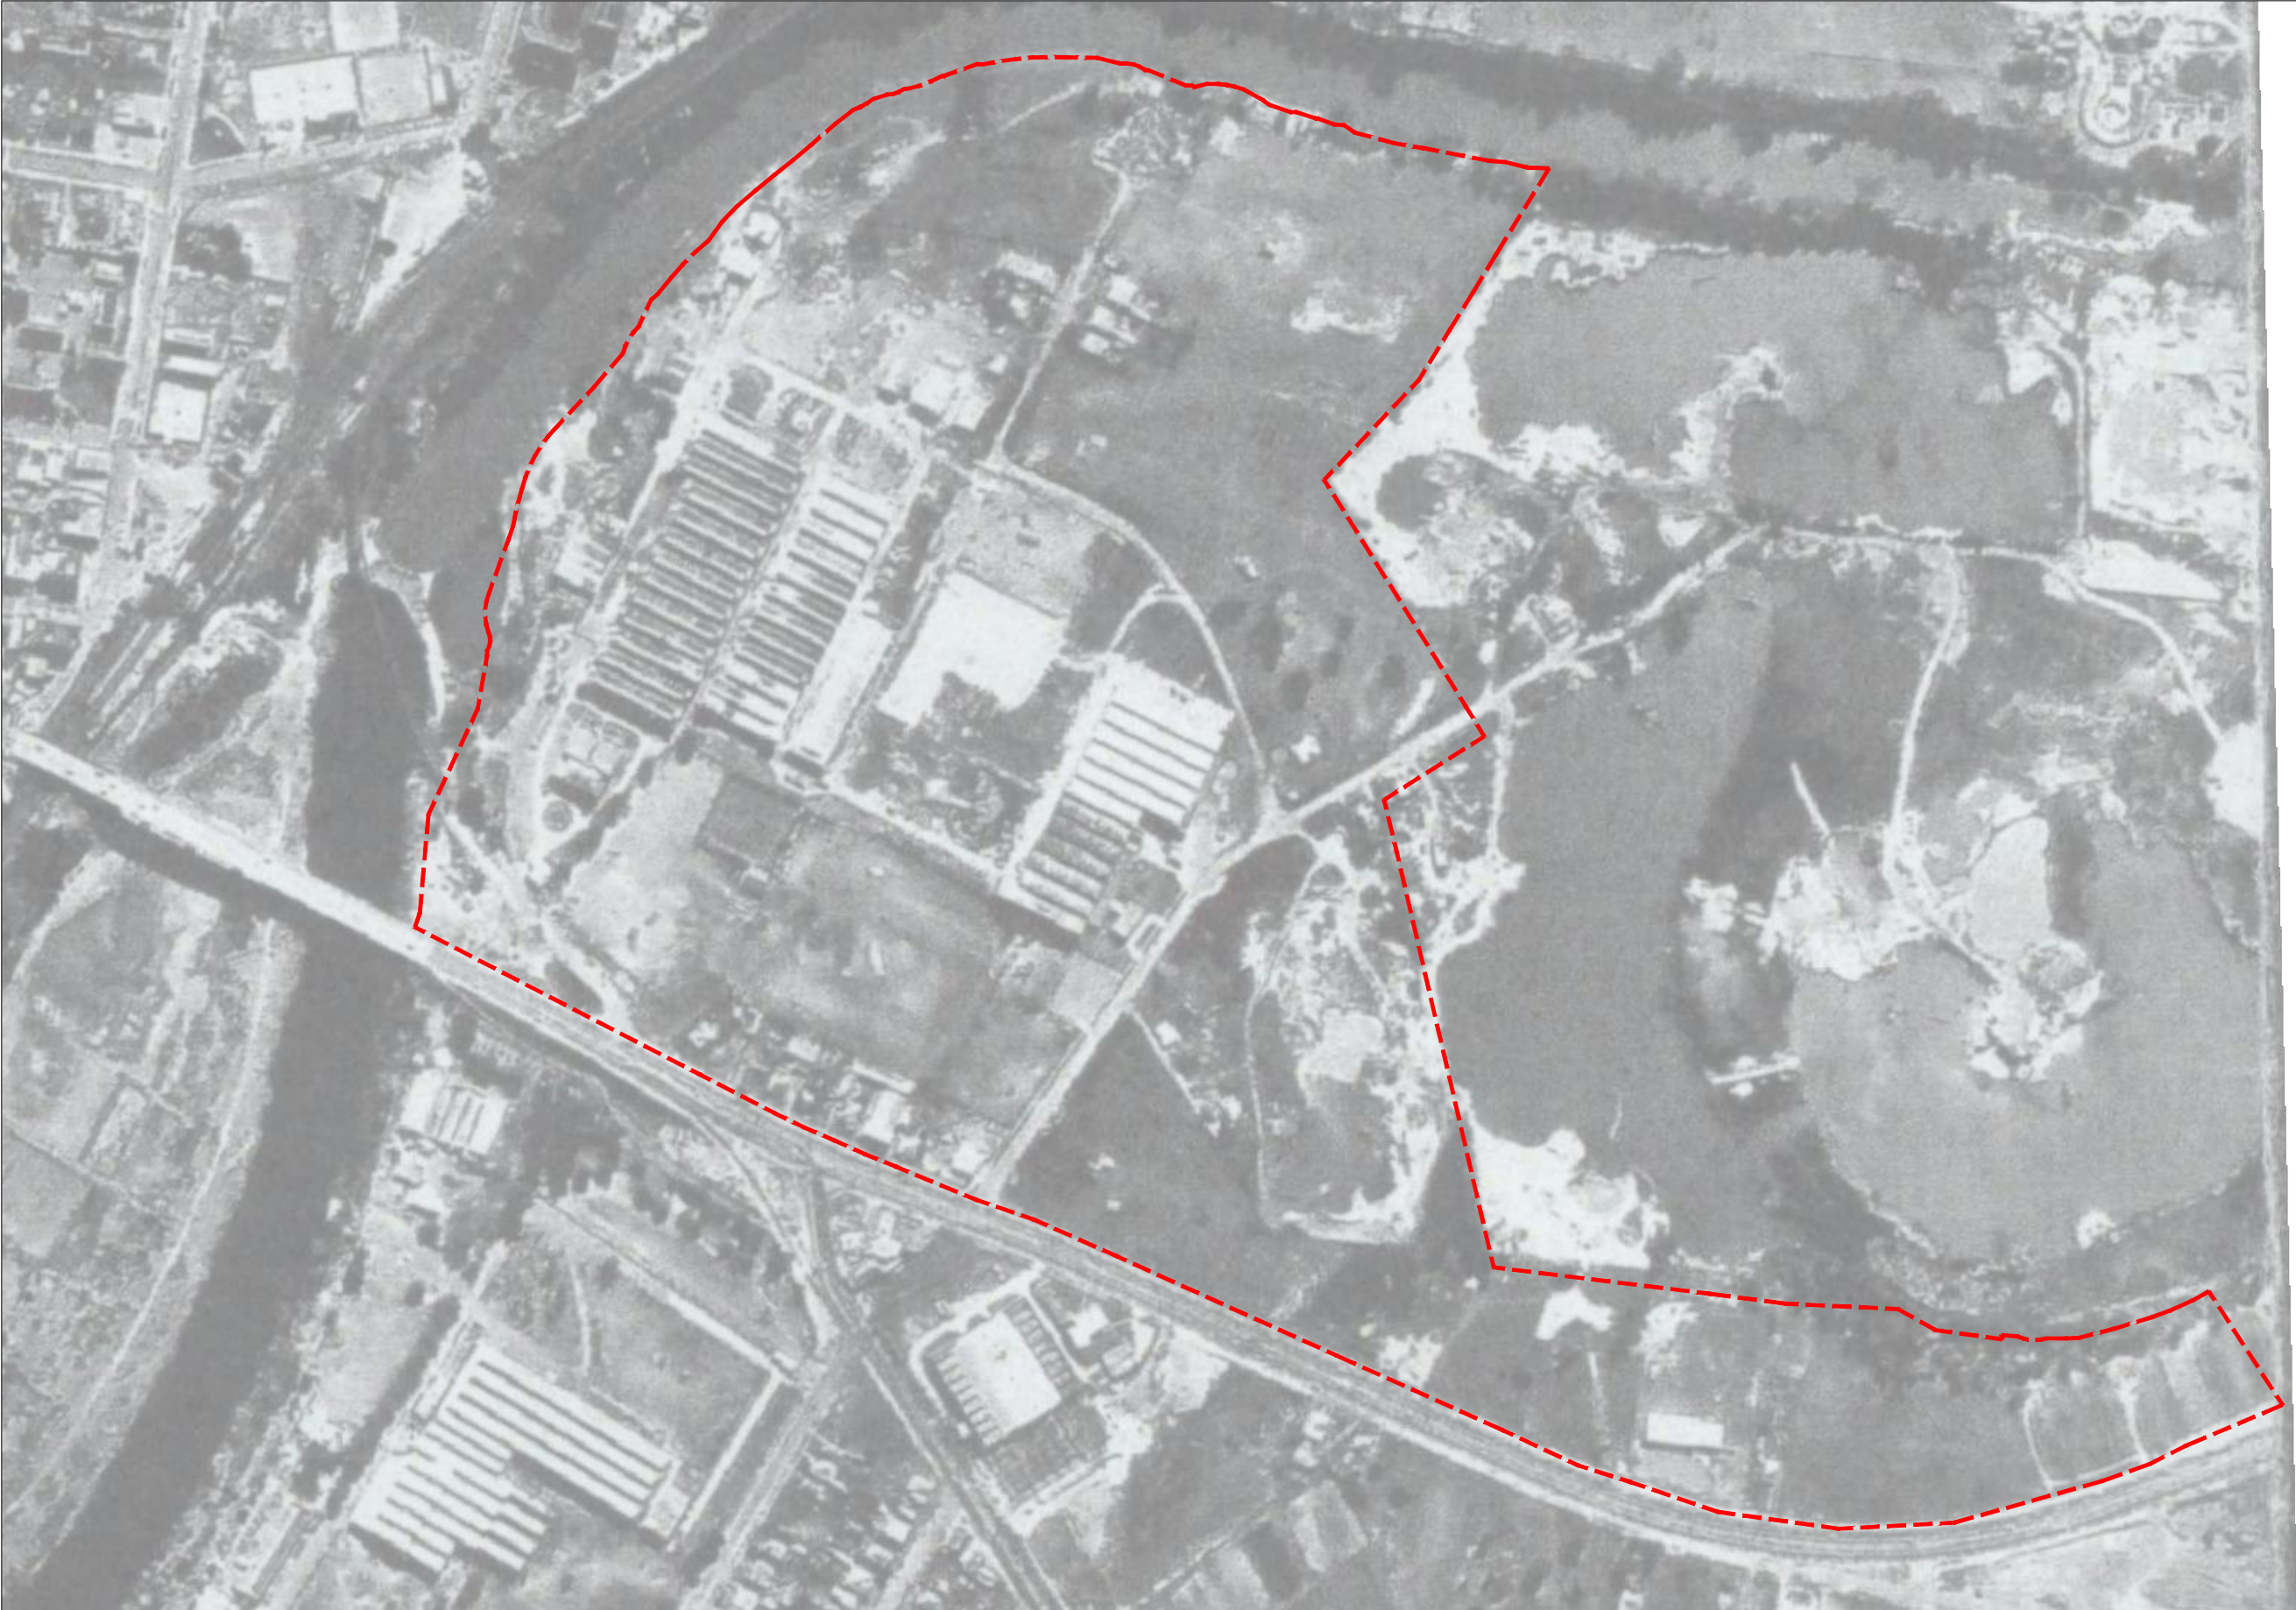
Figure:  
**C-3**  
Project: E22882.E09

Photo Source: NSW Lands Department, Cumberland, NSW Survey 5228, Run 23, Photo 1404, 29-8-65

**LAC JV Pty Ltd**  
Moore Point Precinct Review Study  
Part 1: Contamination, Acid-Sulfate Soils and Remedial Strategy  
Newbridge & Bridges Roads, Liverpool NSW  
Aerial Photograph - 1965

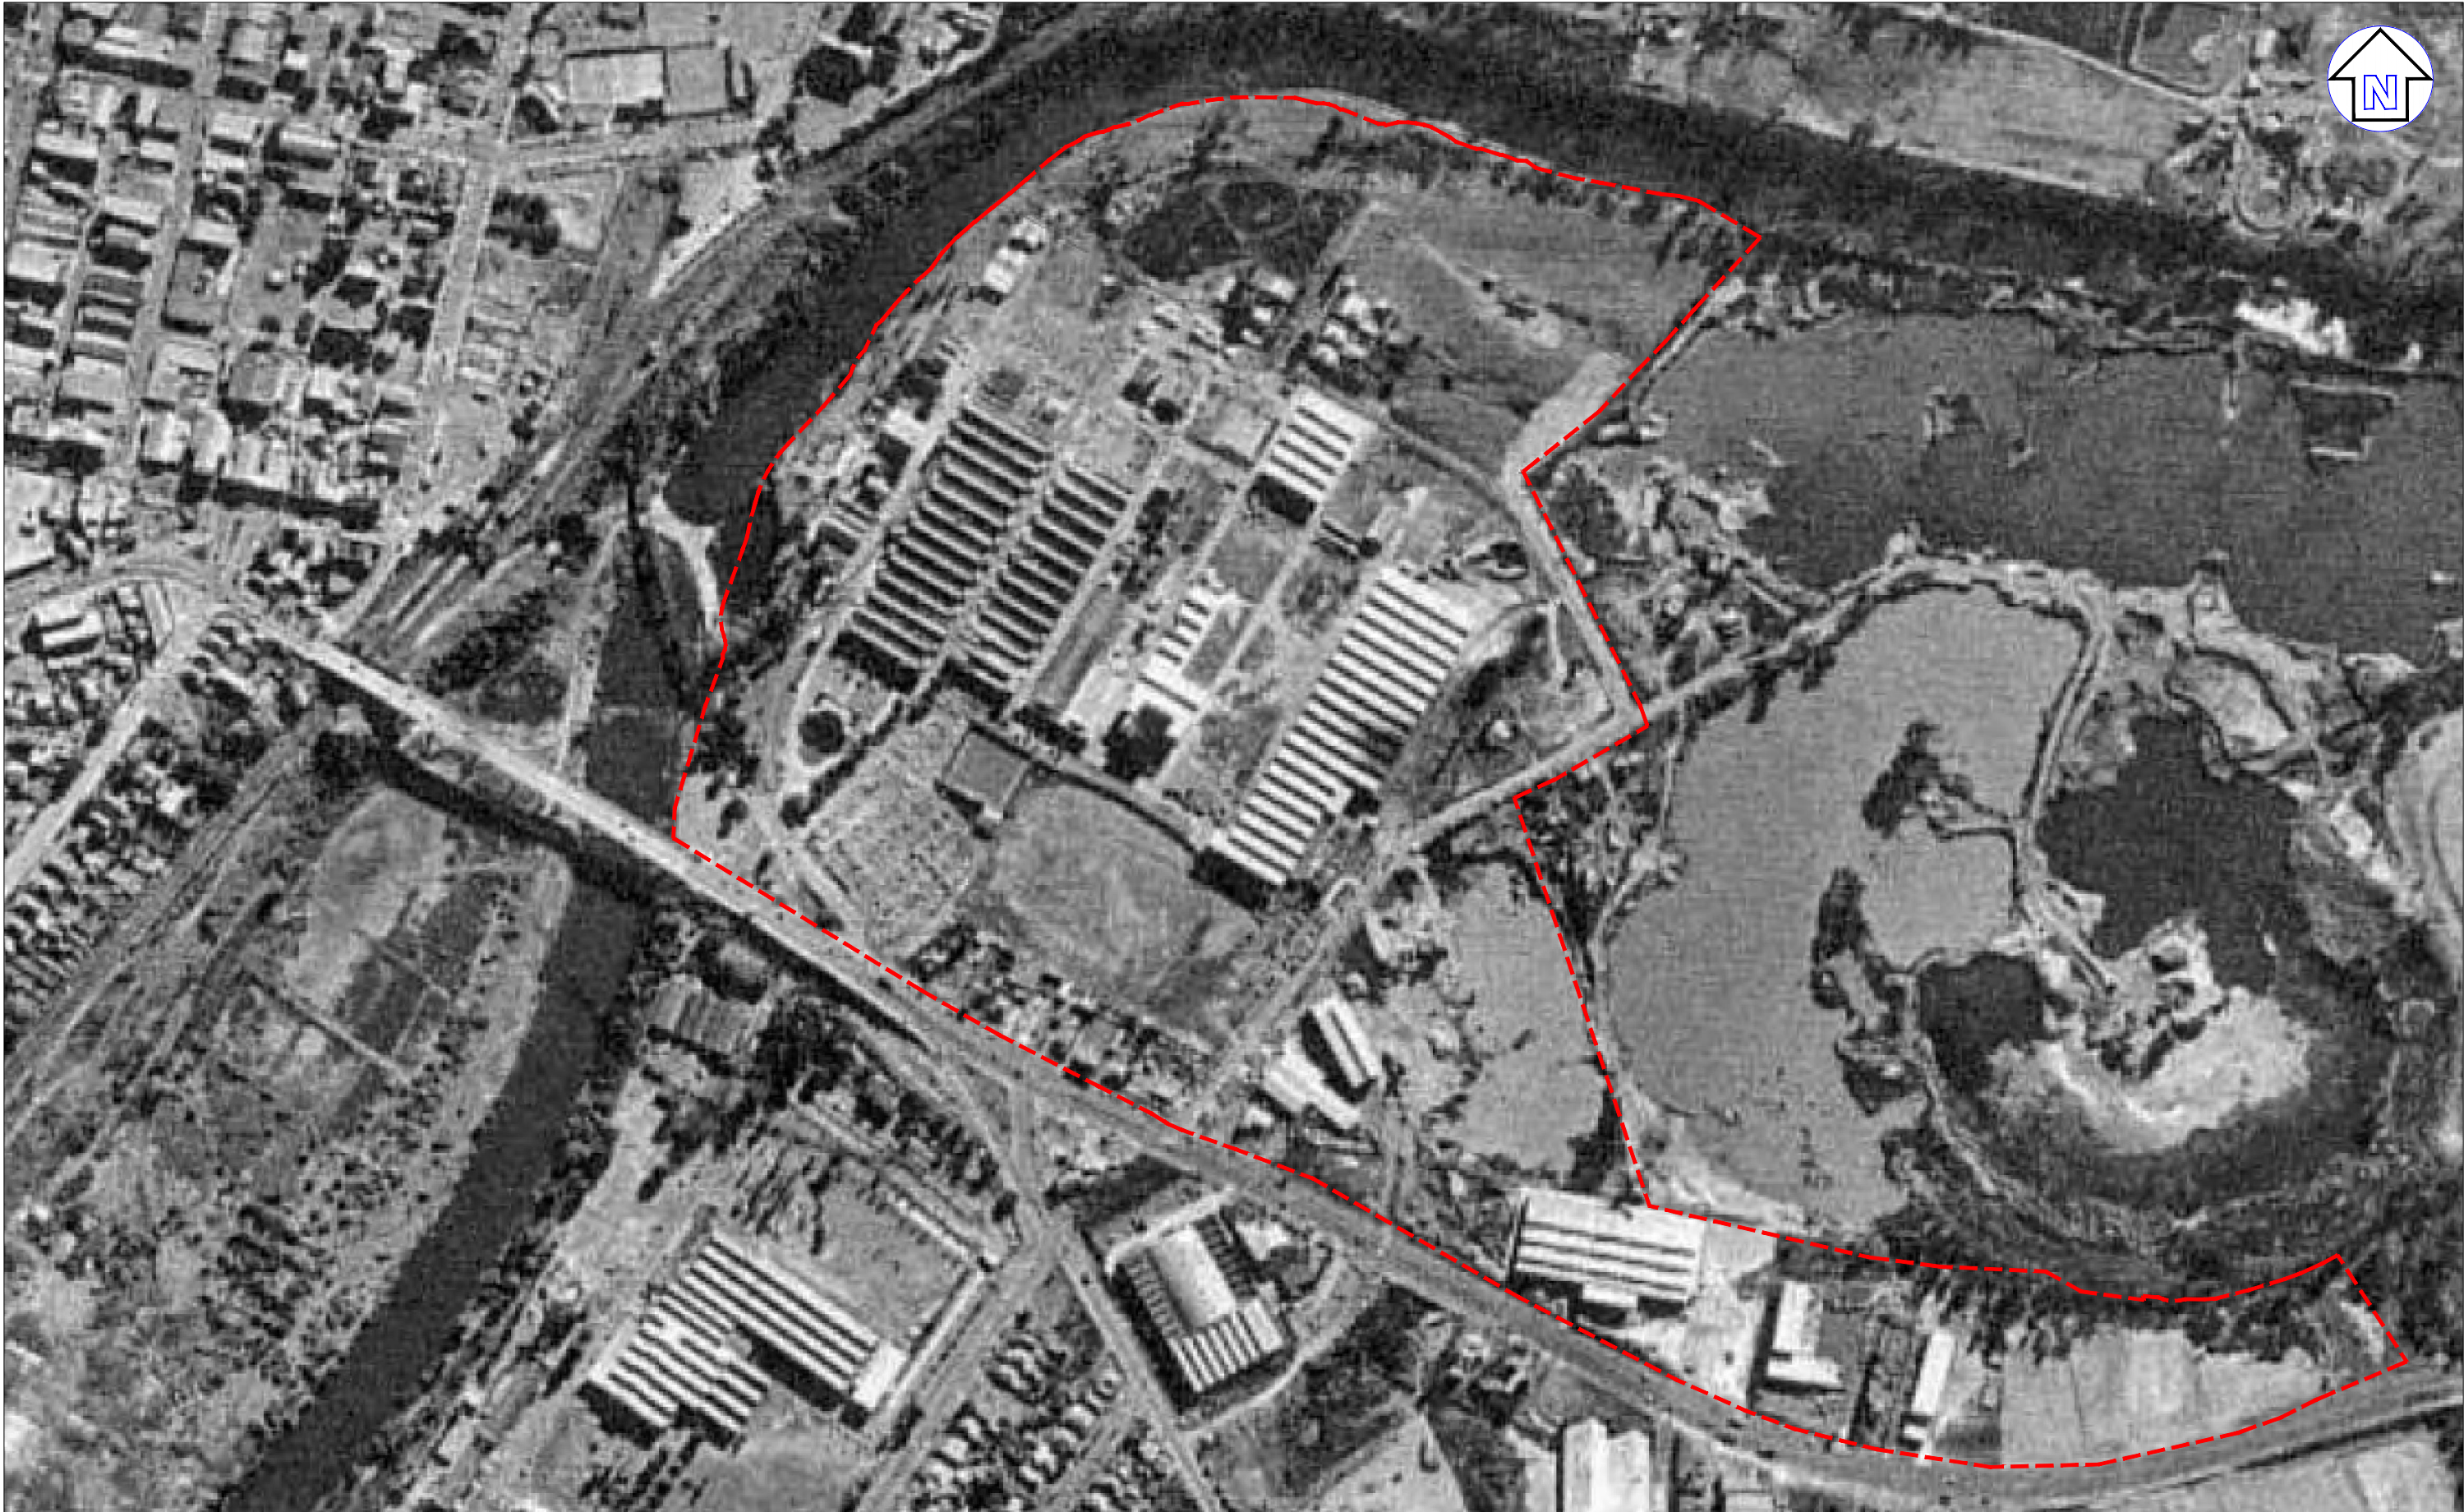
Figure:  
**C-4**  
Project: E22882.E09

Photo Source: NSW Lands Department, Cumberland, NSW Survey 5195, Photo 1908, 07-07-1970

**LAC JV Pty Ltd**  
Moore Point Precinct Review Study  
Part 1: Contamination, Acid-Sulfate Soils and Remedial Strategy  
Newbridge & Bridges Roads, Liverpool NSW  
Aerial Photograph - 1970

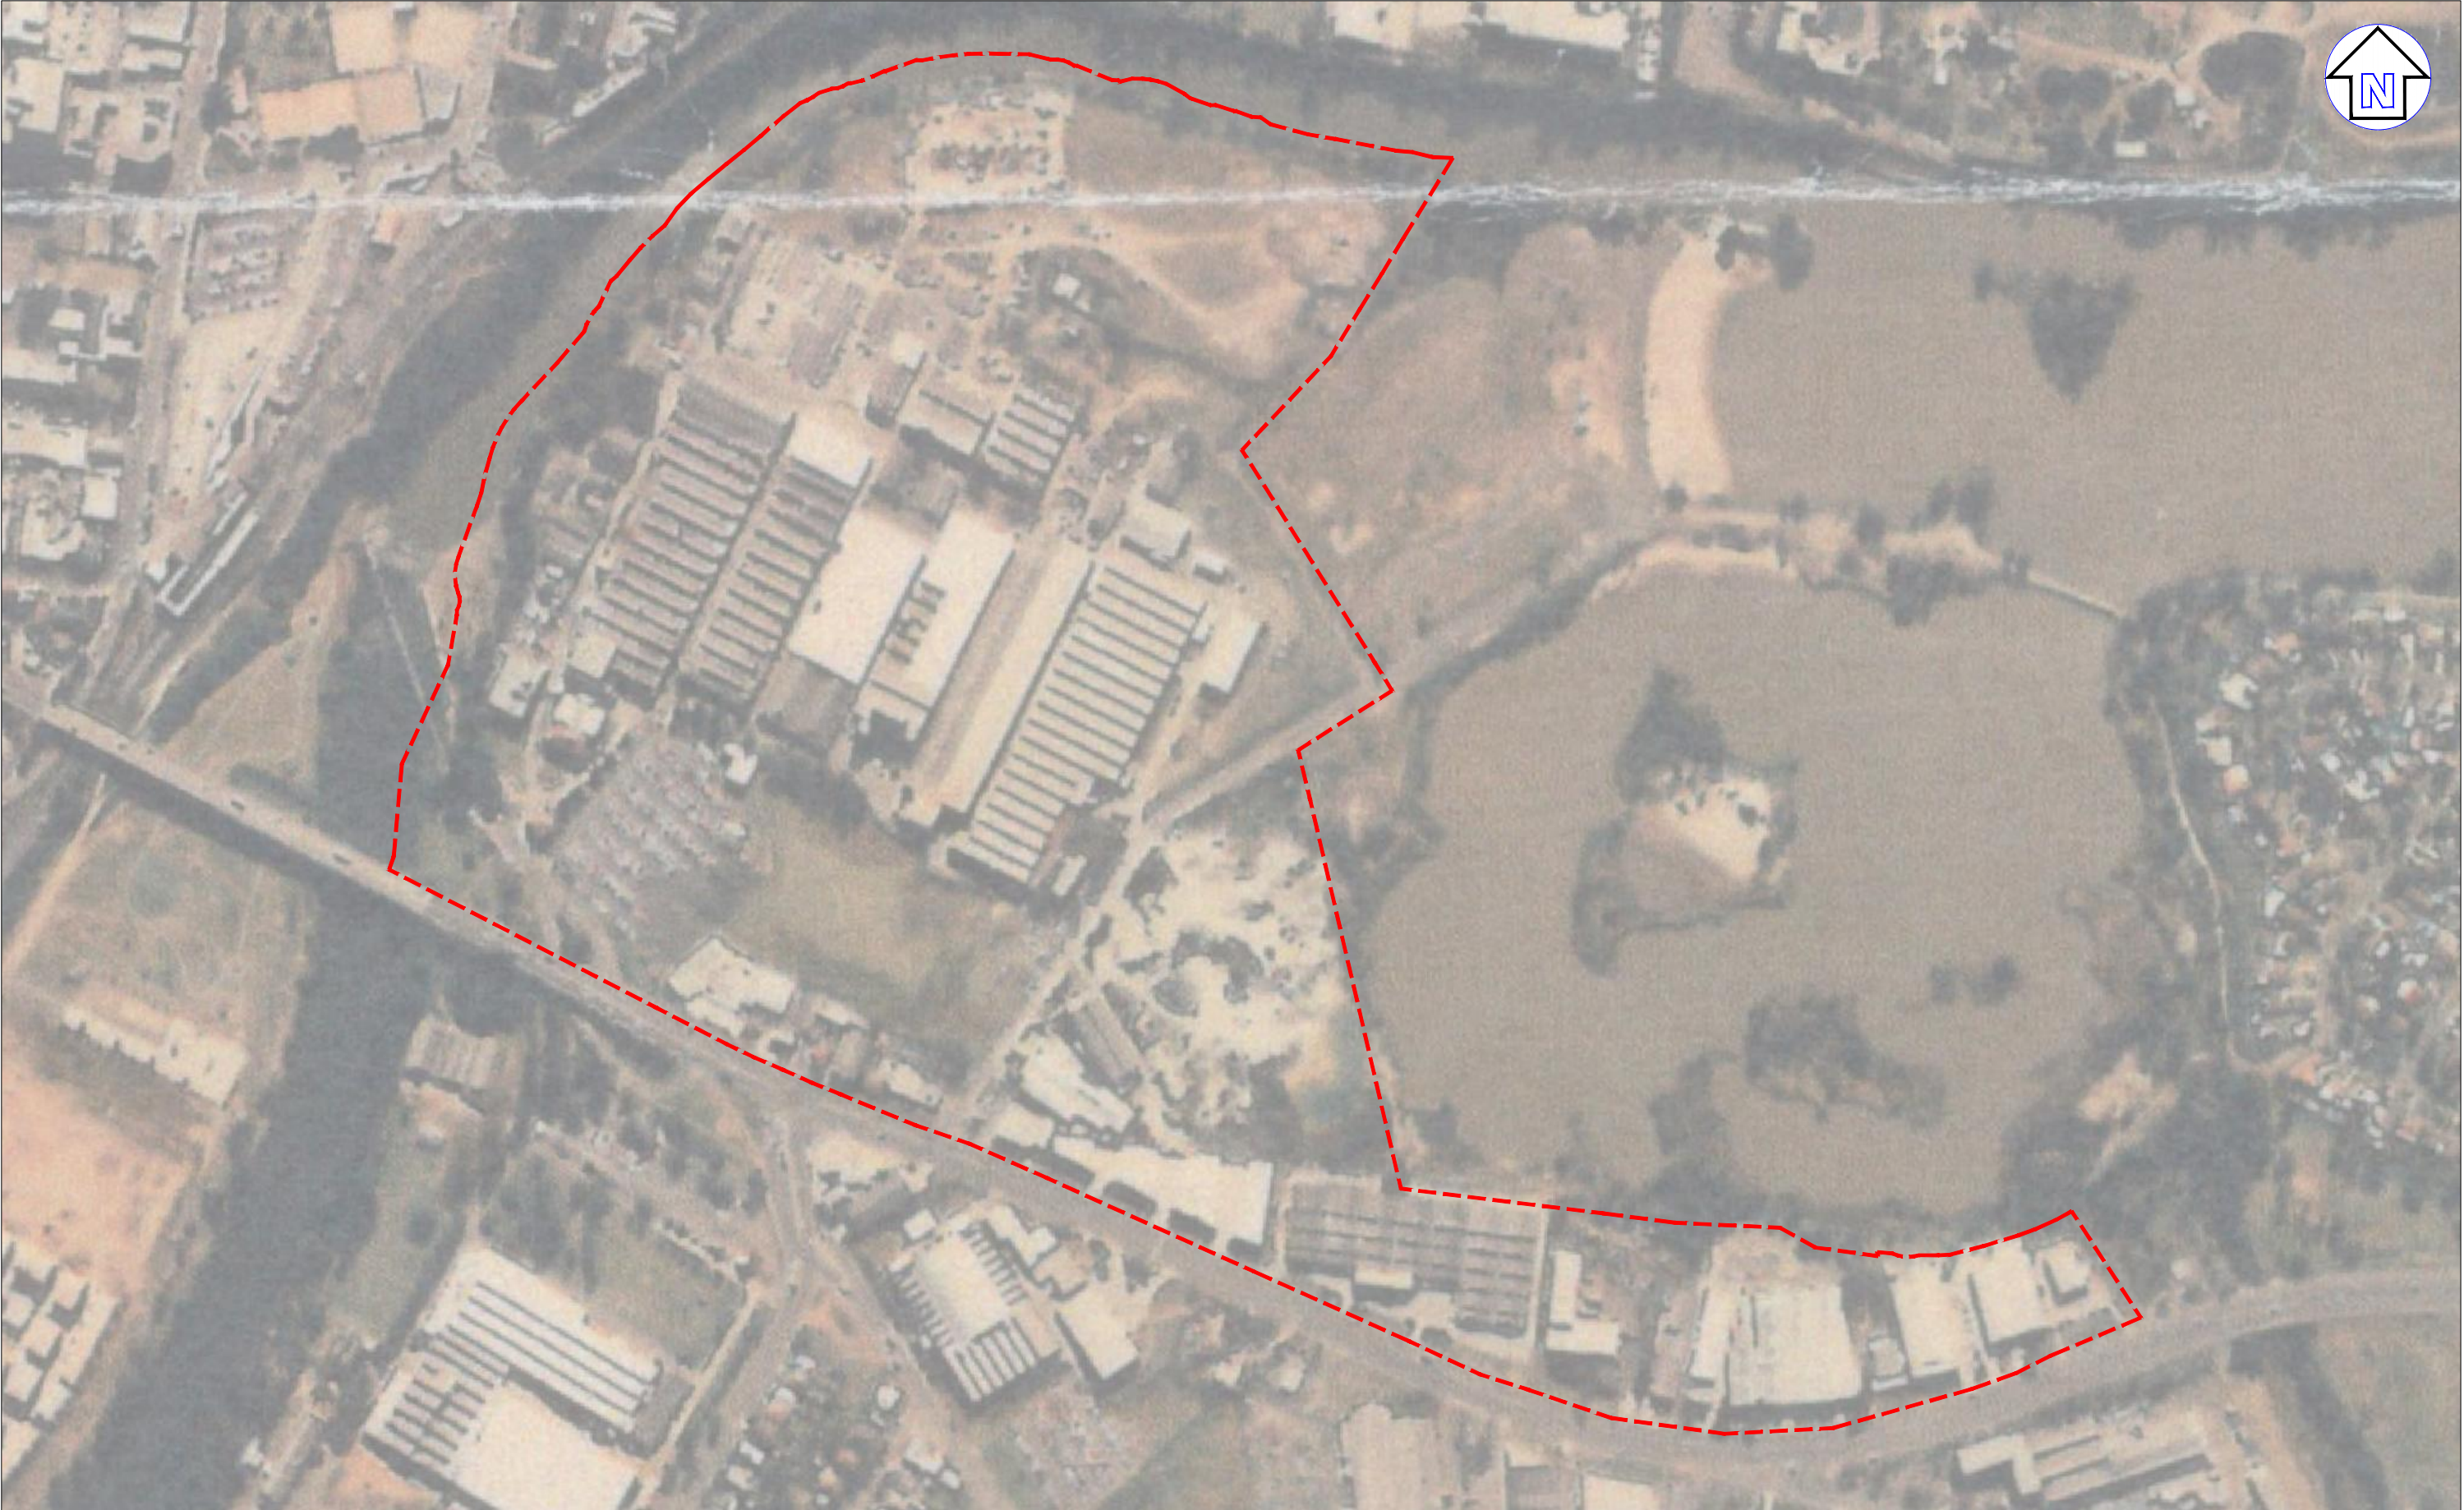
1991	<p>Survey: Sydney NSW 4028, Run 12, Photo 197; Photo date: 13-8-1991; Source: NSW Dept. of Lands, see <b>Figure C-5</b></p>	<p><b>Within the precinct:</b></p> <p>Additional industrial development occurred across the precinct as follows:</p> <ul style="list-style-type: none"> <li>Extensions to the existing factory buildings to the north and south of land parcel B-west and to the north of parcel B-east; and</li> <li>New industrial buildings or extensions to existing buildings had been constructed on land parcels N, P and R to X.</li> </ul> <p>The sand-mined, eastern part of Parcel C was only partially flooded, probably indicating that some filling of this site had commenced to raise its level above that of Lake Moore to the east. An industrial operation was taking place on the western part of parcel C, corresponding with historical information regarding a concrete batching plant in this area.</p> <p><b>Surrounding Properties:</b></p> <p>Sand mining operations east of the precinct appeared to have ceased and the shape of Lake Moore with islands was formed generally as per the present day layout of this surface water feature.</p> <p>New industrial developments were evident on the land south of Newbridge Road, opposite land parcels V to X, and on properties located north of Georges River. All other off-Precinct properties remained mostly unchanged.</p>	Industrial
