# Moore Point Precinct Review Study Part 1: Contamination, Acid Sulfate Soils & Remedial Strategy

Newbridge & Bridges Roads, Liverpool, NSW

**Report No:** E22882.E09\_Rev1

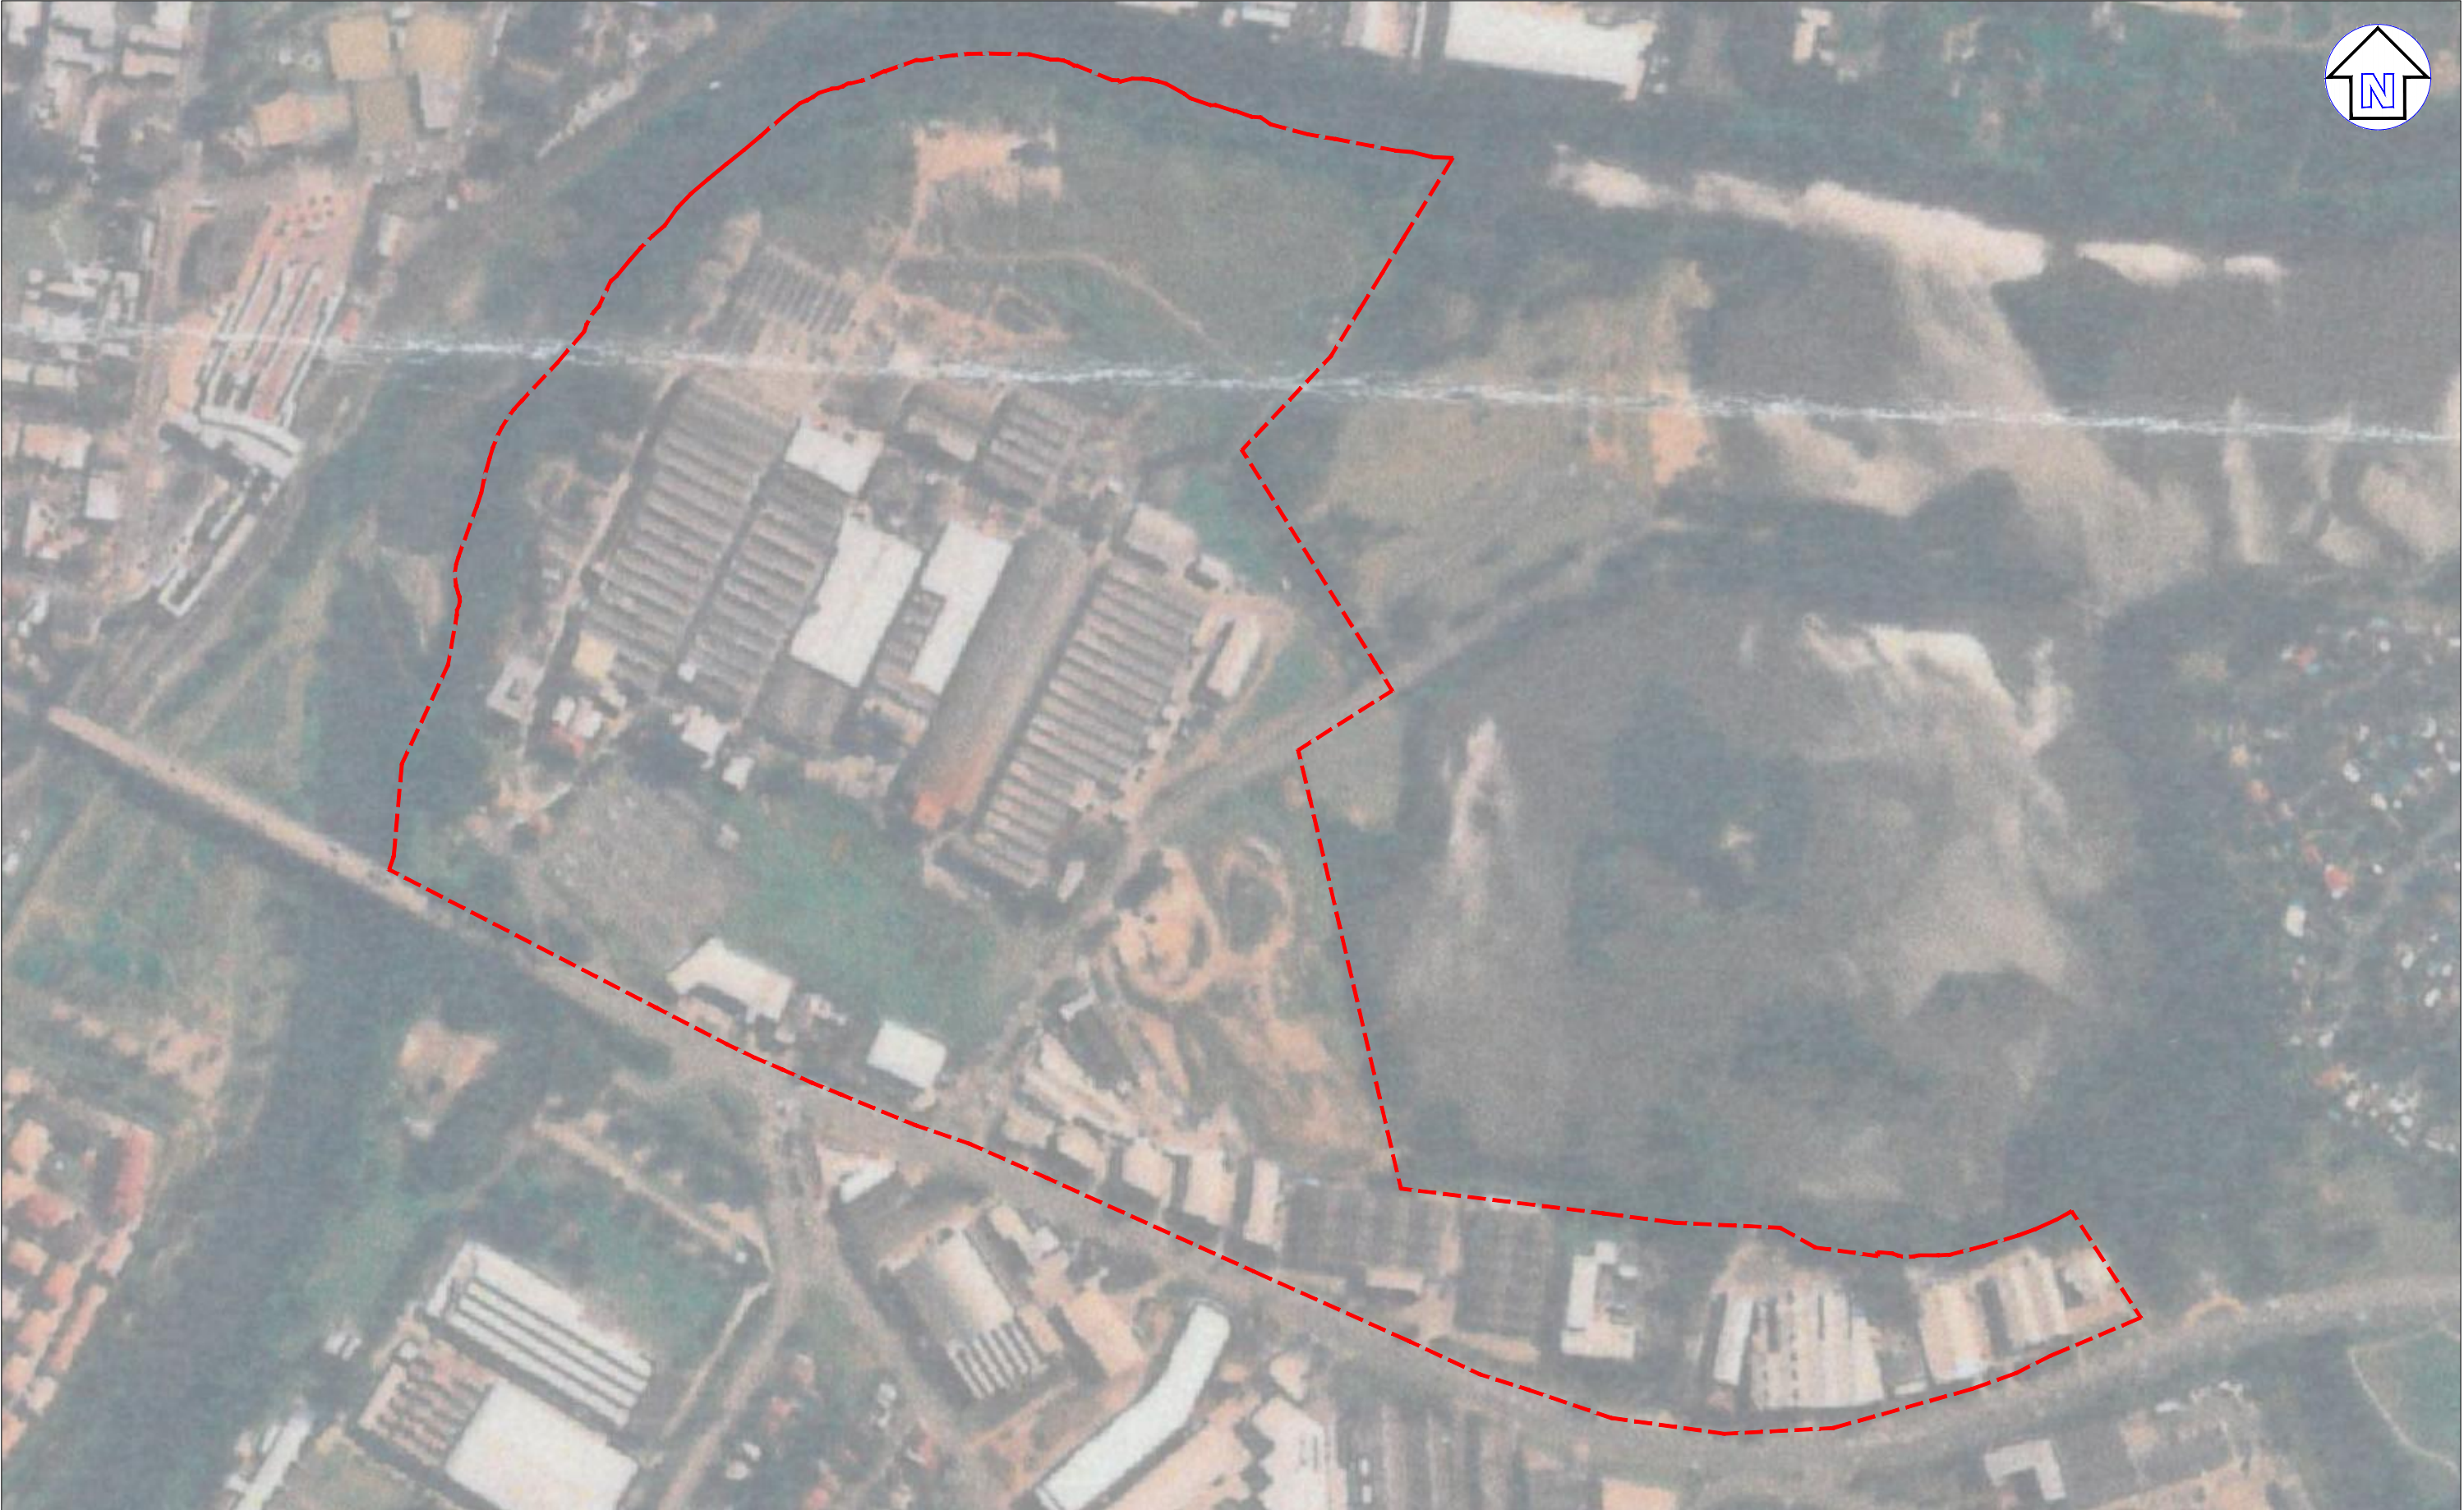
Figure:  
**C-6**  
Project: E22882.E09

Photo Source: NSW Lands Department, PENRITH, NSW Survey 4724 (M2302), Run 12, Photo 53, 16-3-02

**LAC JV Pty Ltd**  
Moore Point Precinct Review Study  
Part 1: Contamination, Acid-Sulfate Soils and Remedial Strategy  
Newbridge & Bridges Roads, Liverpool NSW  
Aerial Photograph - 2002
