# Preliminary Site Contamination Assessment

39 Calderwood Road  
Rylstone NSW

(Our Reference:36965 ER01)

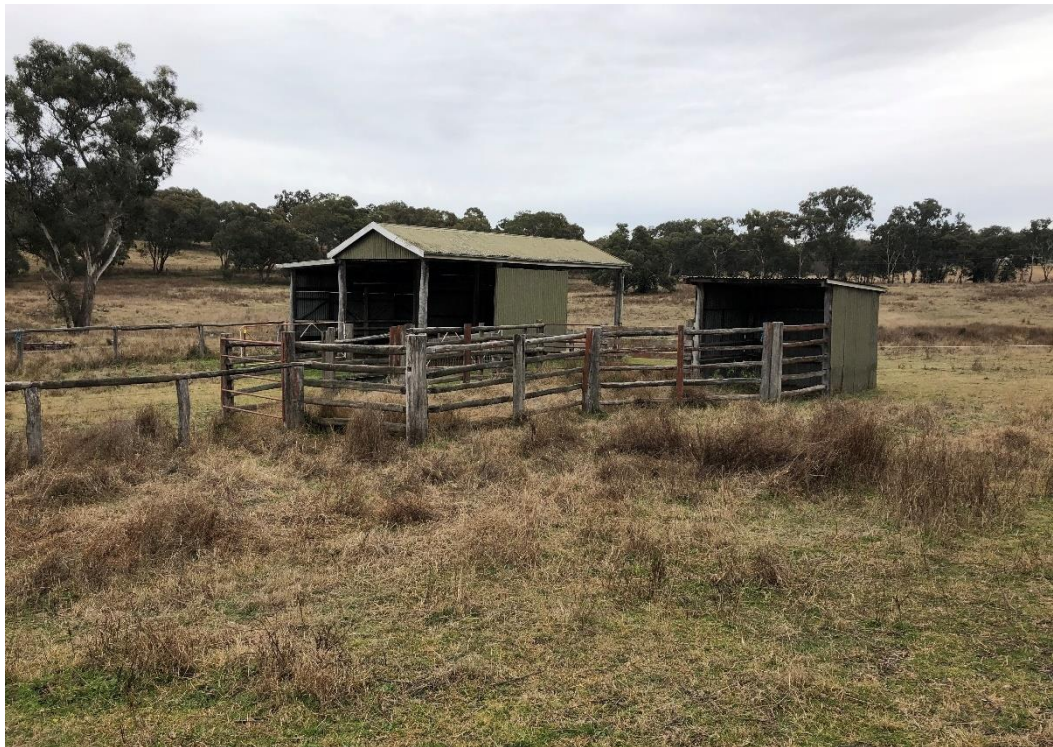
Figure 2.3: Photo A –Existing sheep/cattle yards (Lot94//DP755426) in a north-west direction

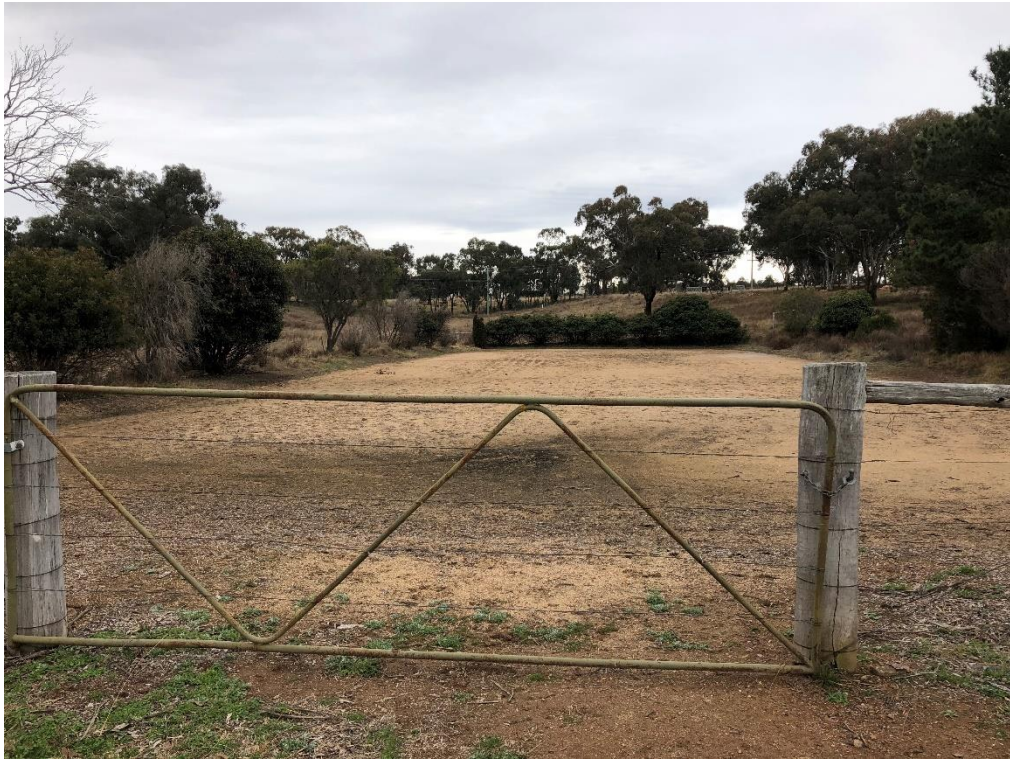
Figure 2.4: Photo B – View of Horse Arena, looking north-east (Lot93//DP755426).

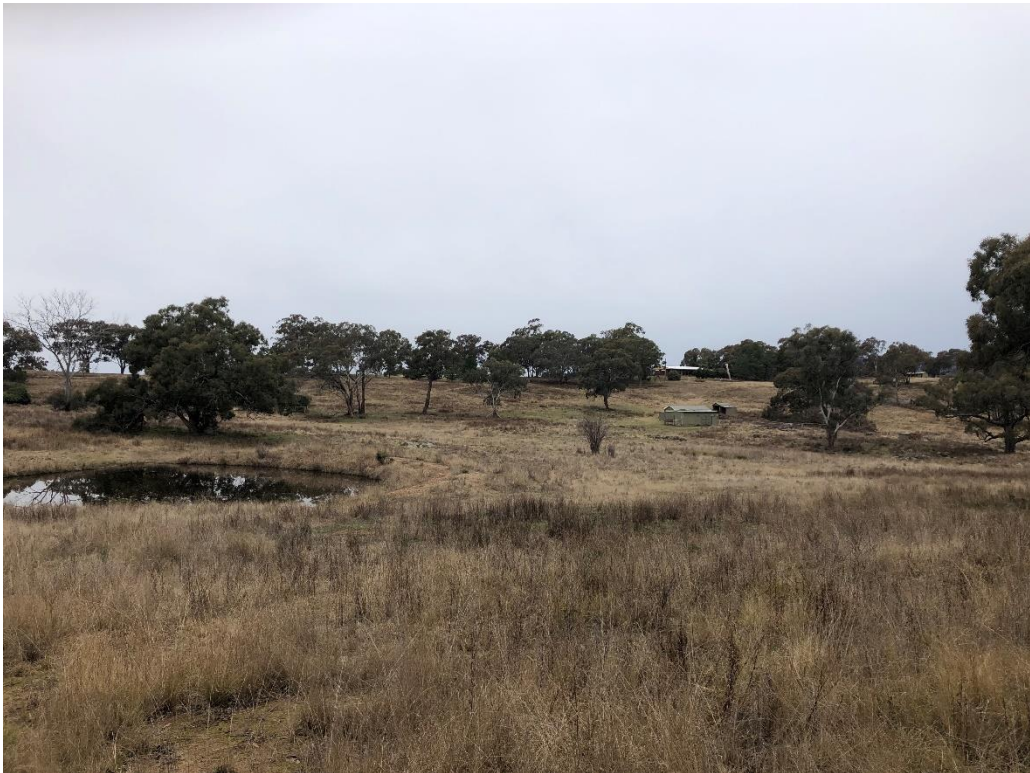
Figure 2.5: Photo C – View across north- western portion of Subject Site looking in south - easterly direction (Lot93&94//DP755426).

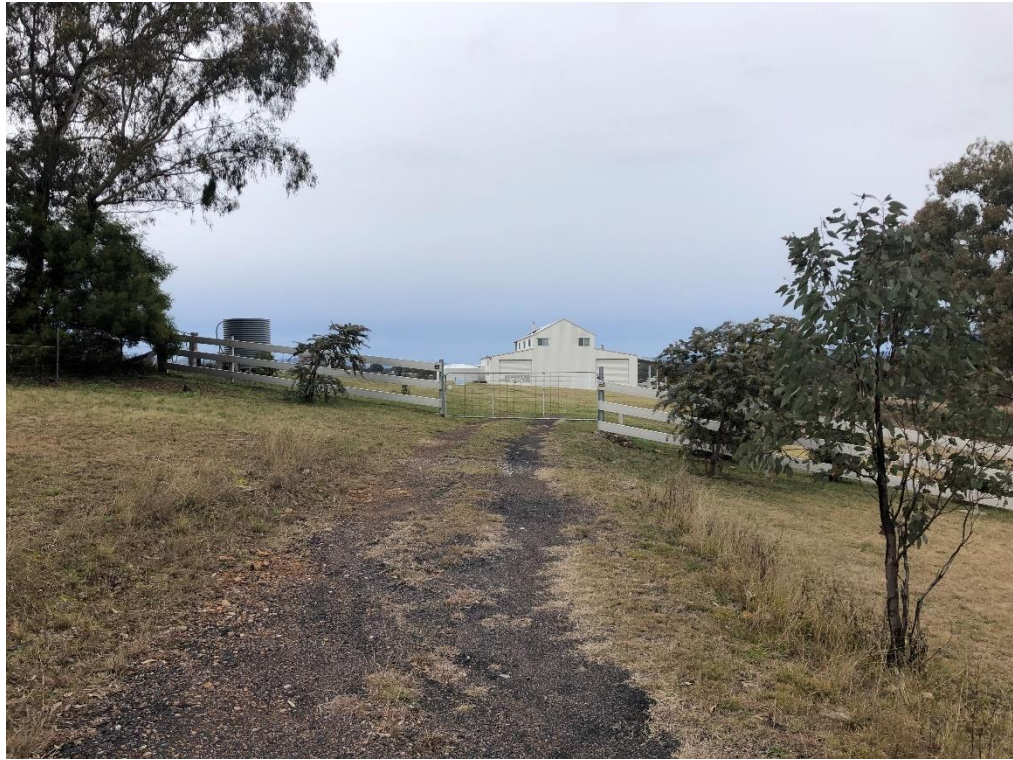
Figure 2.6: Photo D - Driveway and shed house on Lot93//DP755426.

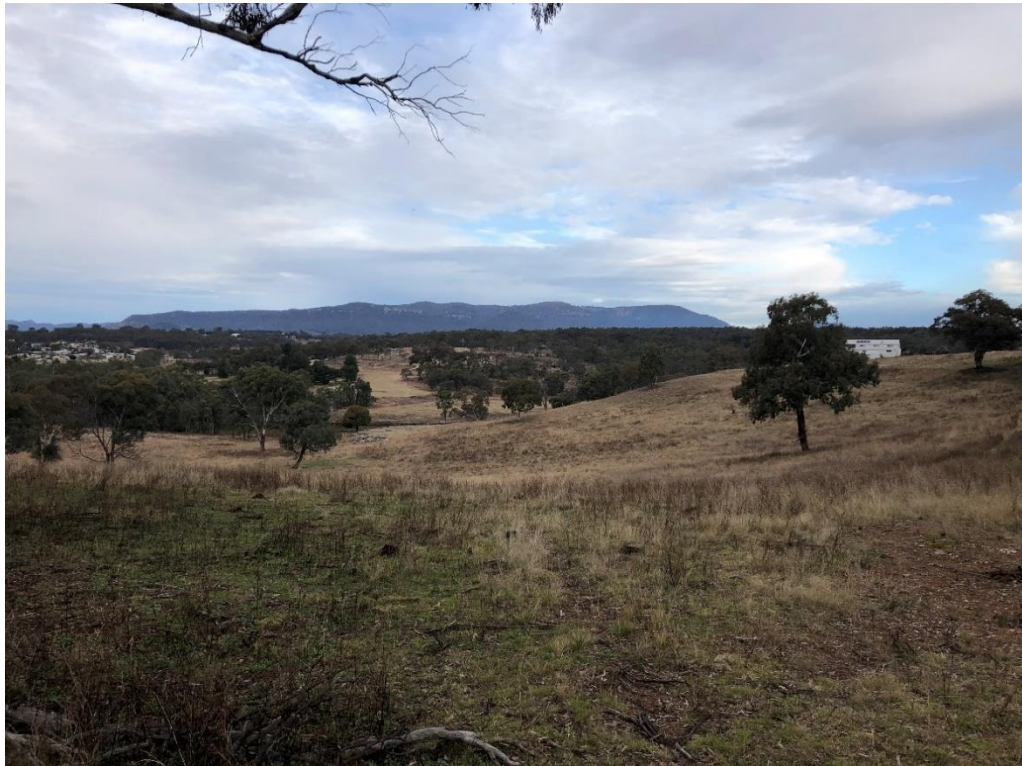
Figure 2.7: Photo E – View looking across the Subject Site in a southerly direction.

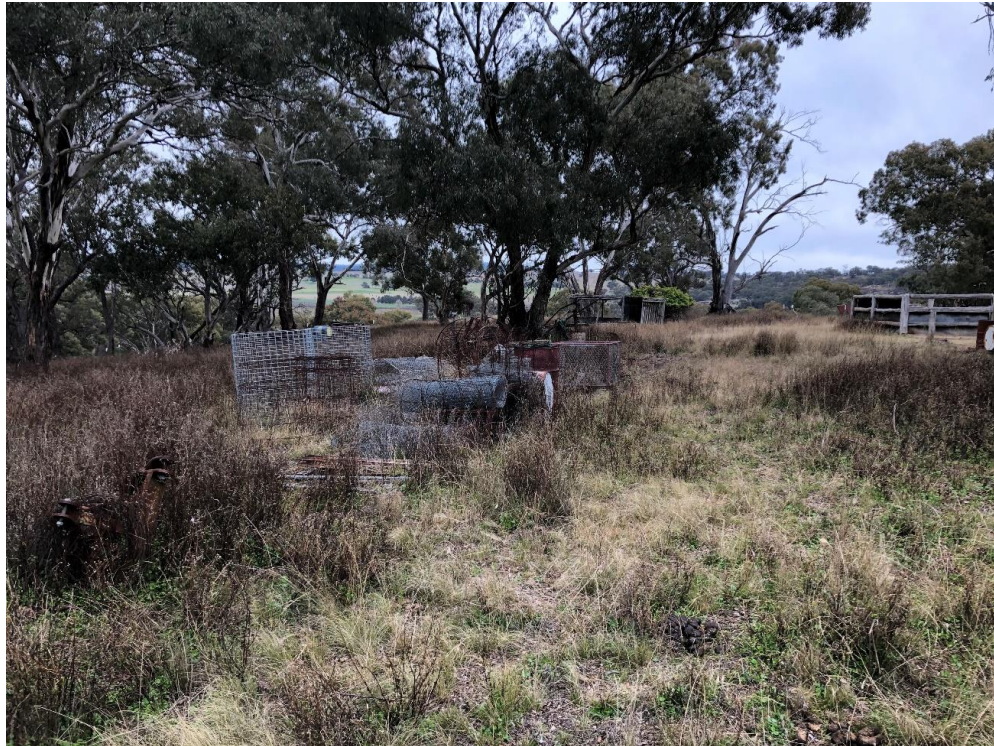
- Lot 94 DP755426, includes an area used for the storage of with old farm equipment and fuel drums (see Figure 6.1), while Lot 93 DP755426 includes a shed used as workshop for vehicles with a ramp structure used for servicing vehicles noted (see Figure 6.2).

Figure 6.1: Old equipment and drums on Lot 94 DP 755426.

- Based on the findings of the desktop review and site investigation it can be stated with a reasonable level of confidence that the Subject Site is suitable for the proposed re-development and land use.
- It is recommended that the equipment storage and maintenance areas at Lots 93 and 94, as well as the livestock management area and associated infrastructure at Lot 97 of DP455426 be removed and appropriately disposed of prior to re-development of these areas.

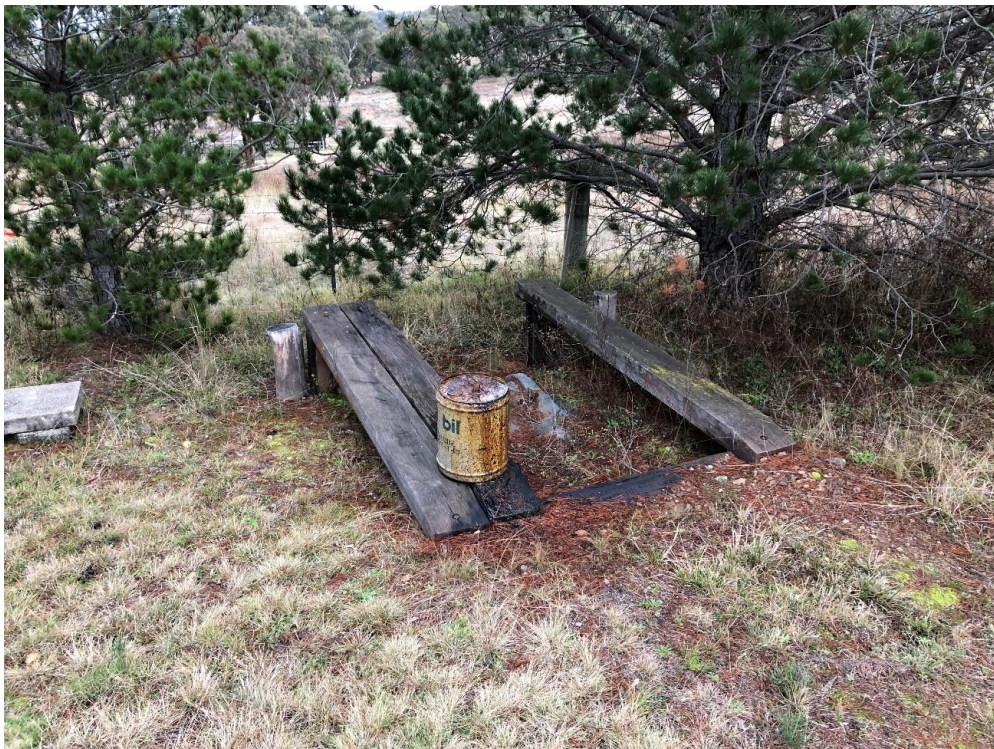
Figure 6.2: Vehicle servicing ramp Lot 93 DP 755426.

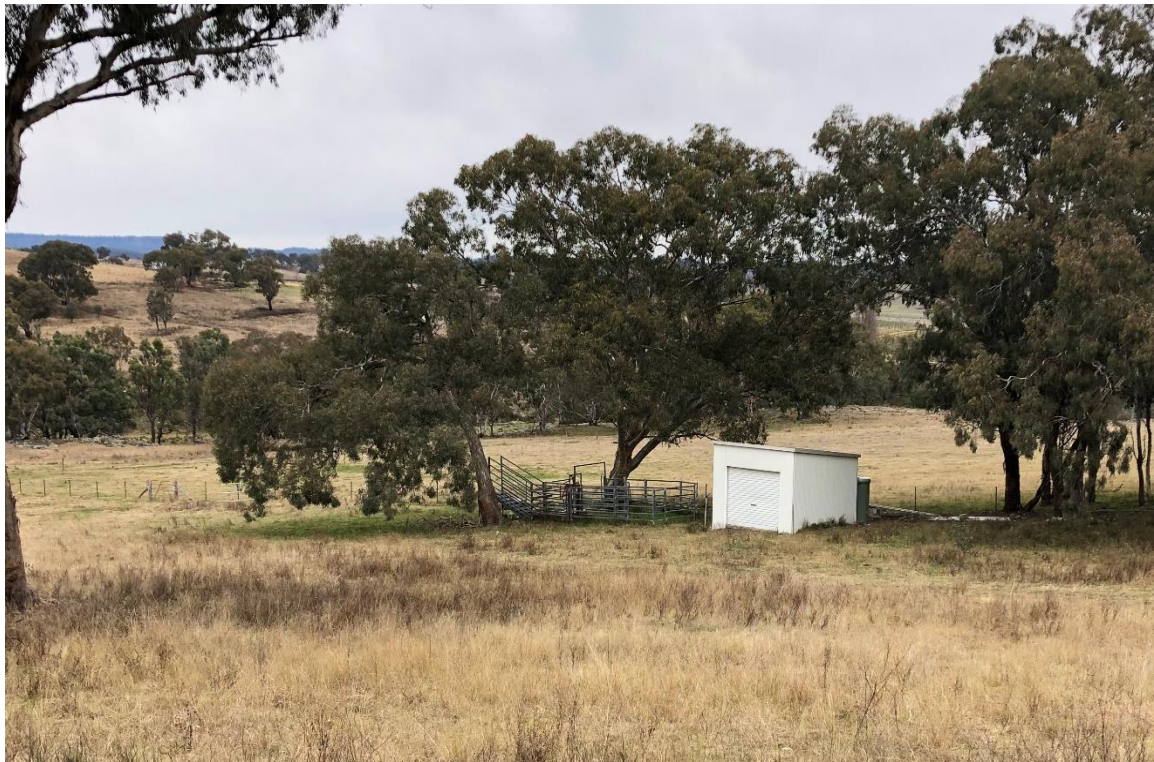
- The Subject Site is divided into different paddocks with steel wire fencing and gates allowing access to the different areas. The parts of the Subject Site was actively grazed during the site inspection.
- There is a livestock yard located on Lot 98 DP 755426 near the boundary with Lot 97 DP 755426 (see Figure 6.3).
- Evidence of waste disposal was discovered in a localised area on Lot 138 DP 755434 under a tree near one of the access roads. The materials found include engine parts such as oil filters and empty cans of engine lubricant. No general waste or any demolition waste was observed in any other part of the Subject Site during the site inspection.

Figure 6.3: Disused livestock pens.x

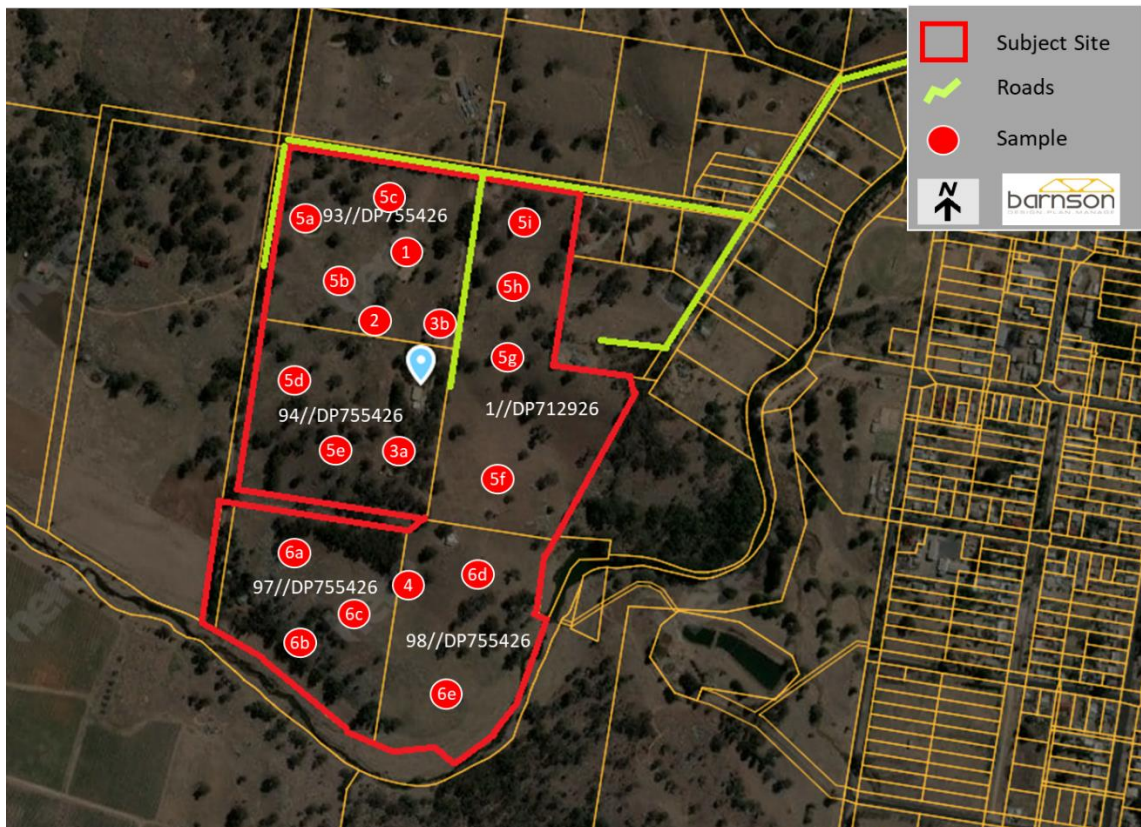
**Figure 6.4: Locations of confirmatory surface soil samples.**

Samples of soil were collected from the paddocks, near structures as well as the livestock management infrastructure. The sheds and areas used for equipment storage in the north-western part of the Subject Site was also specifically investigated with separate surface soil samples collected. Individual samples collected over large areas were combined into composite samples for analysis. Figure 6.4 presents a map of the Subject Site with the locations of the surface soil samples indicated. Table 6.1 is a summary description of the collected samples as well as indicating which samples were combined for analysis.

The pattern followed for the soil sampling can be described as Judgement Sampling, where points are selected on the basis of the investigator's knowledge of the proposed land use and likely distribution of contaminants at a site. It is an efficient sampling method for confirmatory sampling that utilises knowledge of the site history and field observations to direct sample collection (NSW EPA, 1995).

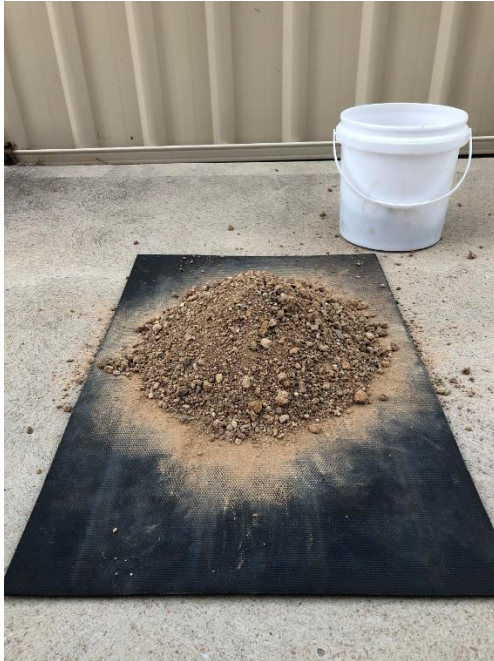
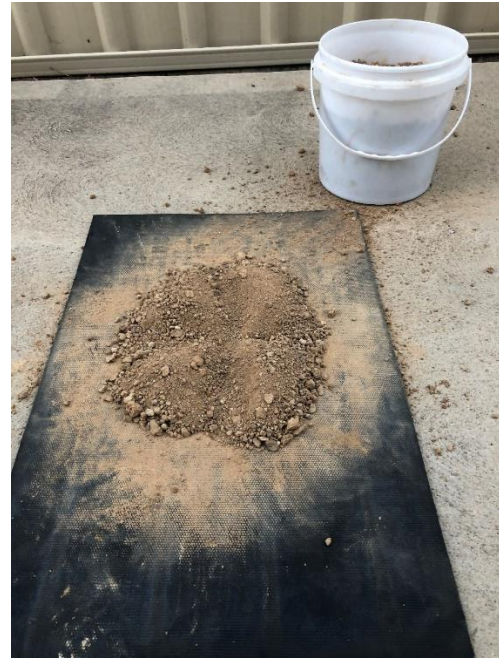
**Figure 6.5:** Cone and quartering.

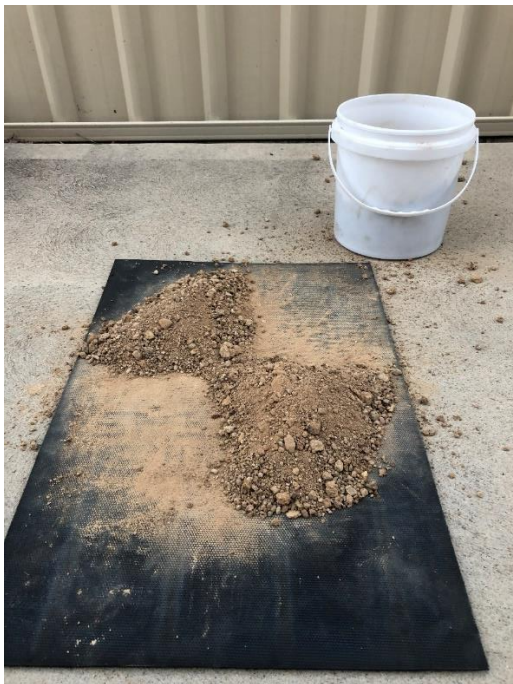
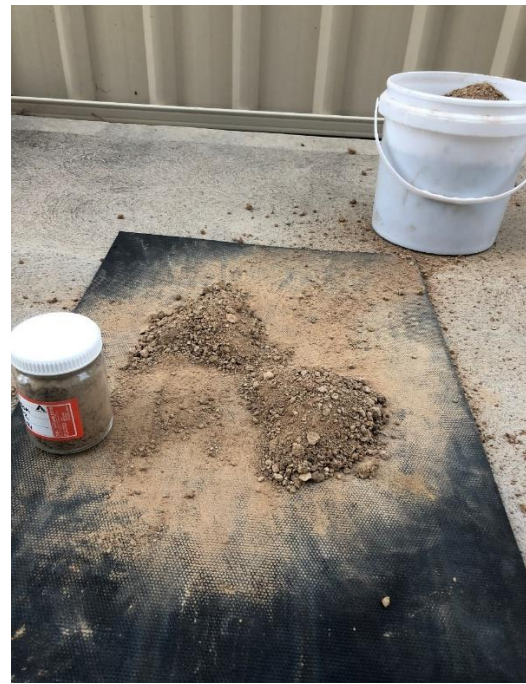
**Figure 6.6:** Sample volume reduction.
