Project 92287.60
29 January 2020
R.002.Rev0
CKM

Salinity Summary Letter Proposed Rezoning Tranche 41, Pondicherry, Oran Park

Report on
Salinity Investigation and Salinity Management Plan

Pondicherry Residential Rezoning
Pondicherry, Oran Park, NSW

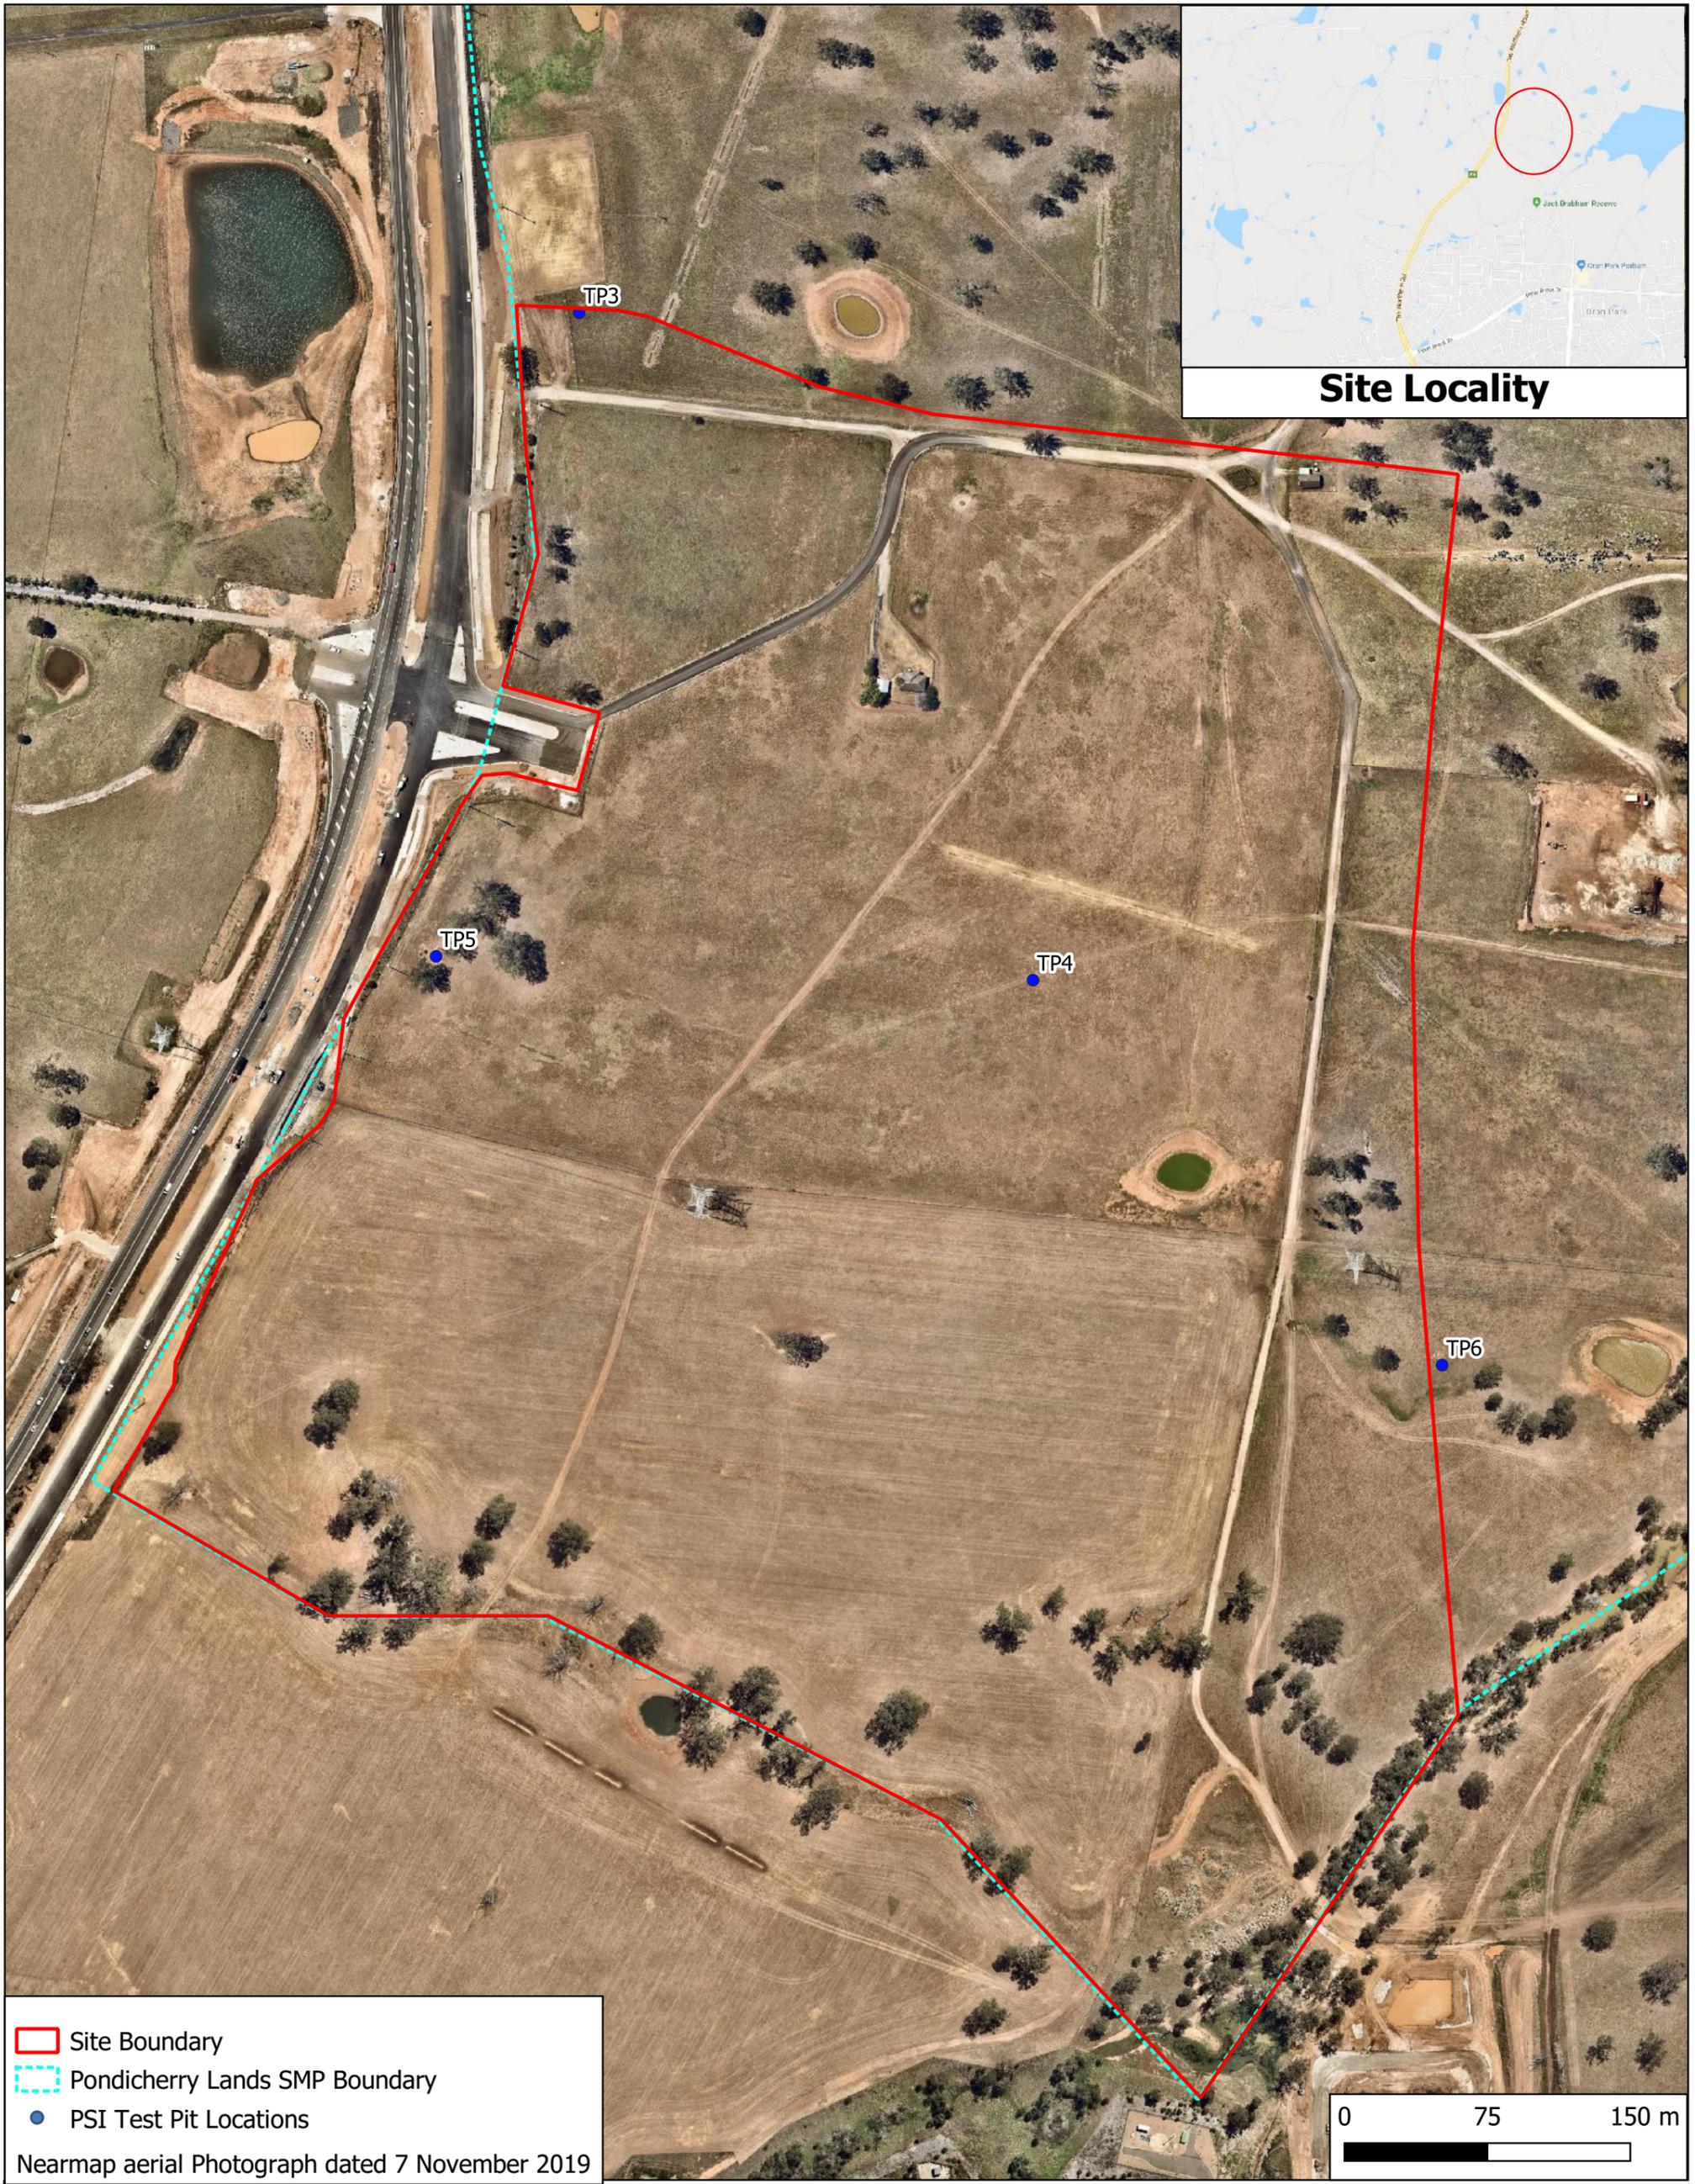
Drawing 1

□ Site Boundary
- - - Pondicherry Lands SMP Boundary
● PSI Test Pit Locations
 Nearmap aerial Photograph dated 7 November 2019

TITLE: **Site Boundaries**
Salinity Summary Letter
Tranch 41, Pondicherry, Oran Park

The locations of the above referenced test pits are shown on Drawing 1.

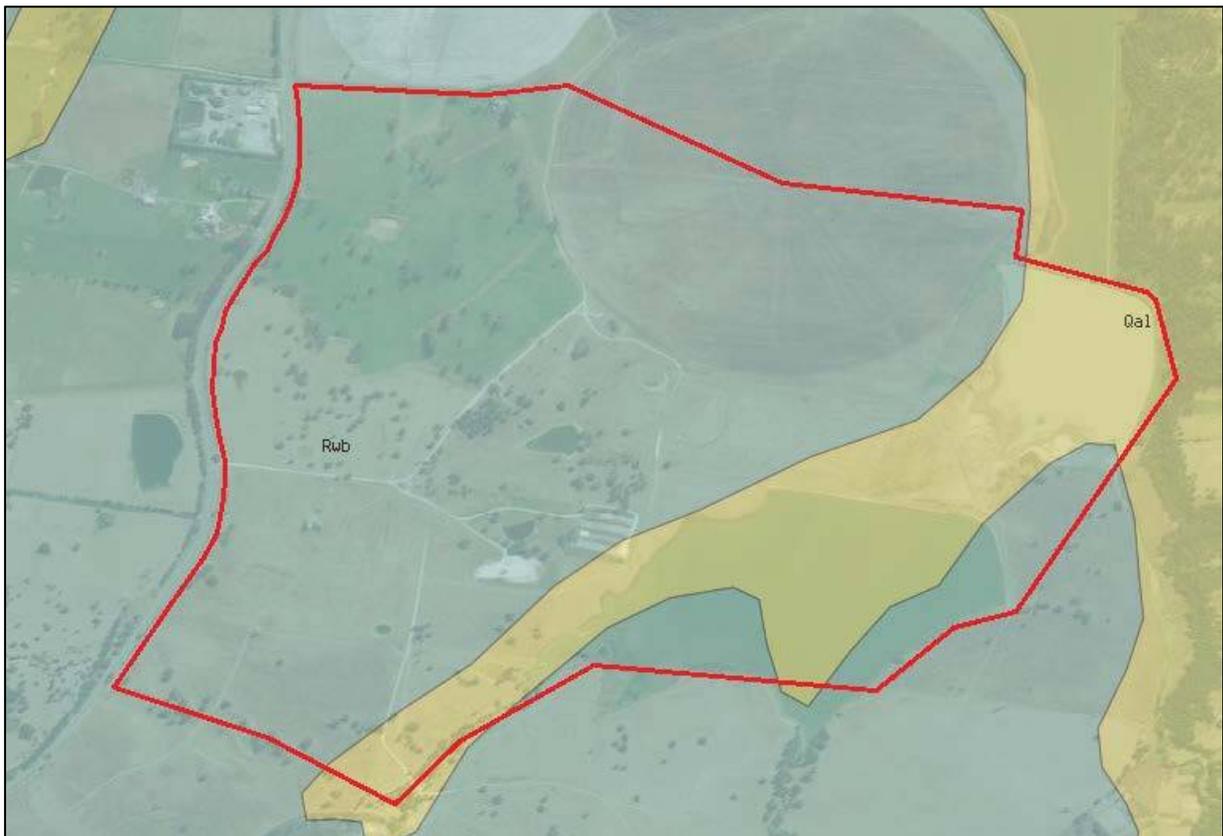
The rolling hills, ridgelines and lower slopes in the northern, western and central portions of the site are underlain by Bringelly Shale (mapping unit Rwb) of the Triassic age Wianamatta Group (Penrith 1:100 000 Geological Series Sheet 9030). The Bringelly Shale in the vicinity of the site includes an unnamed, fine to medium grained quartz-lithic sandstone member, typically comprises shale, carbonaceous claystone, laminite and some minor coaly bands which weather to form clays of high plasticity.

The lower lying eastern portion of the site is generally underlain by Quaternary alluvial deposits (mapping unit Qa1) of the Nepean River which are mainly derived from weathering of Permian and Triassic bedrock and typically comprise grey-brown, medium grained quartz sand with layers of silt and humic clay.

Figure B1: Geological Landscapes (Yellow – Quaternary Alluvium and Blue – Bringelly Shale)

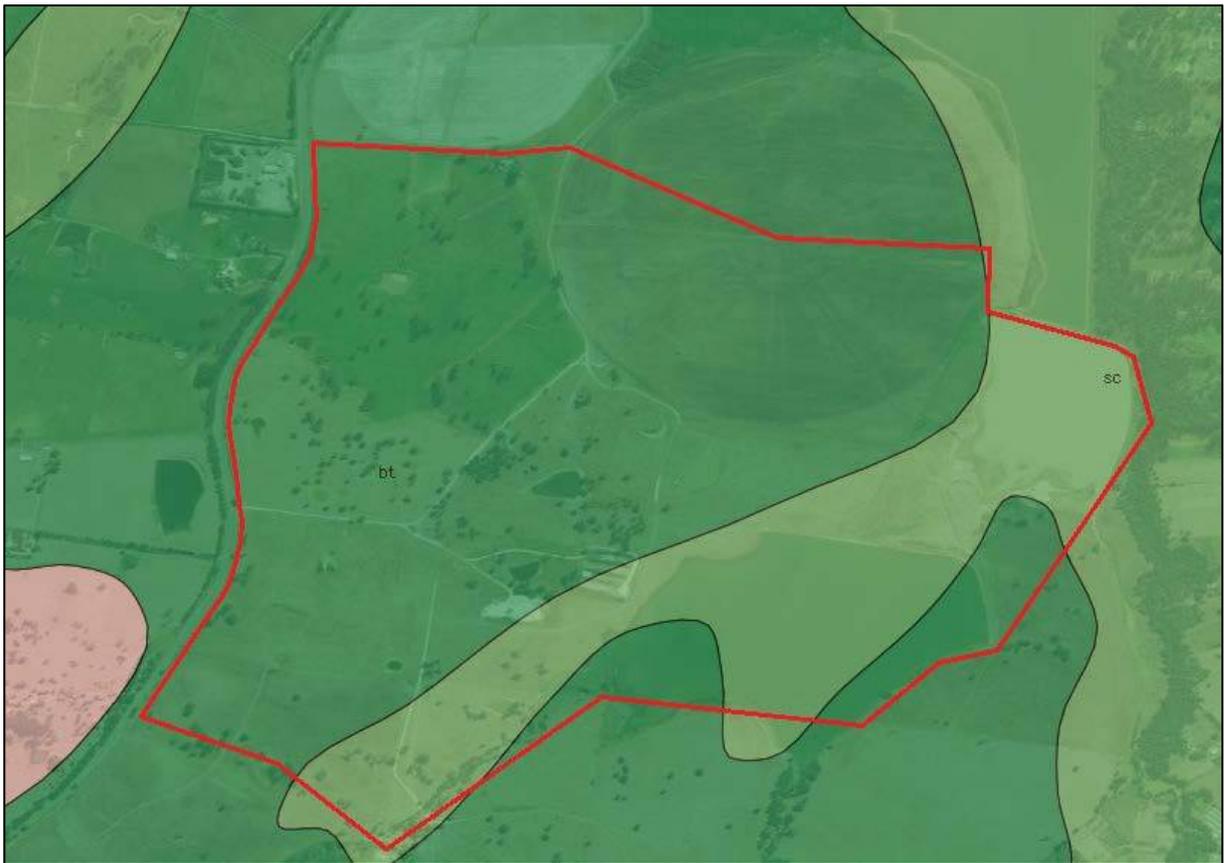
- **The Blacktown Soil Landscape** (mapping unit bt) is a residual soil group associated with the gently undulating slopes and broad rounded crests and ridges on the Wianamatta Group in the eastern part of the site. The unit comprises up to four soil horizons that range from shallow red-brown hard-setting sandy clay soils on crests and upper slopes to deep brown to yellow sand and clay soils overlying grey plastic mottled clay on mid to lower slopes. These soils are typically of low fertility, are moderately reactive and have a generally low wet bearing strength.

- **South Creek Soil Landscape** (mapping unit sc) is an alluvial soil group associated with floodplains, valley flats and drainage depressions of the channels on the Cumberland Plain. Usually flat with incised channels, mainly cleared, and is mapped along South Creek and associated minor creek extending south and south-west through southernmost dam. Mapping indicates soils associated with this landscape comprise very deep layered sediments over bedrock or relict soils. Red and yellow podsollic soils occur.

Figure B2: Soil Landscapes (Dark Green – Blacktown Soils and Light Green – South Creek Soils)

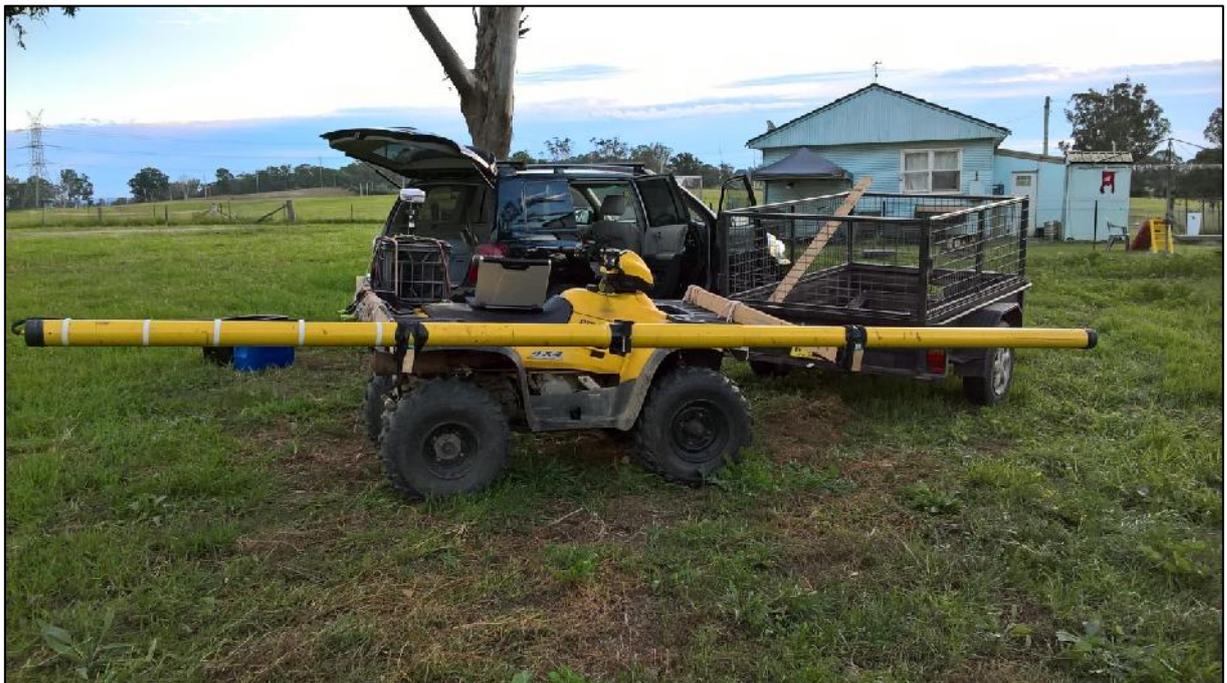
A Hemisphere R130 Differential Global Positioning System was used to continuously record position and to navigate and both positional data and ECa data were acquired at 1 Hz (1 second intervals) to the Profiler's data logger.

Data were obtained along approximately 107 line kilometres of traverse (38,500 data points) on a grid of primary survey lines approximately 18 m apart, with an average data point spacing of approximately 2.8 m.

Figure B3: DUALEM Profiler extended across quad bike, with DGPS system visible at rear

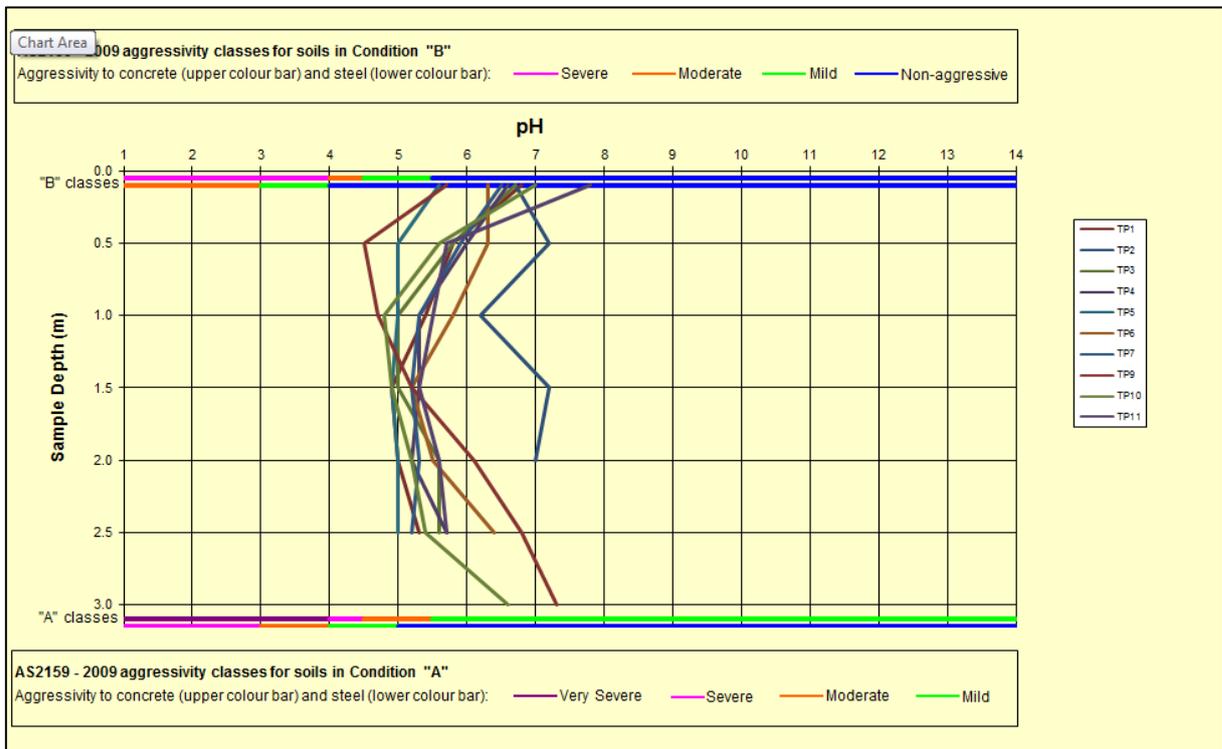
Figure B4 presents variations of aggressivity with depth, based on pH profiles at all test pit locations, together with the aggressivity class ranges as indicated in Australian Standard AS 2159 - 2009 (Ref 8). The absence of free groundwater from all test pits and the impermeability of the sampled clay-rich soils indicate that soils at all test pits are in Condition "B".

Figure B4: Vertical Soil pH Profiles and Aggressivity

The pH profiles (Figure B4) indicate that the materials throughout the site, at all investigation depths are generally non to mildly aggressive to concrete (with the exception of TP9 - moderately aggressive) and non to moderately aggressive to steel. Where measured, the sulphate and chloride concentration indicates that the soil is non-aggressive to concrete and steel respectively. However, based on sample resistivity data, samples were classified as non-aggressive, mildly aggressive to moderately aggressive to steel. Calculated worst-case soil resistivities for concrete and steel were interpolated to define areas of non-aggressive, mildly aggressive and moderately aggressive soil, as presented in Drawings B3 and B4, respectively (Appendix A).

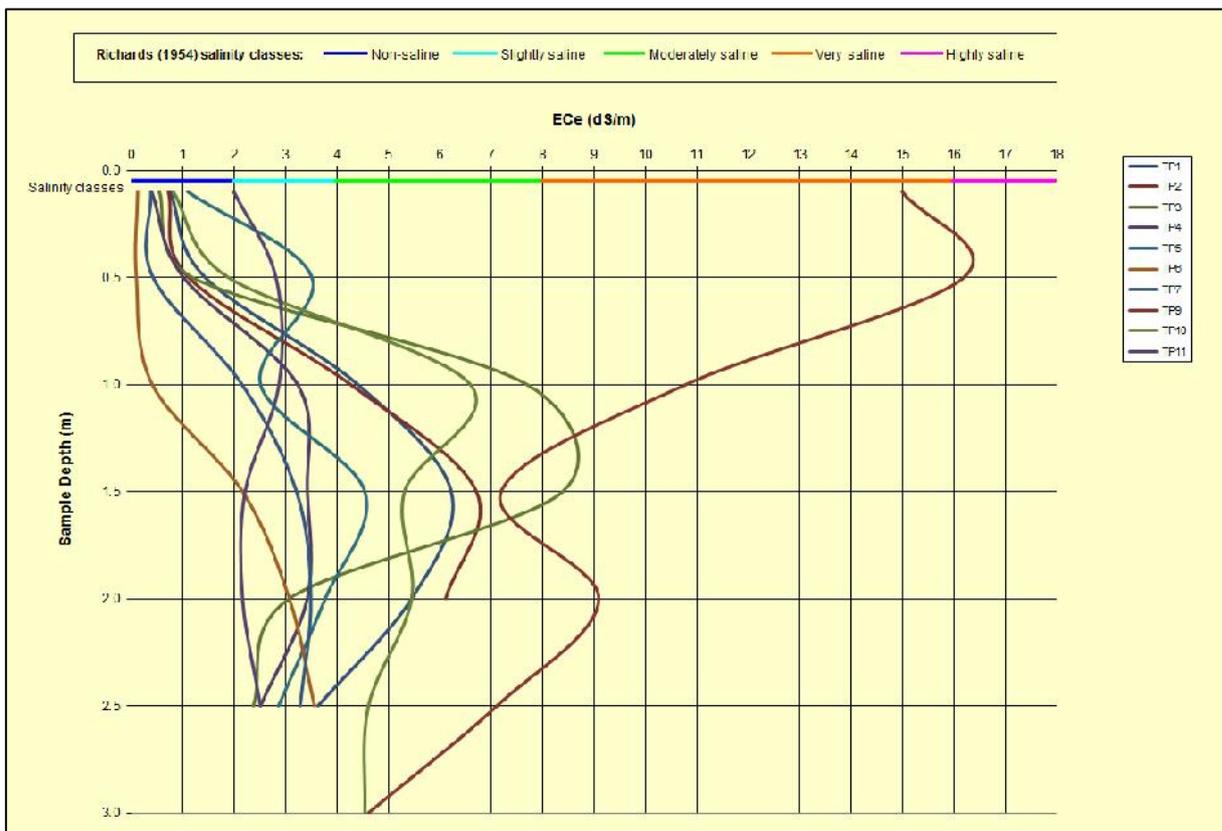
Salinity measurements on 61 samples from 11 test pits (Pit 8 was not subject to salinity testing - refer to Section 2), including areas of elevated apparent conductivity determined by EM profiling, are distributed throughout the salinity classes as shown in detail in the Summary Table (Appendix D) and graphically in Figure B5.

Figure B5: Vertical Soil Salinity Profiles

The Summary Table (Appendix D) indicates that 31% of all soil samples were non saline, 34% were slightly saline, 26% were moderately saline, 7% were very saline and 2% were highly saline.

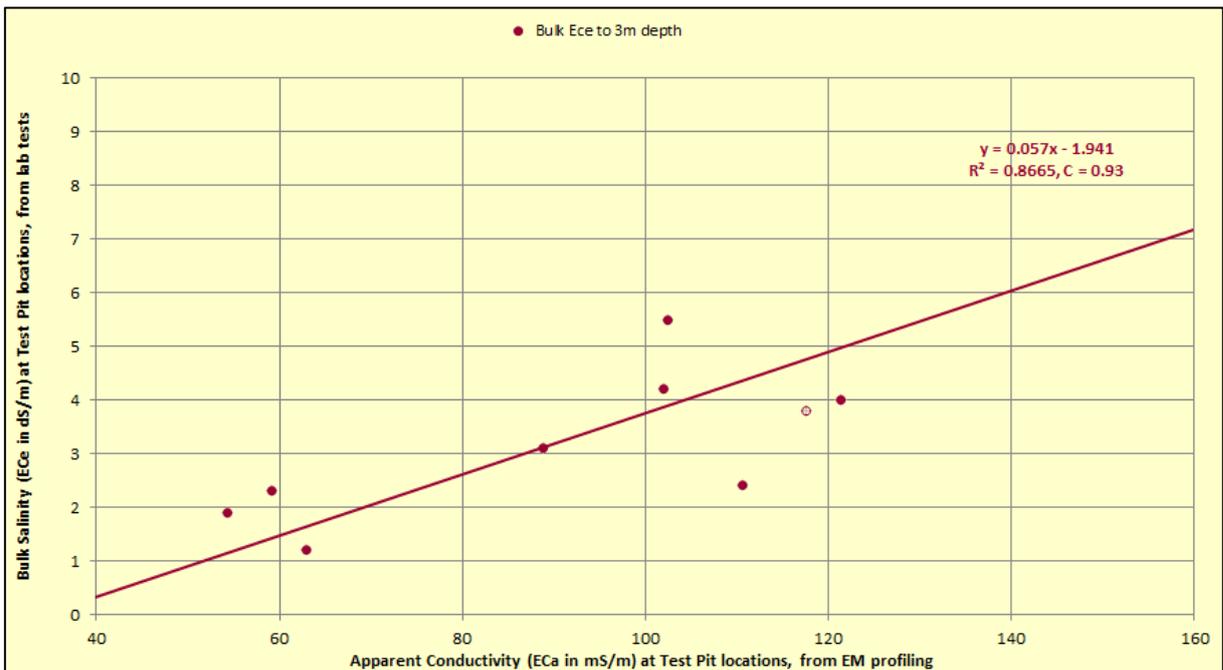
To carry out the required correlations, the ECa gridded line data was evaluated at the nearest test pit locations and the ECa values were plotted in a scattergram (Figure B6, below) against bulk ECe values. A reasonably strong positive linear trend between these parameters (correlation coefficient of 0.93) indicates that the EM system is responding to soil salinity and that the EM data obtained provides a good relative measure of the site salinity.

The line of best fit defines the ECe / ECa trend and provides an equation by which to convert apparent conductivities (ECa in mS/m), to estimate apparent salinities (ECe in dS/m) throughout the data set.

Figure B6 - Correlation of Bulk ECe and ECa data

The correlation equation ($ECe = 0.057 \times ECa - 1.941$) has been applied to all apparent conductivity gridded data for presentation as a correlated salinity image with continuous colour spectral scales in dS/m (refer to Drawing B5).

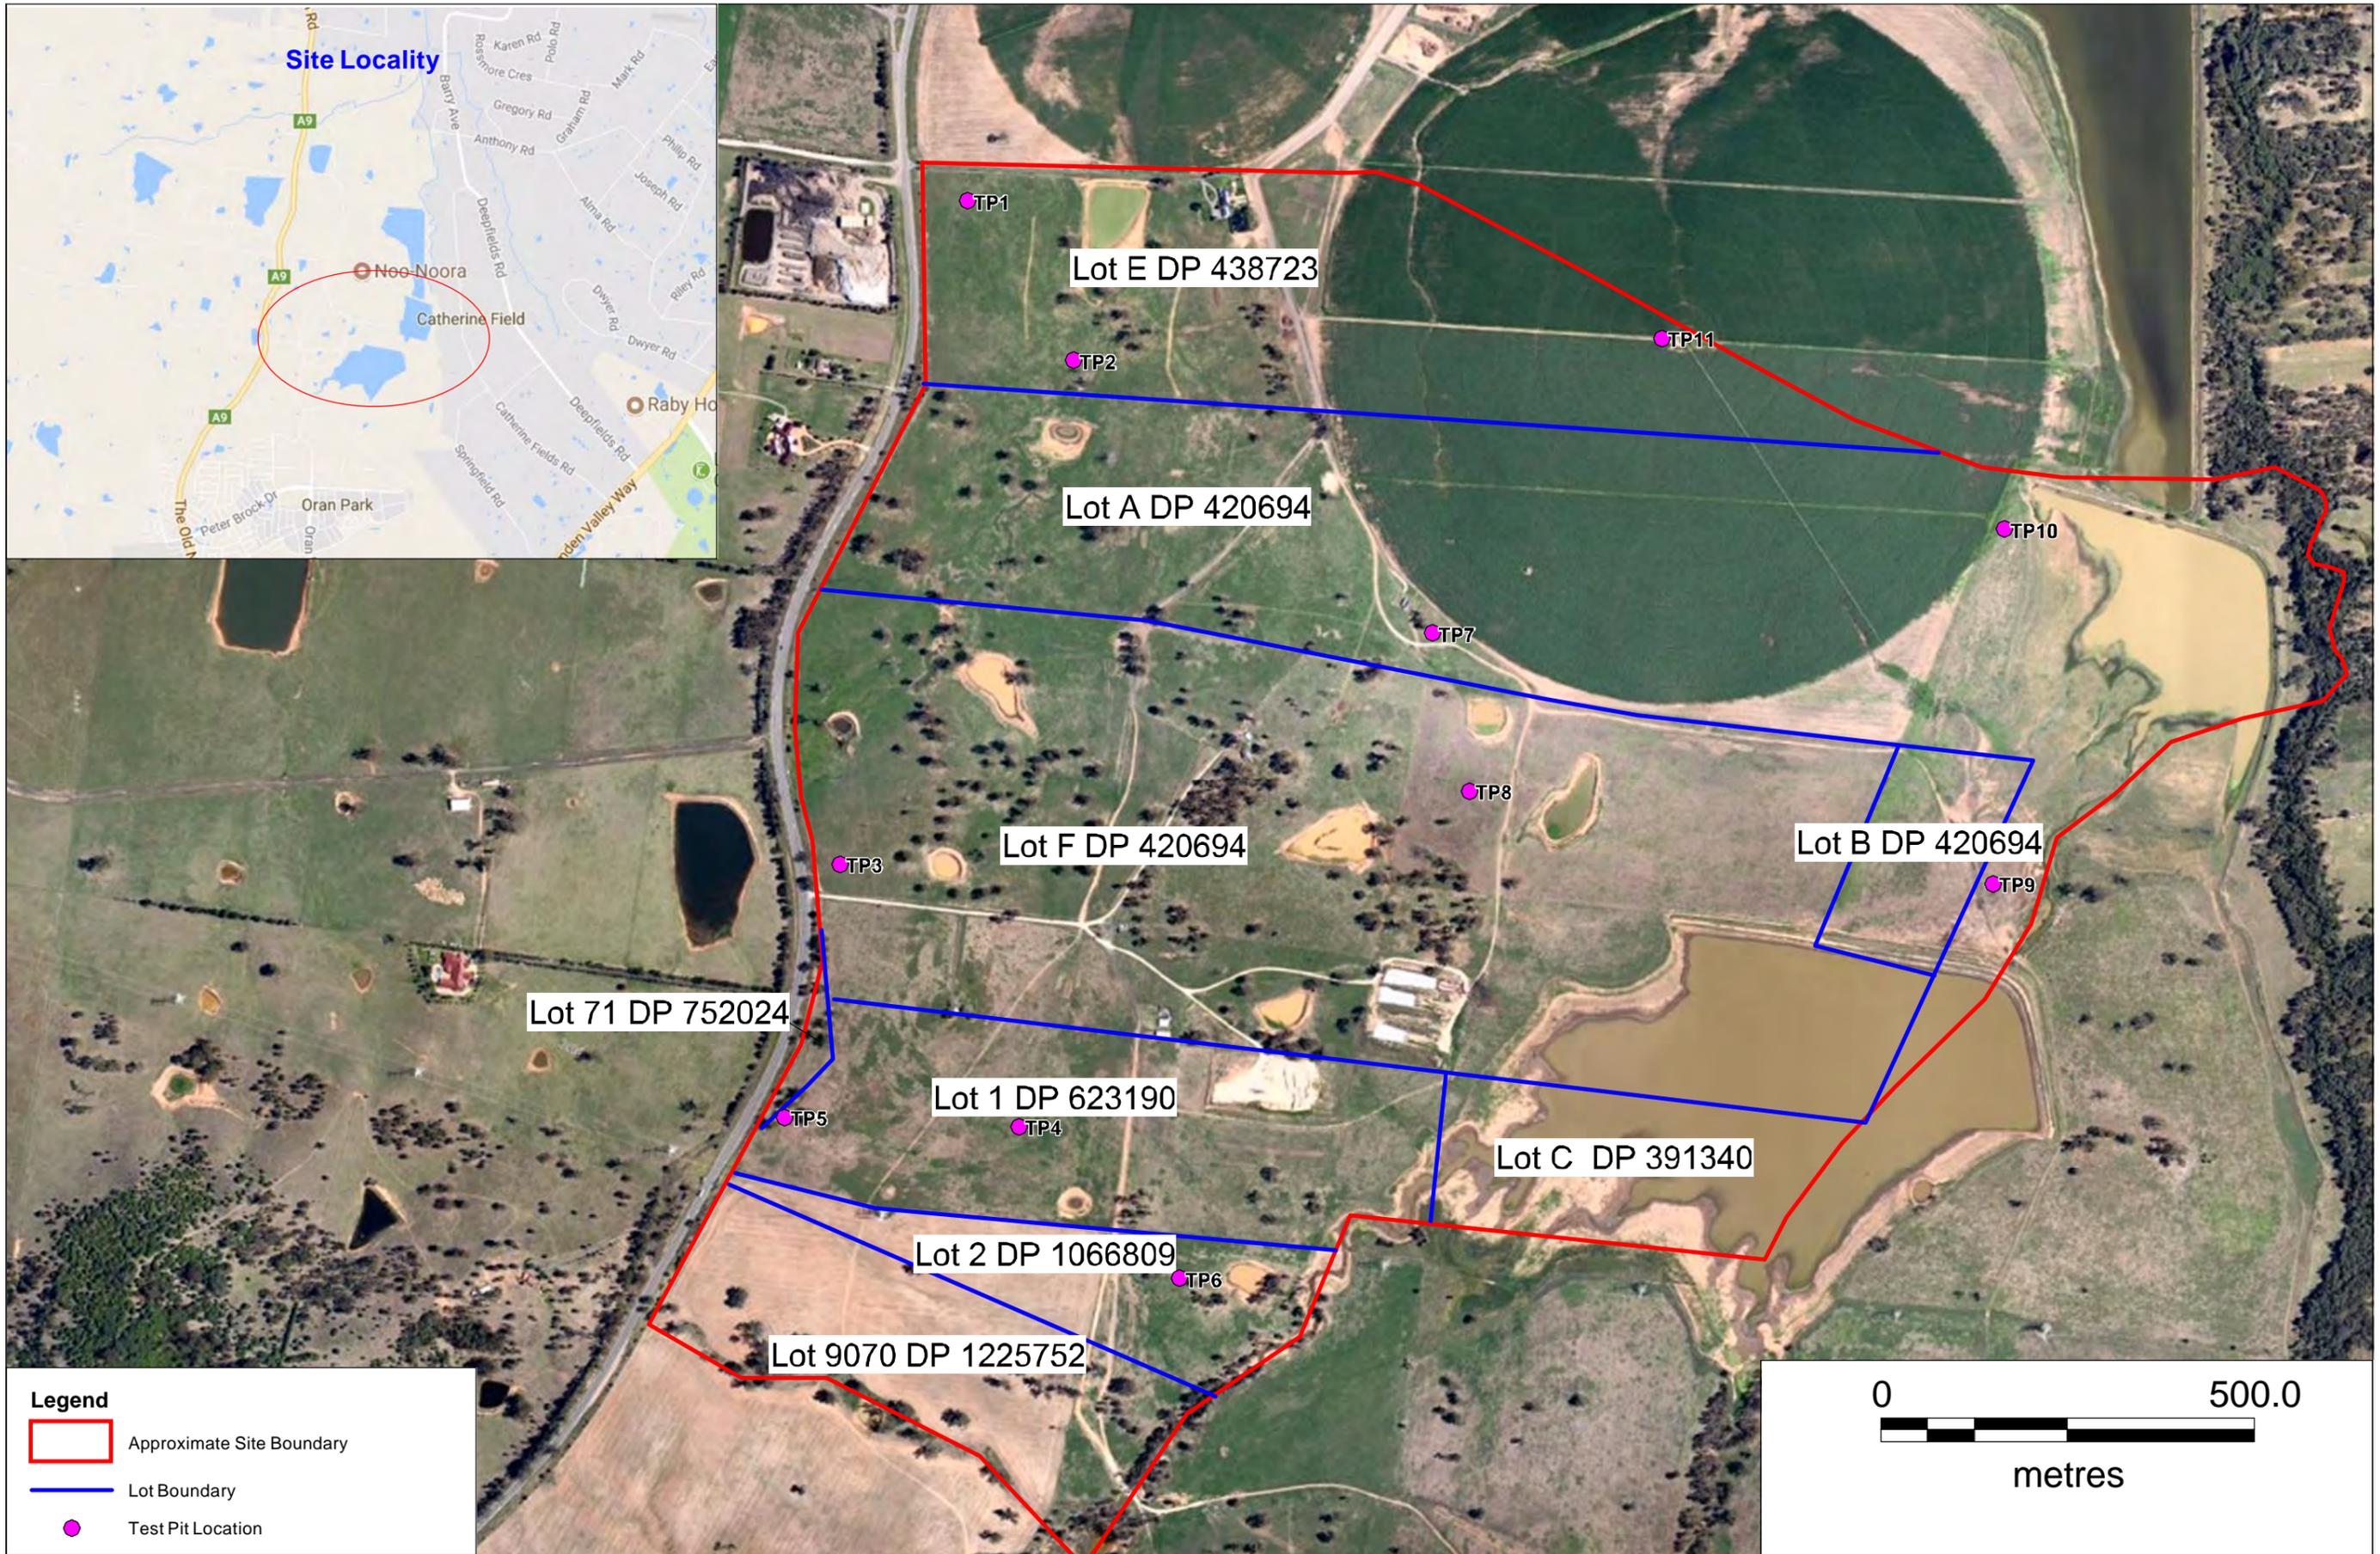
PROJECT No: 76778.29
 DRAWING No: B1
 REVISION: A

TITLE: **Site Layout and Test Pit Locations**
Proposed Residential Subdivision
Pondicherry Lands, Oran Park, NSW
