Reverse Amenity Air Quality Assessment – Pondicherry Tranche 41

Greenfields Development Company Pty Ltd

Job: 20-102

Date: 25 September 2020

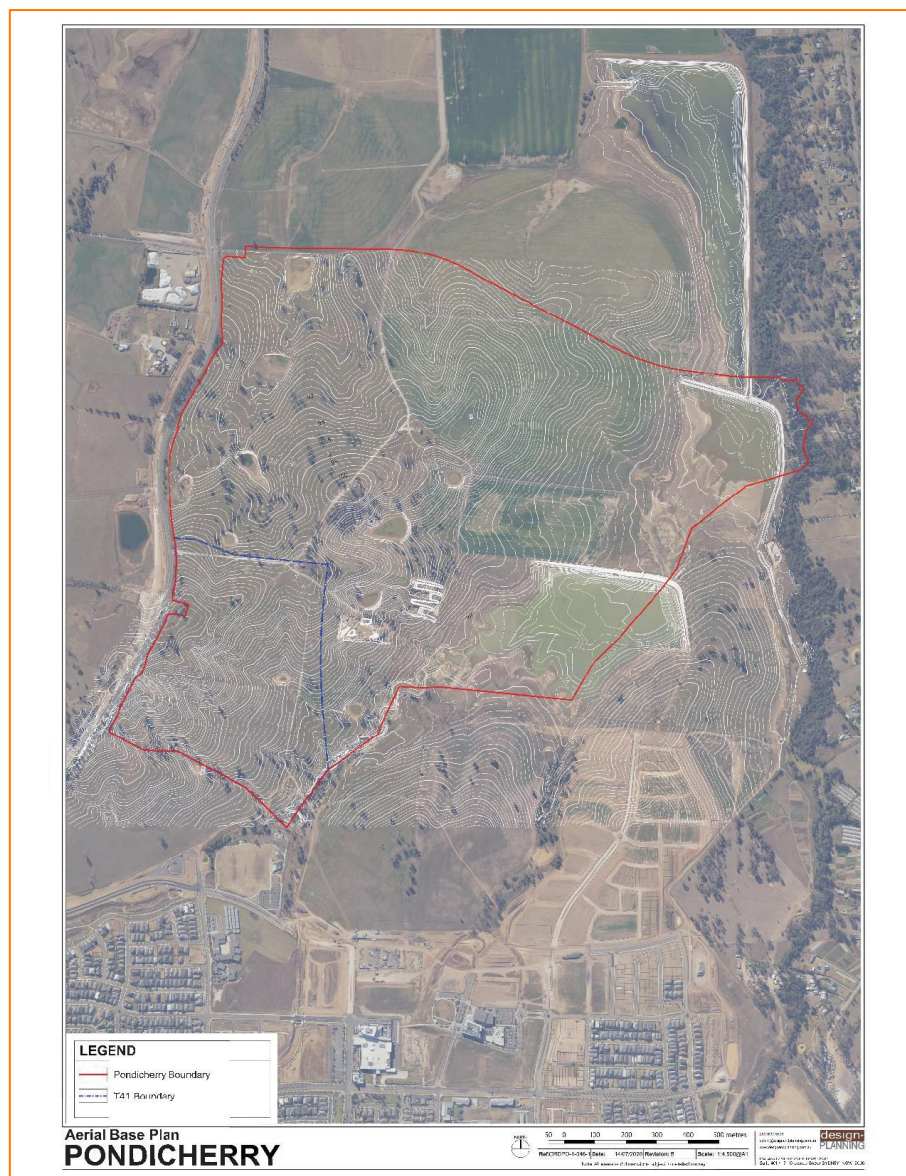
Figure 1-1: Pondicherry Precinct (Red Polygon)

The Pondicherry Precinct (“Pondicherry”) sits in the Oran Park area and is shown below in Figure 1-1. Tranche 41 forms a sub part of Pondicherry and is shown in Figure 1-2. Note that the indicative layout for Pondicherry shown in Figure 1-1 is notional and has no official status.

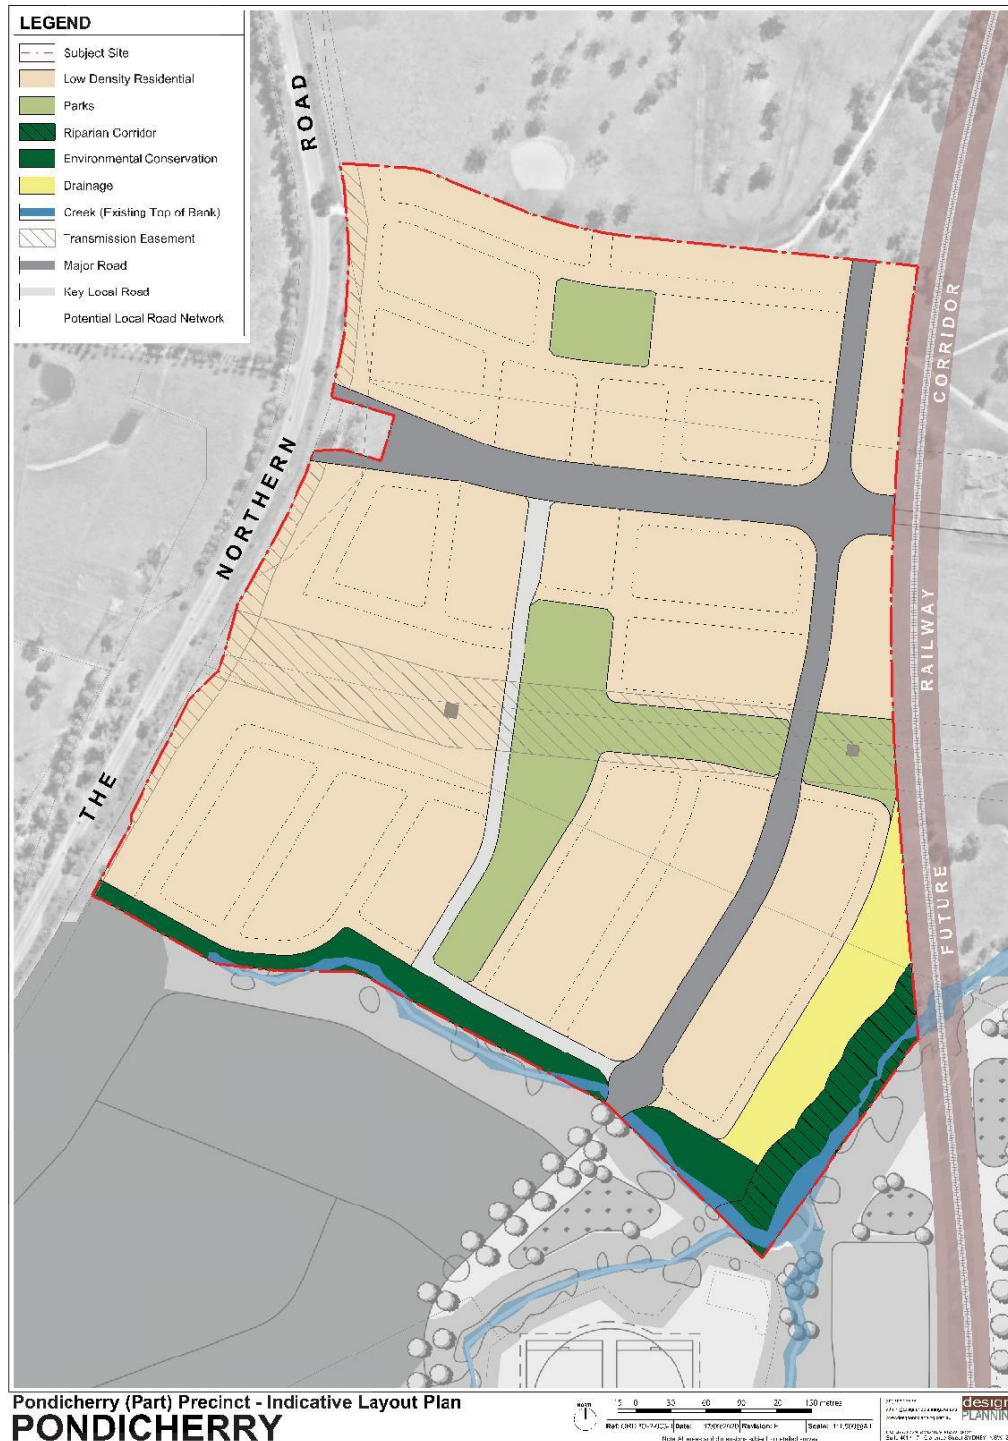
Figure 1-2: Tranche 41 Indicative Layout Plan 17/09/2020 Rev E

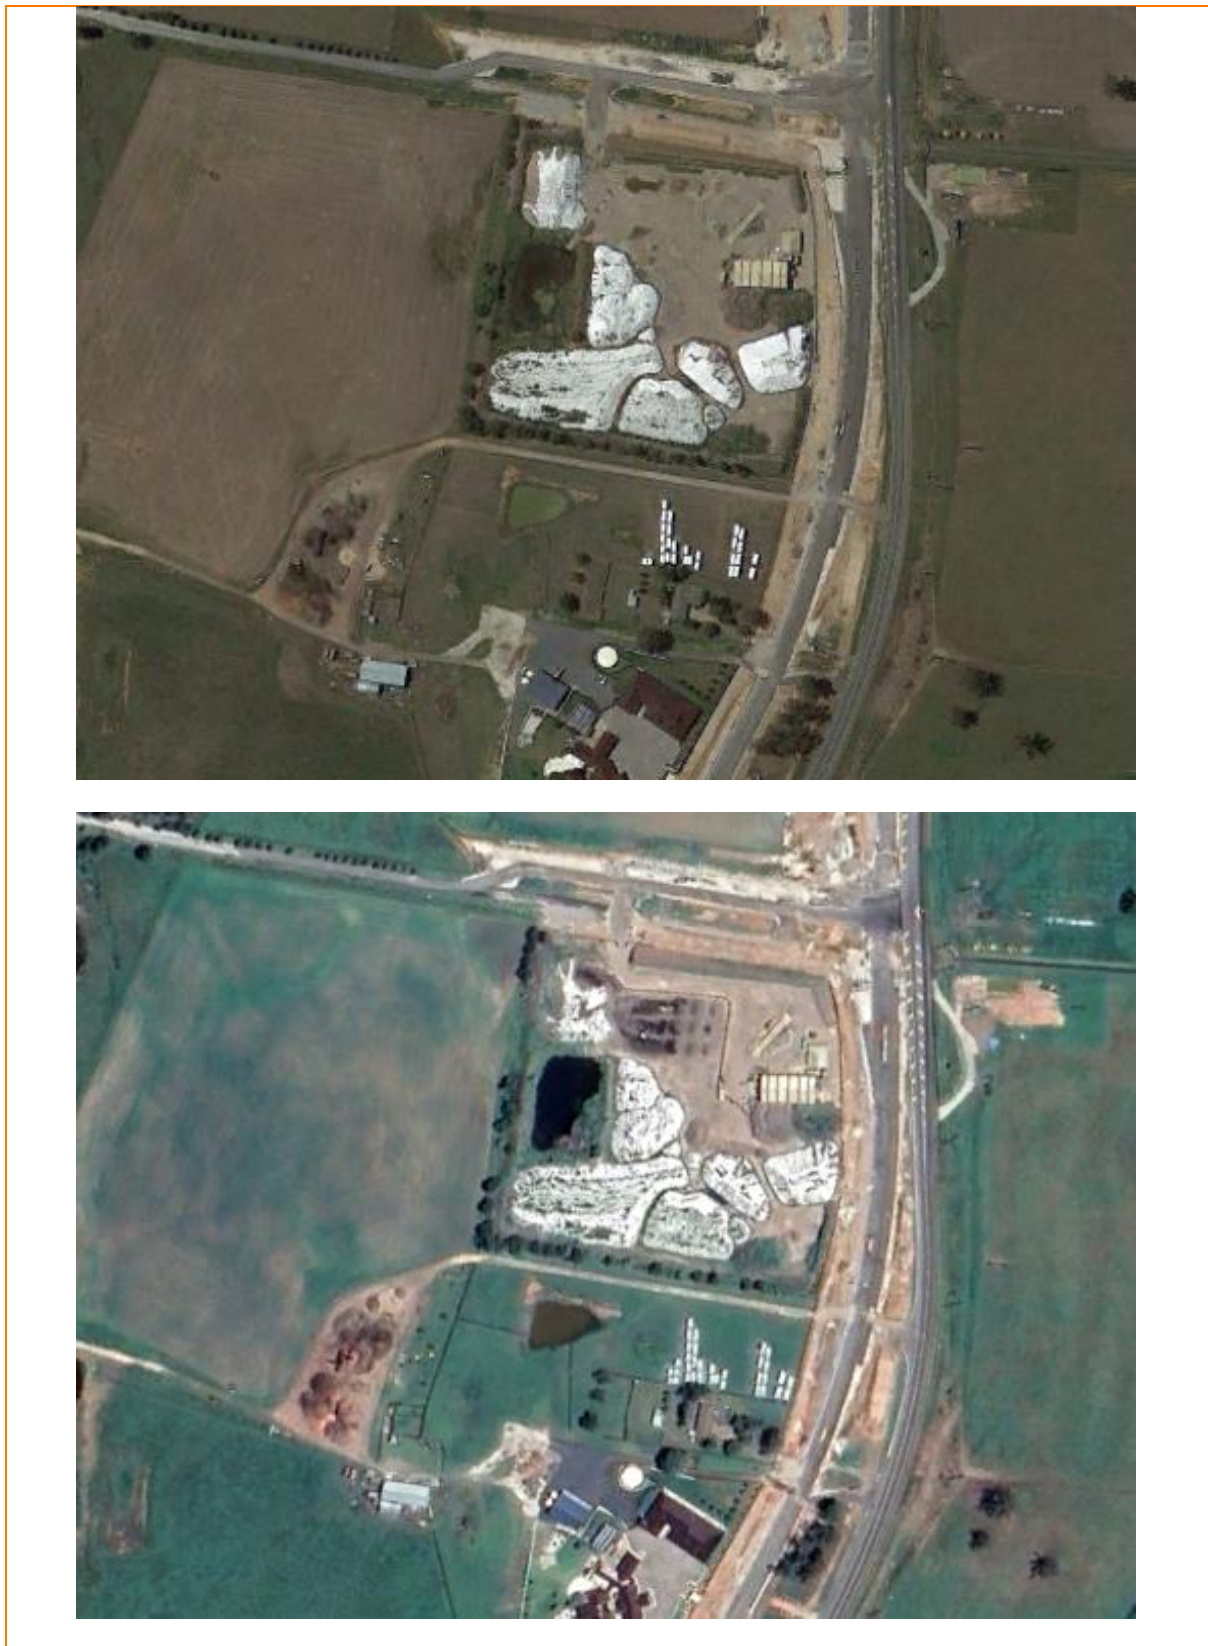
A review of recent aerial imagery as well as Google Street View imagery has highlighted that the site has a number of stockpiles of material and these have been covered by large tarps since at least November 2018. Recent aerial imagery is shown below in Figure 2-1 and Street View images in Figure 2-2.

Figure 2-1:Google Earth – December 2018 (top) and April 2019 (bottom)

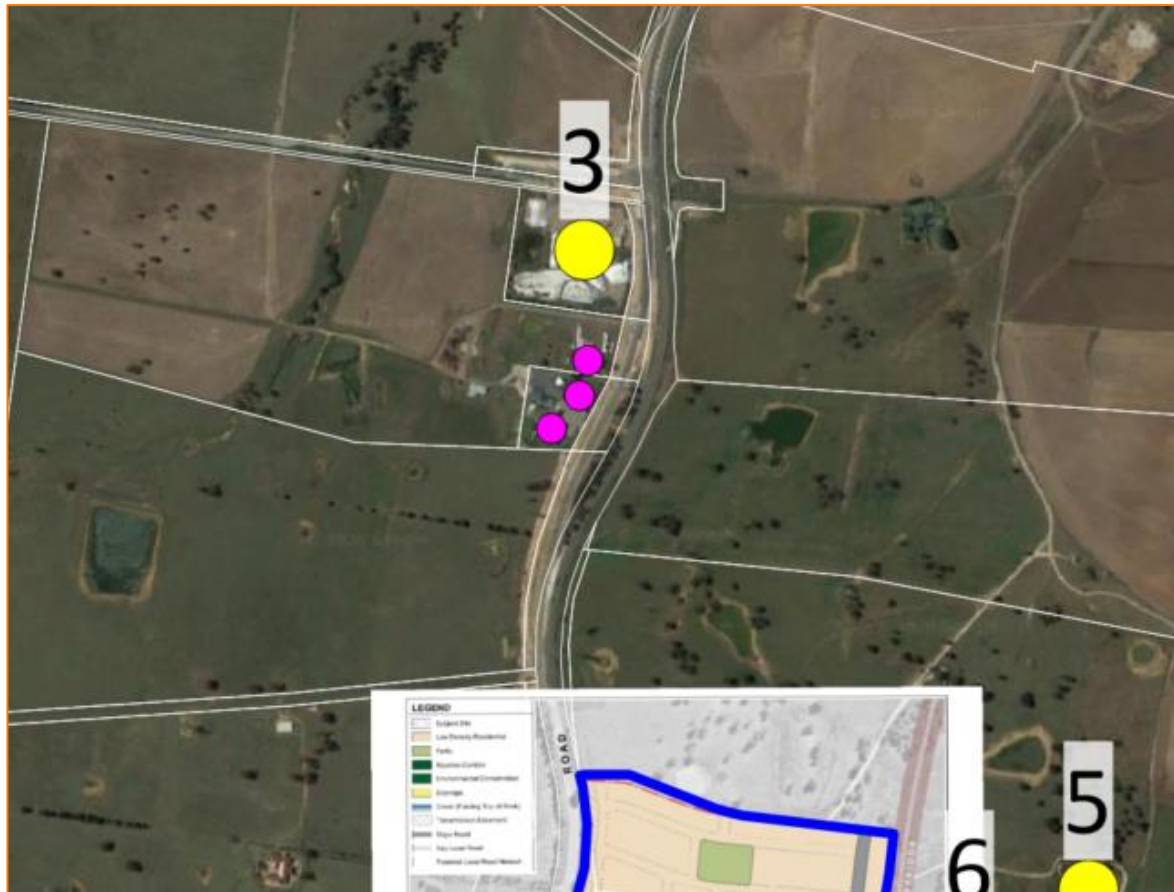
Relevant to this condition is the location of nearby sensitive locations. These are shown with regard to the Hi-Quality site in Figure 2-3. Considering the prevailing winds and the location of the receptors shown in Figure 2-3 it is considered that the Hi-Quality site would need to be in breach of its License if impacts were to occur at Tranche 41. This is because there are existing sensitive locations far closer to the Hi-Quality site than Tranche 41. Therefore, the risk of impact at Tranche 41 is low.

Figure 2-3: Location 3 and Receptors (Pink Circles)
