## Remedial Action Plan (RAP) – Revision A

30 – 46 Auburn Road, Regents Park NSW

29 JUNE 2021

Project # SES\_590

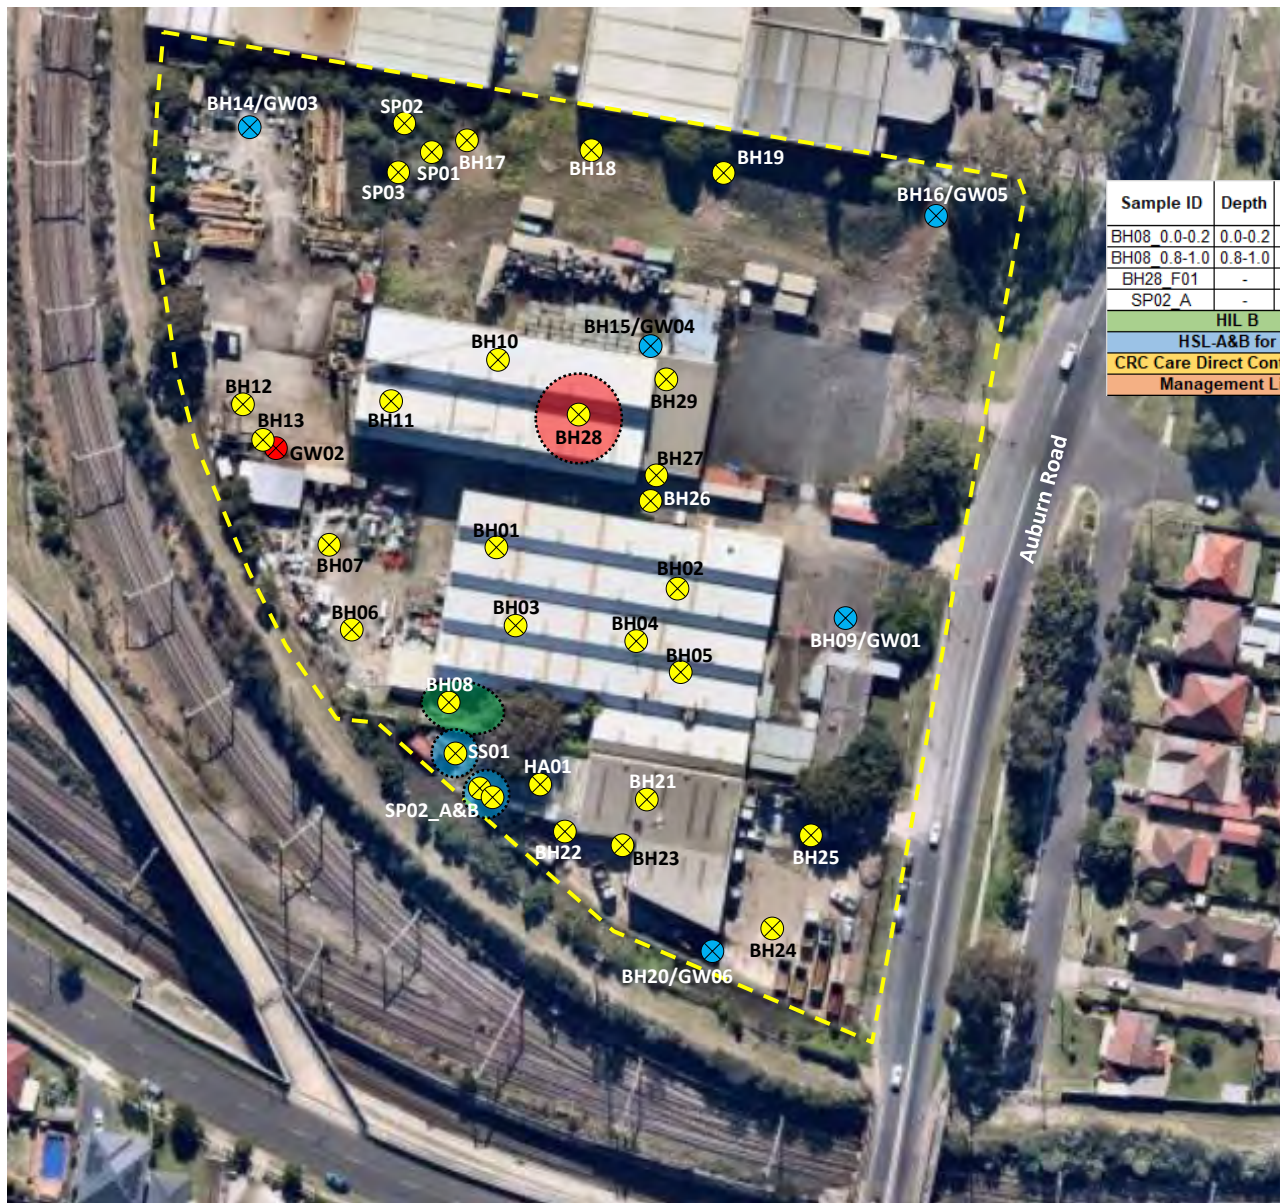
Sample ID	Depth	Date	Asbestos (Bulk)	Lead	TRH >C <sub>10</sub> -C <sub>16</sub> (F2)	TRH >C <sub>15</sub> -C <sub>34</sub> (F3)
BH08 0.0-0.2	0.0-0.2	7/6/2021	-	2,800	<25	290
BH08 0.8-1.0	0.8-1.0	7/6/2021	-	6	190	250
BH28 F01	-	9/6/2021	Yes	-	-	-
SP02 A	-	9/6/2021	-	58	120	8,000
HIL B			Detect	1,200	-	-
HSL-A&B for VI			-	-	110	-
CRC Care Direct Contact HSL-B			-	-	3,300	4,500
Management Limits			-	-	-	2,500

- Site boundary
- ⊗ New groundwater monitoring well
- ⊗ Existing groundwater monitoring well
- ⊗ Soil sample location
- Former AST Approx. Remediation Area
- Beneath Building #2 Approx. Remediation Area
- Stockpile SP02\_A&B and Oil stains at SS01

Remediation Area	Investigation Locations	Contaminant	Approx. Remediation Depth (m bgl)	Approx. Remediation Area (m <sup>2</sup> )	Approx. Remediation Quantity (m <sup>3</sup> )
Former AST	BH08	Lead and TRH in surface and deep soils	1.5m	TBD Estimated 100	TBD Estimated 150
Beneath Building #2	BH28	Bonded asbestos in gravel fill	0.5m	TBD Estimated 100	TBD Estimated 50
Waste pile on #46 Auburn Rd	SP02_A&B	TRH	-	-	Estimated 15
Oil-stained surface soils	SS01	Oily staining and discolouration - TRH	0.2m	Estimated 25m	Estimated 5

The surface soils in and around the blue shipping container on #46 Auburn Road are stained/discooured from leaks/spills originating from the storage of waste oil drums. While petroleum hydrocarbons are not detected in surface soil sample SS01 at levels that pose a potential human health risk, the stained/discooured soils are considered an aesthetic issue requiring remediation and validated (refer Section 4.8). Moreover, the presence of oily stained soils is likely to cause a potential risk to terrestrial organisms if left insitu.
