Job No: 13188/1
Our Ref: 13188/1-AA
12 September 2014

re: **Proposed Redevelopment
160 Burwood Road, Concord
Preliminary Geotechnical Investigation**

13188/1-AA
160 Burwood Rd, Concord

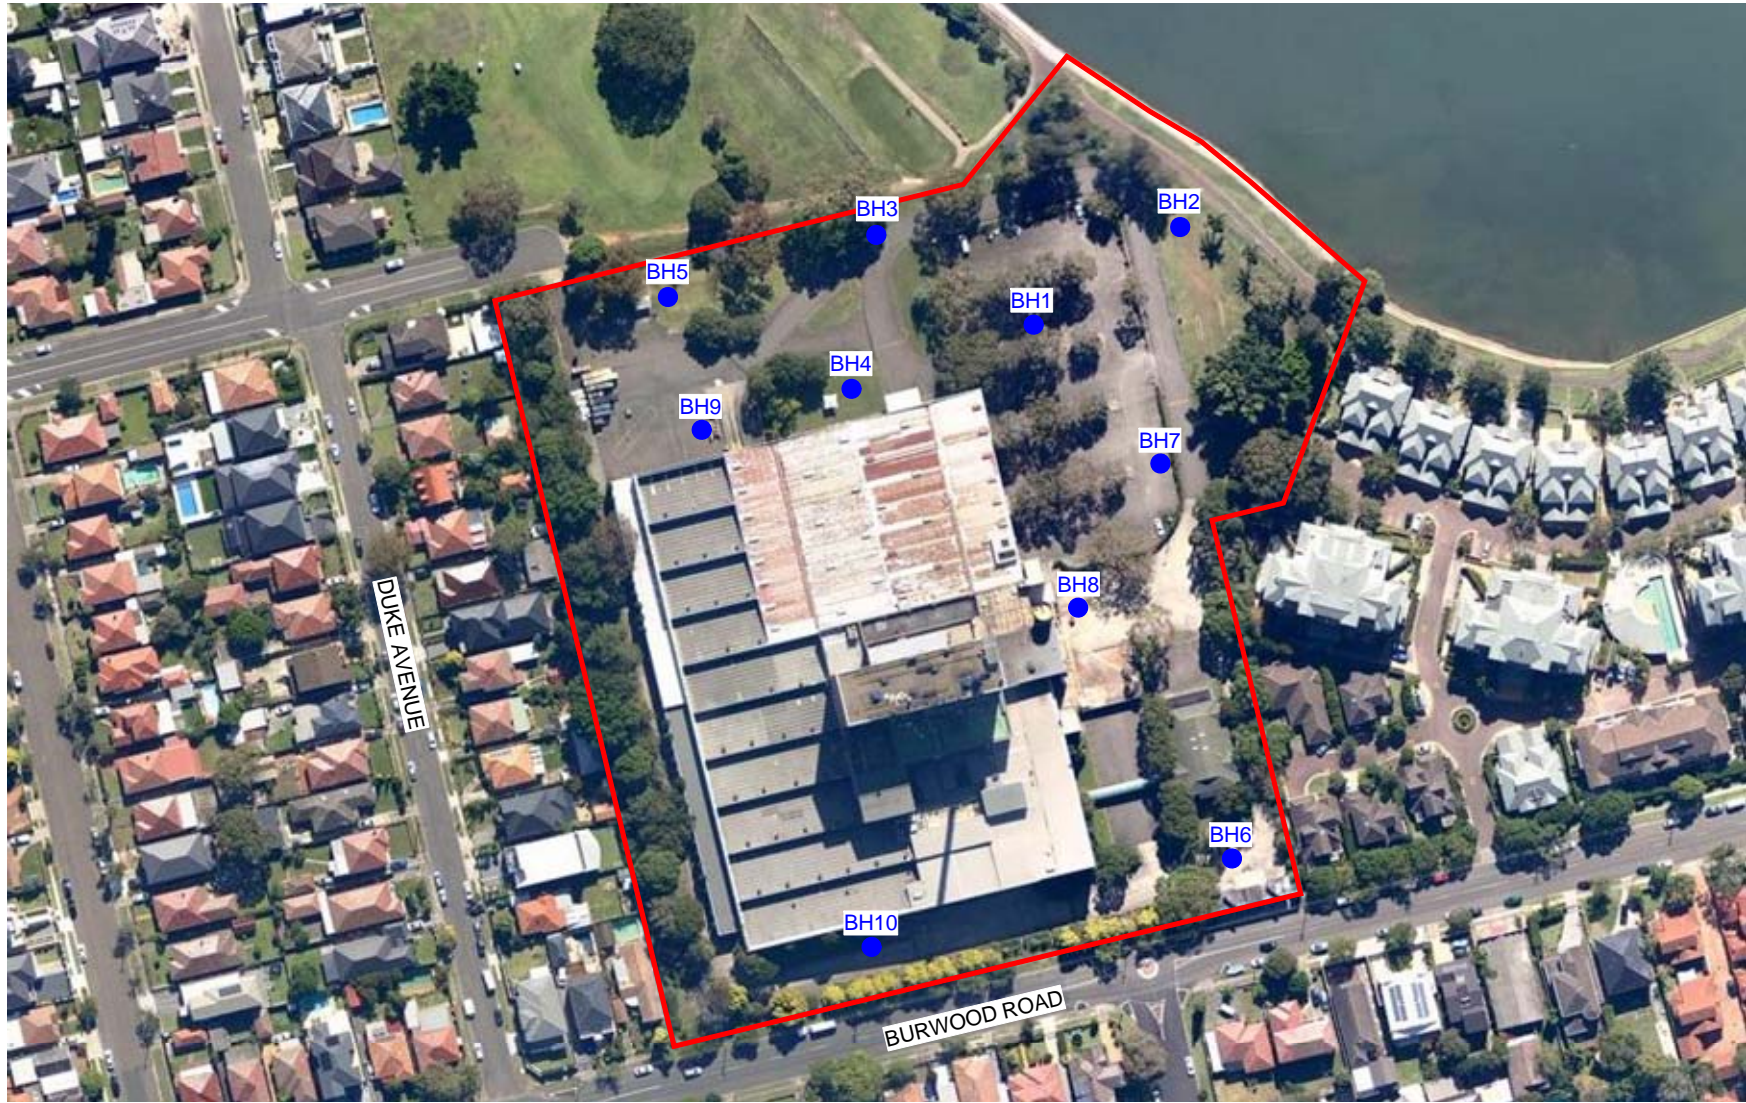
● Borehole

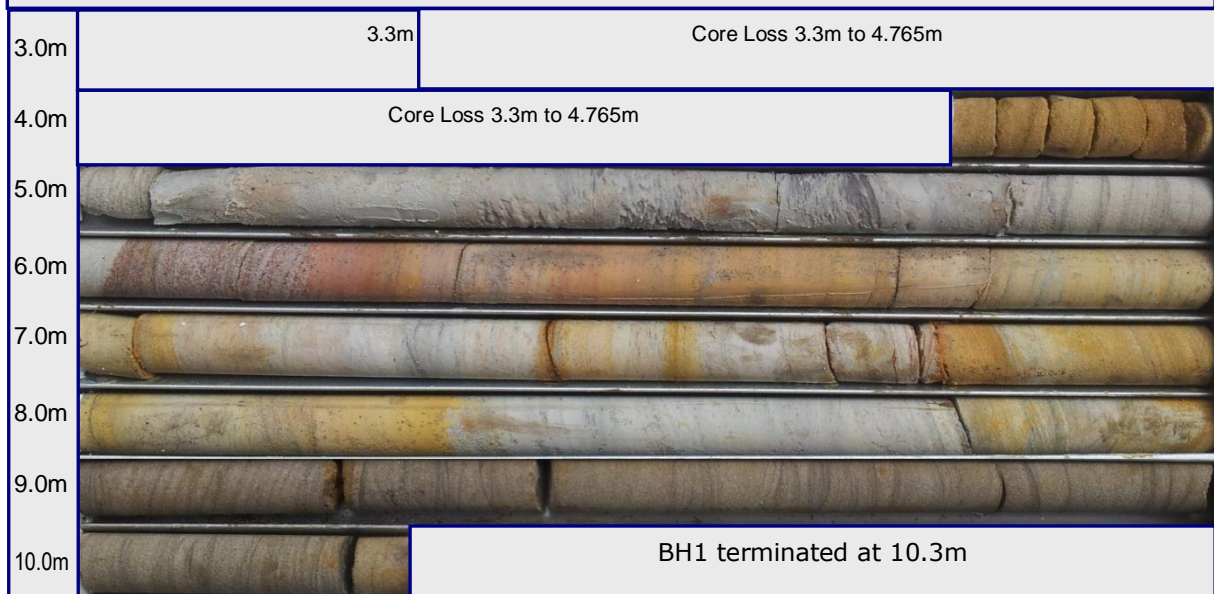
Job No 13188/1 BH1 Started Coring at 3.3m

Client : Nix Anderson Pty Ltd		Job No. : 13188/1											
Project : Proposed Development		Borehole No. : 1											
Location : 160 Burwood Road, Concord		Date : 11/08/2014											
		Logged/Checked by : AN											
drill model and mounting : Edson Truck Mounted		slope : 90 deg.	R.L. surface : $\cong 5.5$										
core size: NMLC		bearing : deg.	datum : AHD										
barrel lift	water loss/level	depth of R.L. in meters	graphic log	CORE DESCRIPTION rock type, grain characteristics, colour, structure, minor components.	weathering	strength	point load index strength $I_s(50)$		DEFECT DETAILS				
							EL	VL	L	M	H	VH	defect spacing (mm)
				Start coring at 3.3m									
				CORE LOSS									Core Loss (3.3m to 4.765m)

Client : Nix Anderson Pty Ltd		Job No. : 13188/1										
Project : Proposed Development		Borehole No. : 1										
Location : 160 Burwood Road, Concord		Date : 11/08/2014										
		Logged/Checked by : AN										
drill model and mounting : Edson Truck Mounted		slope : 90 deg.	R.L. surface : $\cong 5.5$									
core size: NMLC		bearing : deg.	datum : AHD									
barrel lift	water loss/level	depth of R.L. in meters	graphic log	CORE DESCRIPTION rock type, grain characteristics, colour, structure, minor components.	weathering	strength	point load index strength $I_s(50)$		DEFECT DETAILS			
							EL	VL	L	M	H	VH
		8										
		8.5										
		9		SANDSTONE, fine to medium grained, grey	SW- F	H						
		9.5										9.32m B=0° st
		10										
		10.5		Borehole No 1 terminated at 10.3m								
		11										
		11.5										
		12										
		12.5

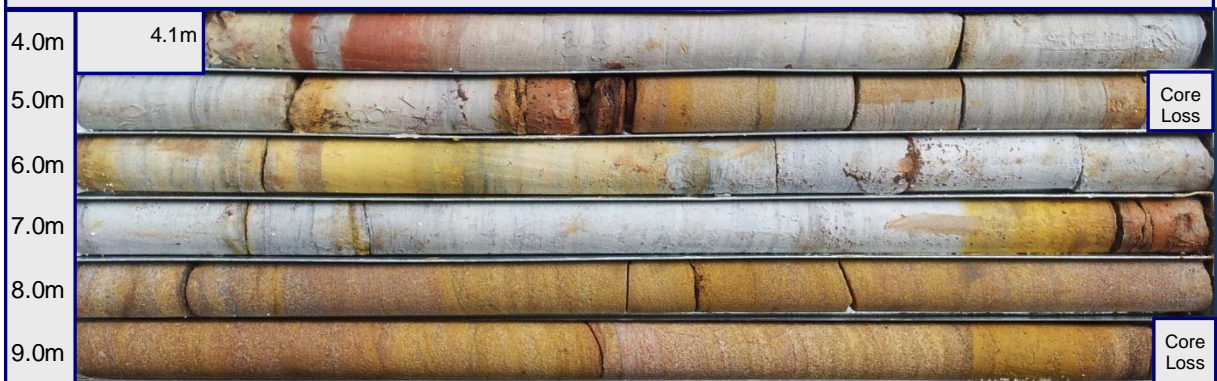
Job No 13188/1 BH3 Started Coring at 4.1m

Client : Nix Anderson Pty Ltd		Job No. : 13188/1							
Project : Proposed Development		Borehole No. : 3							
Location : 160 Burwood Road, Concord		Date : 11/08/2014							
Logged/Checked by : LY/MT									
drill model and mounting : Edson Truck Mounted		slope : 90 deg.	R.L. surface : $\cong 5.4$						
core size: NMLC		bearing : deg.	datum : AHD						
barrel lift	water loss/level	depth of R.L. in meters	graphic log	CORE DESCRIPTION rock type, grain characteristics, colour, structure, minor components.	weathering	strength	point load index strength $I_s(50)$	DEFECT DETAILS	
								defect spacing (mm)	DESCRIPTION type, inclination, thickness, planarity, roughness, coating.
		4		Start coring at 4.1m			EL VL L M H VH

barrel lift	water loss/level	depth of R.L. in meters	graphic log	CORE DESCRIPTION rock type, grain characteristics, colour, structure, minor components.	weathering	strength	point load index strength $I_s(50)$		DEFECT DETAILS	
							EL	VL	L	M
		9								
		9.5								
		10		CORE LOSS Borehole No 3 terminated at 10.0m						
		10.5								
		11								
		11.5								
		12								
		12.5								
		13								
		13.5

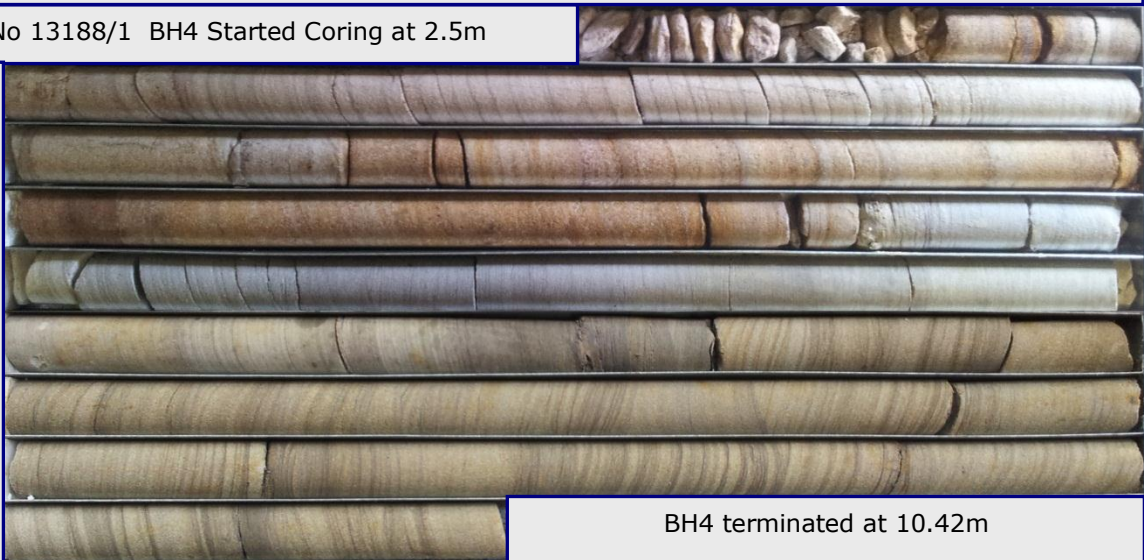
Job No 13188/1 BH4 Started Coring at 2.5m

Client : Nix Anderson Pty Ltd		Job No. : 13188/1								
Project : Proposed Development		Borehole No. : 4								
Location : 160 Burwood Road, Concord		Date : 11/08/2014								
		Logged/Checked by : LY/MT								
drill model and mounting : Edson Truck Mounted		slope : 90 deg.	R.L. surface : $\cong 5.8$							
core size: NMLC		bearing : deg.	datum : AHD							
barrel lift	water loss/level	depth of R.L. in meters	graphic log	CORE DESCRIPTION rock type, grain characteristics, colour, structure, minor components.	weathering	strength	point load index strength $I_s(50)$		DEFECT DETAILS	
							EL VL L M H VH	defect spacing (mm)	DESCRIPTION type, inclination, thickness, planarity, roughness, coating.	
				Start coring at 2.5m

Client : Nix Anderson Pty Ltd		Job No. : 13188/1								
Project : Proposed Development		Borehole No. : 4								
Location : 160 Burwood Road, Concord		Date : 11/08/2014								
		Logged/Checked by : LY/MT								
drill model and mounting : Edson Truck Mounted		slope : 90 deg.	R.L. surface : ≈ 5.8							
core size: NMLC		bearing : deg.	datum : AHD							
barrel lift	water loss/level	depth of R.L. in meters	graphic log	CORE DESCRIPTION rock type, grain characteristics, colour, structure, minor components.	weathering	strength	point load index strength $I_s(50)$	DEFECT DETAILS		
								defect spacing (mm)	DESCRIPTION type, inclination, thickness, planarity, roughness, coating. Specific General	
		7.5					EL		7.5m - clay seam (10mm)	
		8						VL		
		8.5						L		
		9						M		
		9.5						H		
		10					VH			
		10.5		Borehole No 4 terminated at 10.42m						
		11								
		11.5

3.0m
4.0m
5.0m
6.0m
7.0m
8.0m
9.0m
10.0m

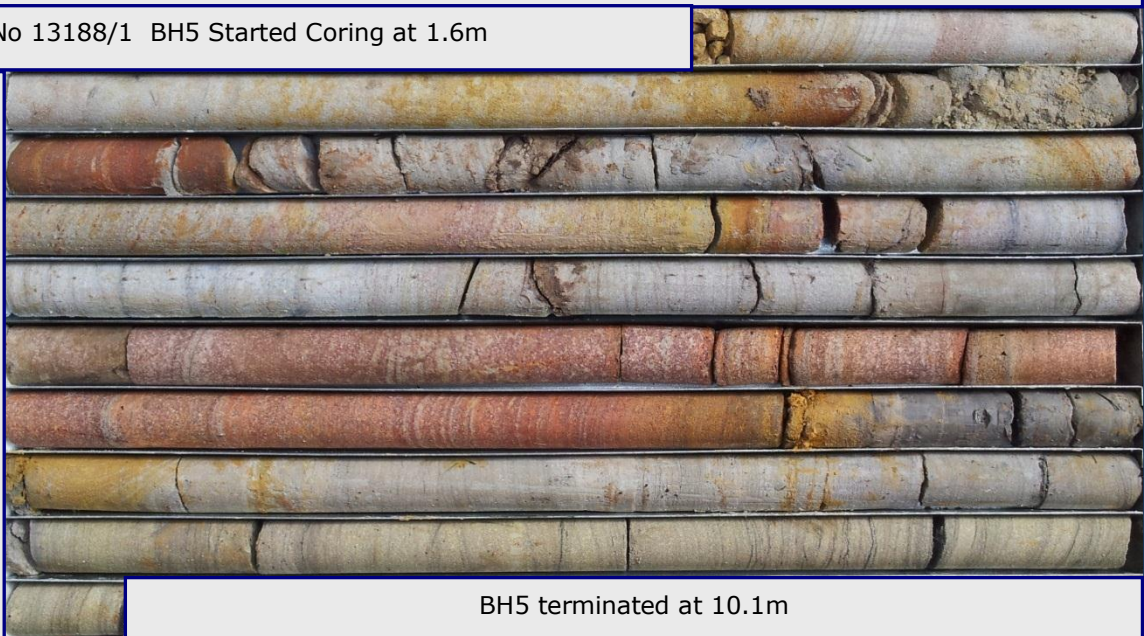
Job No 13188/1 BH5 Started Coring at 1.6m

Client : Nix Anderson Pty Ltd		Job No. : 13188/1							
Project : Proposed Development		Borehole No. : 5							
Location : 160 Burwood Road, Concord		Date : 11/08/2014							
		Logged/Checked by : LY/MT							
drill model and mounting : Edson Truck Mounted		slope : 90 deg.	R.L. surface : ≈ 6.7						
core size: NMLC		bearing : deg.	datum : AHD						
barrel lift	water loss/level	depth of R.L. in meters	graphic log	CORE DESCRIPTION rock type, grain characteristics, colour, structure, minor components.	weathering	strength	DEFECT DETAILS		
							point load index strength $I_s(50)$	DEFECT DESCRIPTION	
							defect spacing (mm)	type, inclination, thickness, planarity, roughness, coating.	
								Specific	General

2.0m
3.0m
4.0m
5.0m
6.0m
7.0m
8.0m
9.0m
10.0m

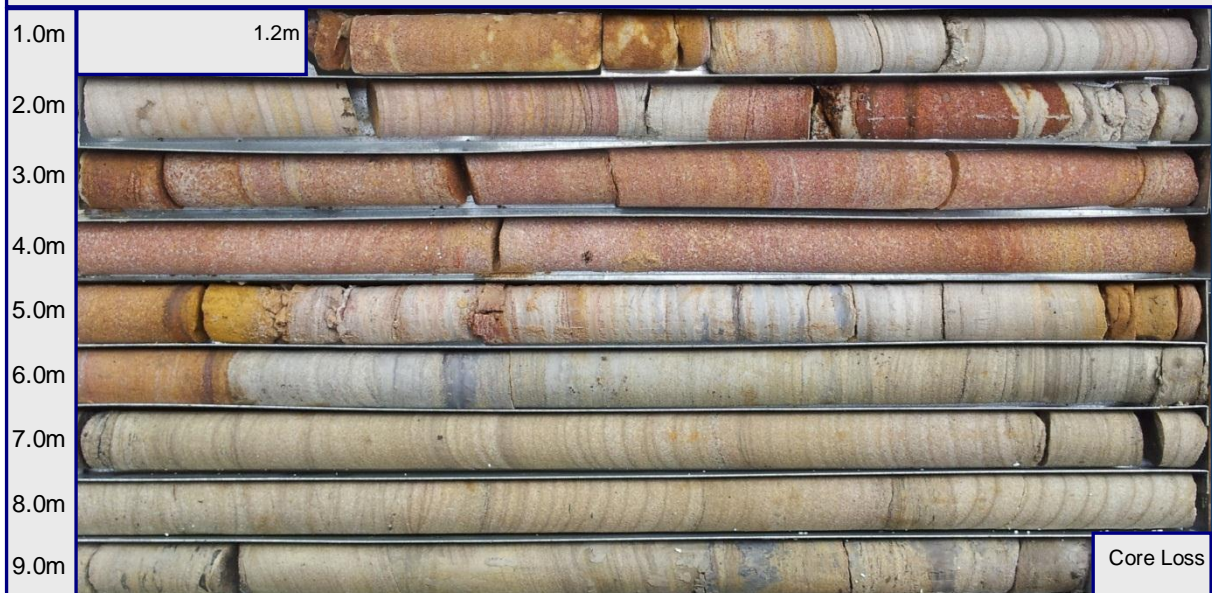
Job No 13188/1 BH6 Started Coring at 1.2m

Client : Nix Anderson Pty Ltd		Job No. : 13188/1							
Project : Proposed Development		Borehole No. : 6							
Location : 160 Burwood Road, Concord		Date : 11/08/2014							
Logged/Checked by : LY/MT									
drill model and mounting : Edson Truck Mounted		slope : 90 deg.	R.L. surface : ≈ 6.3						
core size: NMLC		bearing : deg.	datum : AHD						
barrel lift	water loss/level	depth of R.L. in meters	graphic log	CORE DESCRIPTION rock type, grain characteristics, colour, structure, minor components.	weathering	strength	point load index strength $I_s(50)$	DEFECT DETAILS	
								defect spacing (mm)	DESCRIPTION type, inclination, thickness, planarity, roughness, coating.
		1		Coring start at 1.2m			EL VL L M H VH		Specific General

Client : Nix Anderson Pty Ltd		Job No. : 13188/1						
Project : Proposed Development		Borehole No. : 6						
Location : 160 Burwood Road, Concord		Date : 11/08/2014						
		Logged/Checked by : LY/MT						
drill model and mounting : Edson Truck Mounted		slope : 90 deg.	R.L. surface : $\cong 6.3$					
core size: NMLC		bearing : deg.	datum : AHD					
barrel lift	water loss/level	depth of R.L. in meters	graphic log	CORE DESCRIPTION rock type, grain characteristics, colour, structure, minor components.	weathering	strength	DEFECT DETAILS	
							point load index strength $I_s(50)$	defect spacing (mm)
		6						5.91m B=0° st
		6.5		SANDSTONE; fine to medium grained, grey	F	H		6.27-6.3m Clay infill
		7						
		7.5						
		8						7.86m B=0° co
		8.5						
		9						9.15m B=5° co
		9.5						9.76m = clay seam (5mm)
		10		CORE LOSS				9.86m B=0° co
		10.5		Borehole No 6 terminated at 10.0m

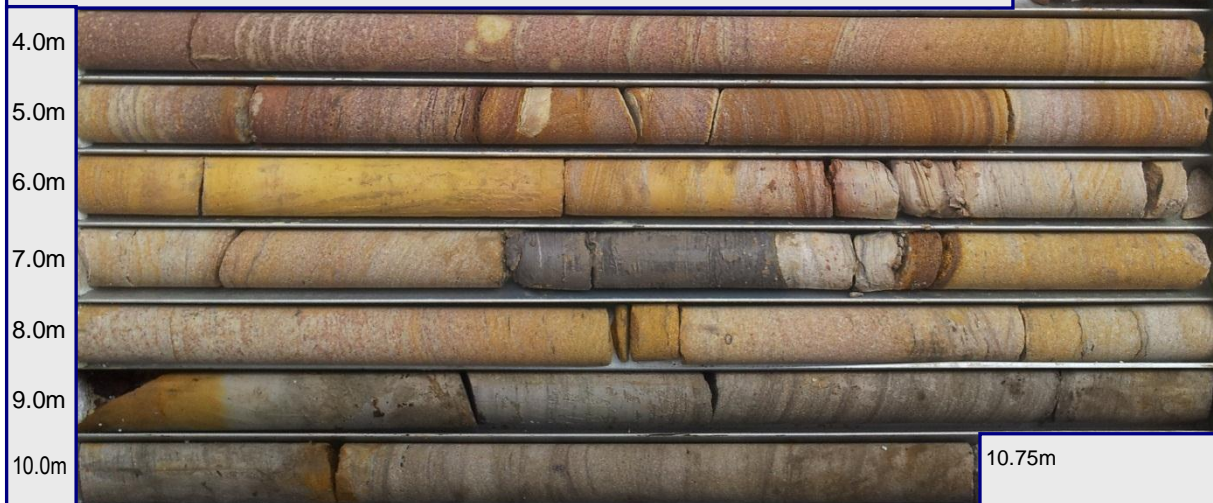
Job No 13188/1 BH7 Started Coring at 3.8m

Client : Nix Anderson Pty Ltd		Job No. : 13188/1							
Project : Proposed Development		Borehole No. : 7							
Location : 160 Burwood Road, Concord		Date : 11/08/2014							
		Logged/Checked by : LY/MT							
drill model and mounting : Edson Truck Mounted		slope : 90 deg.	R.L. surface : ≈ 5.6						
core size: NMLC		bearing : deg.	datum : AHD						
barrel lift	water loss/level	depth of R.L. in meters	graphic log	CORE DESCRIPTION rock type, grain characteristics, colour, structure, minor components.	weathering	strength	point load index strength $I_s(50)$	DEFECT DETAILS	
								defect spacing (mm)	DESCRIPTION type, inclination, thickness, planarity, roughness, coating.
				Start coring at 3.8m			EL VL L M H VH		Specific General
		4		SANDSTONE; coarse grained, brown to red, with some orange staining	DW	M-H

Client : Nix Anderson Pty Ltd		Job No. : 13188/1							
Project : Proposed Development		Borehole No. : 7							
Location : 160 Burwood Road, Concord		Date : 11/08/2014							
		Logged/Checked by : LY/MT							
drill model and mounting : Edson Truck Mounted		slope : 90 deg.	R.L. surface : $\cong 5.6$						
core size: NMLC		bearing : deg.	datum : AHD						
barrel lift	water loss/level	depth of R.L. in meters	graphic log	CORE DESCRIPTION rock type, grain characteristics, colour, structure, minor components.	weathering	strength	point load index strength $I_s(50)$	DEFECT DETAILS	
								defect spacing (mm)	DESCRIPTION type, inclination, thickness, planarity, roughness, coating.
