GEOTECHNIQUE[®] PTY LTD

re: **Proposed Redevelopment
160 Burwood Road, Concord
Additional Contamination Assessment**

13188/4-AA
160 Burwood Road, Concord

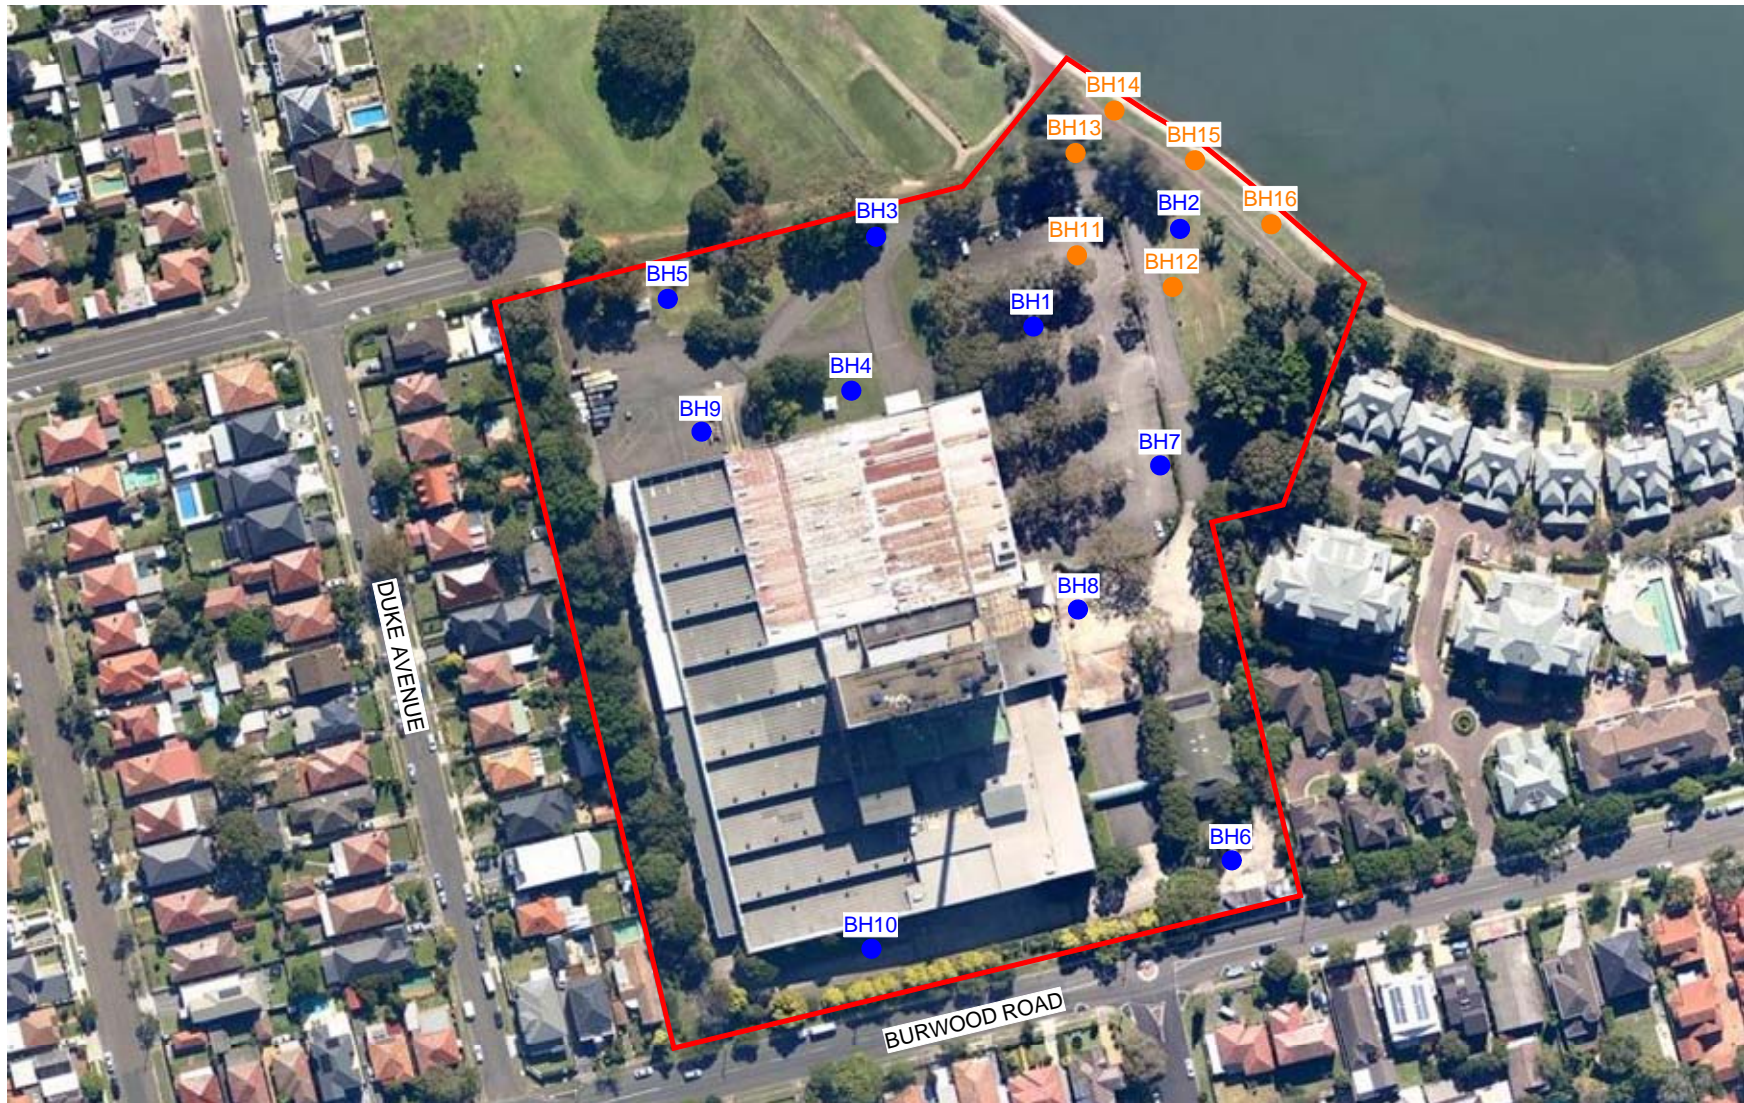
The sampled borehole locations are indicated on the attached Drawing No 13188/3-AA1.

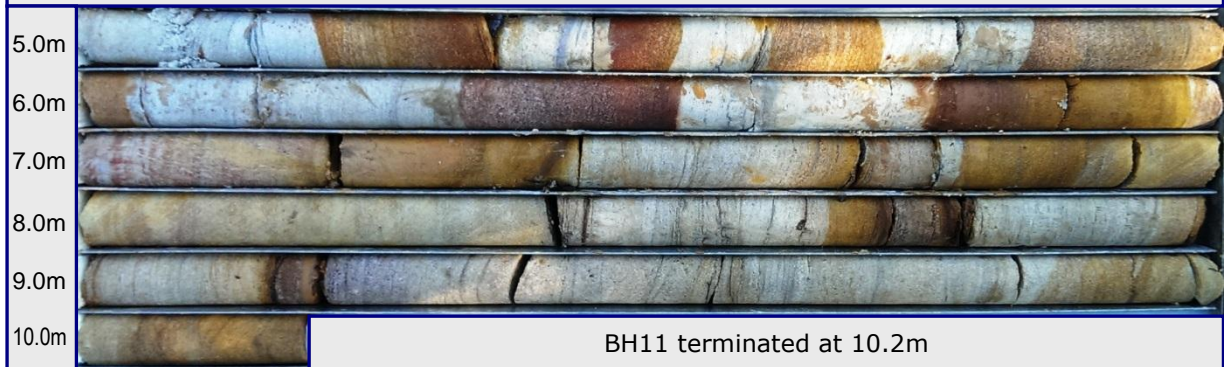
Job No 13188/3 BH11 Started Coring at 5m

Client : Nix Anderson Pty Ltd		Job No. : 13188/3							
Project : Proposed Development		Borehole No. : 11							
Location : 160 Burwood Road, Concord		Date : 09/07/2015							
		Logged/Checked by : MT							
drill model and mounting : Utility Mounted		slope : deg.	R.L. surface : ≈ 3.5						
core size: NMLC		bearing : deg.	datum : AHD						
barrel lift	water loss/level	depth of R.L. in meters	graphic log	CORE DESCRIPTION rock type, grain characteristics, colour, structure, minor components.	weathering	strength	point load index strength $I_s(50)$	DEFECT DETAILS	
								defect spacing (mm)	DESCRIPTION type, inclination, thickness, planarity, roughness, coating.
							EL VL L M H VH	2000 1000 500 300 100 50	Specific General
		5		Coring Commenced at 5.0m					
		6		SANDSTONE, fine to coarse grained, grey to red-brown	DW-SW	L-M			
		7							
		8		SANDSTONE, fine to coarse grained, grey-brown	DW-SW	M-H			
		9

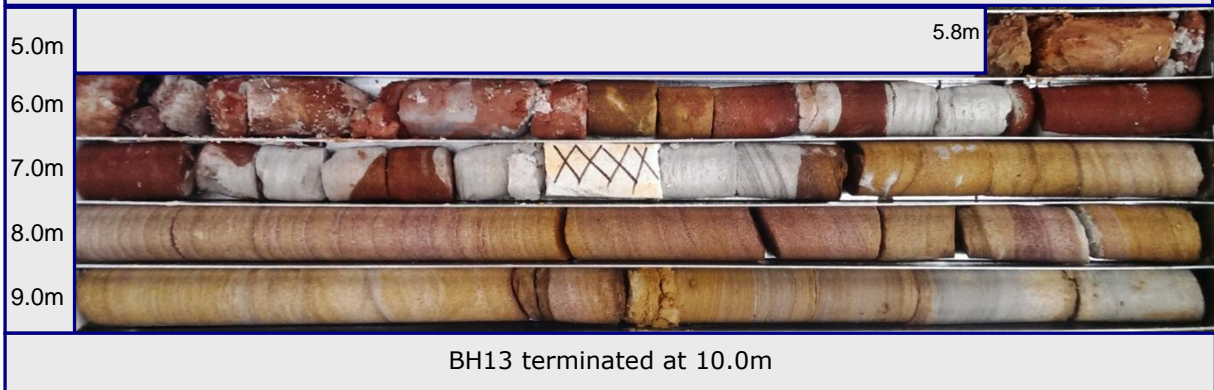
Job No 13188/3 BH13 Started Coring at 5.8m

Client : Nix Anderson Pty Ltd		Job No. : 13188/3							
Project : Proposed Development		Borehole No. : 13							
Location : 160 Burwood Road, Concord		Date : 10/07/2015							
		Logged/Checked by : MT							
drill model and mounting : Utility Mounted		slope : deg.	R.L. surface : ≈ 3.4						
core size: NMLC		bearing : deg.	datum : AHD						
barrel lift	water loss/level	depth of R.L. in meters	graphic log	CORE DESCRIPTION rock type, grain characteristics, colour, structure, minor components.	weathering	strength	point load index strength $I_s(50)$	DEFECT DETAILS	
								defect spacing (mm)	DESCRIPTION type, inclination, thickness, planarity, roughness, coating.
							EL VL L M H VH	2000 1000 500 300 100 50	Specific General
				Coring Commenced at 5.8m					
		6		SANDSTONE, fine to coarse grained, brown to red-grey	DW	L-M			
				SANDSTONE, fine to coarse grained, grey to red-brown	DW	L-M	X		
		7							
				CORE LOSS: 7.4-7.5m					Core loss 100mm

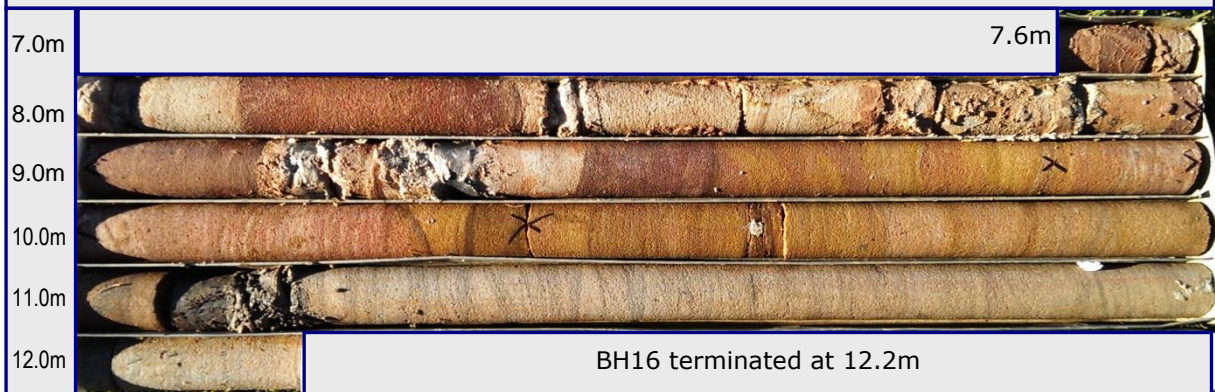
Job No 13188/3 BH16 Started Coring at 7.6m

Client : Nix Anderson Pty Ltd		Job No. : 13188/3								
Project : Proposed Development		Borehole No. : 16								
Location : 160 Burwood Road, Concord		Date : 13/07/2015								
		Logged/Checked by : MT								
drill model and mounting : Utility Mounted		slope : deg.	R.L. surface : ≈ 3.2							
core size: NMLC		bearing : deg.	datum : AHD							
barrel lift	water loss/level	depth of R.L. in meters	graphic log	CORE DESCRIPTION rock type, grain characteristics, colour, structure, minor components.	weathering	strength	point load index strength $I_s(50)$		DEFECT DETAILS	
							EL VL L M H VH	defect spacing (mm)	DESCRIPTION type, inclination, thickness, planarity, roughness, coating.	
				Coring Commenced at 7.6m						
				CORE LOSS: 7.6-7.85m						Core loss 250mm
		8		SANDSTONE, fine to coarse grained, red-brown, grey	DW-SW	M				
		9								
		10		SANDSTONE, fine to coarse grained, red-brown	DW-SW	M-H
