Site Audit Report

0503-1805

165 -169 Holden Street
Ashbury NSW

54448/122753 (Rev 0)

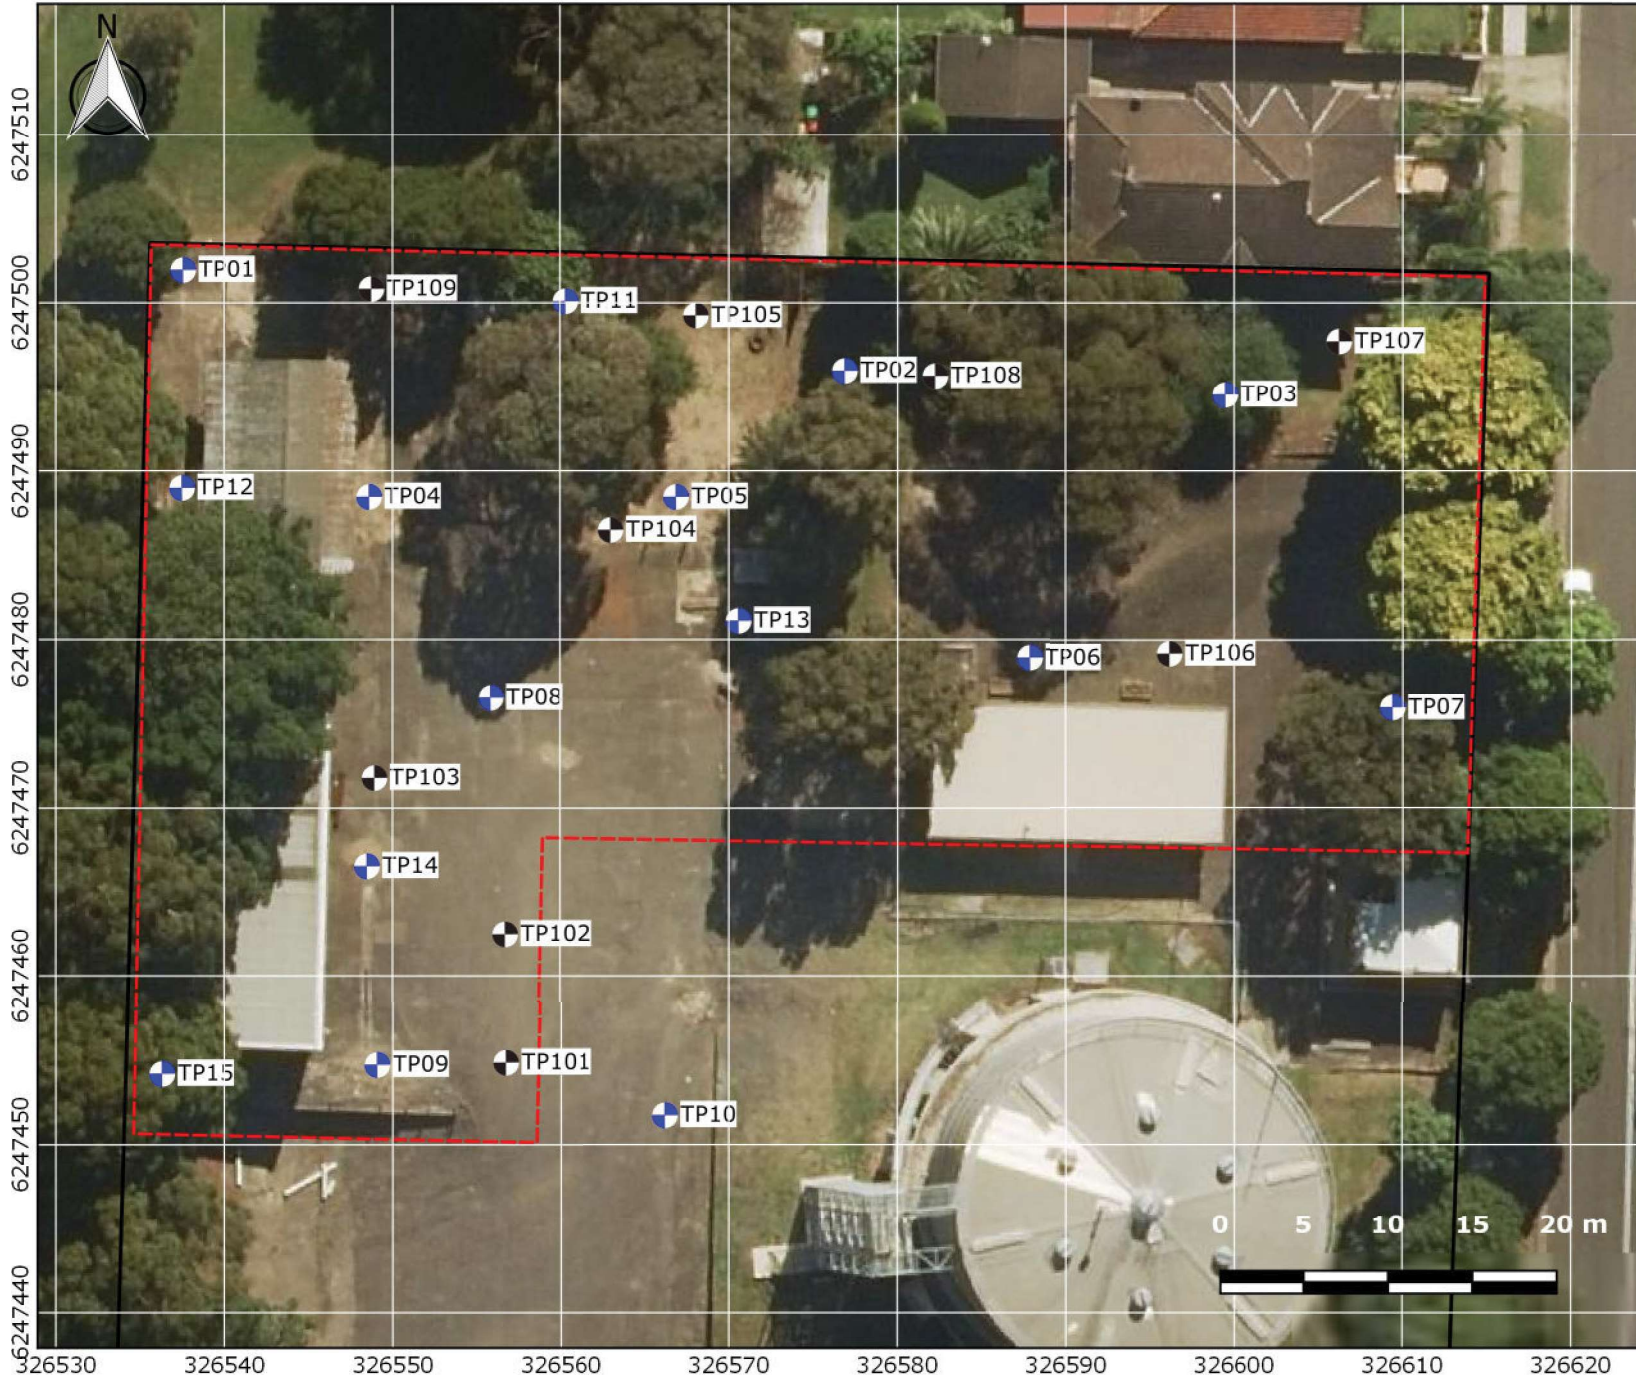
Project Reference	P033725
Report Name	Data Gap Analysis
Client	Sydney Water

- PB Testpit Locations (2015)
- PRM Testpit Location
- Approx. Disposal Area Boundary
- Approx. Sydney Water Property
