Sydney Water

**Summary of Contamination Condition
Part of Ashbury Reservoir, 165-169 Holden Street, Ashbury NSW**

Project Details:	
Project Name:	Summary of Contamination Condition
Site Details:	Part of Ashbury Reservoir, 165-169 Holden Street, Ashbury NSW
Client Name:	Sydney Water
Project Reference	P033725.005 / C0151

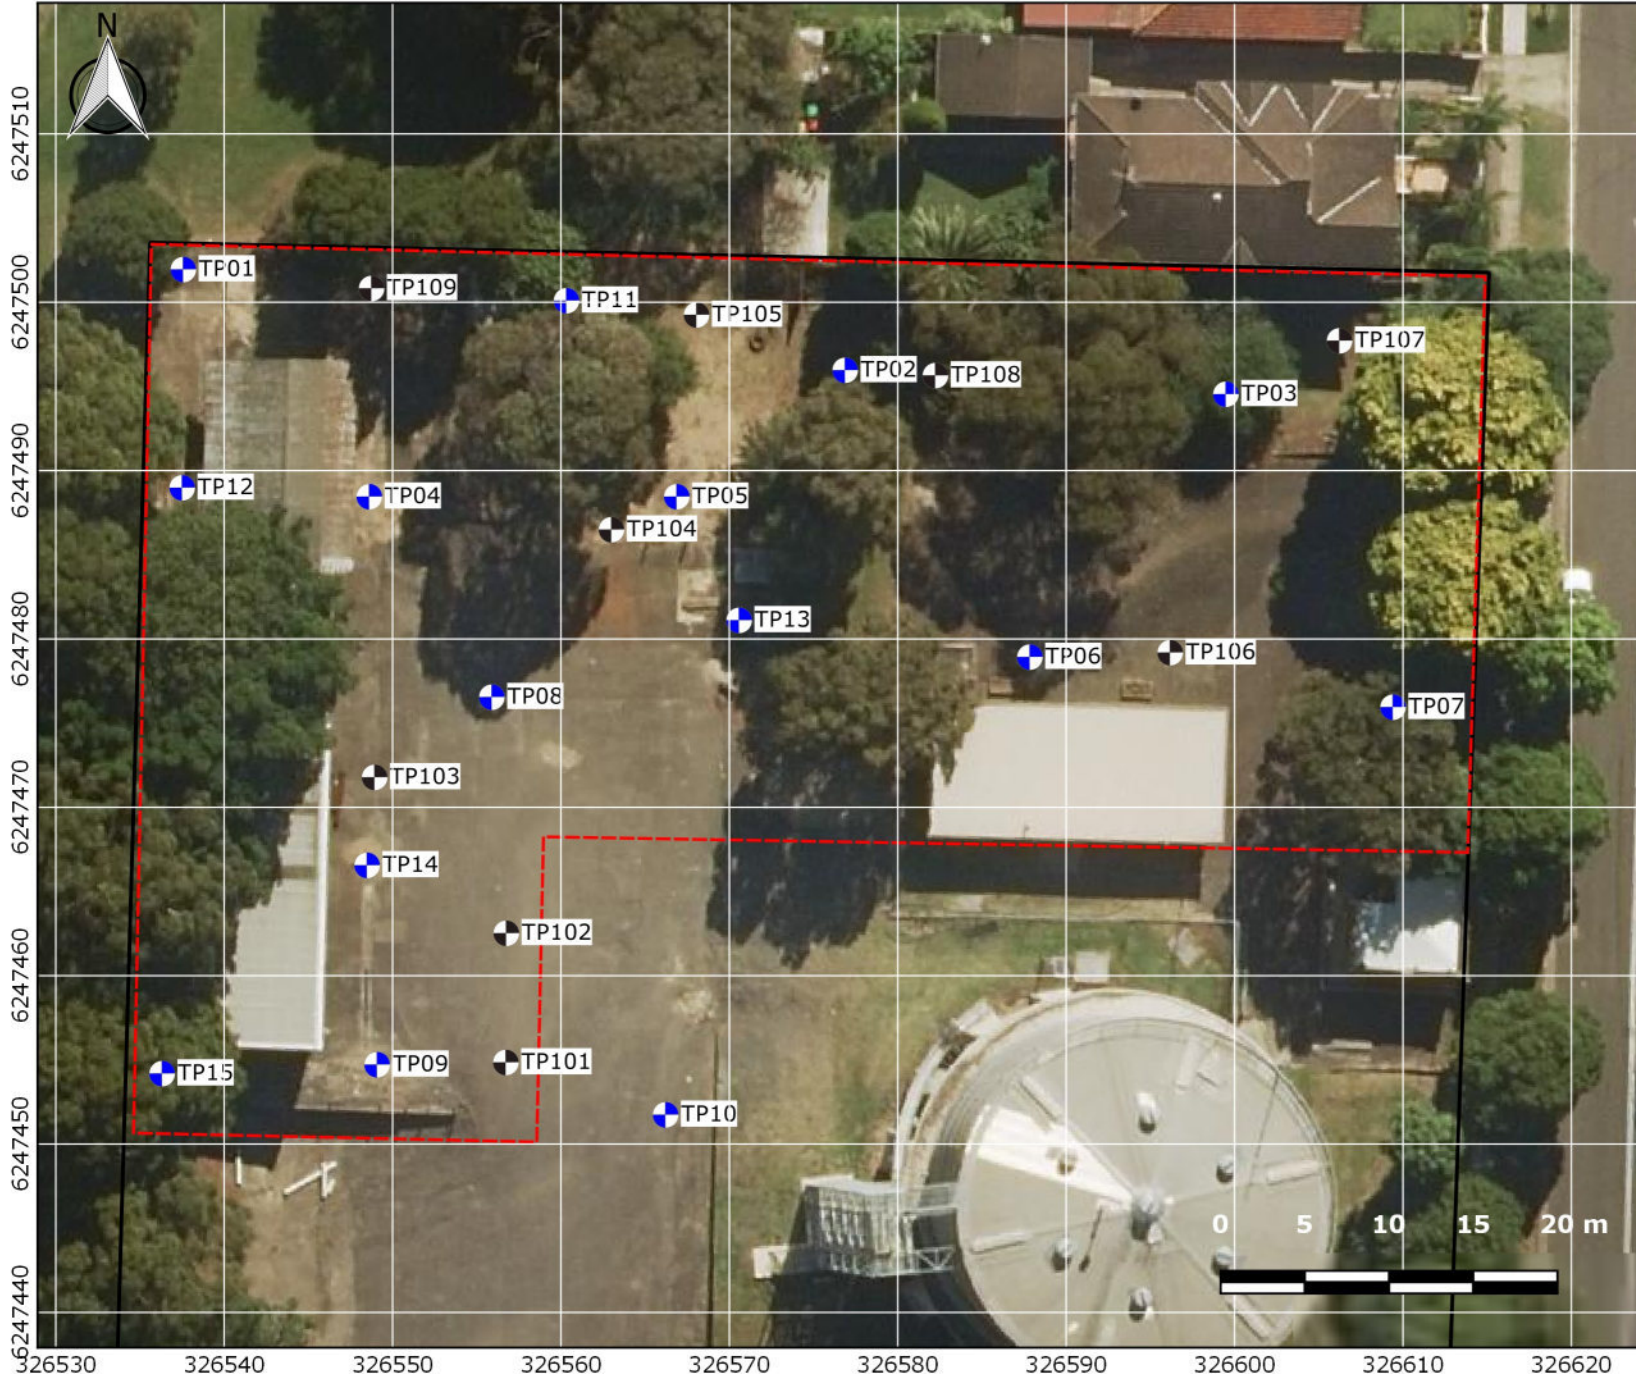
**Site Testing Plan
Figure 2**

- PB Testpit Locations (2015)
- PRM Testpit Location
- Approx. Disposal Area Boundary
- Approx. Sydney Water Property
