Our ref: 2201679B-CLM-LTR-1007 RevC

Stage 1 Preliminary Site Investigation and Sampling, Analysis and Quality Plan - Sydney Water Ashfield Reservoir, 165-169 Holden Street, Ashbury, NSW

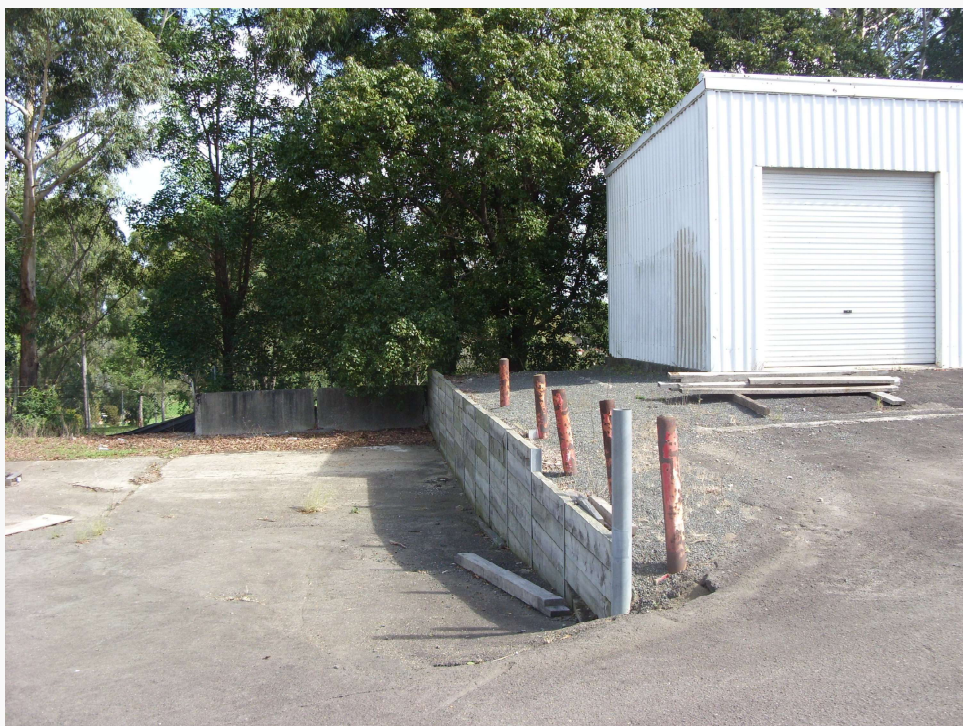
The site is separated from the lower south-western area of the property by a retaining wall, with the areas differing by approximately 1 m at the western side of the site.

Photo 4: View of retaining wall in south-western corner of site area, facing west.

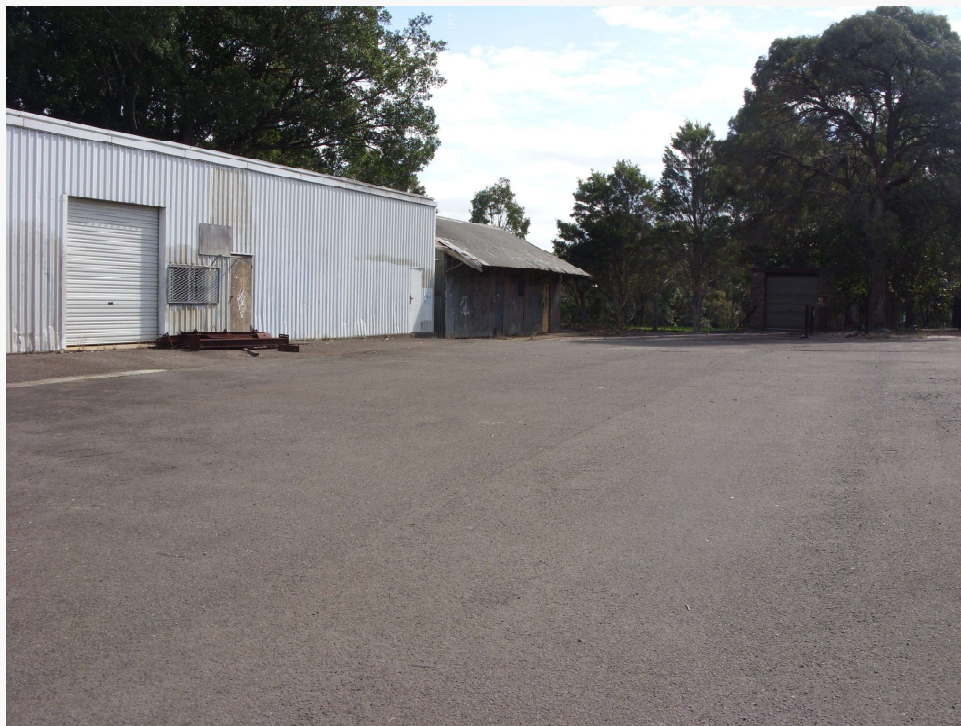
There are three buildings on the site, including a small brick building (likely used for storage) located along the northern boundary, and two larger corrugated metal buildings located along the western site boundary. The southernmost of these buildings appears to have been used for vehicle storage/maintenance, with the northernmost building potentially being used for storage or as a workshop. The southernmost building was indicated to have previously housed petroleum in cabinets on historical licencing information provided by NSW WorkCover (see Table 2). The buildings have fallen into disrepair and are no longer in use.

Photo 5: View of western area of site and site buildings, facing north.

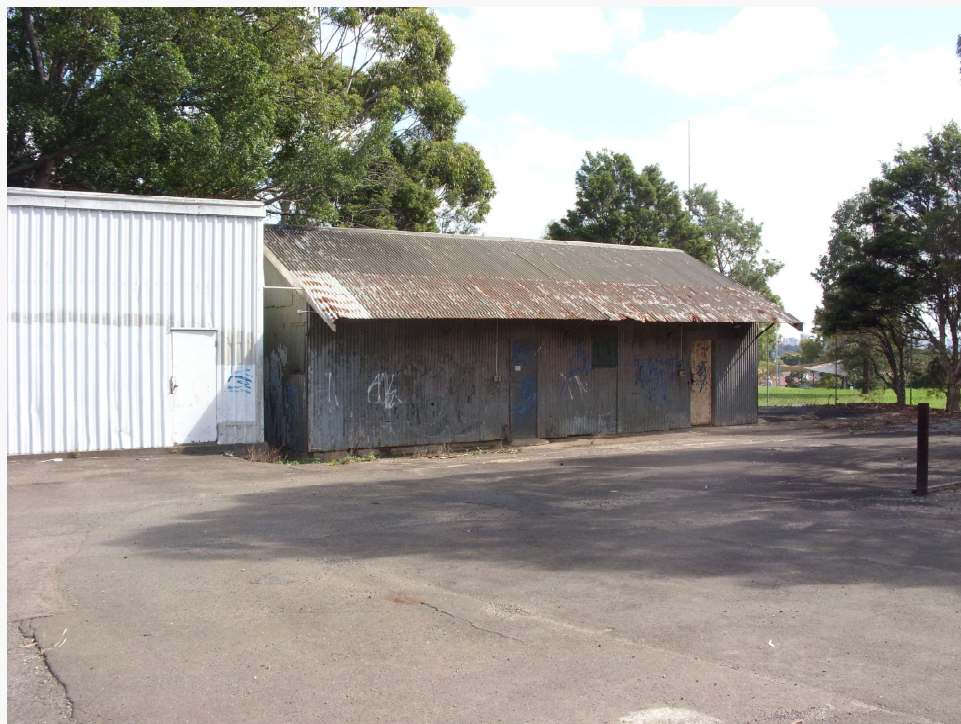
Photo 6: View of site buildings in western and north-western area of site, facing west.

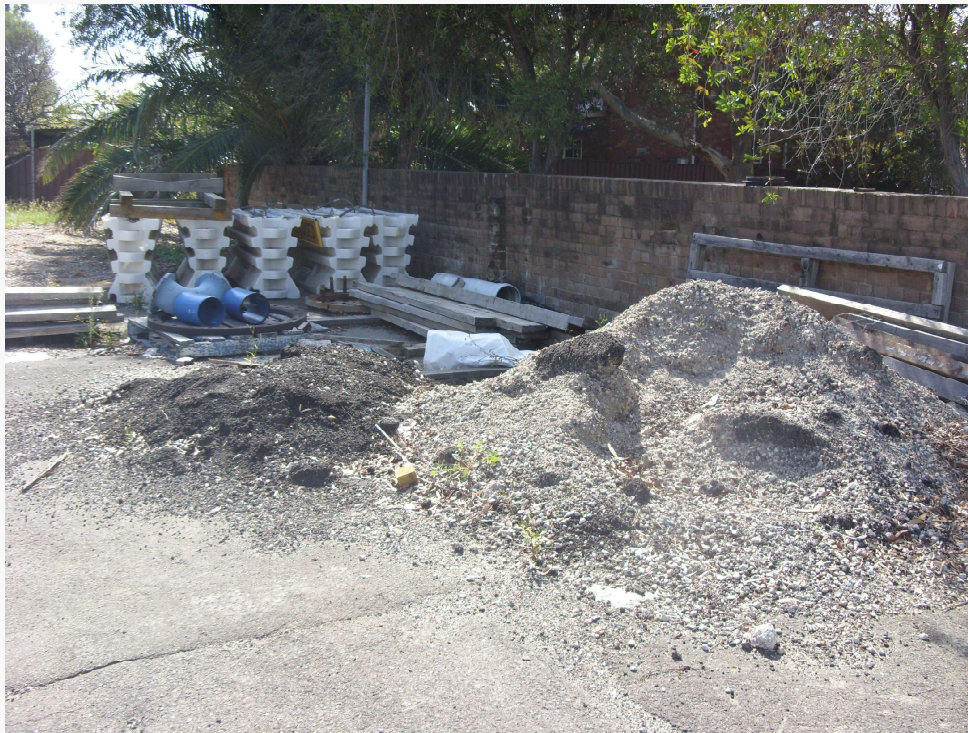
Some building/construction equipment has been placed/stored in the central area of the site, comprising traffic barriers, timber pallets and beams, sections of pipe, and stockpiled gravel/bitumen.

Photo 7: View of storage area in central part of site, facing north-east.

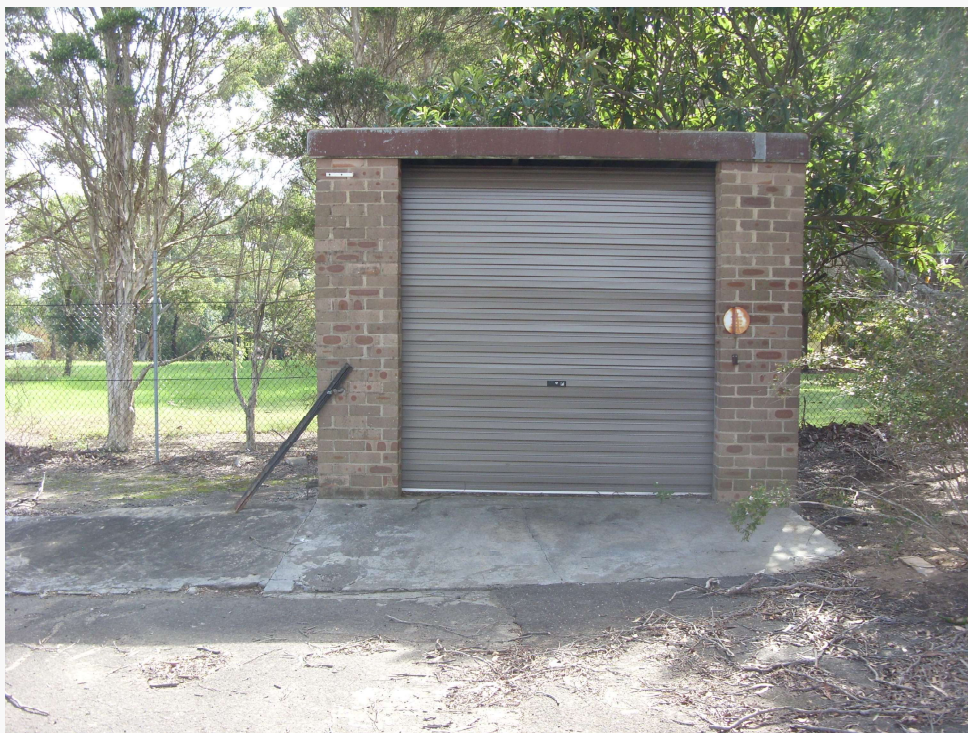
Photo 8: View of storage shed in northern area of site, facing north.

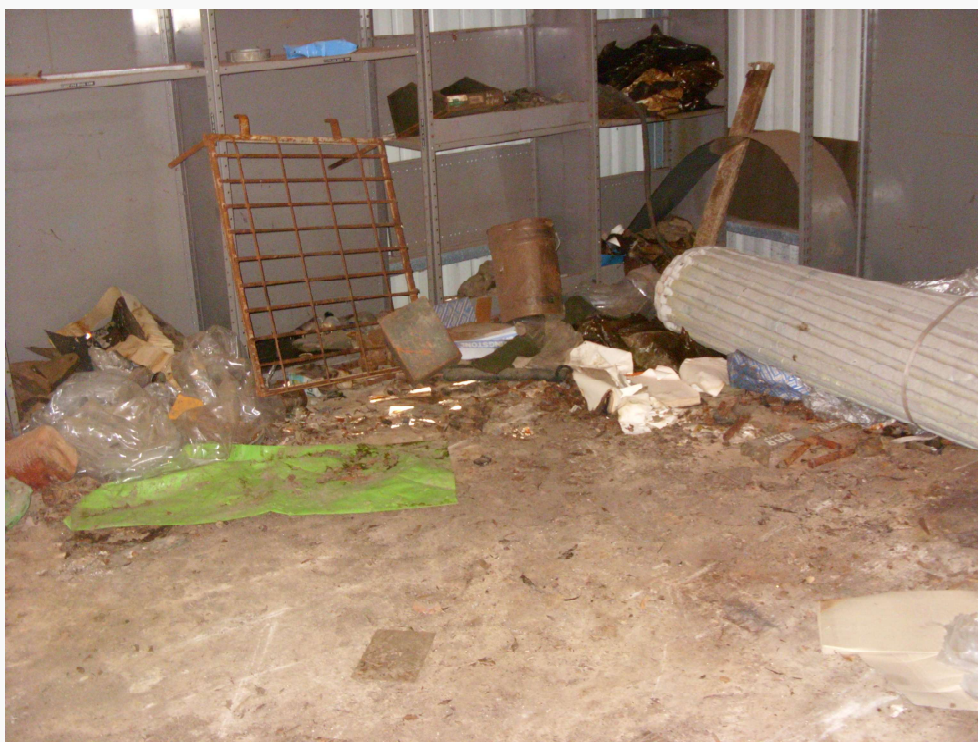
Photo 12: Storage area in southern portion of the south-western site building.

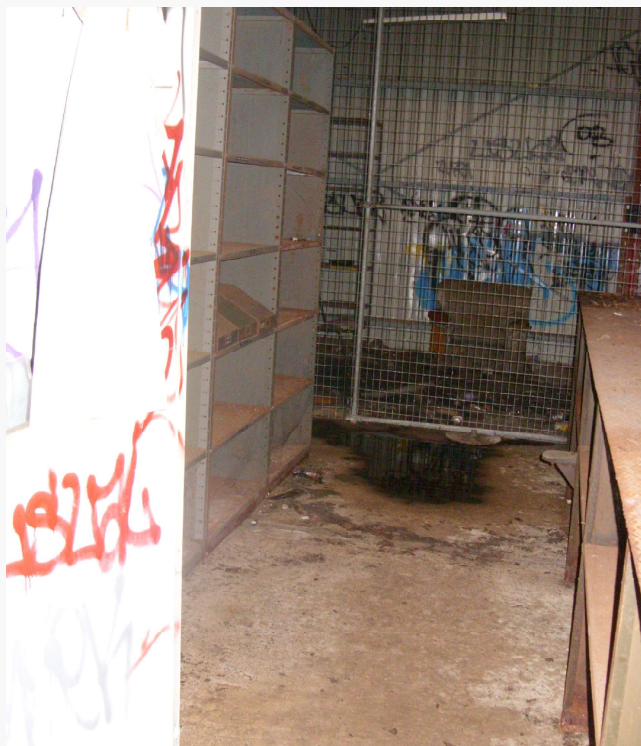
Photo 13: Storage area in northern portion of the north-western site building.

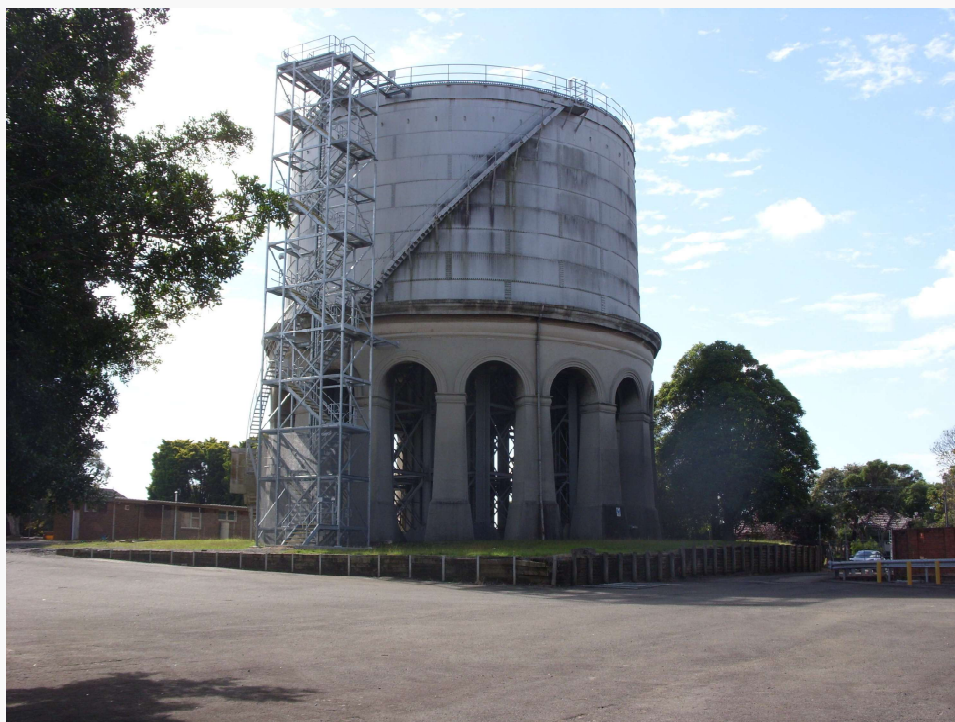
The area of the property to be retained by Sydney Water features the Ashfield Reservoir which is an elevated reservoir (on a large sandstone base structure) located in the central eastern area of the property. Areas of the property to the west and south of the reservoir are lower, with retaining walls having been constructed around this area of the property.

Photo 15: View of Sydney Water reservoir on area of property to be retained, facing north-east.

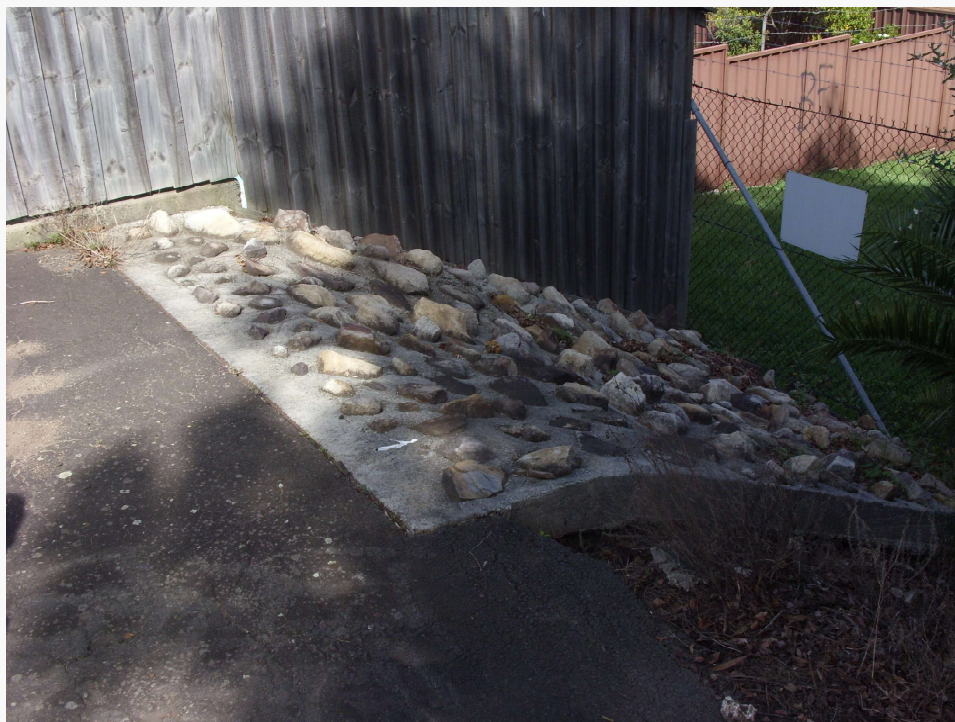
Some cutting and/or filling is apparent at the Sydney Water property, with retaining walls used on the southern and western sides of some areas. This is further discussed in the site walkover section of this report (Section 4). Surface water is expected to flow to the south and west, towards Peace Park, with the retaining wall in the south-western area of the property constructed to reduce the flow speed of surface water entering the park.

Photo 16: View of drainage area into the neighbouring park, in south-western corner of the Sydney Water property (in area to be retained), facing south-west.
