'WOODLANDS' PROPOSED MEDIUM DENSITY
RESIDENTIAL REZONING
126 GREVILLE STREET, WEST CHATSWOOD

ENVIRONMENTAL OVERVIEW

Prepared for **Barana Group Pty Limited**

**22 May 2007
06502278.01
QA.2-05(1)/M**

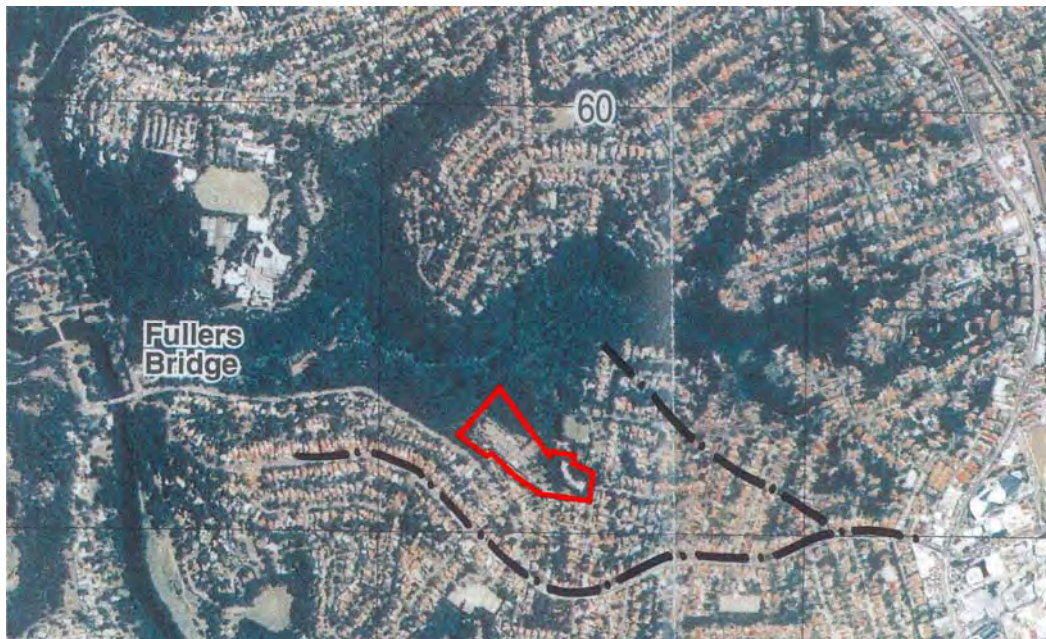
Figure 2: Site Context – Excerpt from 1:25 000 aerial photo showing site and watershed boundary

The context within which the site is set is broadly defined in Figures 1 and 2.

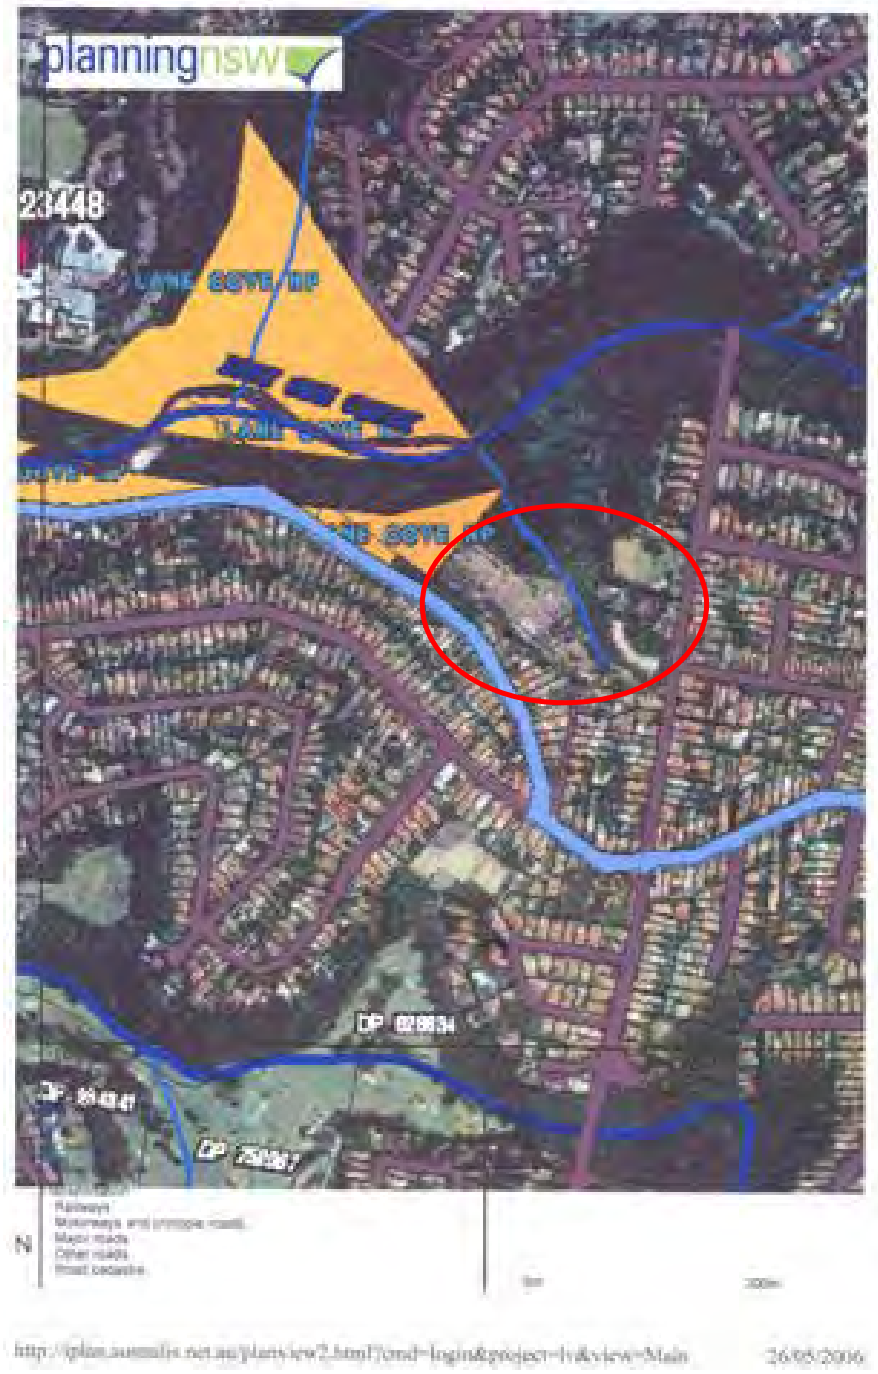
Figure 3: Plan showing location of Lane Cove National Park relative to site

The site is set on its north-western and north-eastern perimeters against the steeply incised, Blue Gum Creek bushland valley. The catchment within which the site is set drains into the Lane Cove National Park (refer Figure 3). The site adjoins the National Park along its north-western boundary, and dense bushland held in State Government ownership along its north-eastern boundary. The bushland to the north-east of the site is severely weed infested, although some of this area has recently been subject to primary bush regeneration works. The corridor running between the two portions of the National Park is currently owned by the RTA, and we have been advised that this land will shortly be transferred to the National Park.

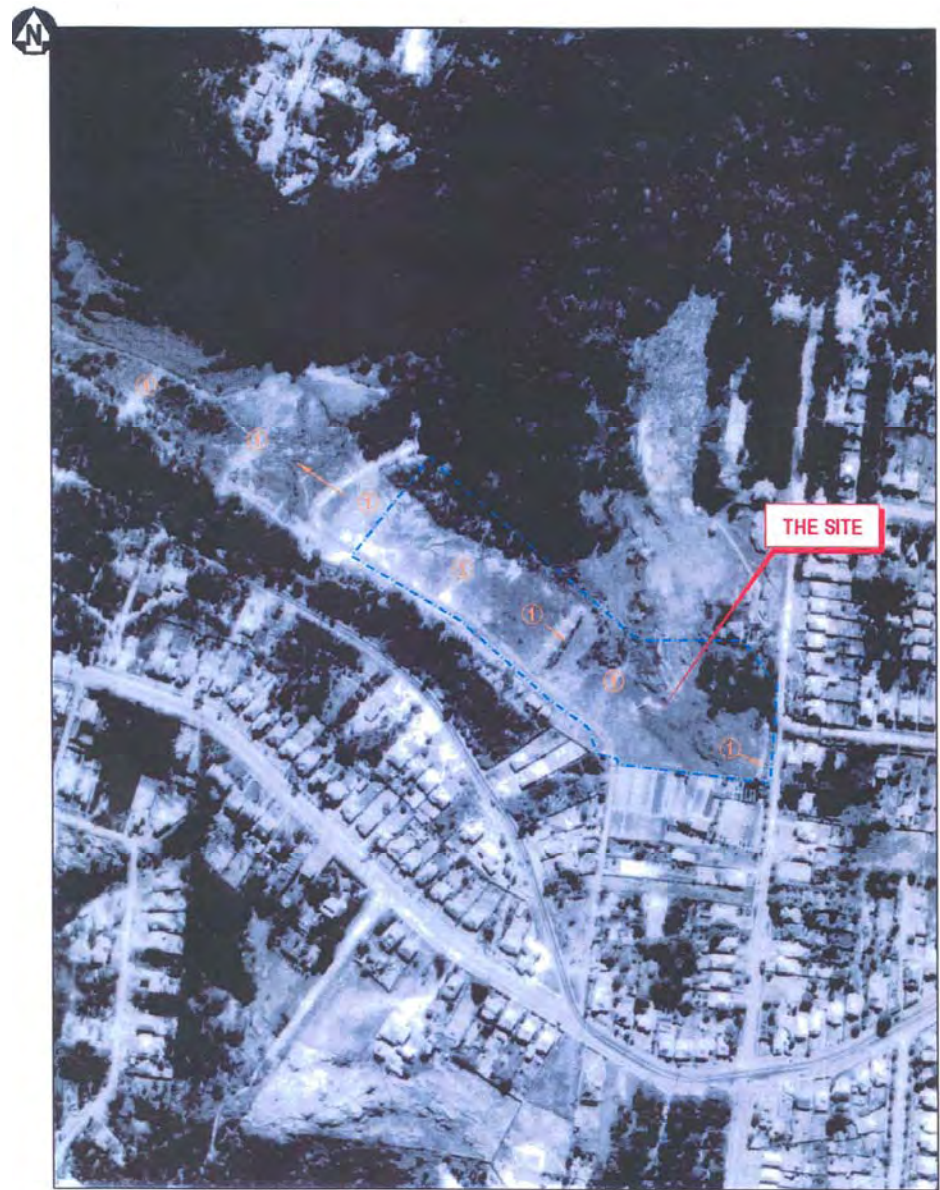
Plate 1: Aerial photograph of the site in 1951 showing land use as a rifle range. Note site is predominantly cleared with the exception of minor remnants retained within the north-west and north-east corner of the site

Between c.1915 and 1985, the site was used as a rifle range. Aerial photographs from 1951 show that it was substantially clear of vegetation (refer Plate 1). The existing development was undertaken in 1986 (refer Plates 2, 3 and 4), and comprises an elevated three and four level concrete office building with a large footprint, and a separate two level concrete car park.

As can be seen from Plate 1, the upper reach of the watercourse was virtually completely cleared in 1951, and then in Plates 2 and 3, this area appears to have again been effectively destroyed as a result of the building construction works. The current watercourse must in the main be presumed to be constructed.

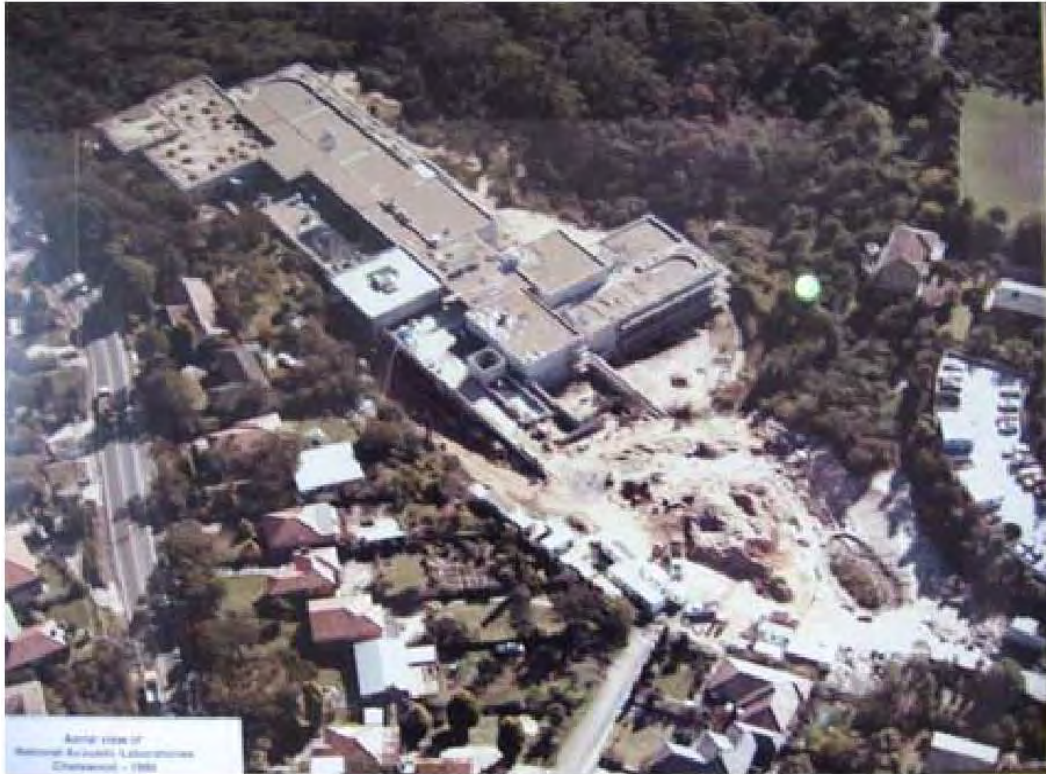
Plate 2: Aerial photograph of the site in 1986 looking due north. Note the extent of construction works over the watercourse.

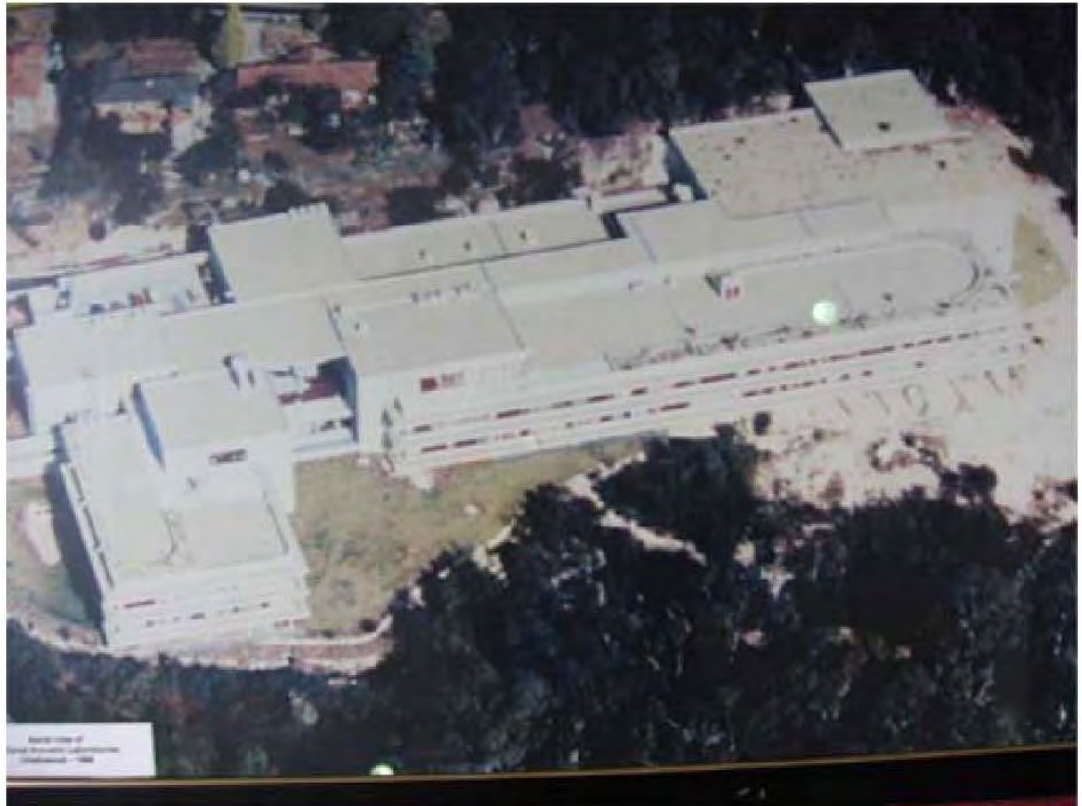
Plate 4: Aerial photograph of the site near completion

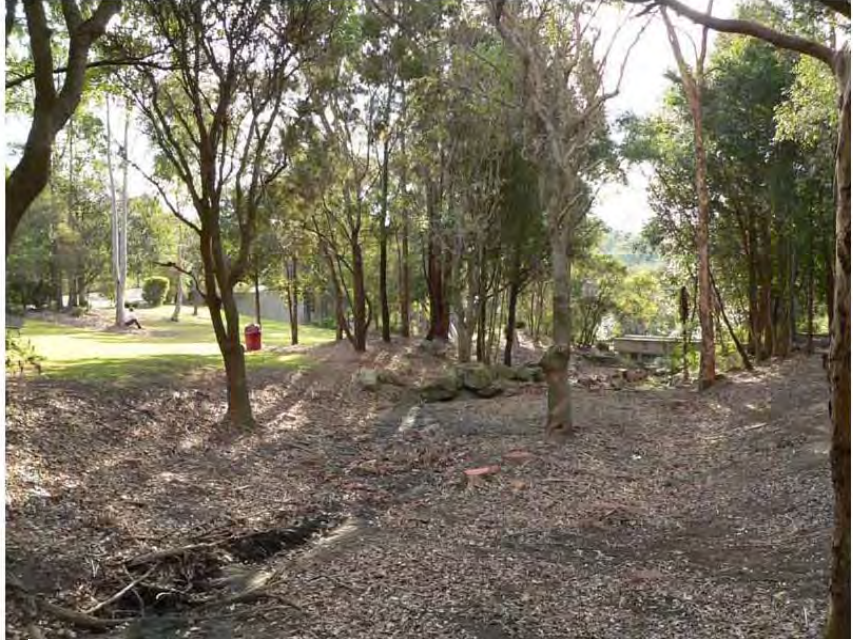
Plate 5: View from the near the top of the watercourse looking downstream to the existing pedestrian bridge. Note the almost entire lack of groundcover, that some of the remaining trees are Coral trees yet to be removed, and the stability of the watercourse in this area.

The upper reaches of the watercourse and areas around the car park were until recently heavily weed infested with coral trees and a forest of privet, as is still in place within the bushland to the north-east of the site. The client has under the supervision of an arborist removed the majority of this weed infestation. Subsequently the upper reaches of the watercourse have limited remaining plant cover (refer Plate 5).

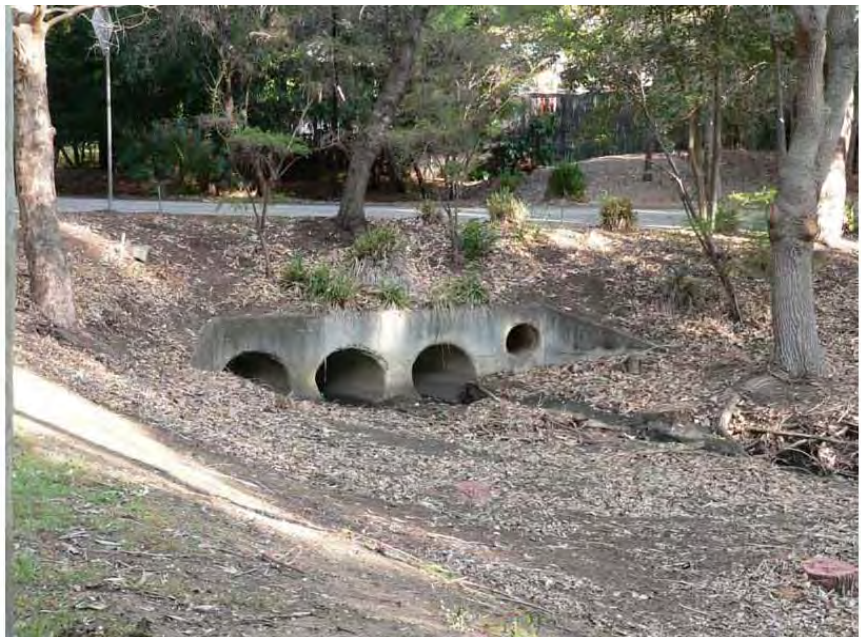
Plate 6: Starting point of the watercourse. The three large pipes connect directly to Greville Street.

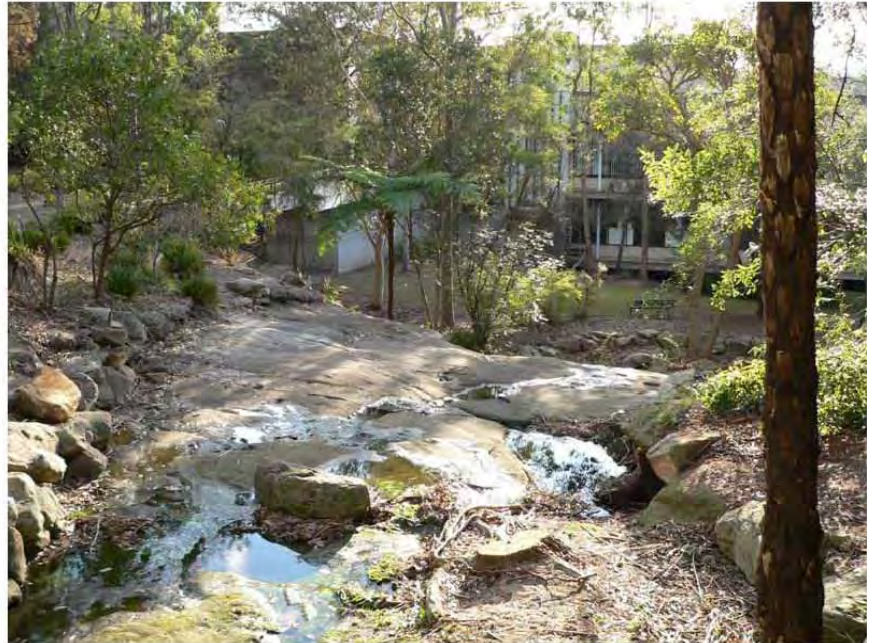
Plate 7: View from existing pedestrian bridge to Waterfall 02

A formed watercourse is evident from downstream of Headwall 01. Some 20m downstream of this point, a small constructed waterfall approximately 1.5m high by 2-3m wide has been made using site rock (Waterfall 01 – Constructed), possibly to conceal a trunk sewer main inspection pit. The trunk sewer main appears to run through the watercourse at this point as shown on the Services Survey (refer Figure 6). Approximately 30m downstream of this point the watercourse leaves its earthen banks and fans out across exposed sandstone shelving before falling at Waterfall 02 some 3m to a further area of broad, open rock shelving (refer Plate 7).

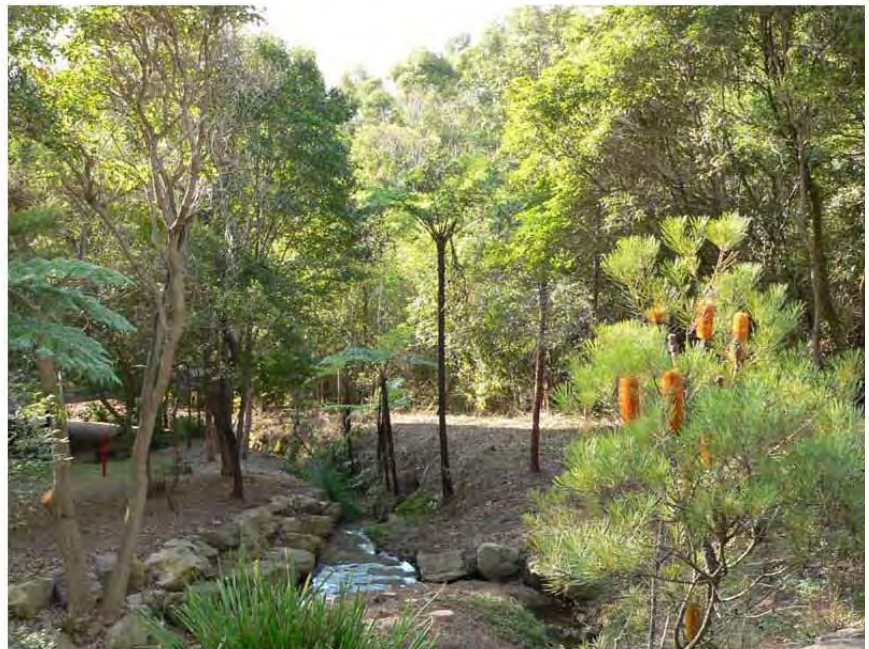
Plate 8: View looking downstream to the channel entry point with adjoining heavily weed-infested neighboring site in the background

This watercourse then quickly transitions to a channel where it appears to have been re-routed as part of the 1986 development of the site, in order to avoid the northern-most part of the existing building. The watercourse in this area is approximately 1.0 – 1.5m wide with steep to near vertical sides, some of which are constructed using rip-rap sandstone, and are approximately 1.0 to 1.5m high, as located in Figure 4, and shown in Plates 8 and 9. The bed of the watercourse in this area is sandstone bed rock which exhibits some potholing, suggesting that the watercourse may have previously been quite flat and broad at this point before spilling over the main waterfall within the site (Waterfall 03), just to the north of the existing building.

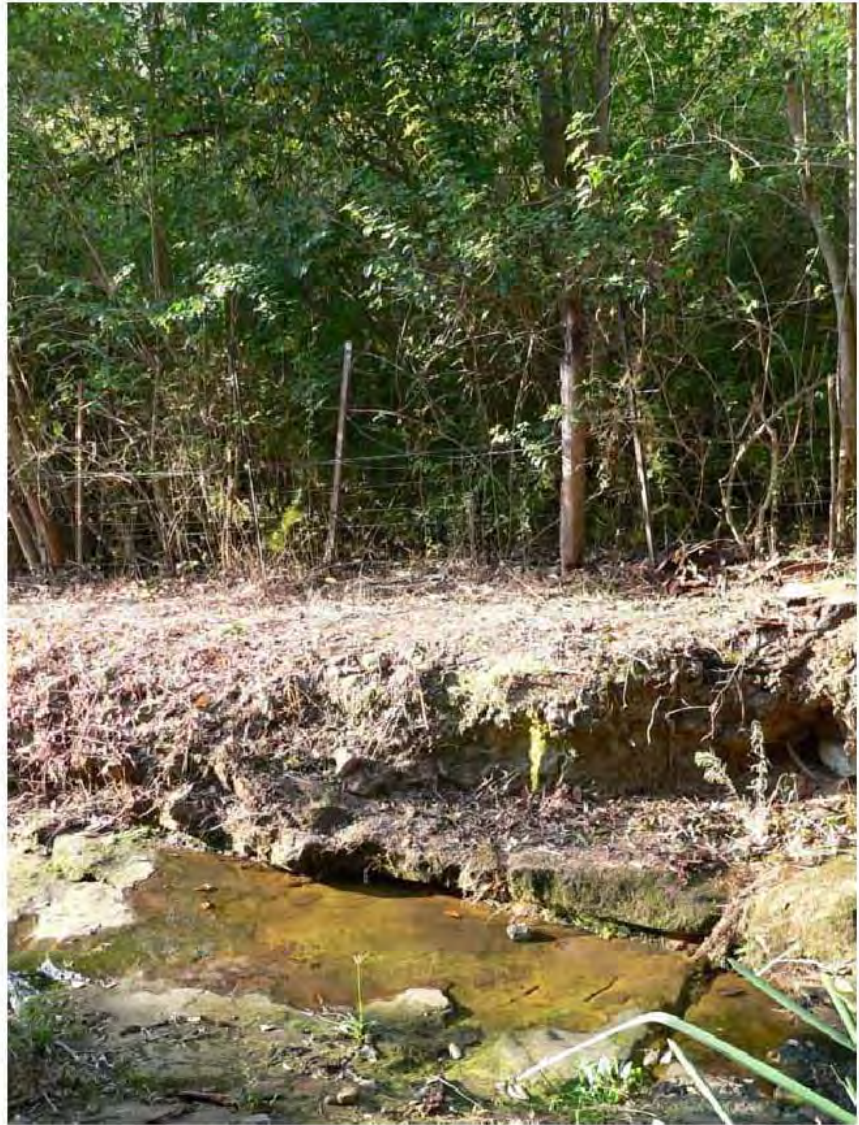
Plate 9: View of watercourse where it is channelled near the north-east boundary of the site. Note the extent of privet infestation on the adjoining lot – the watercourse on the site was until recently in the same condition. Note the sandstone bed of the channel and active erosion to the bank in this

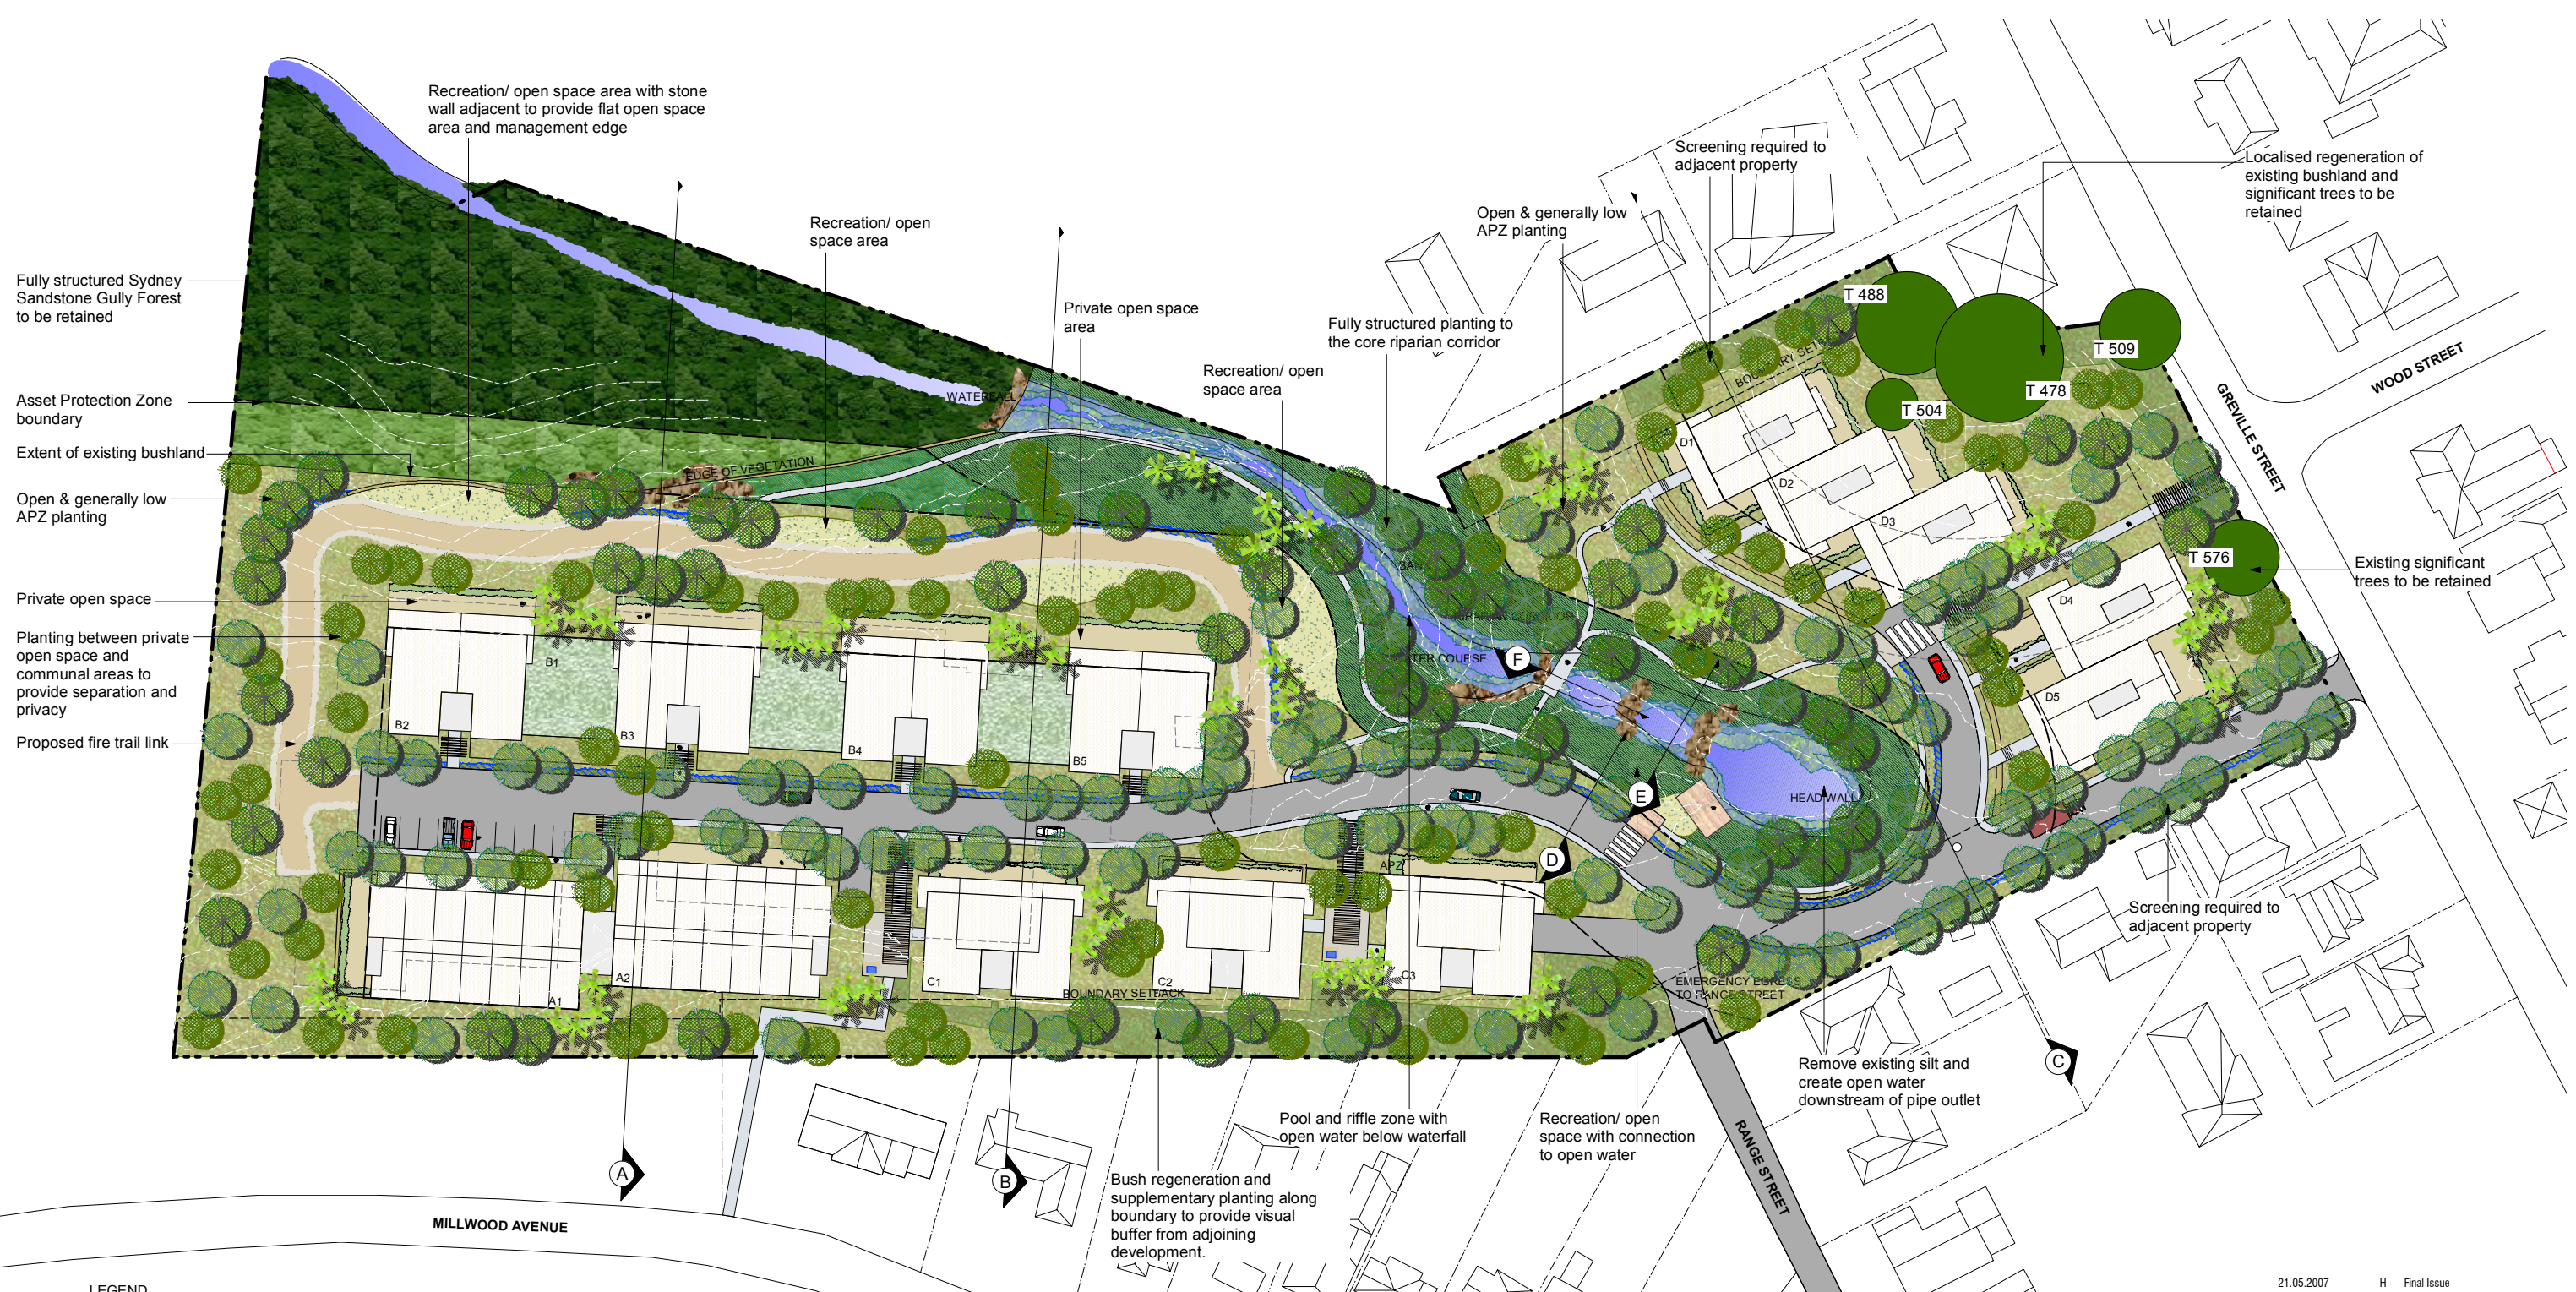
SK01H

Landscape Plan
'Woodlands' Medium Density Residential Development
 Barana Group

Figure 7 (EDAW Dwg. No. SK01) shows the layout of the proposed development, and the associated proposed Landscape / Restoration approach. Figure 8 (EDAW Dwg. No. SK07) comprises:

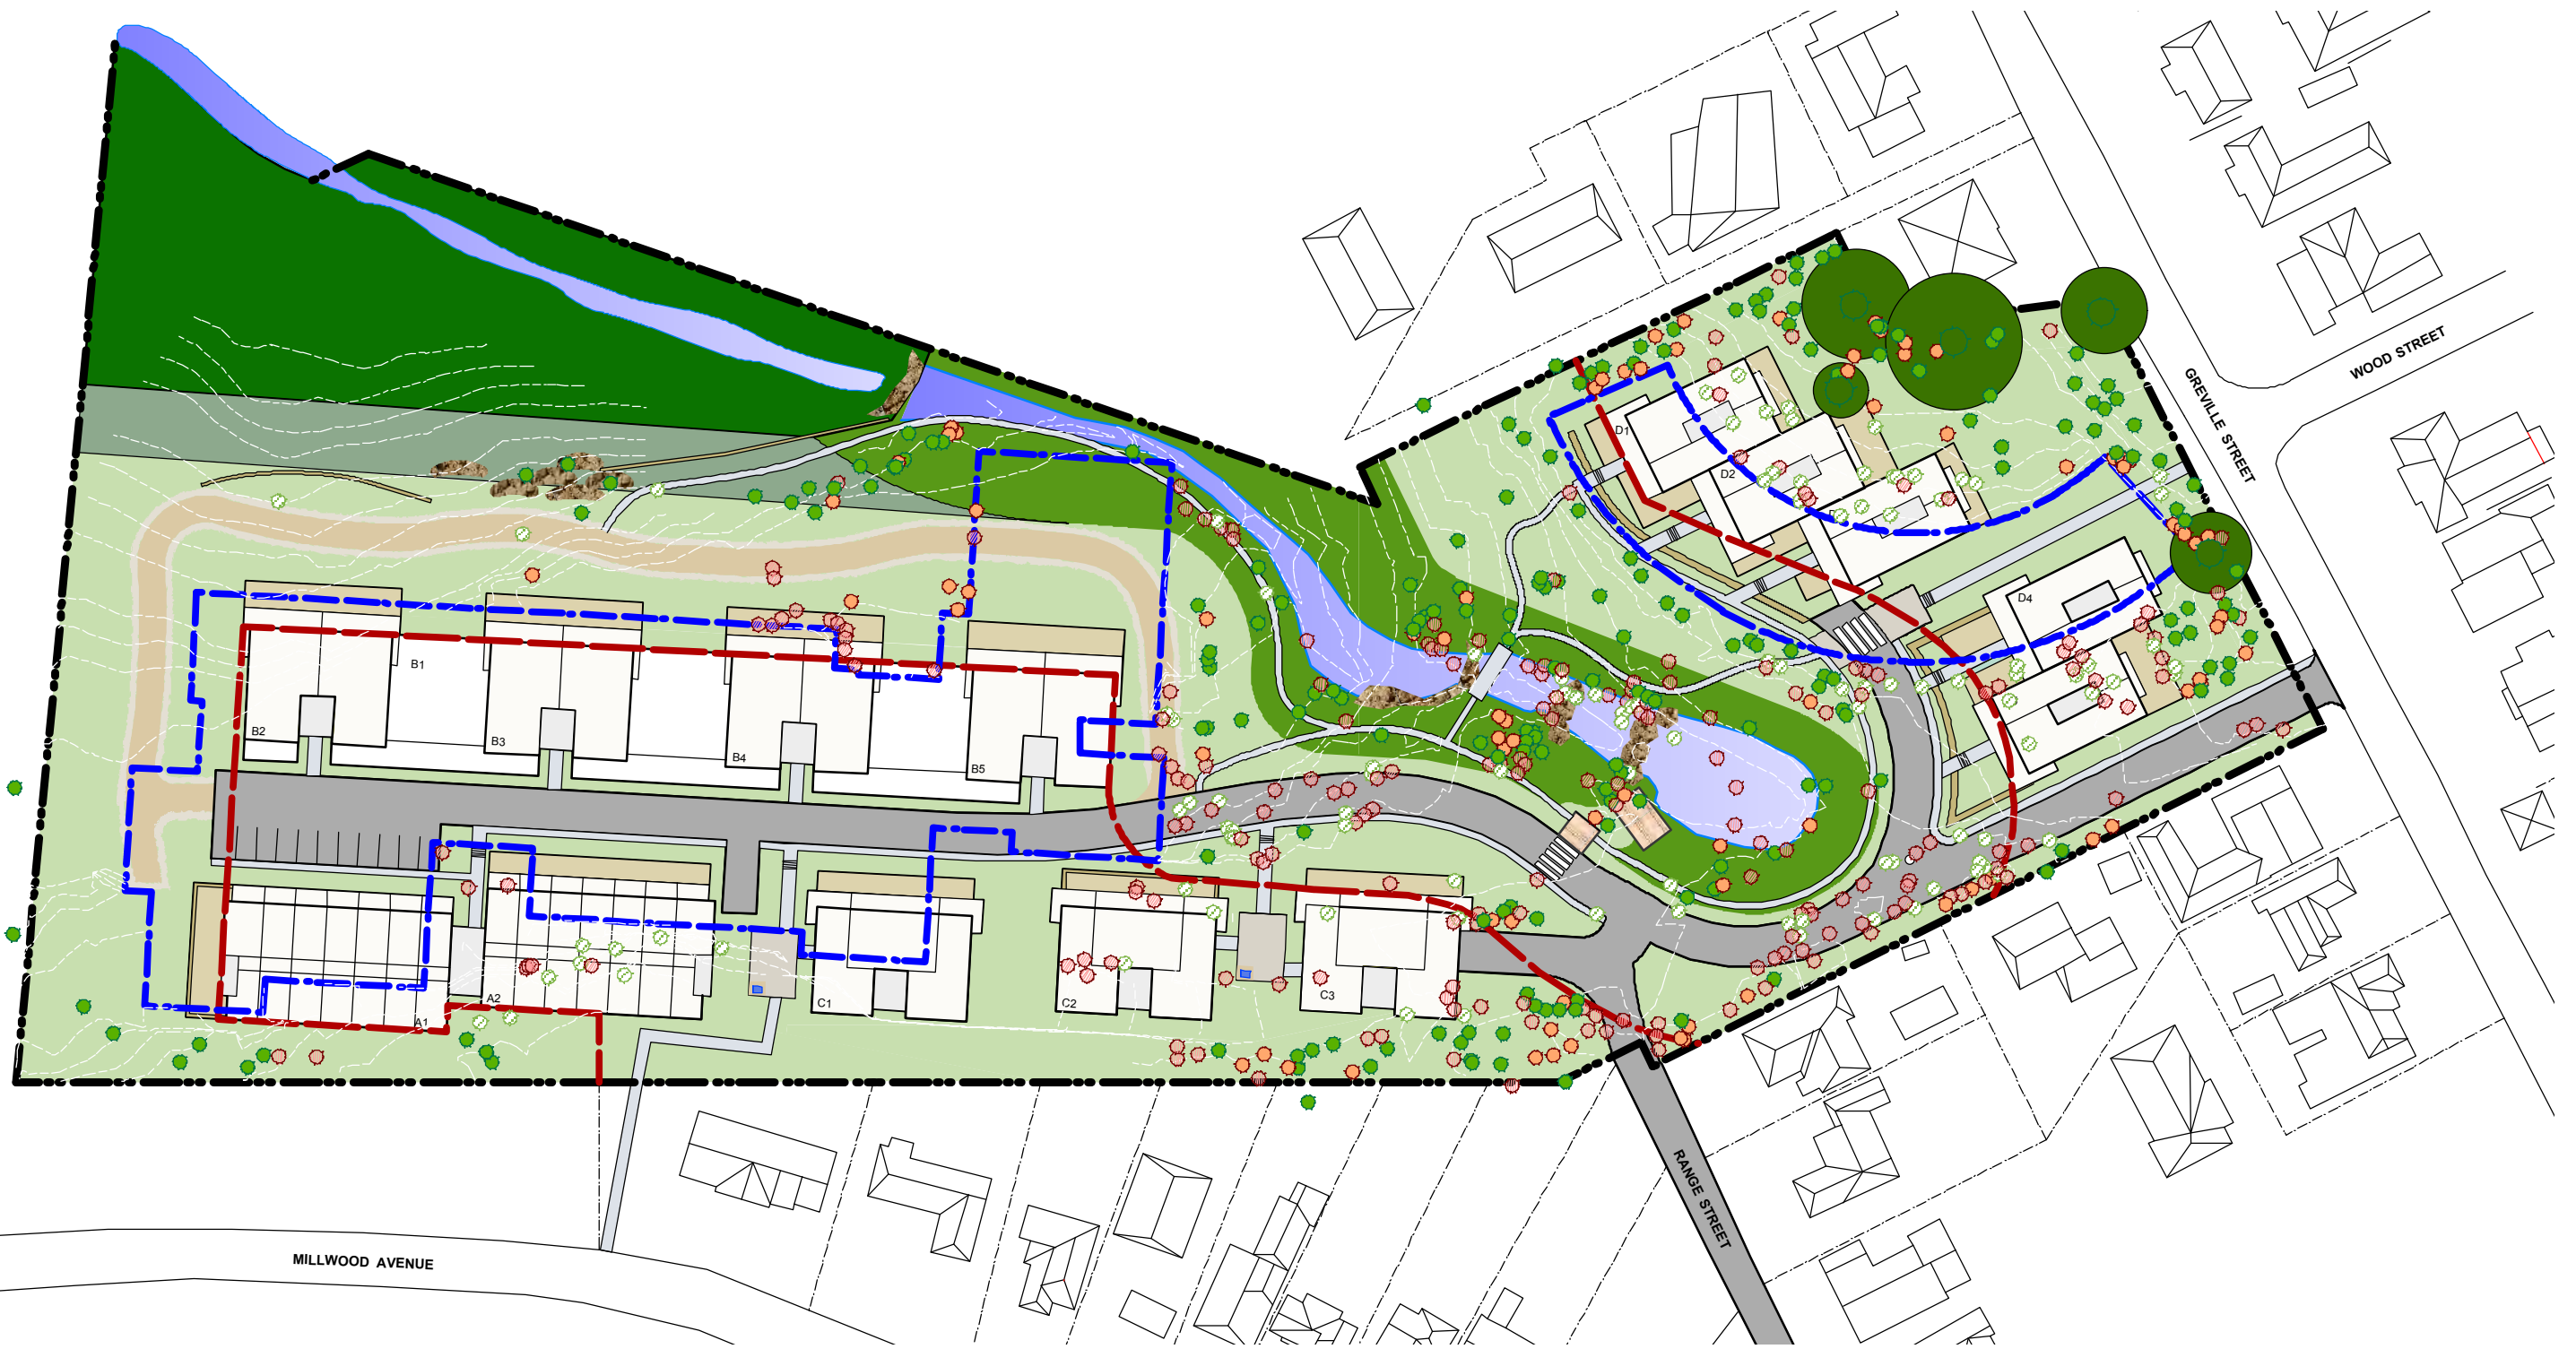
- Existing tree to be retained with class AA. Total number to be retained = 5
- Existing tree to be retained with class A1, A2, A3 and A4. Approximate number to be retained = 200
- Existing tree to be removed with any A classification that falls within 2 metres of building and construction works. Approximate number to be removed = 100

- Existing tree to possibly retain with Z1, Z6, Z8, Z10 and Z11 category. Approximate number potentially to be retained = 80
- Existing tree to be removed with class Z2, Z3, Z4, Z5, Z7, Z9, Z12 and those with any Z class that falls within 2 metres of building and construction works. Approximate number to be removed = 220

1. Refer to Arborist Report, May 2007 for further detail. Report prepared by Australian Tree Consultants.
2. This drawing provides an indication of trees likely to be retained and removed based upon their proximity to construction works. Final numbers will be determined as part of the detail design process.
3. Some tree symbols represent more than a single tree.

An arboricultural assessment of the site was undertaken by Australian Tree Consultants Pty Ltd. Remnant bushland trees no. 478, 488, 504, 509 and 576 (Angophoras and Blackbutts) within the eastern corner of the site, were identified as being significant trees worthy of being retained. Two of these trees were identified as being 'large old remnants'. It is proposed to retain these five (5) trees as part of any re-development of the site.

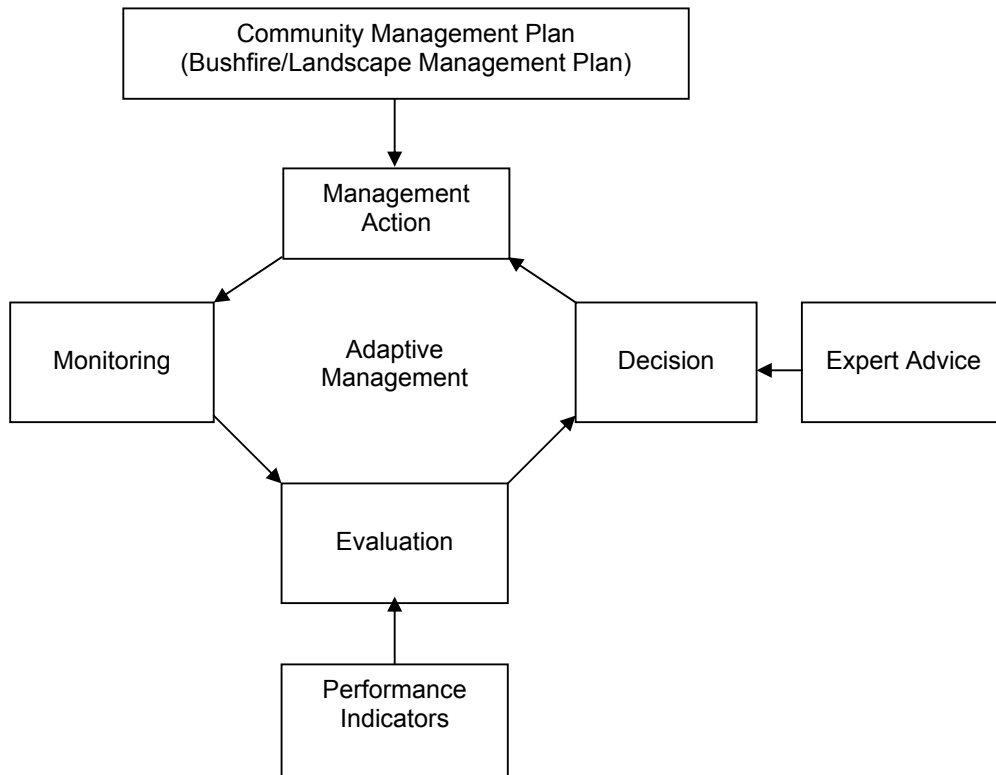
Figure 10: Adaptive Management Flow Diagram

The above management approach would be an adaptive one (see Figure 10), that can be reviewed upon request on an annual basis by the Bushfire Management Consultant, in consultation with other specialists / stakeholders as appropriate, e.g. the Bushland Regeneration Contractor, Landscape Architect, Council, etc. The aim of the management process is to facilitate the establishment and on-going creative development of a high quality 'urban/bushland community precinct' that maximises both environmental and urban design outcomes. However, where any proposed change to the management plan has the potential to impact adversely upon bushfire safety outcomes, the final decision on what changes (if any) can be made would rest with the Bushfire Management Consultant.
