**DETAILED SITE INVESTIGATION REPORT  
67 & 75 MARY STREET, 43 ROBERTS STREET, 50 & 52 EDITH STREET, ST PETERS  
NSW**

**Report E22317 AA\_Rev 3  
18 September 2015**

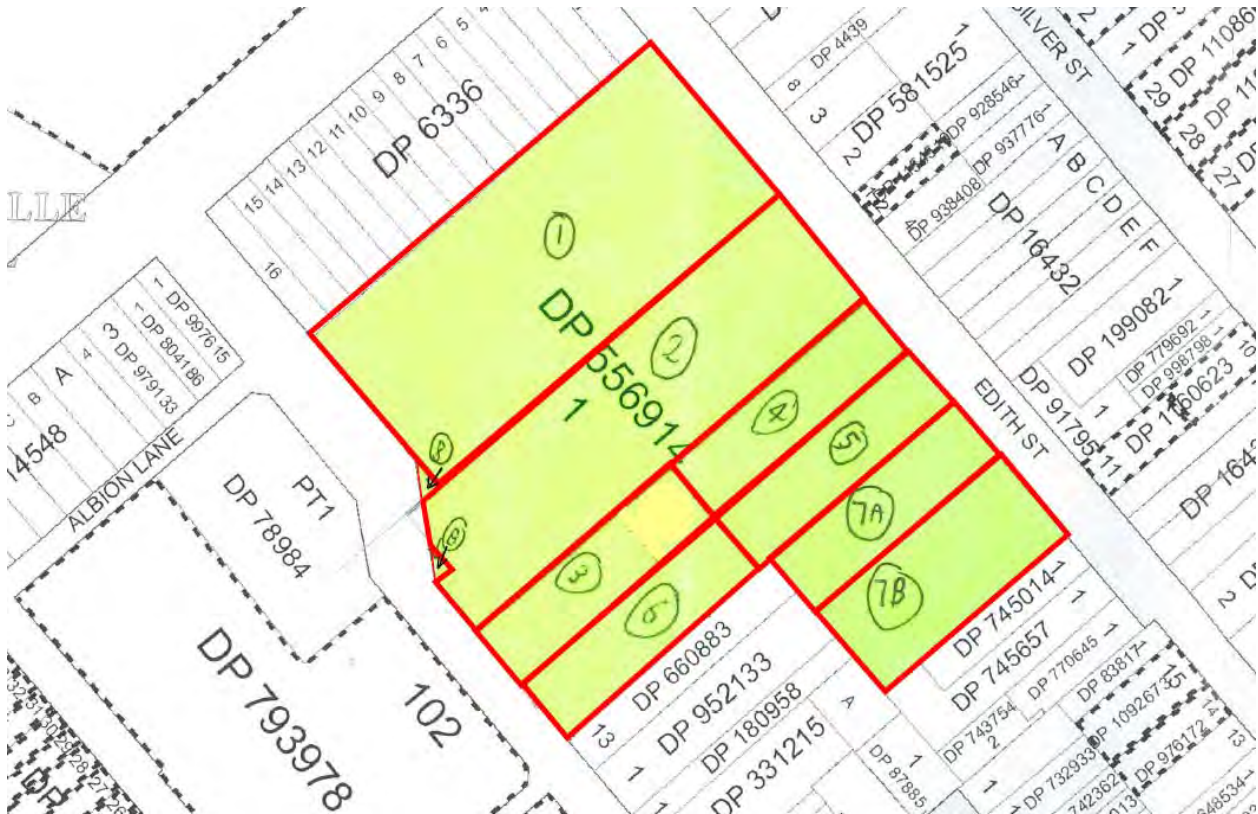
**Figure 3-1 Approximate Outline of Former Allotments**

The site was found to be consisting of 8 allotments previously, the outlines of which are shown in **Figure 3-1**. A consolidation of land titles of these allotments took place in 1973. A chronicle list of all historical and current registered proprietors is presented below.

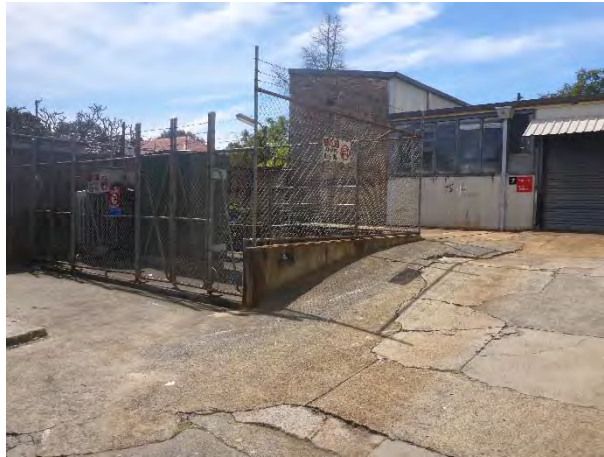
**Photo 1: Kiosk Substation**

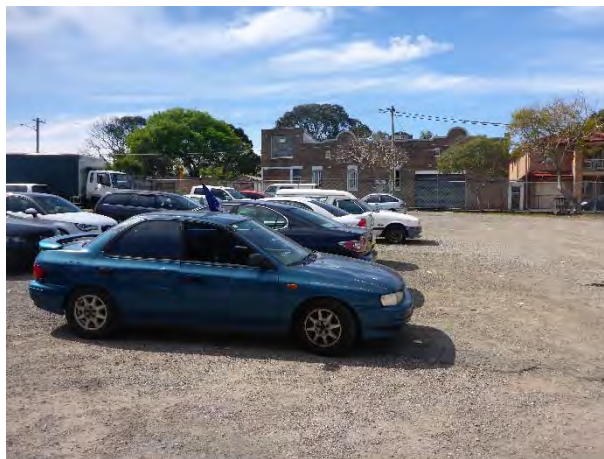
| Site Area | Buildings | USTs/ASTs | Observations |
|---|---|---|---|
| Open Car Park | The area was unsealed and paved with loose gravels. | No UST identified. | Vehicle parking was noted in the area. A piece of damaged asbestos pipe was observed half buried in the gravel pavements. |

**Photo 2: Unsealed Car Park Area**

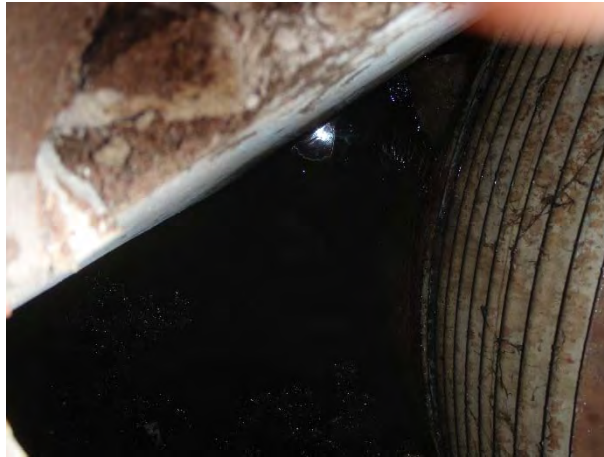
- An approximately 4.2 m deep void was encountered during the drilling of BH13, immediately beneath the concrete hardstand (approximately 280mm thick). Trapped water at 2.7 m bgl with slight hydrocarbon sheen was observed in the void.

**Photo 4: Underground Void at BH13.**
