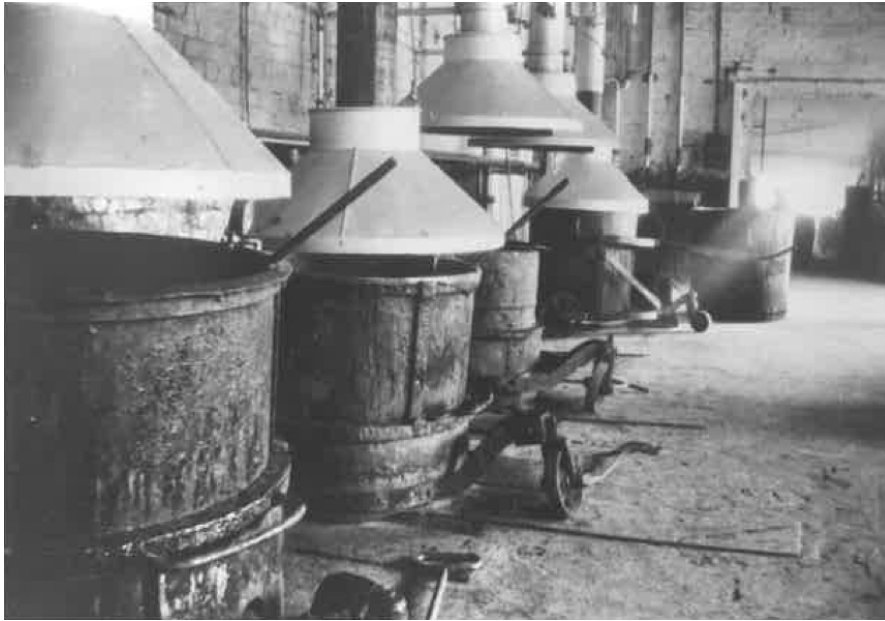
*Varnish kettles in the running room at St Peters, 1930s,*  
Source: Taubmans Paints Archive

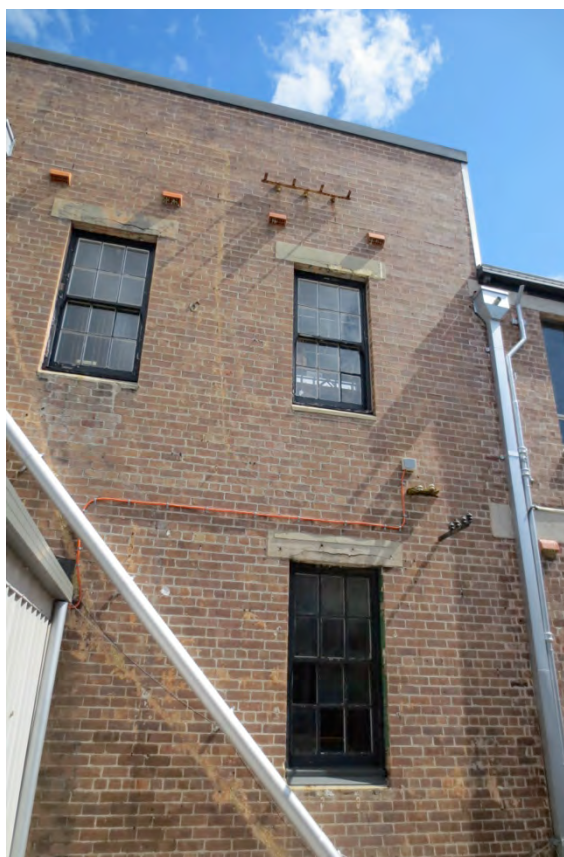
*Building 1D, showing ceramic insulators that should be retained.*

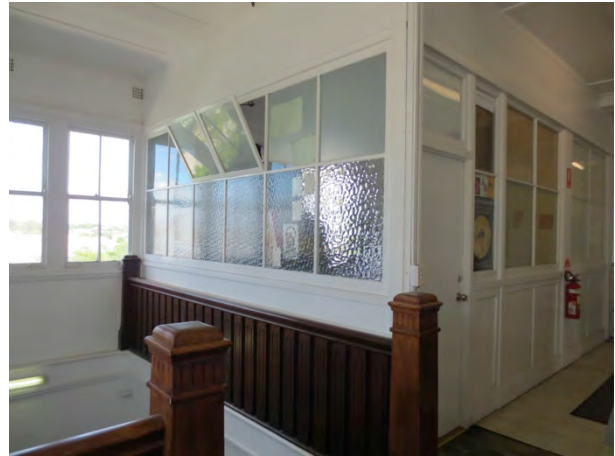
*Building 2, L1, timber stair + office room. These elements should be retained if possible.*

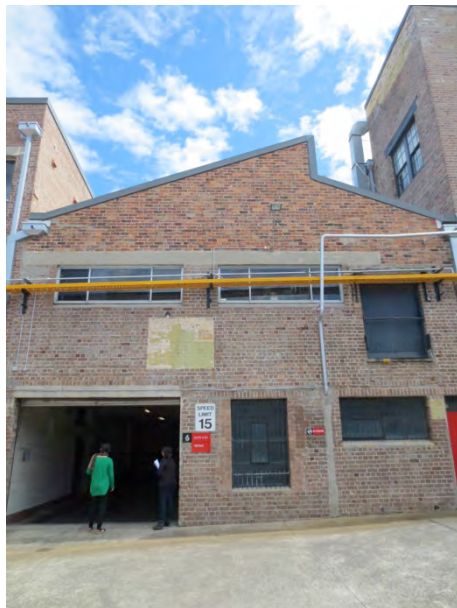
*Building 6C. This section of the building is a later addition.*

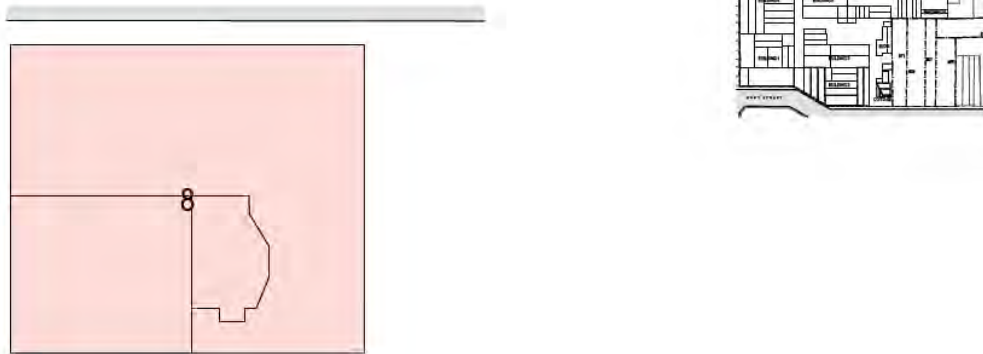
**Figure 4.114** Plan showing parts of Building 8 and location on the site, TZG, 2014.

**Building 8** is a three storey face brick building with concrete structural columns. The third floor is relatively small. The first two storey part of the building has a flat concrete slab roof, while the third storey is made up of two parts, each with a skillion metal roof. The floors are concrete and the windows are steel framed. There are two internal stairs on the south side of the building, both of which provide access to all levels.

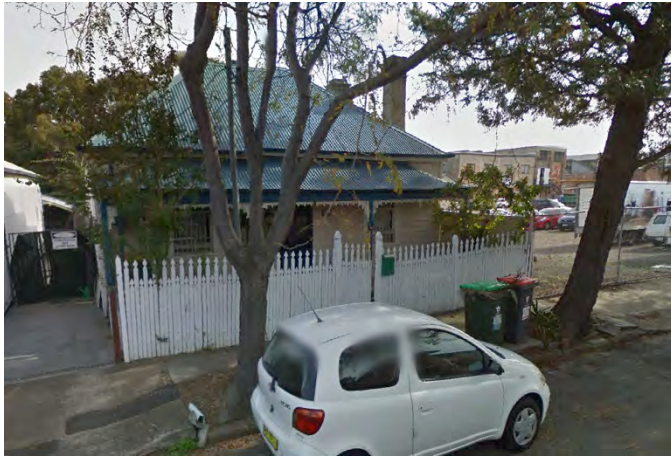
52 Edith Street, St Peters

Constructed post 1900, this single storey workers cottage is set back from the street behind a painted timber picket fence. It is constructed from weatherboards and has a corrugated iron roof.

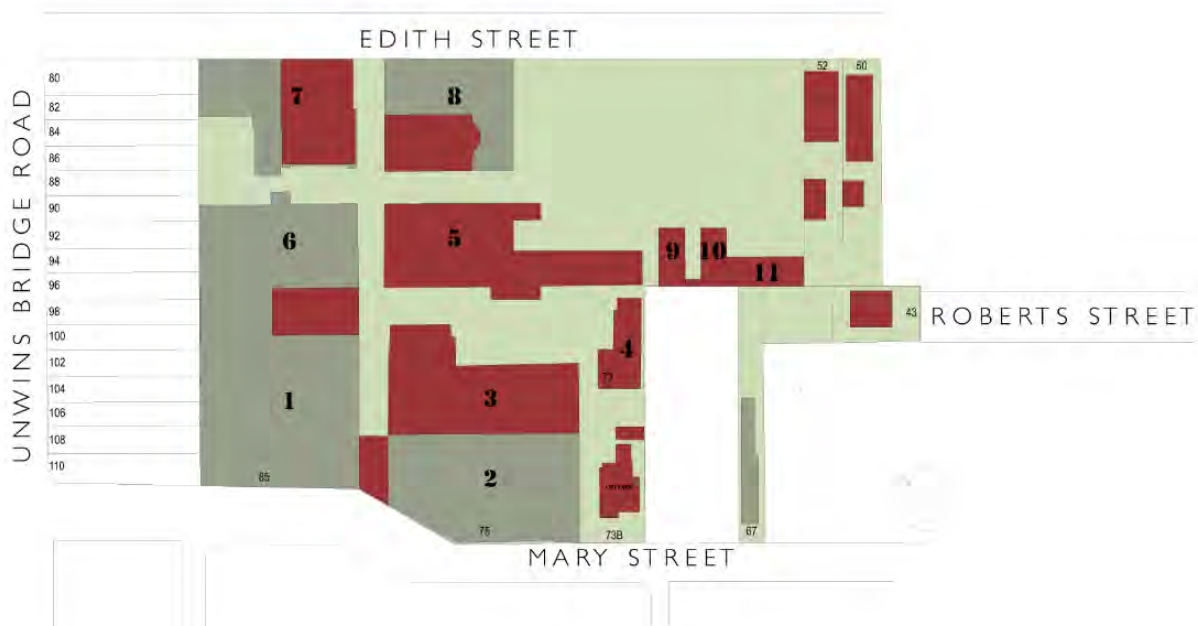
Demolition Plan, TZG Architects, 2014.

Four lightweight sheds (Buildings 4, 9, 10 and 11) are proposed to be demolished along with two brick industrial buildings (Buildings 3 and 5) and three houses (50-52 Edith Street and 43 Roberts Street) on the western part of the site. These buildings are not listed as heritage items and are considered to be of little heritage value.
