**ON**  
**PRELIMINARY DESKTOP ENVIRONMENTAL**  
**ASSESSMENT**

**FOR**  
**PLANNING PROPOSAL - PROPOSED RESIDENTIAL**  
**DEVELOPMENT**

**AT**  
**1-31 WALTER STREET AND 452-462 WILLOUGHBY**  
**ROAD, WILLOUGHBY, NSW**

Date: 23 August 2019  
Ref: E30088KPrptRev2

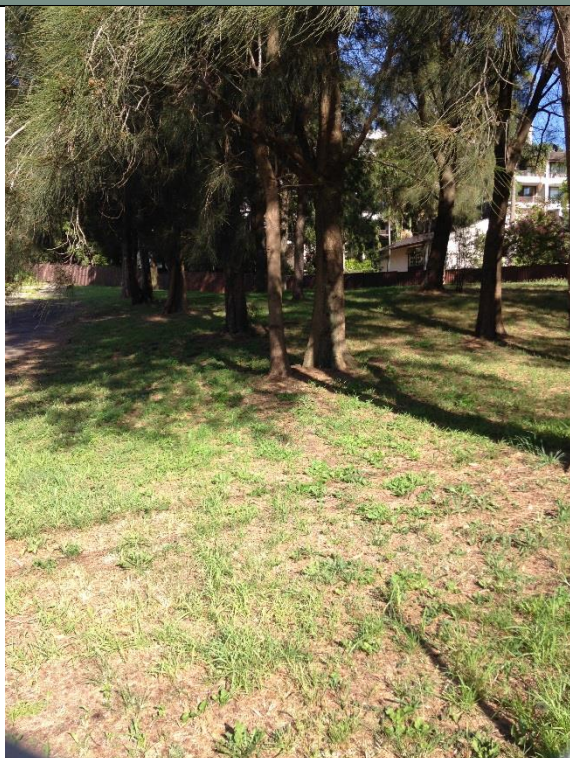
Sandy fill was observed at the ground surface in the eastern section of the 462 Willoughby Road property. This area of the site also included a raised mound which was likely to be fill considering the local topographic features. Fill was considered likely to be present behind raised garden beds and retaining walls at the front of a number of individual properties.

462 Willoughby Rd (facing north-west), showing suspected Fill mound

- A preliminary intrusive investigation should be undertaken to make an assessment of the soil and groundwater contamination conditions. Although the investigation should be designed to assess the broader site conditions, a higher density of sampling and more detailed investigation is recommended in the eastern site areas;

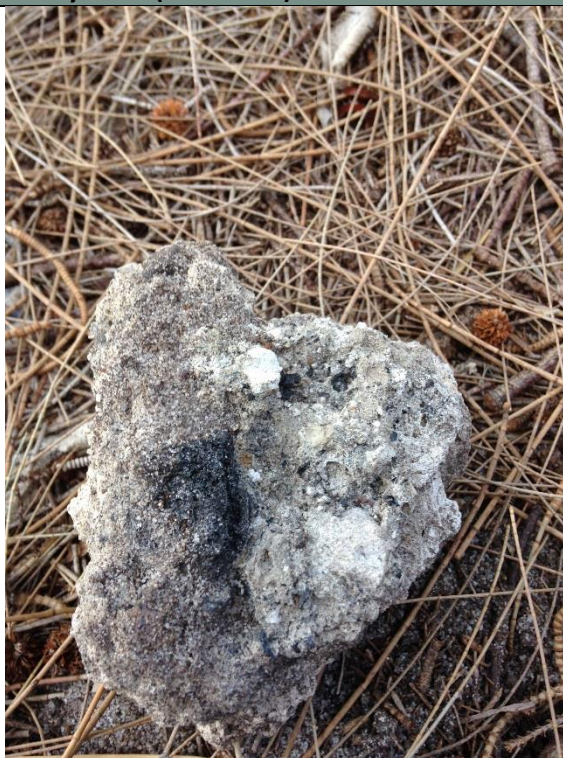
A slag cobble (including metallurgic furnace slag) was observed at the ground surface in the eastern section of the 462 Willoughby Road property (see Figure 2). Pieces of ash were also observed in several garden beds

Slag cobble at surface at eastern end of 462 Willoughby Rd

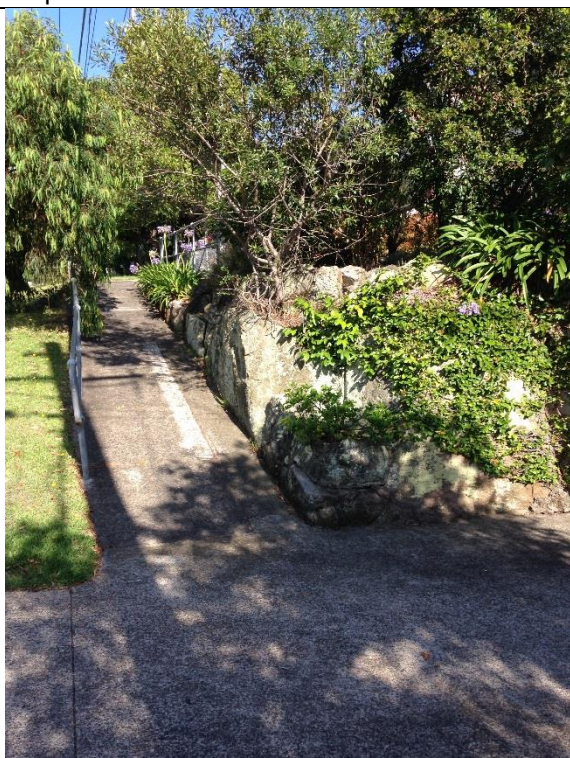
Sandstone outcropping was observed at the front of several Walter Street properties (see Figure 2) during the site inspection.

Sandstone outcropping along 7 Walter Street property frontage

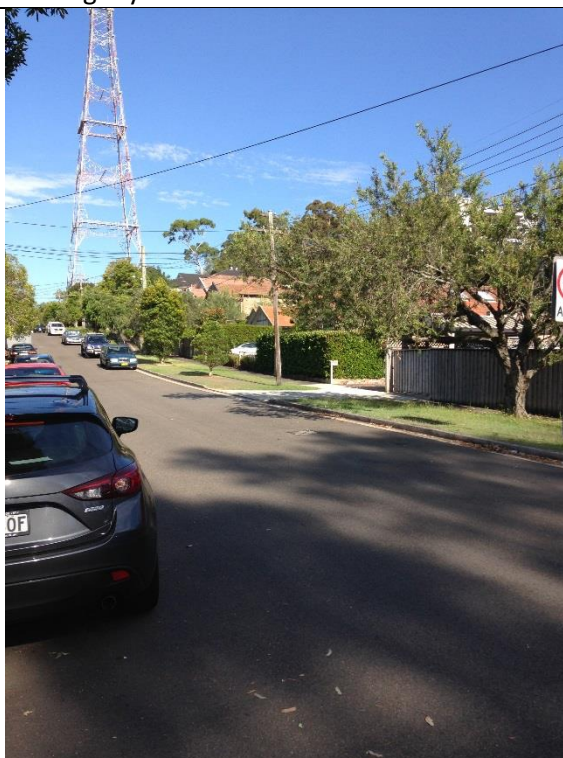
The site was occupied by various one and two storey, brick or brick rendered residences. Some parts of the buildings such as the eaves and some upper floor additions appeared to be constructed from fibre cement sheeting (possibly containing asbestos). Gravel or concrete driveways were observed at the front of each property.

Site along Walter Street frontage (facing north-west)

- A hazardous building materials survey should be undertaken prior to demolition of the buildings. Following demolition of the buildings (and preferably prior to removal of the hardstand), an asbestos clearance certificate should be provided; and
