JBS&G 50970-101448
L01 Willoughby Rd Artarmon Review (Rev 0)

21 September 2015

Review of Contamination Status – Lot 2 DP 586037, Willoughby Road, Artarmon, NSW

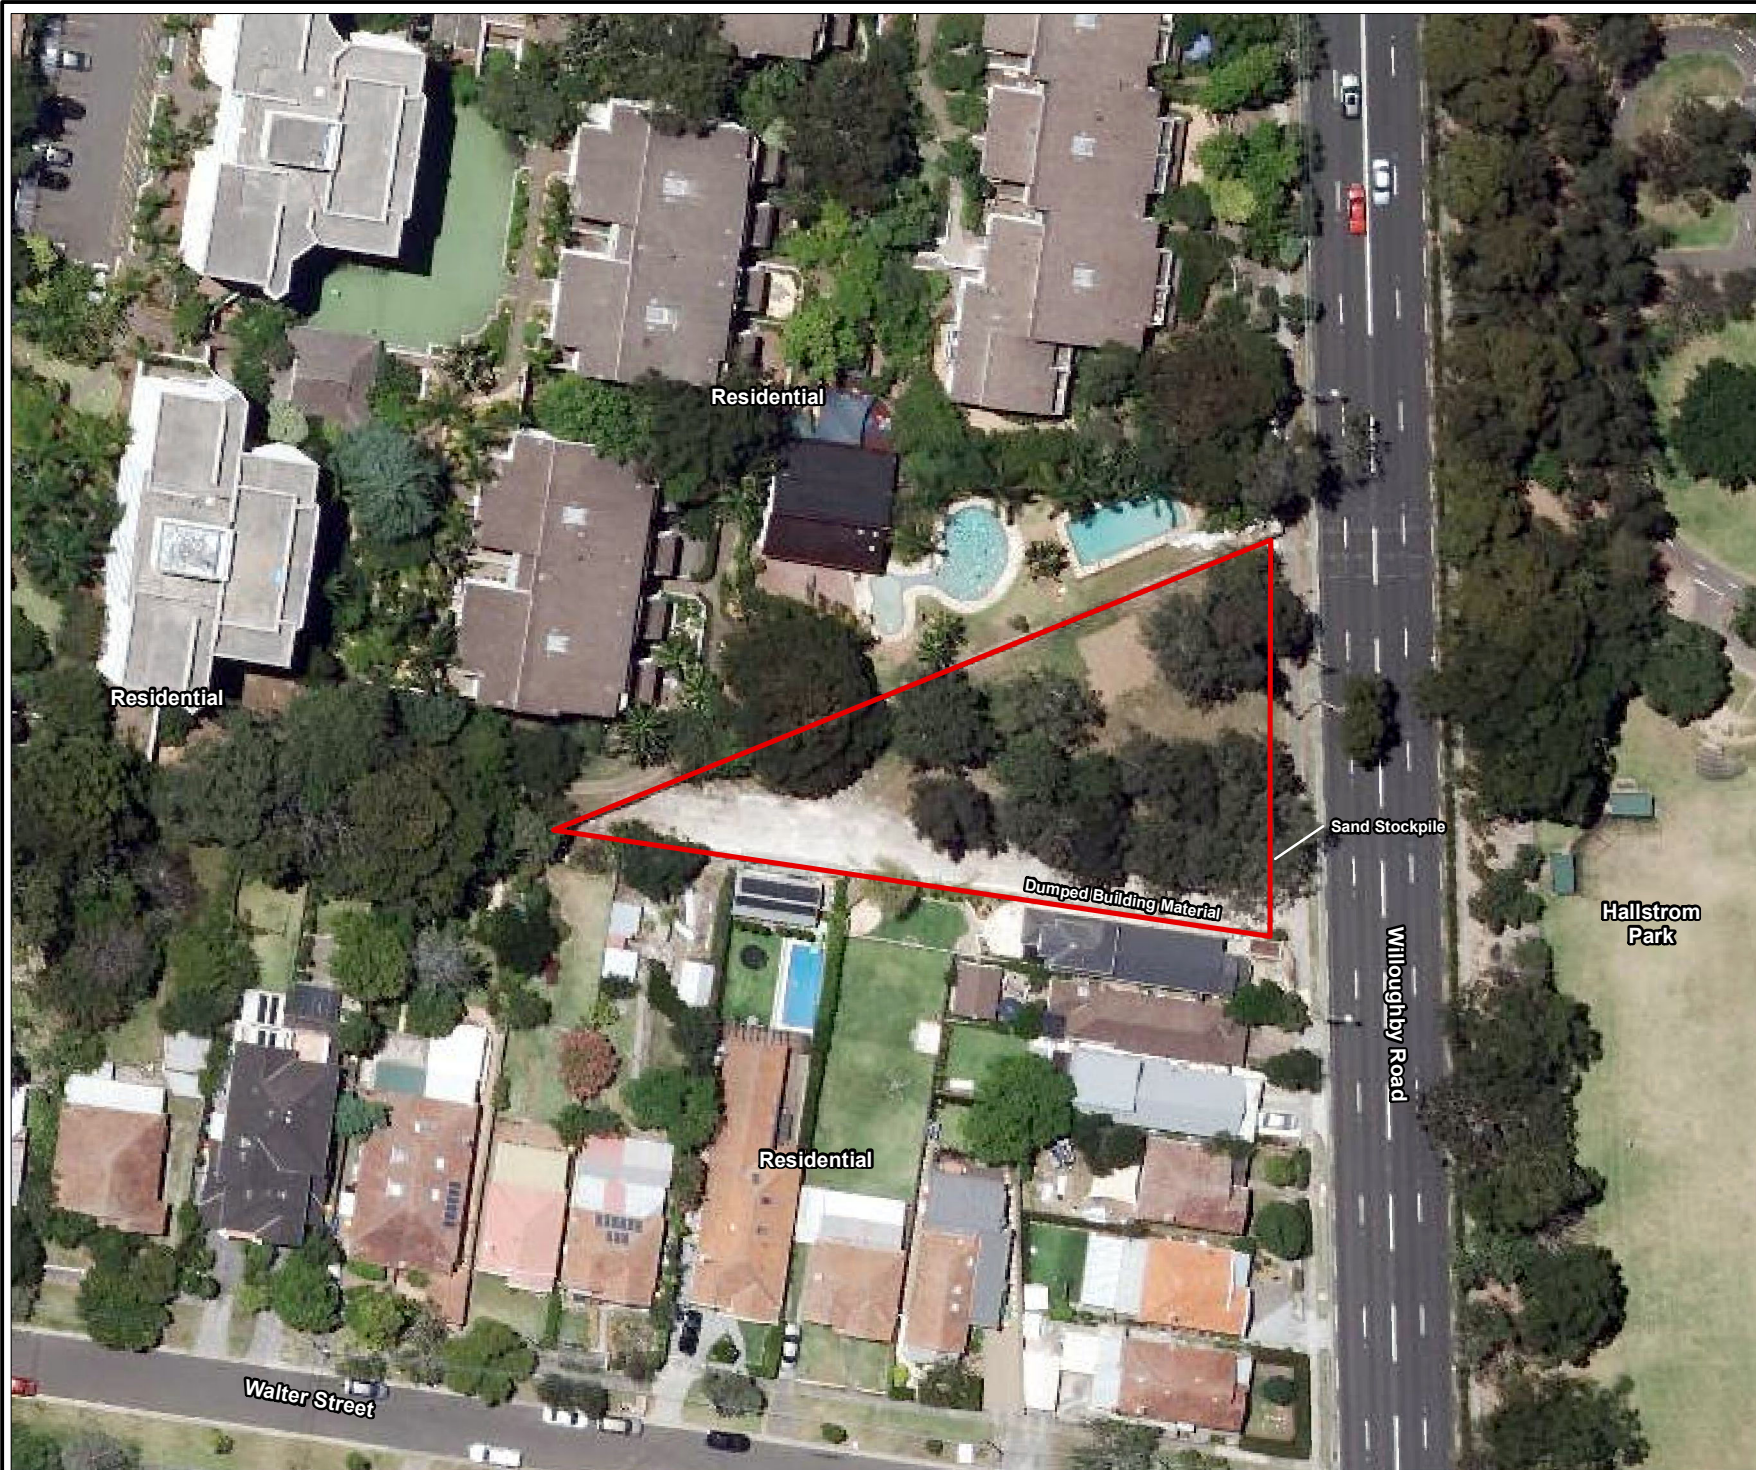
FIGURE 2

SITE LAYOUT

The site details are summarised in **Table 2.1** below and shown on **Figure 2**.

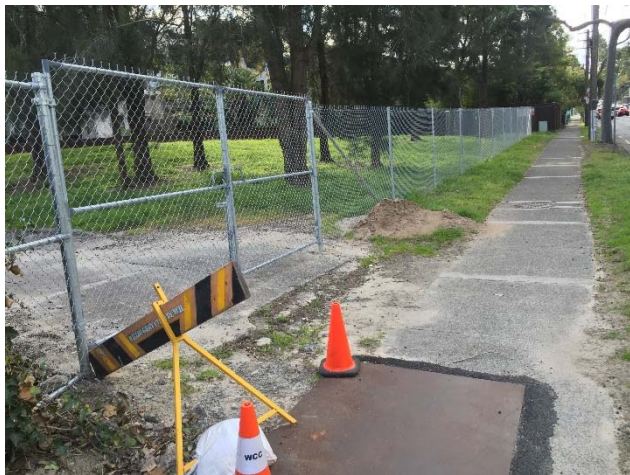
View from Willoughby Road, including sand stockpile

Dumped building materials were present along the southern border of the site. This included concrete, wood, metal fencing, and a Willoughby Council green recycling bin. No asbestos was observed on-site. A small sand stockpile (less than 2 m³) was also observed directly against the eastern site fence, with a small amount of sand falling within the site.

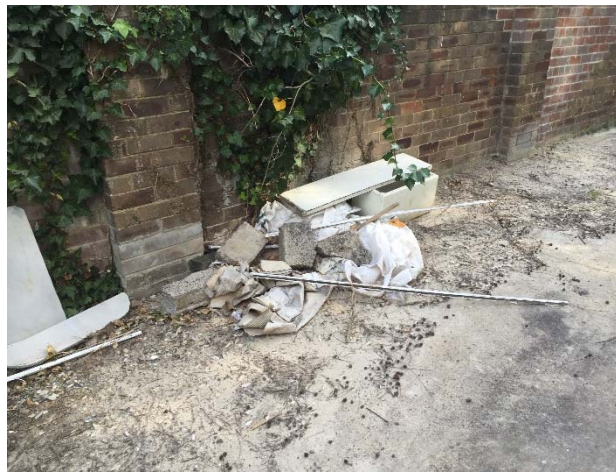
Building rubble on southern border of site

As detailed in Section 2.2, some dumped building material was observed at the south of the site including concrete, metal and recycling bins. No ACM was observed.

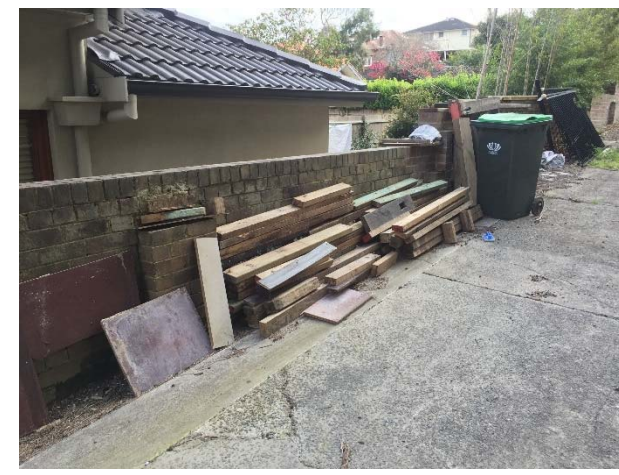
Building rubble on southern border of site

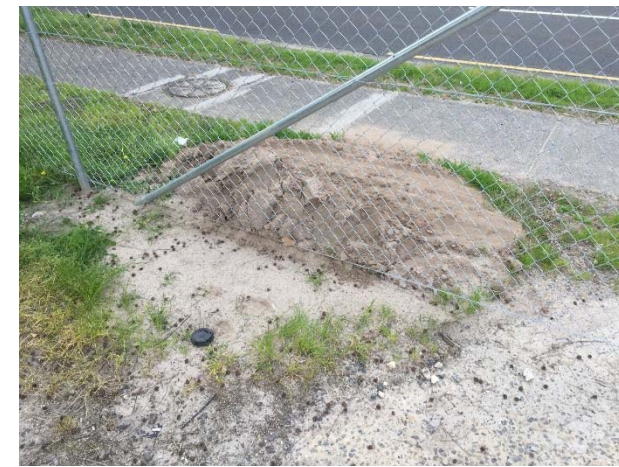
Sand stockpile on eastern border of the site

The stockpile was observed to be yellow to brown homogeneous sand. No odours, staining or ACM or other anthropogenic materials were observed within the stockpile.
