Report on Detailed Site Investigation for Contamination

7 Concord Avenue Concord West

Prepared for F.T.D Holdings (Concord West) Pty Ltd & Floridana Pty Ltd

> Project 84964.01 November 2015

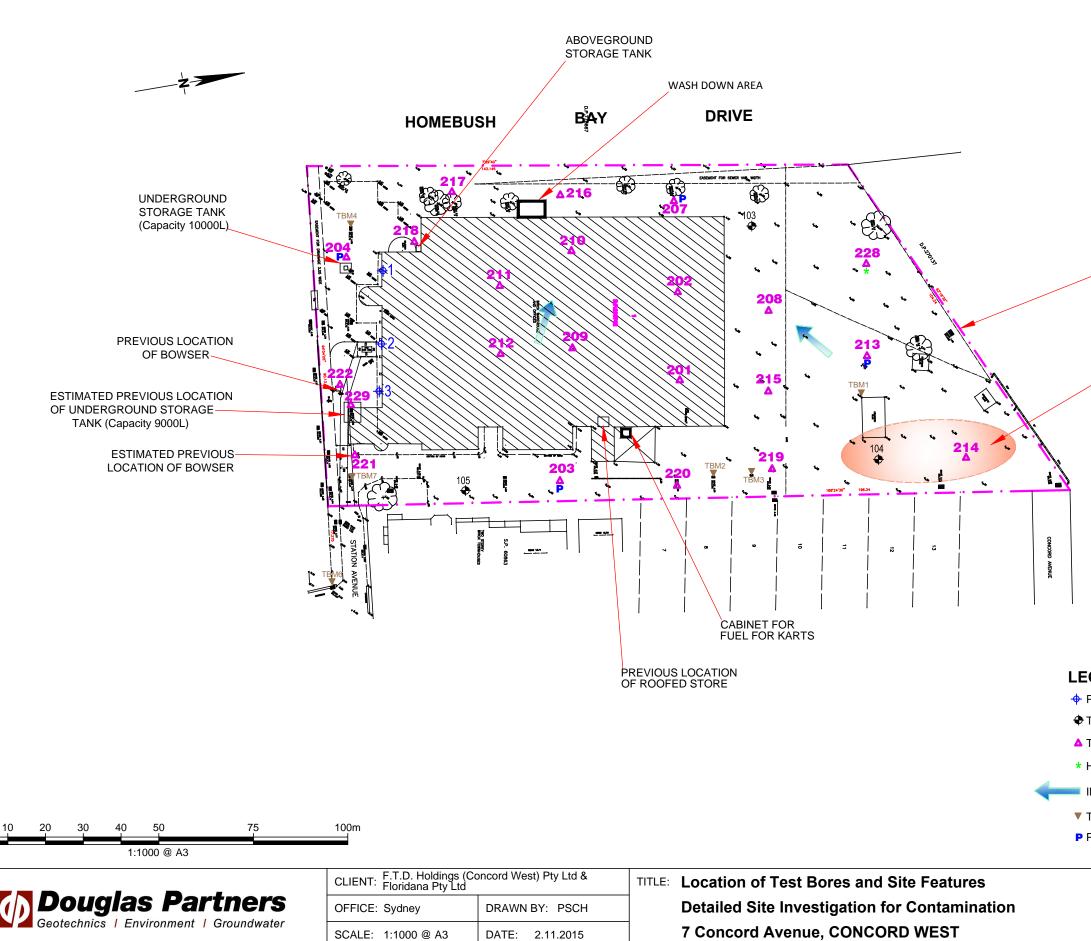
A disused underground storage tank (UST) is located at the south of the site. No bowsers were present at the time of the site walkover, but the footprint of a former bowser is located approximately 40m to the east of the UST. An above-ground storage tank (AST) is currently located at the southwest corner of the building. A roofed store for dangerous goods was located inside the factory building in 2007 but is no longer present. Currently, a cabinet is located at the east of the building for the storage of fuel for the karts. Drawing 1, Appendix A shows the location of these features.

In 2007, a small number of fibre-cement fragments were observed on the soil surface at the northeastern part of the site as shown on Drawing 1, Appendix A. The fibre-cement fragments were not observed during the recent walkover.

An above-ground storage tank (AST) is currently located at the south-west corner of the building (see Photograph 5, Appendix B). It was understood (in 2007) that the AST was used for heating oil. The AST was on an asphalt surface which was cracked near the building wall. The AST did not have a

The remaining 17 sample locations were positioned on a loose grid pattern to compliment the targeted sampling locations and geotechnical sampling locations. In addition, the sampling locations were designed to accommodate drill-rig accessibility, the location of underground services and site operations (traffic and staff movements). Sampling locations are shown on Drawing 1, Appendix A.

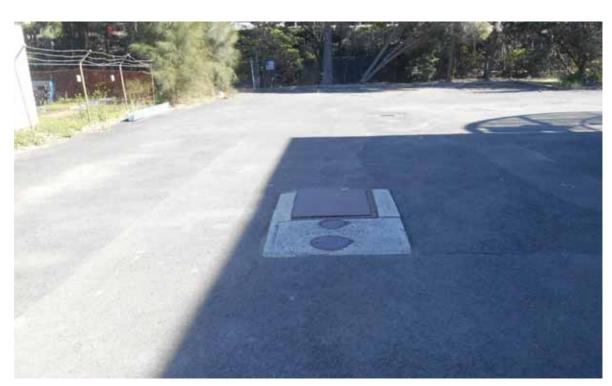
Photo 3 - Underground Storage Tank

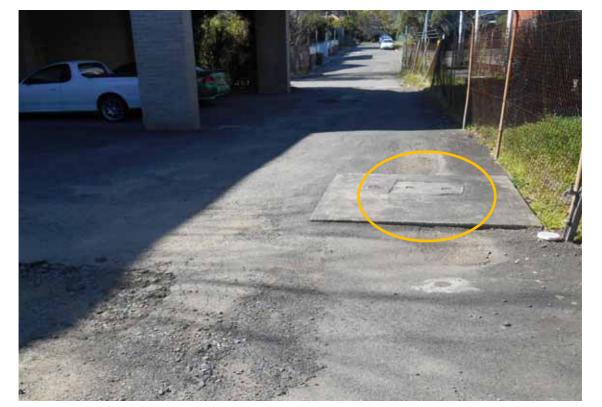
Test Bore 221 was drilled on a garden surface at the south-west corner of the building at the location of a former bowser. A surface layer of silty sand filling, to a depth of 0.5 m bgl, was observed to be underlain by a gravelly sand filling, to a depth of 1.7 m bgl, identified with a strong hydrocarbon odour from 0.8 m to 1.7 m bgl and stained grey from 1.0 m bgl to 1.7 m bgl. Drilling refusal was on concrete at 1.7 m bgl.

Photo 4 - Location of previous bowser

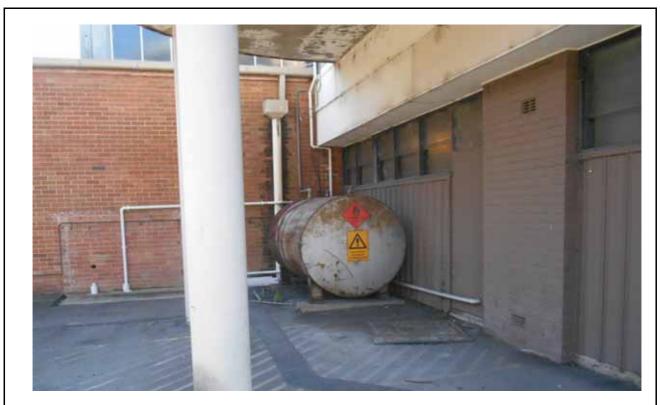
bund. Associated piping was observed to be above ground. Drawing 1, Appendix A shows the location of the AST.

Photo 5 - Aboveground storage tank

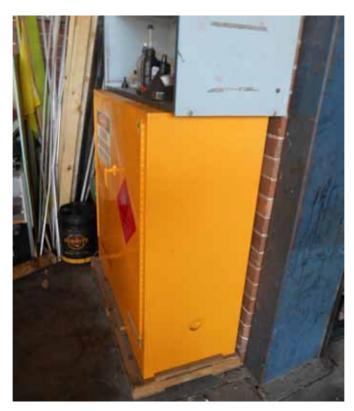
Photo 6 - Cabinet for fuel storage
