Remediation Action Plan

Proposed Residential Development  
7 Concord Avenue, Concord West

Project 84964.02  
September 2016

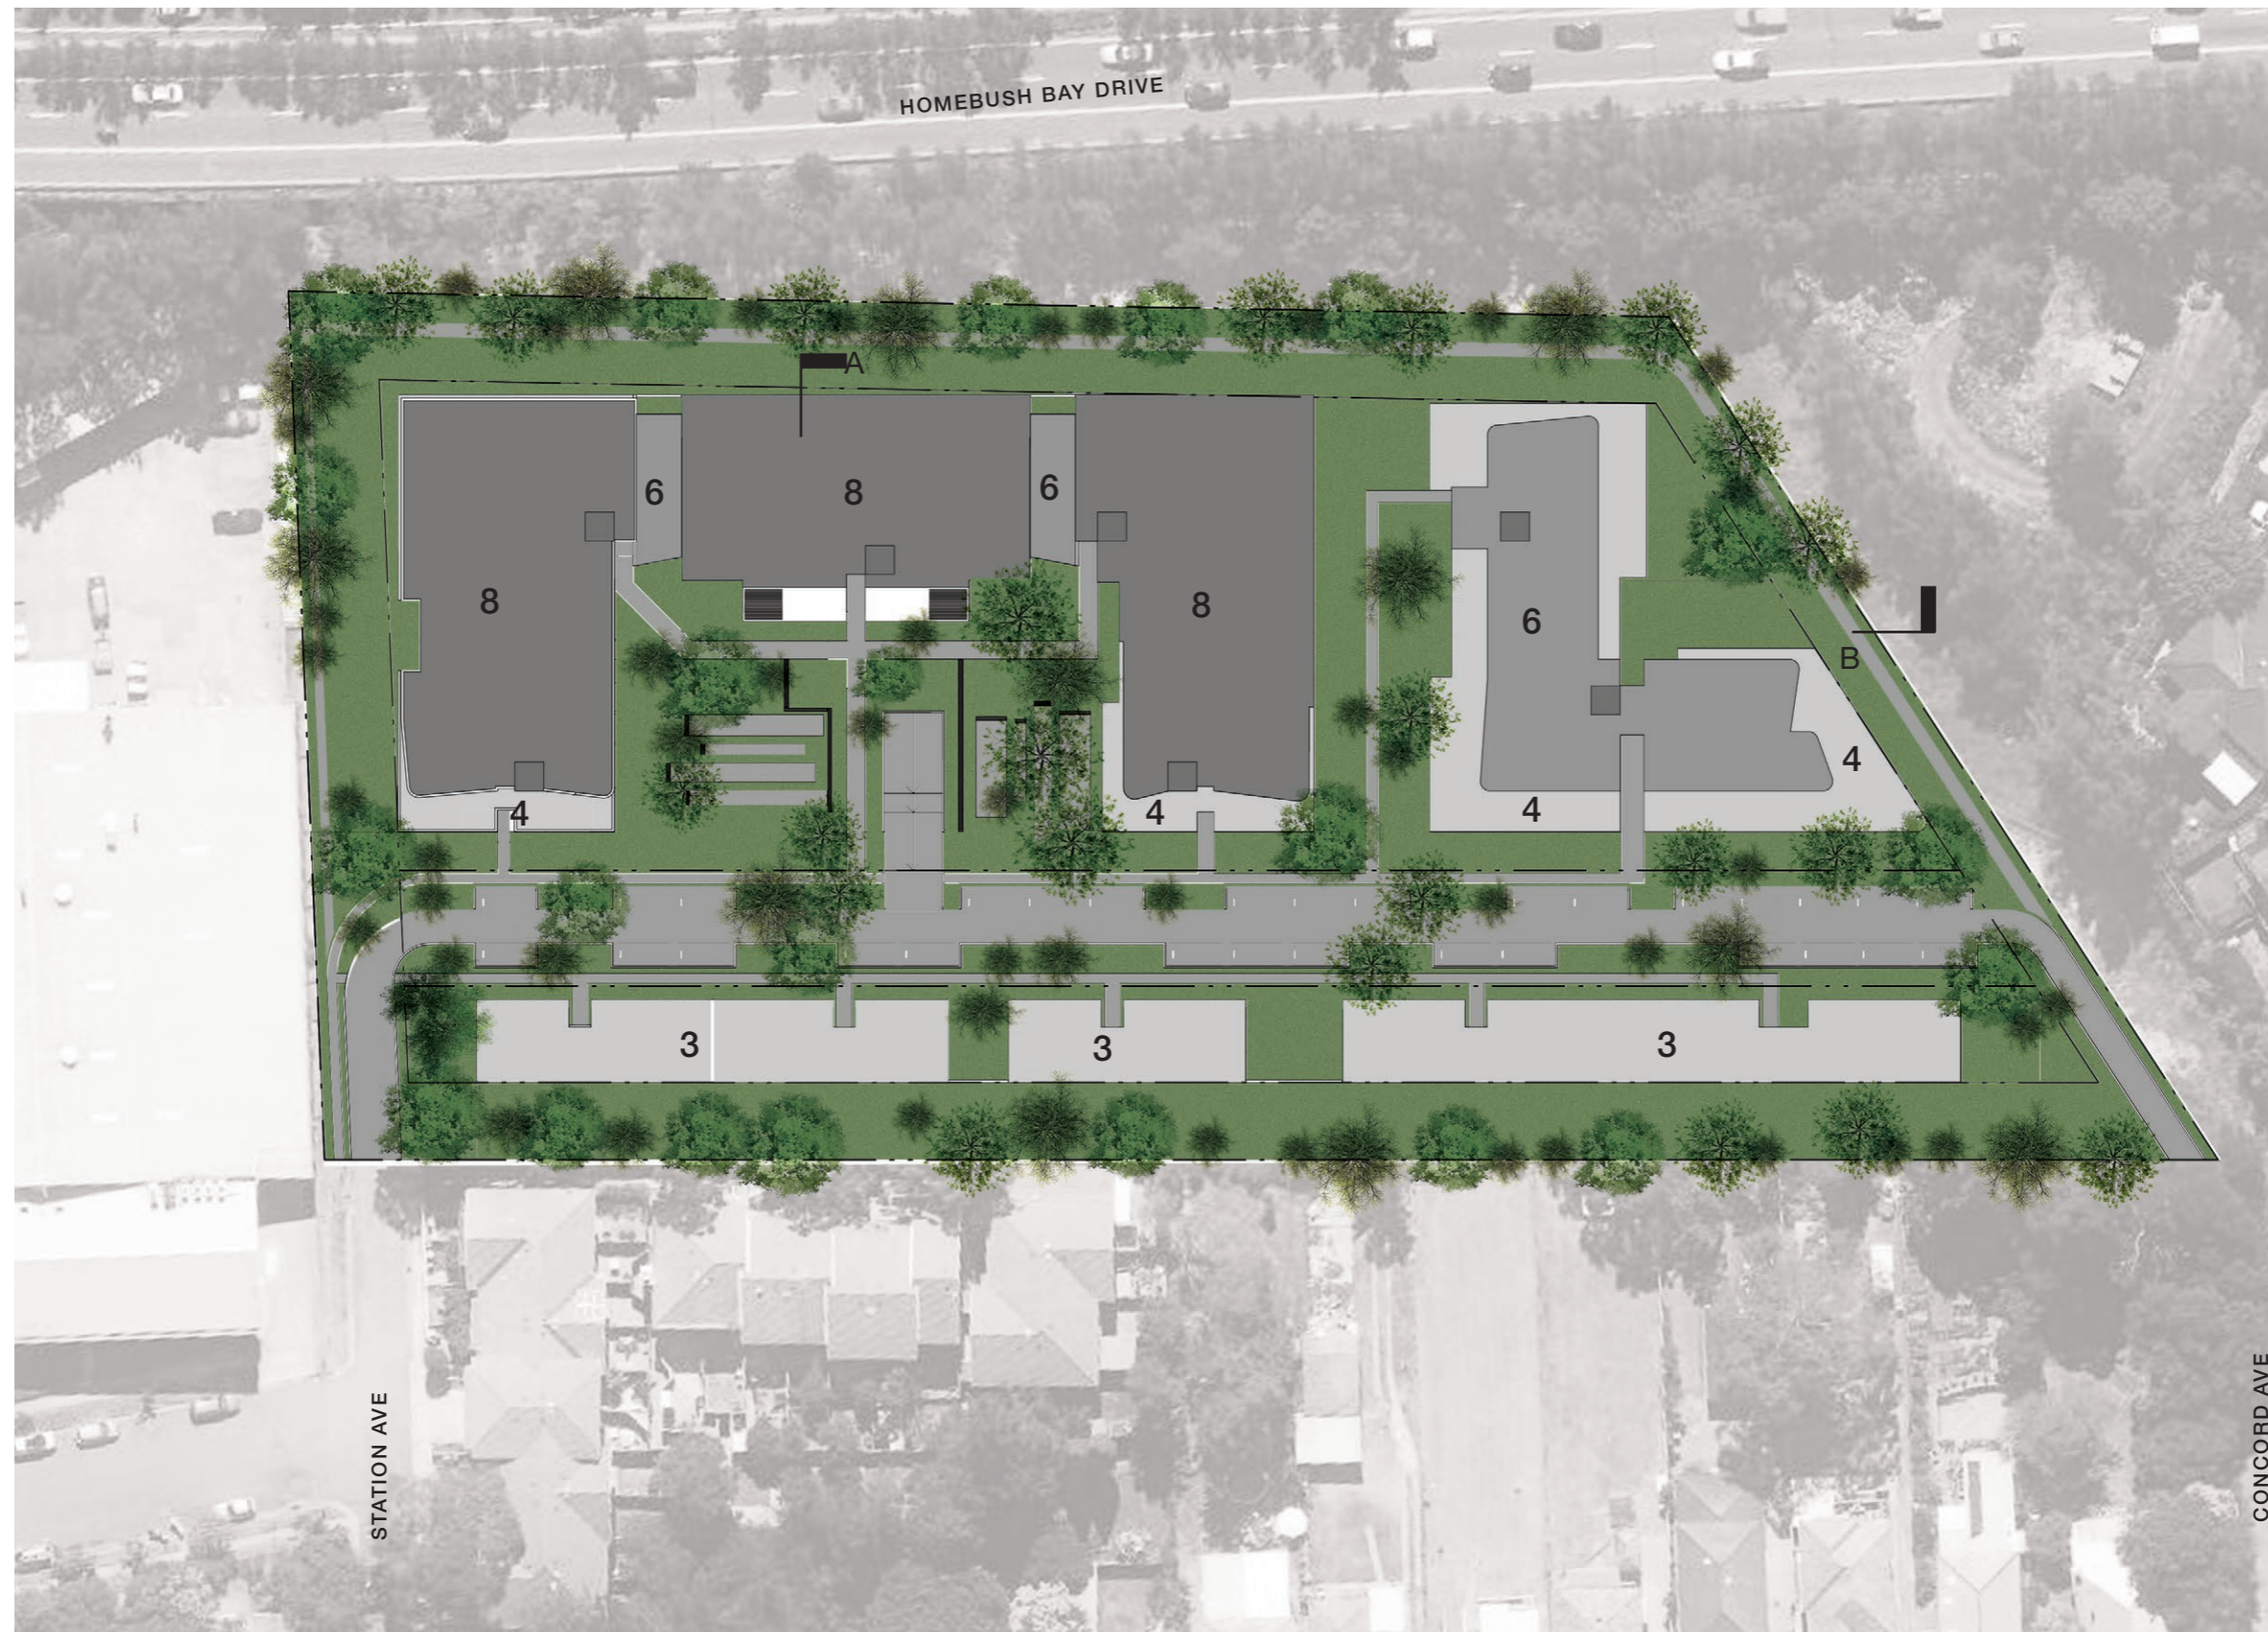
**SITE PLAN**

Numbers Indicate Building Storeys

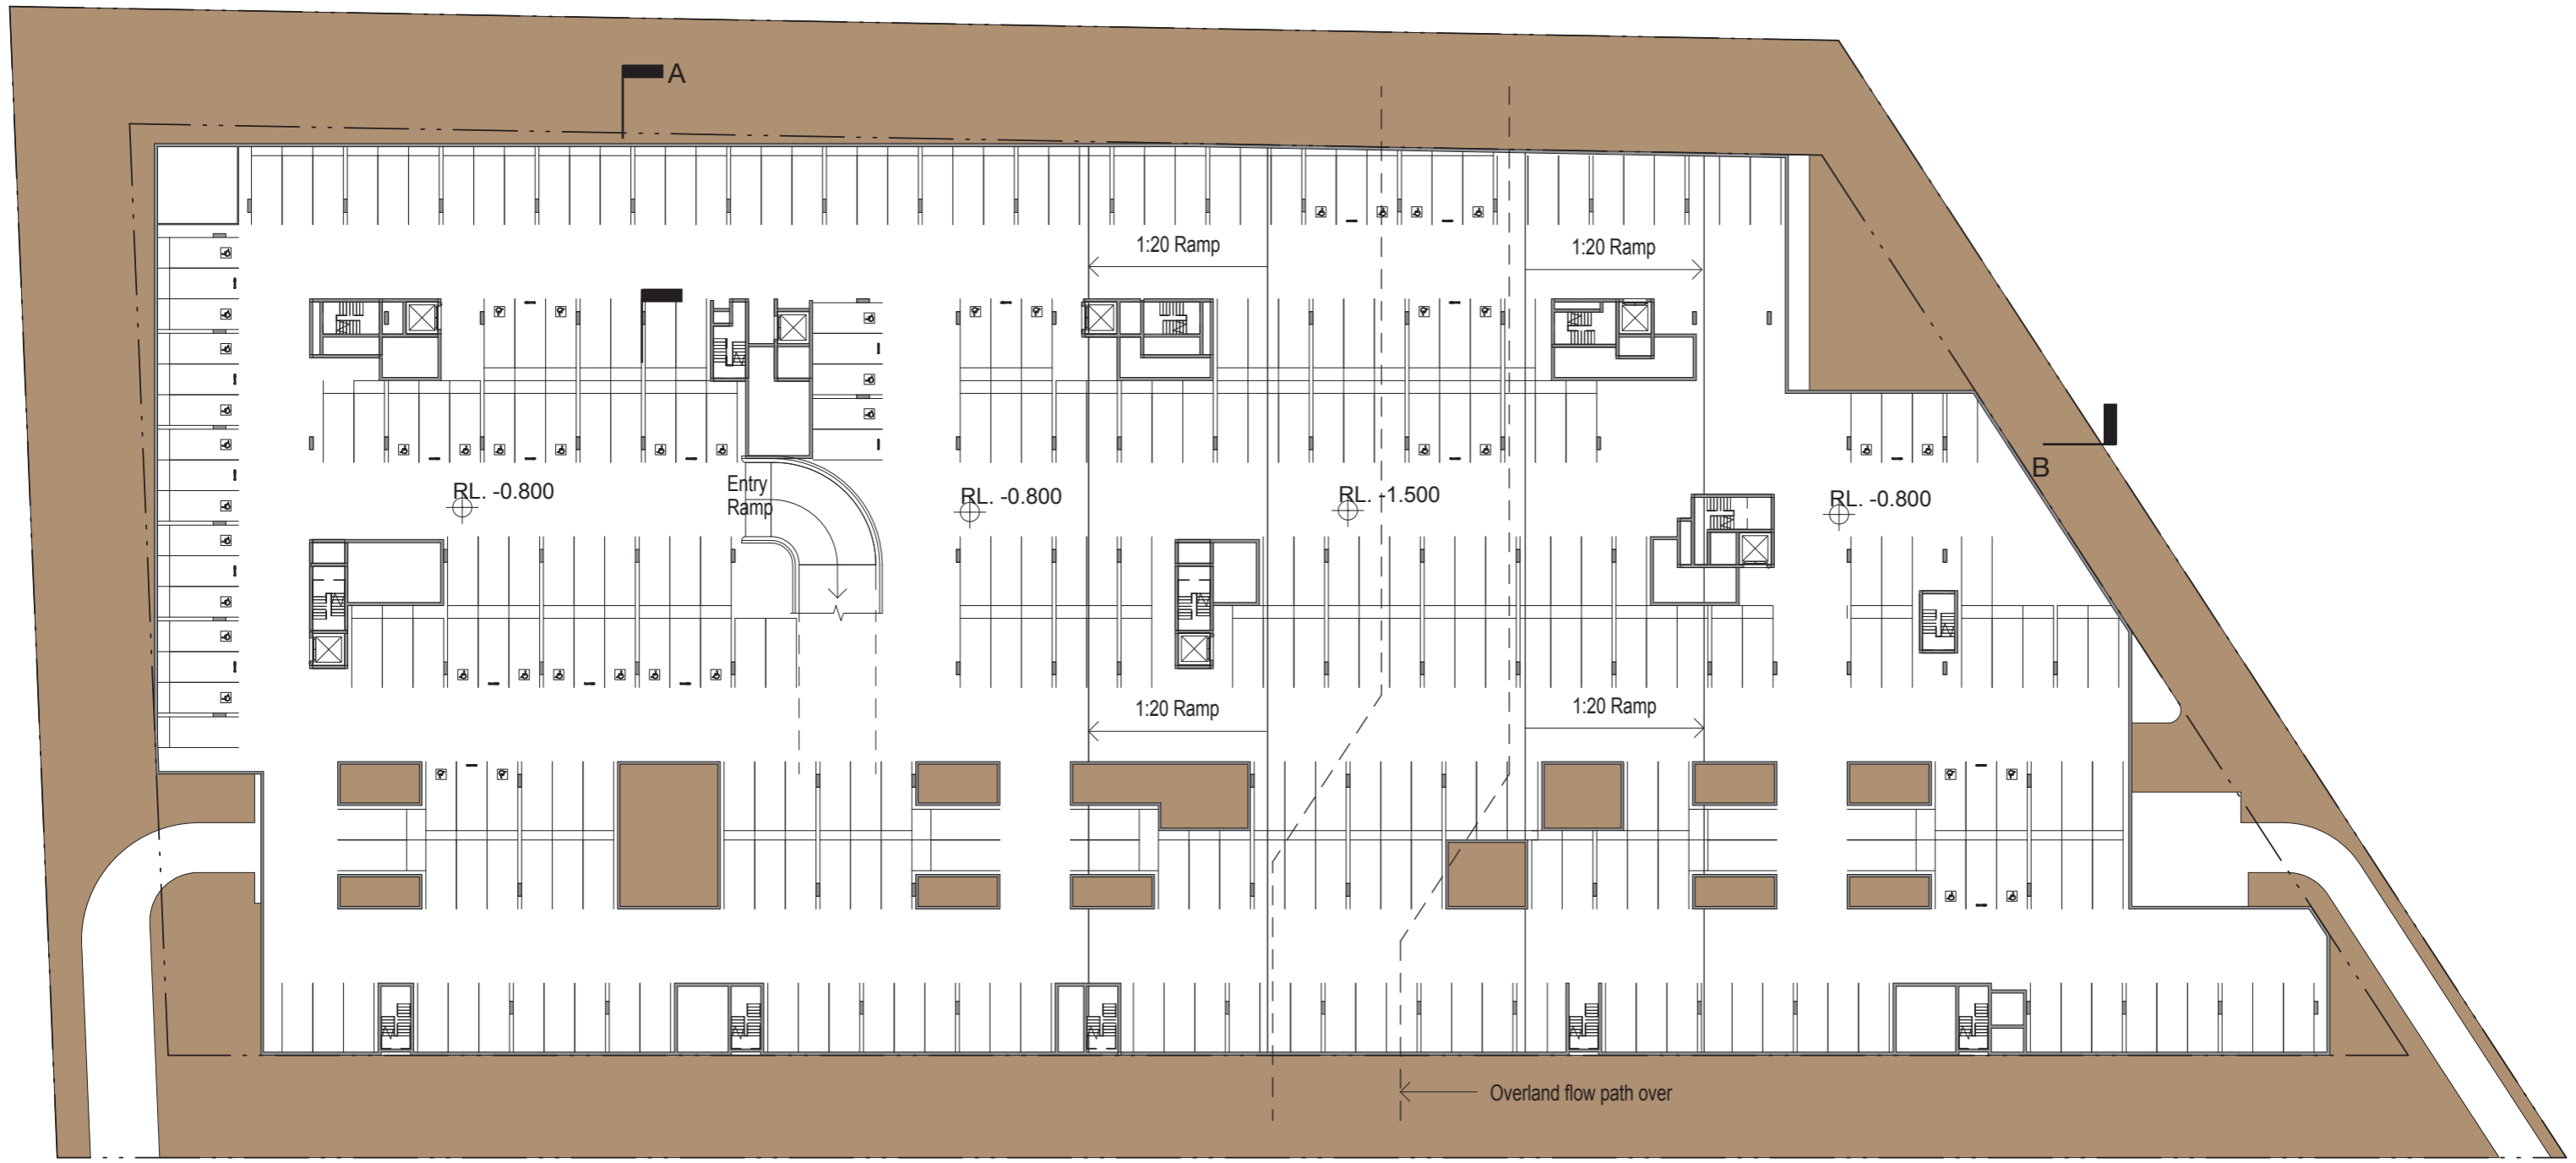
**BASEMENT PLAN**

■ Deep Soil

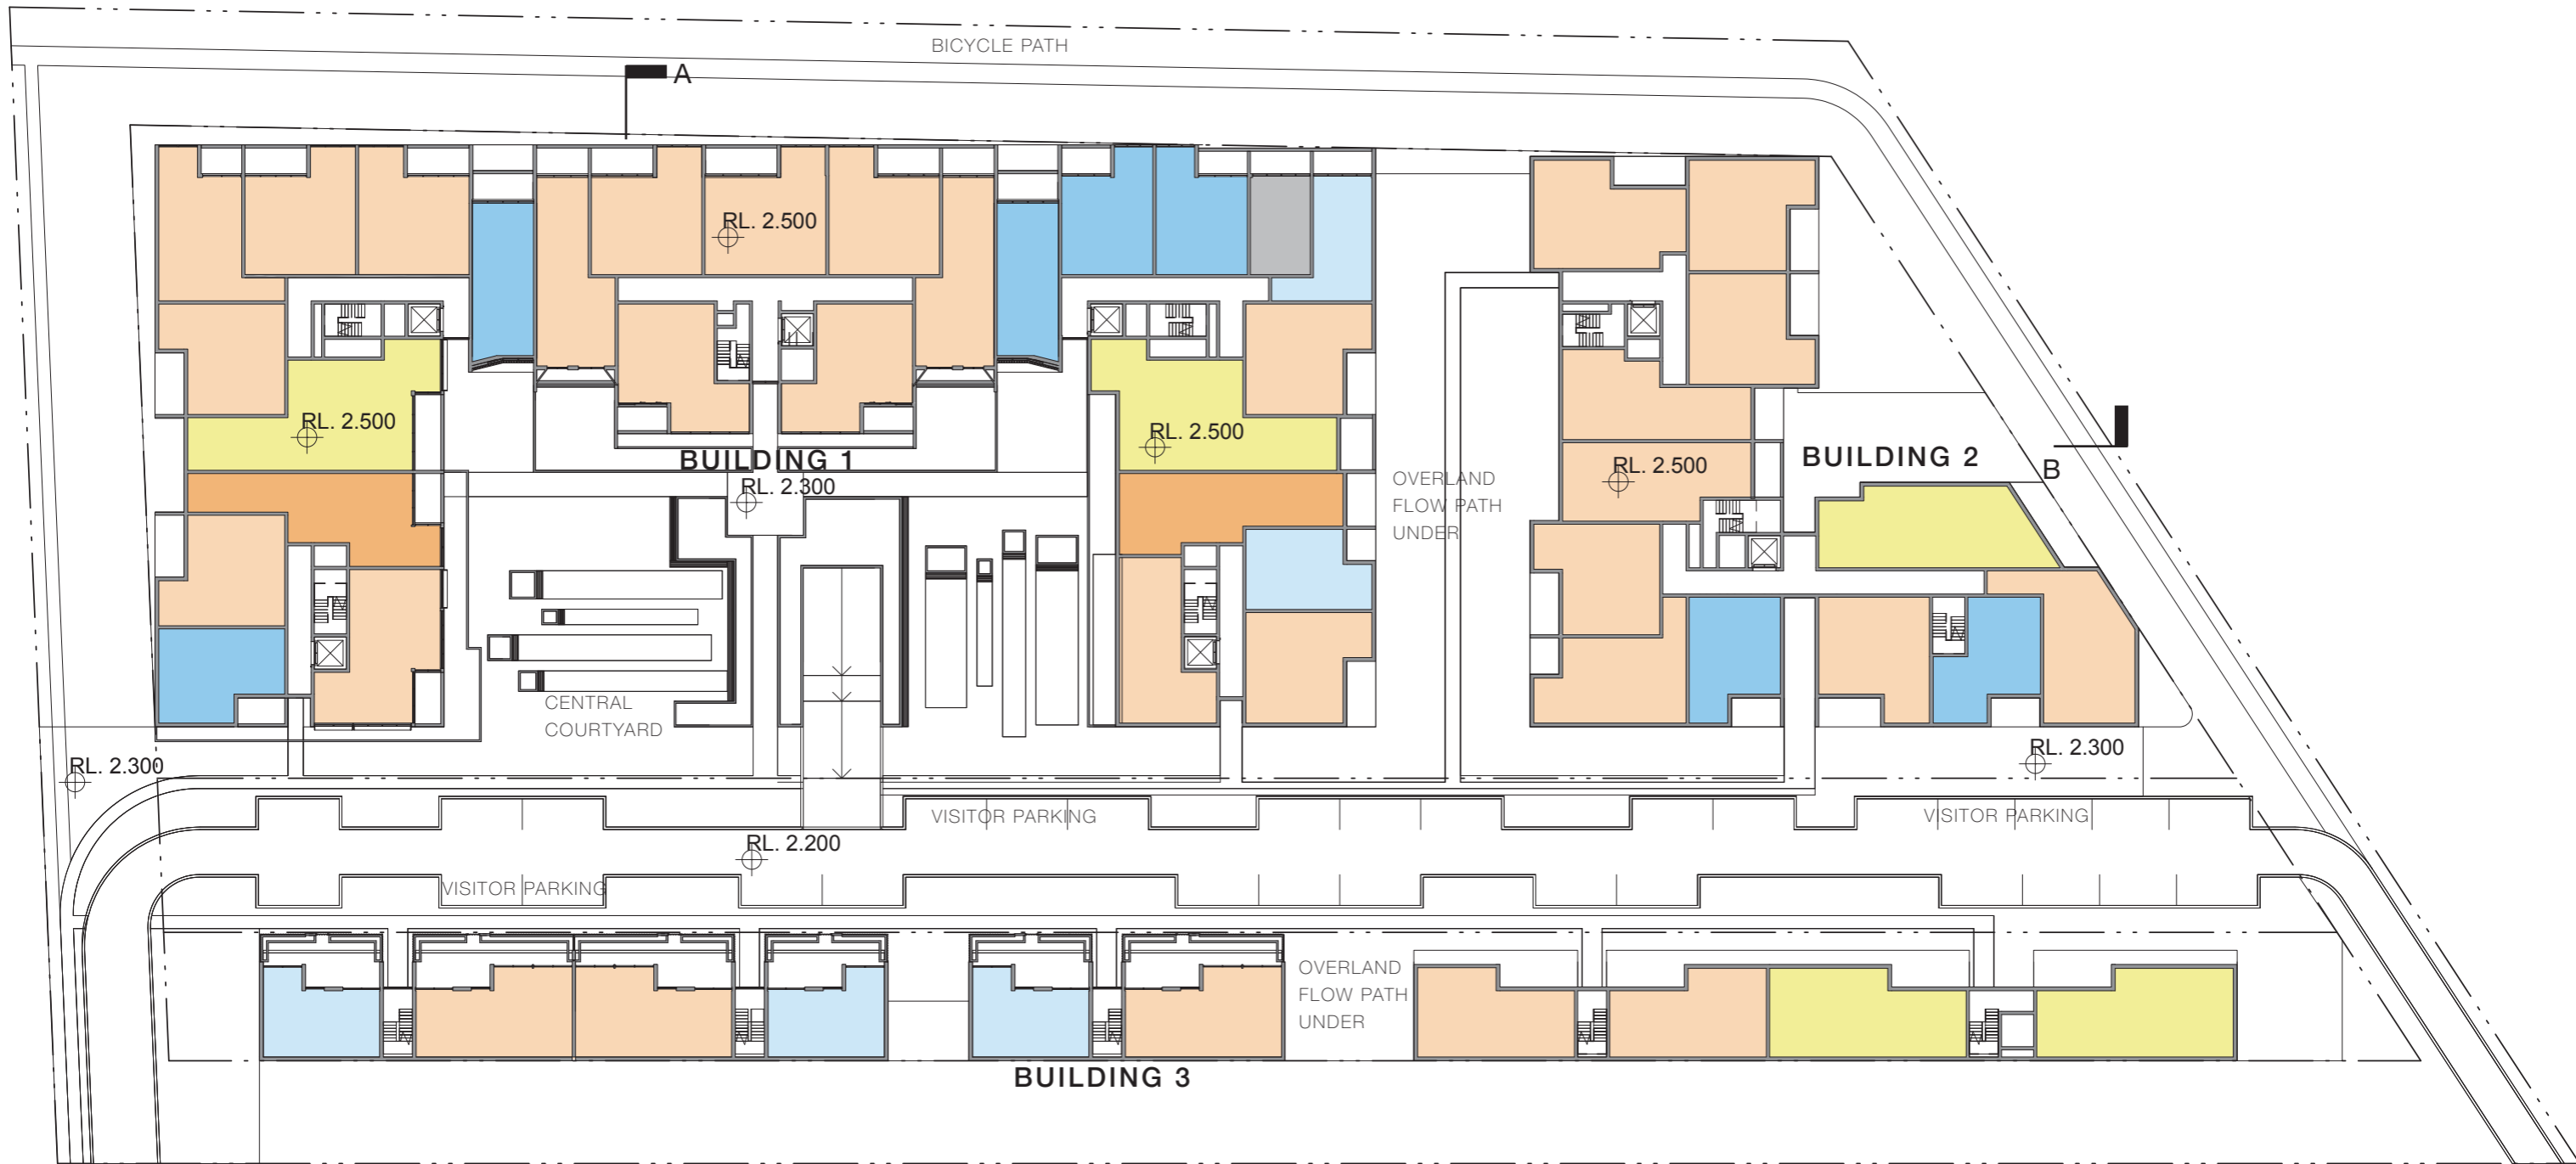
**GROUND FLOOR PLAN**

- 1 Bed
- 2 Bed +
- 1 Bed +
- 3 Bed
- 2 Bed
- Studio
