# ASSESSMENT OF HERITAGE SIGNIFICANCE

Glen Brae

28 Cook Road, Killara

August 2015

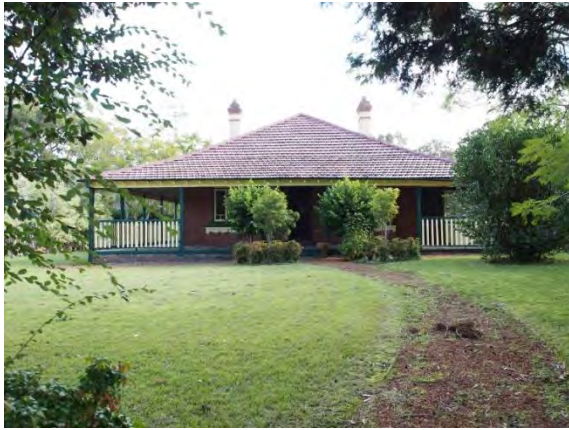
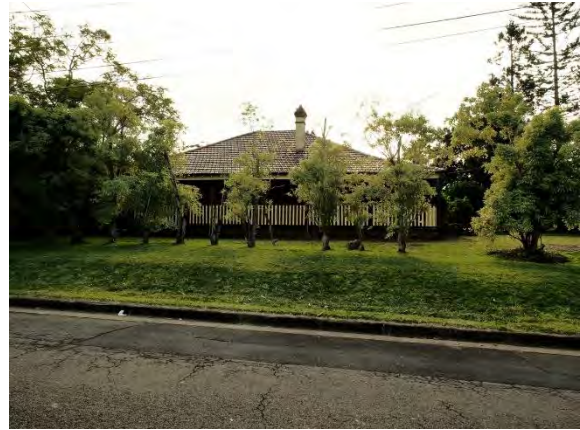
Figure 7 and 8. The property has retained its encircling verandah – giving it a traditional rural character that is rare in the context of the development of Ku-ring-gai. (left: Cook Road elevation; right: Redbank Road elevation).

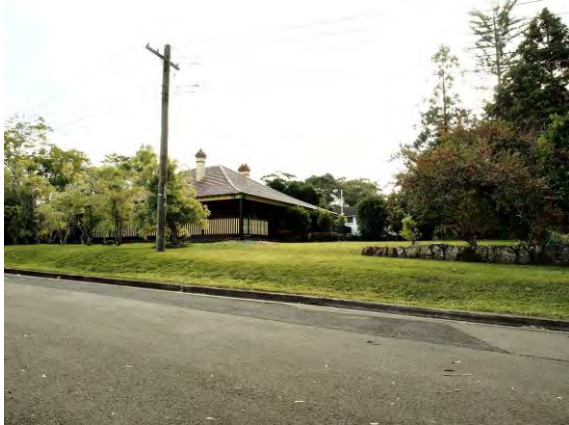
Figure 9. The lack of boundary fences to the front garden allows the property to address the local streetscape strongly (view from the intersection of Cook and Redbank Roads).

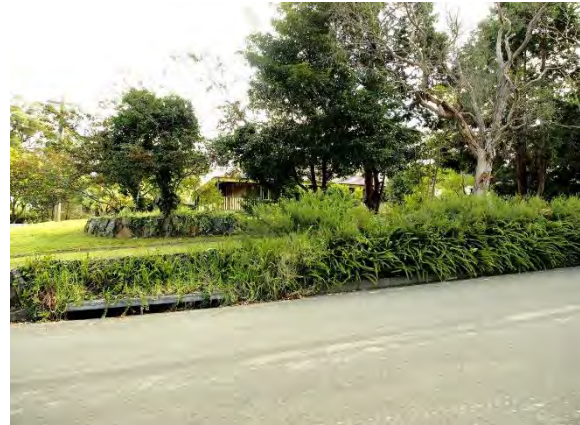
Figure 10. The topography of Cook Road falls away from the site and the garden, the footpath and the carriageway levels are separated by rockery terraces.

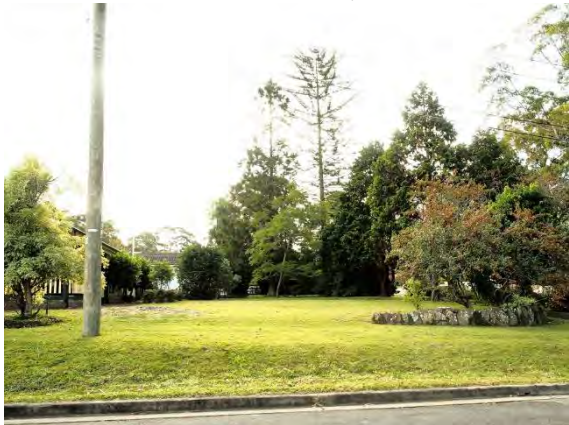
Figure 11. The boundary to the adjoining property at 30 Cook Road (originally part of the garden of Glen Brae) is also unfenced, allowing the original garden to be interpreted when looking over the site.

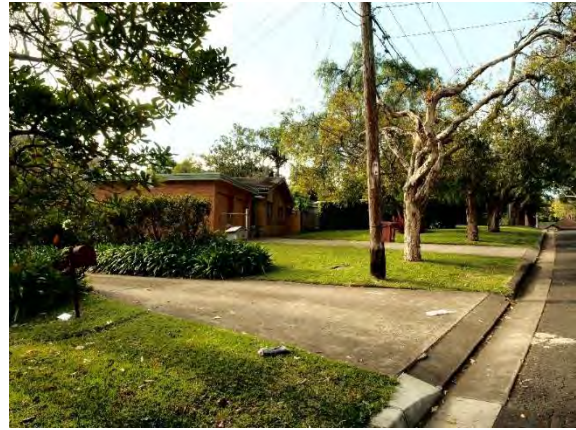
Figure 14. The view over the property from the south (along Redbank Road) is dominated by the garage and fence to the rear part of the garden, the eye being directed to Cook Road by the planting on the verge.

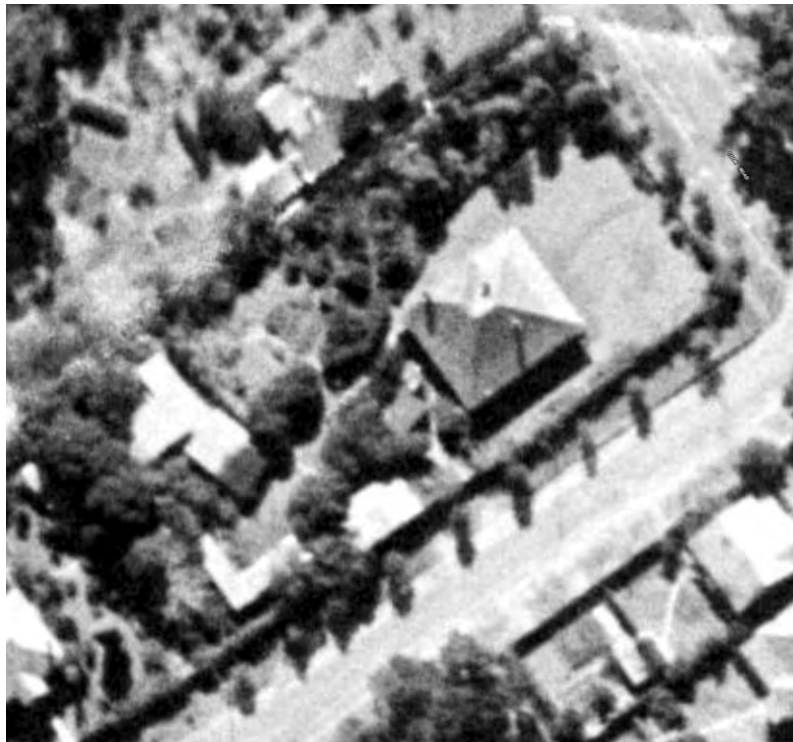
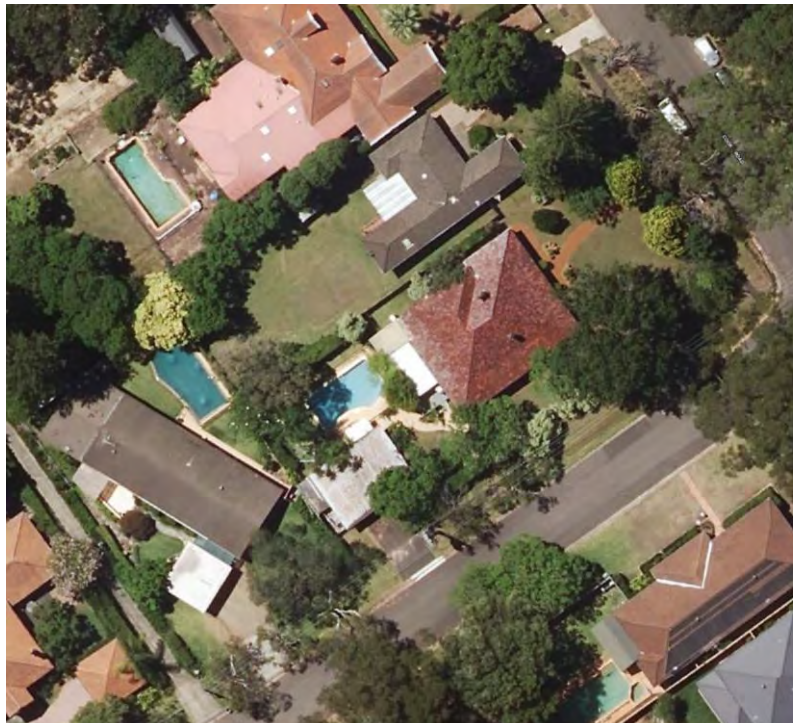
Figure 25 and 26. The 1943 aerial photographs reveal that the underlying landscape principle of the original development has survived substantially intact even though much of the original planting has been lost through removal or subdivision. The house continues to be set against a wide swathe of grass with curved path (the alignment of which was replicated by the edge of the planted area) and no evidence of feature planting of the specimen trees or garden beds that were common in the era.

The 1943 image suggests that the perimeter was planted with a hedge or wall of shrubbery and street trees had been planted in the verge, although these do not continue beyond the boundaries along Cook and Redbank Roads. The pair of conifers either side of the entrance path are consistent with the small plantings visible in the 1943 image, but the large tree at the eastern corner of the house visible in the recent (2014) aerial had been removed by the time of the site visit. This tree had been planted after 1943.

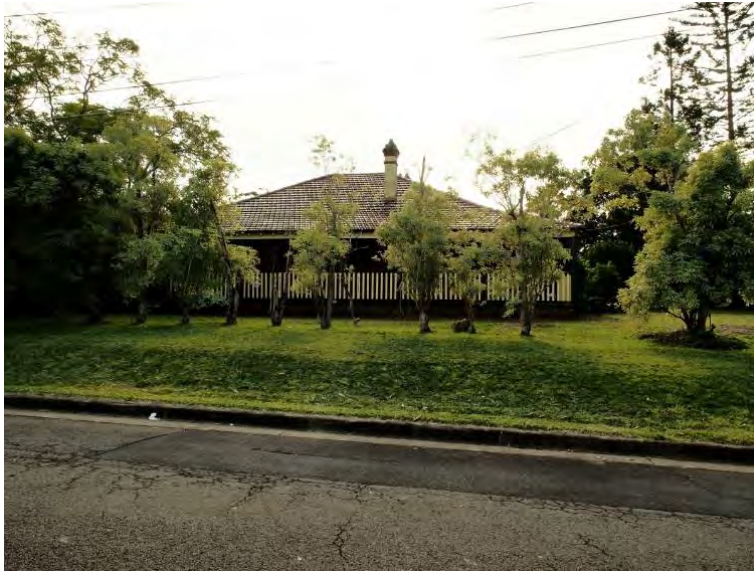
Figure 30. The site slopes down to both Cook and Redbank Roads which increases the aesthetic prominence of the house in streetscape views, particularly from Redbank Road. The lack of boundary fencing or demarcation other than the row of young sweet pittostem trees further enhances the sense of connectivity of Glen Brae as an important element of the streetscape.

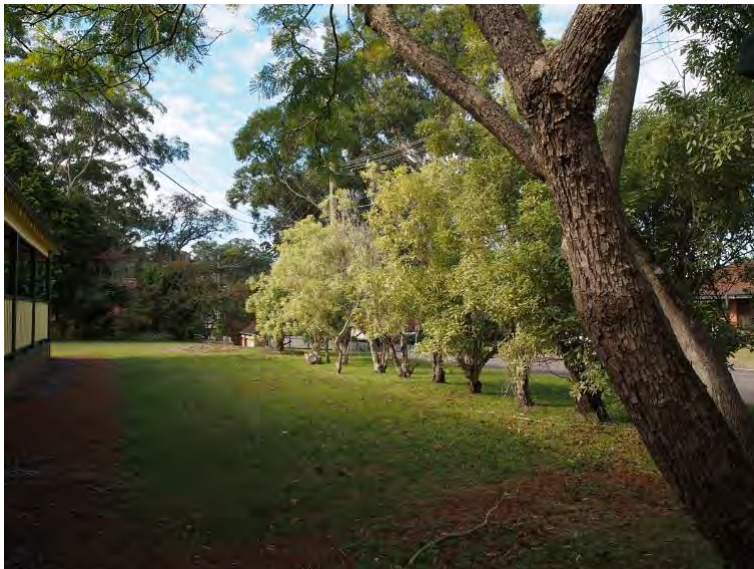
Figure 31. The grounds surrounding the house today are very simple in character and are marked by perimeter planting rather than fencing.

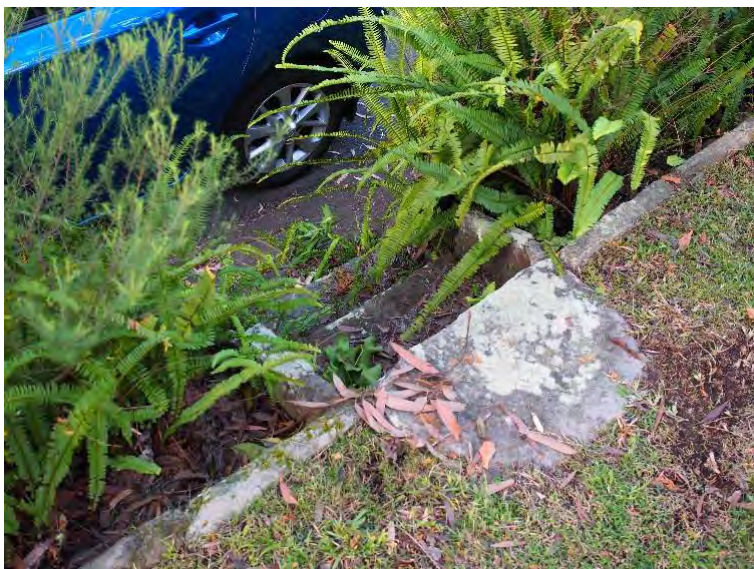
Figure 32. The footpath is set above the level of the carriageway of Cook Road and is reached by stone steps. A rockery wall separates the footpath and roadway levels.

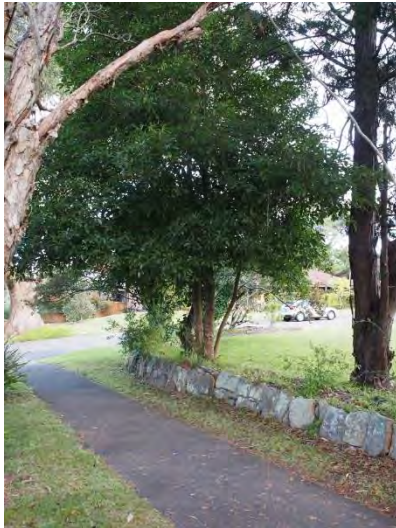
Figure 33-35. The boundary to Cook Road is defined by a low rockery garden

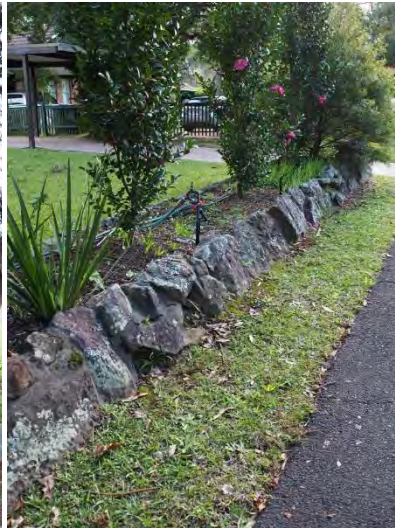
The rockery fence also extends across the frontage of 30 Cook Road.

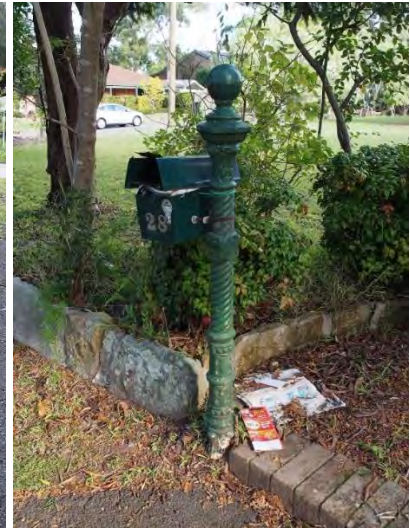
The iron post supporting the letterbox may be from the original front fence.

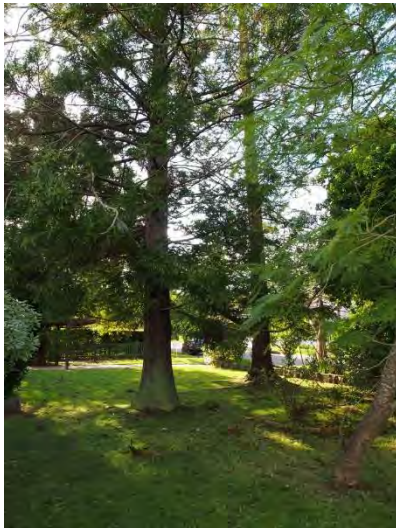
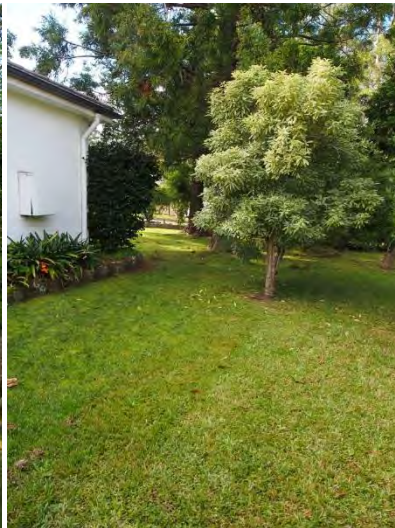
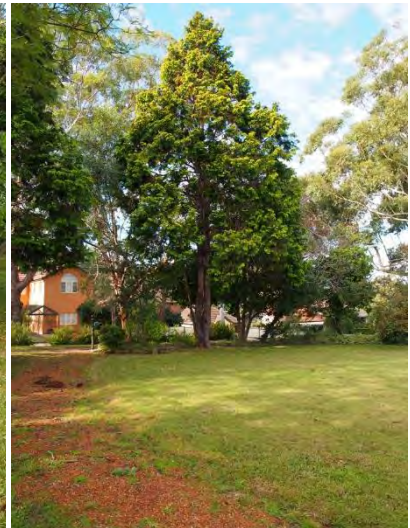
Figure 36-38. The boundary between 28 and 30 Cook Road is not marked by fencing, and allows the original extent of the front garden to still be interpreted. Consistent approaches to garden care and planting have further facilitated the impression of a generous garden setting shared and enjoyed by both properties. The maturing pines in this area were planted after 1943, but potentially prior to 30 Cook Road being excised.

The paired planting either side of the front gate are visible on the 1943 aerial photographs and continue to mark the formal entrance to the property. The gravel path has not been maintained recently and weeds are establishing.

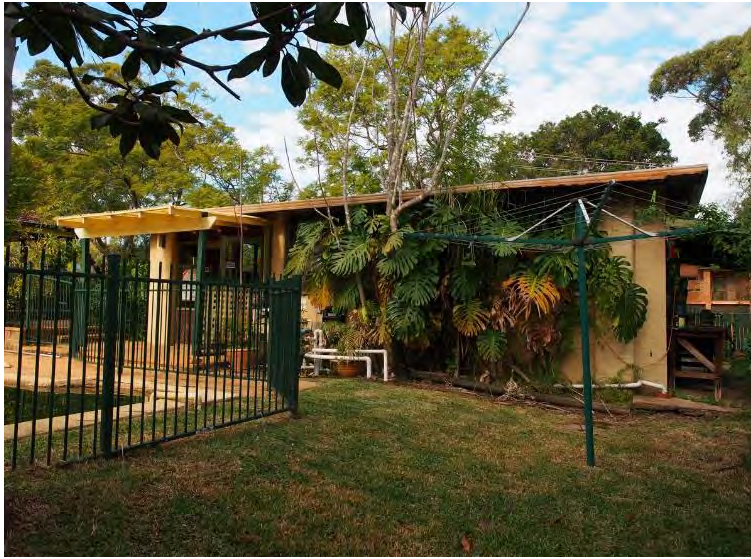
Figure 39. The garage is built of pre-cast concrete blocks with a flat metal deck roof. The main distinguishing characteristic of this garage is the curved profile of the blocks to some of the attached pillars.

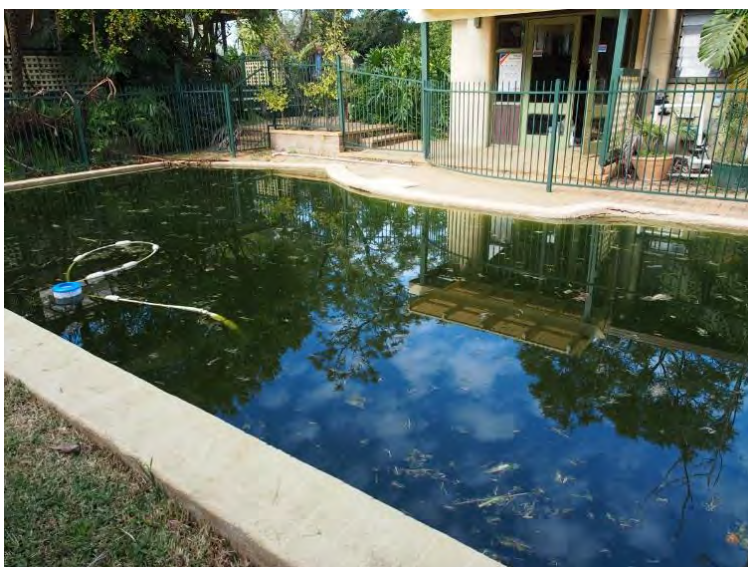
Figure 41. The in-ground pool is typical of those built in many of the properties in Kuring-gai in the second half of the 20<sup>th</sup> Century.

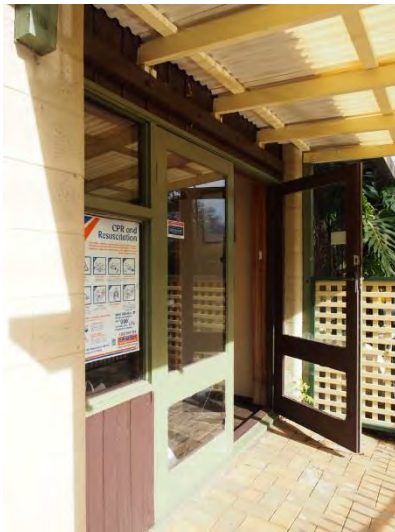
Figures 42-44. The garden structure includes accommodation for two cars and a recreation room that opens to the swimming pool area via glazed doors.

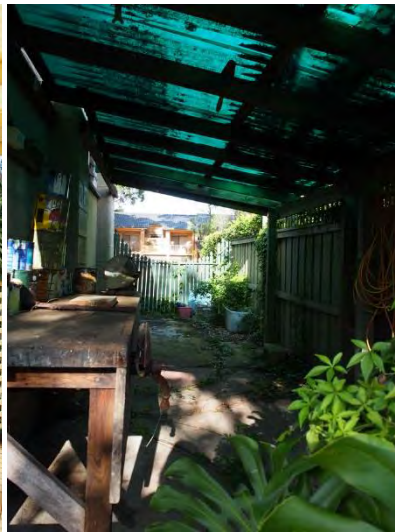
A carport/storage area has been created by adding a skillion roof with green polycarbonate sheet roofing to the space between the garage and the western fence.

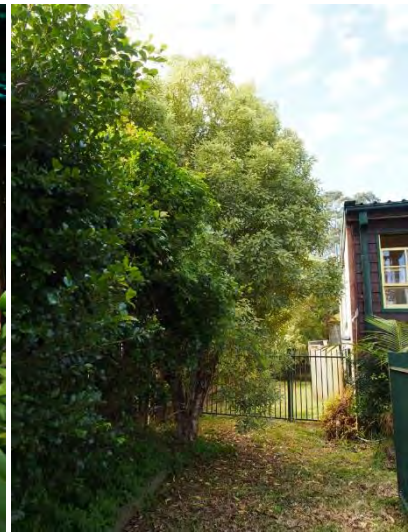
The northern side garden is now a simply planted separation between the house and the fence to 30 Cook Road.

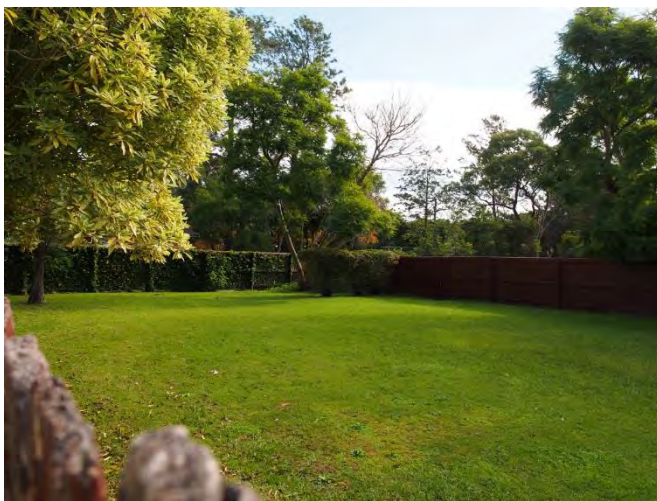
Figure 46. Rear garden to 30 Cook Road. The garden and utility activities evident in this area in the 1943 aerial have been replaced by a simple grassed space.

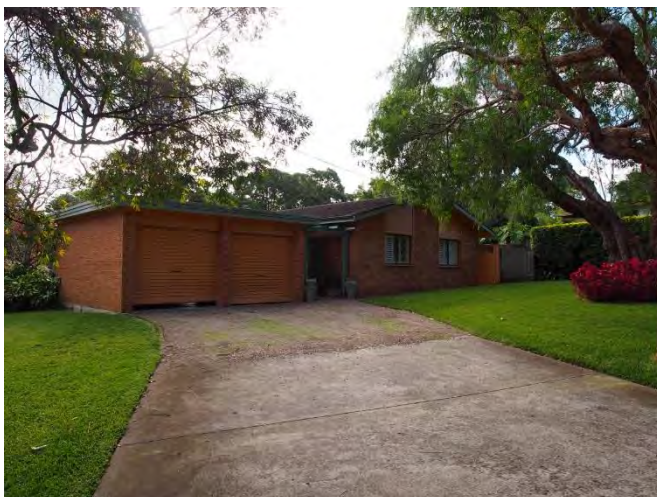
Figure 47. The adjoining property at 1-3 Redbank Road was formed from land subdivided from the back garden of 28 Cook Road in 1965.

The house on this site is modest in its scale and street presentation. It is a ranch-style house that has been set obliquely on the lot to present its main elevation to the north-east and minor elevation to Redbank Road. This oblique alignment is generally consistent with that of the collection of sheds on this part of the site when it was part of Glen Brae's garden.

Although not an outstanding example of its type, the low scale and downhill siting of this infill house have minimised the impact on the setting of Glen Brae.

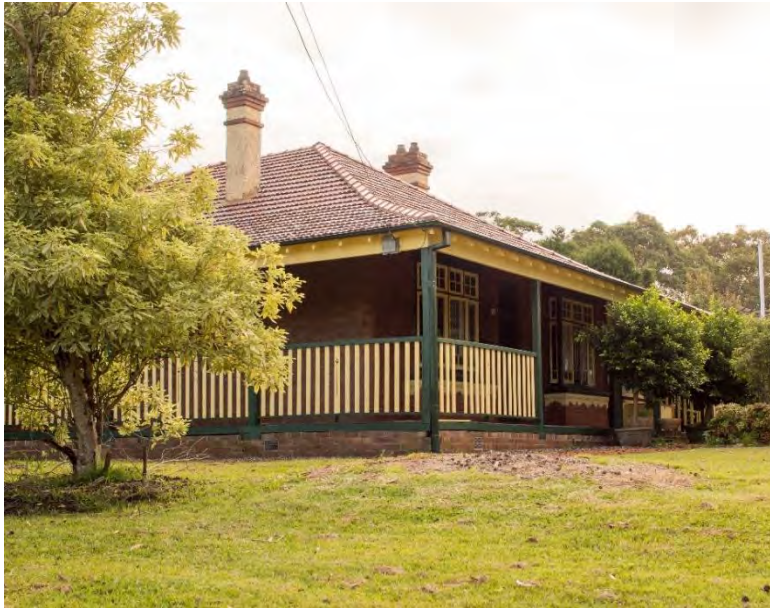
Figure 48. The whole of the original roof form, including the two main chimneys, are intact.

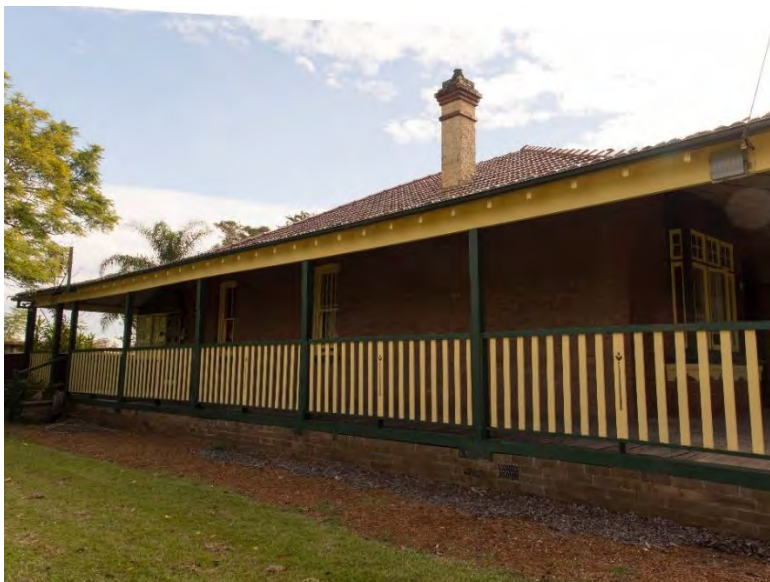
Figure 49. Redbank Road elevation showing the exposed rafter ends characteristic of the Federation period

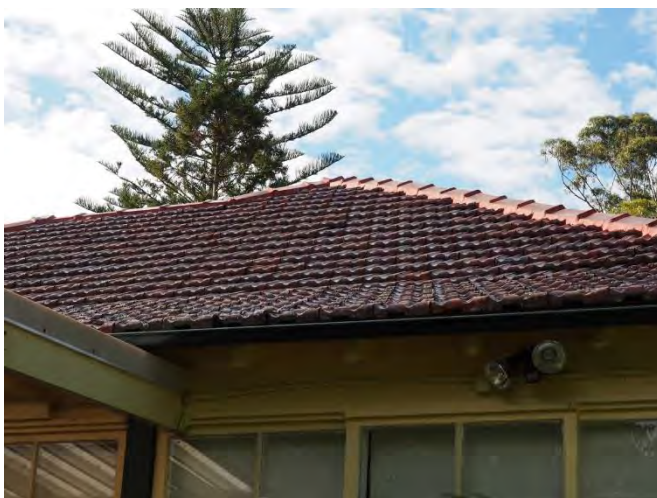
Figure 50. The roof cladding has been replaced with a traditional low-glazed terracotta tile in a red-toned simplified Marseilles pattern. The 2009 image on Google StreetView suggests that the previous roof was also tiled in a dark brown finish. It was not possible to access the roof space to inspect the roof carpentry and determine the original roof cladding material.

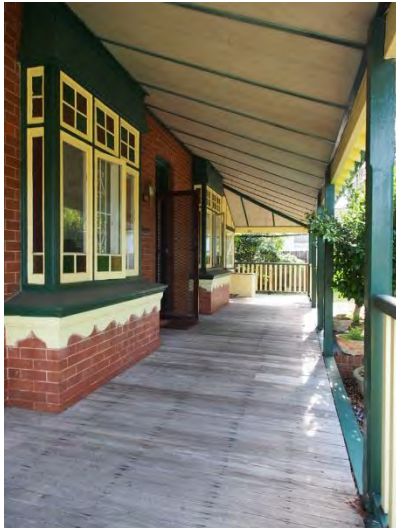
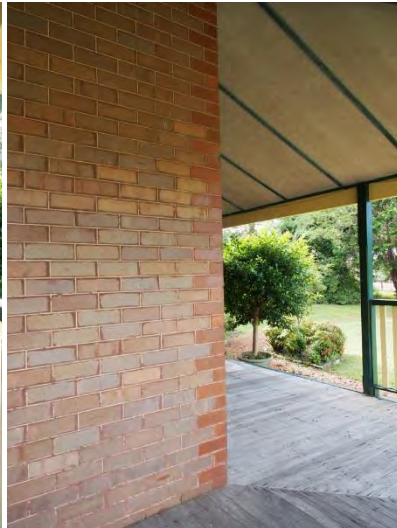
Figures 51-53. The verandahs are deep and sheltering. Floorboards are hardwood and most appear to be original except some replacement where weathered at the outer edges.

The verandah roof is steeply raked and lined in batted sheeting.

The verandah railing has been replaced in a traditional manner and reads as being sympathetic to the style of the property.

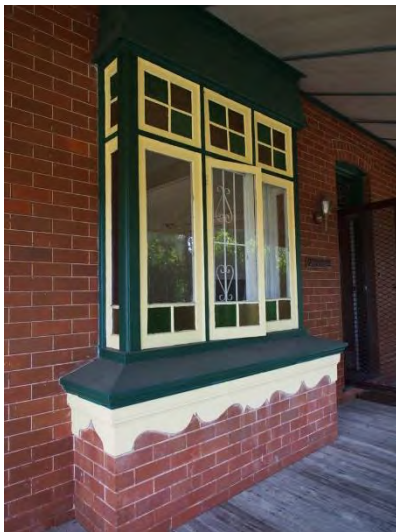
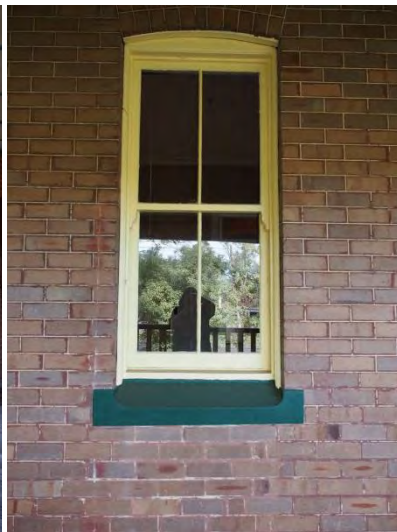
Figures 54-56. The main elevation to Cook Road is distinguished by a pair of simple-bay-light windows that protrude slightly from the façade and flank the front door. This window form allows extra light into the interior and better oblique views from the rooms within. Glazing patterns are characteristic of the Federation period, with multi-paned detailing and plain casement openings. The transom is clad in timber shingles.

Other windows are double-hung timber framed sash openings with the arched headers and cast cement sills characteristic of the early 20<sup>th</sup> Century.

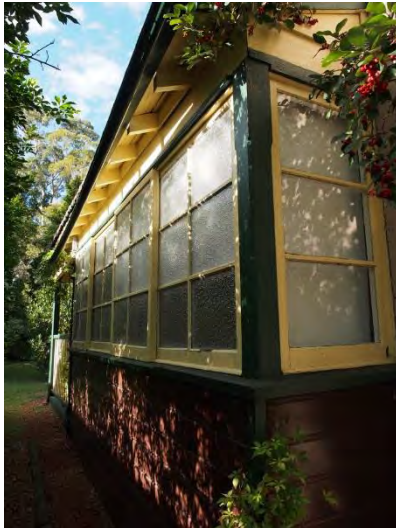
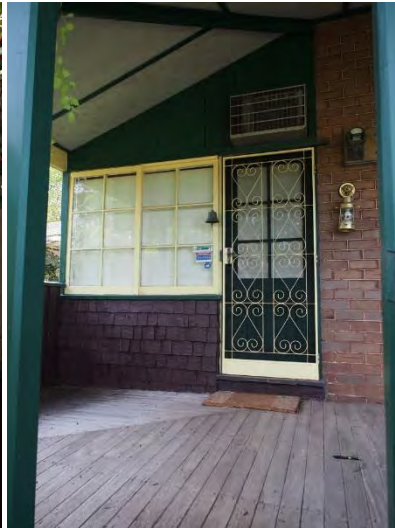
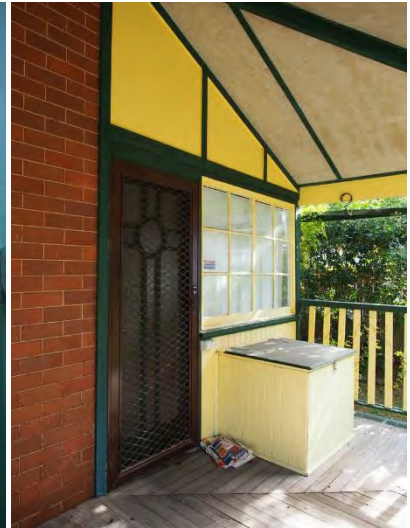
Figures 57-59. The enclosed verandah spaces also have timber-framed windows consistent with their period of installation. The original sawn rafters have remained in situ.

The rear verandah has also been enclosed to create a sunroom. The entrance to this space is modestly but carefully detailed in a manner similar to that of the northern enclosure, suggesting that they may have been made at a similar time.

The northern return of the verandah has been enclosed in the Inter-War period with lightweight glazing and panelled doors characteristic of the period. The original verandah floor of this enclosed space is intact, although the boards have been polished.

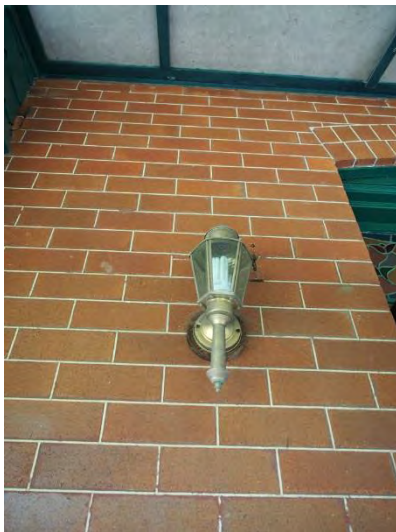
Figures 60-61. The Cook Road elevation is finished in tuck-pointed face brickwork.

The side elevations provide evidence of both the modesty of design and the high level of attention to detail and finishes.

Each room has only one window, with the front rooms (originally the parlour and main bedroom) opening only to the Cook Road elevation, and presenting a blank wall to Redbank Road and the original verandah overlooking the garden to the north. Brickwork to the side and original rear elevations is commons laid in stretcher bond, but in an atypical detail, are tuck-pointed, a detail rare on common brick walls to secondary elevations.

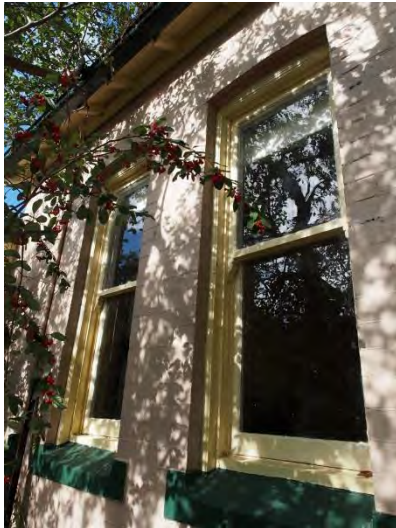
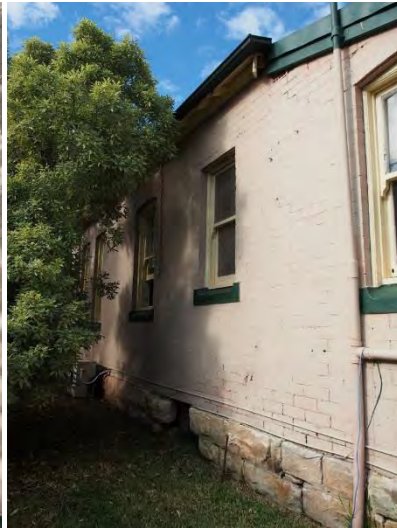
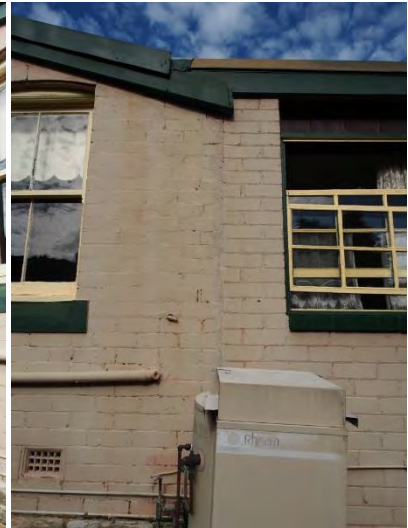
Figures 62-64. The rear half of the north-western elevation has a more utilitarian character, with most windows, other than this pair to the original dining (now main living) room serving utility rooms.

The North-western elevation has been painted, possibly to hide the evidence of the addition and alteration to the bathroom and kitchen at the rear.

The most recent addition was that of the rear bathroom and laundry wing at the rear of the house. This addition is noticeably cruder in design and detailing than the remainder of the property but is set unobtrusively at the rear corner of the footprint and is not visible from the street.

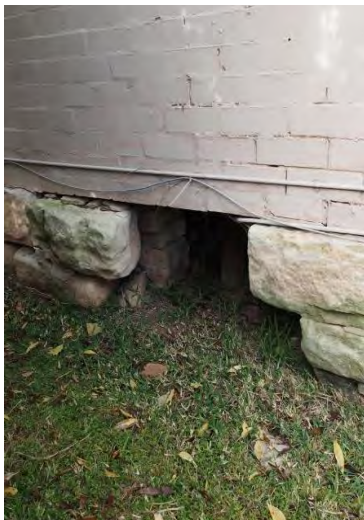
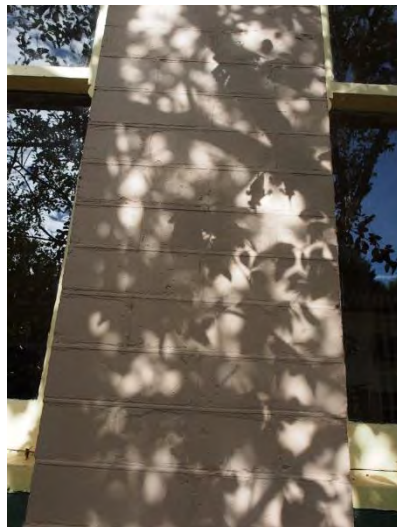
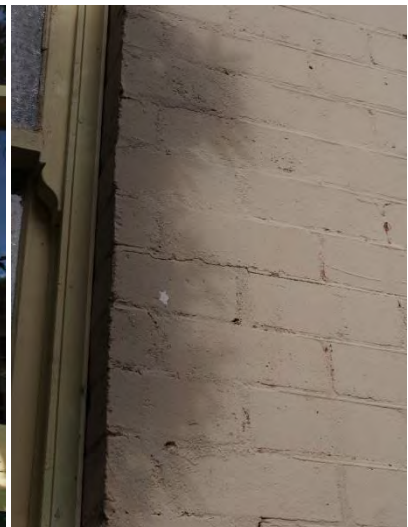
Figures 65-67. Evidence of disturbance to the space now occupied by the bathroom: stonework has been removed to provide access to the subfloor space.

Northern elevation now painted over, but tuck-pointing extant beneath the paint. Not known if originally common or face bricks to this elevation

Evidence suggestive of the windows being removed and re-inserted in the space (brickwork jointing), but impact on integrity of fabric minimal. Likely as part of the rearrangement of uses to utility rooms

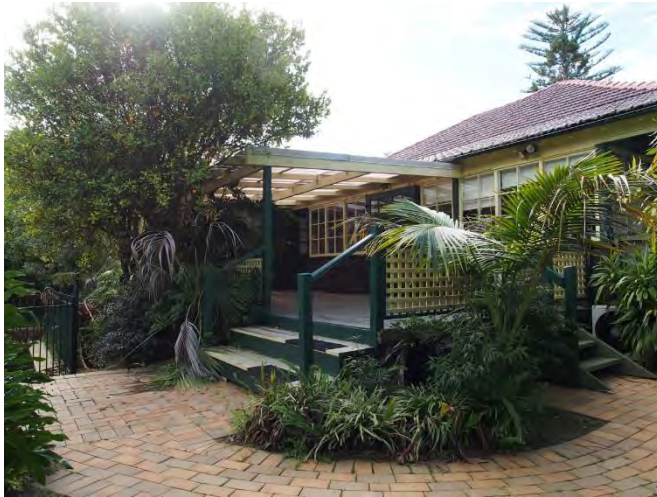
Figure 68. Rear elevation from the garden area. The timber deck has been added to the original rear elevation and the area at the base paved in bricks.

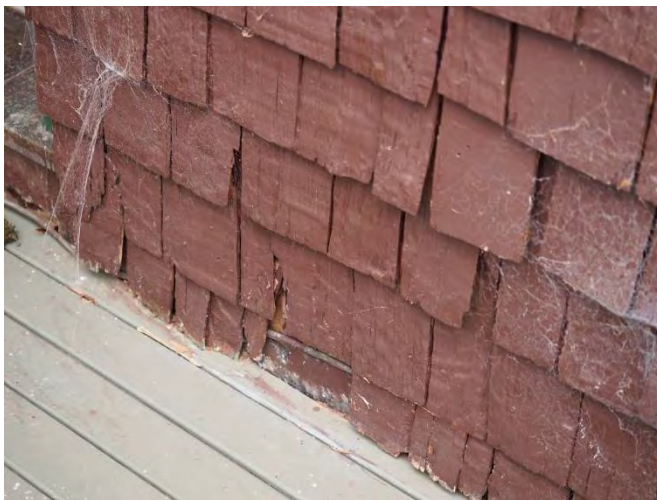
Figure 69. The original rear wall of the verandah has retained what may be original timber shingle cladding to partially enclose the space. The shingles were individually cut and affixed to the wall and are well-weathered.

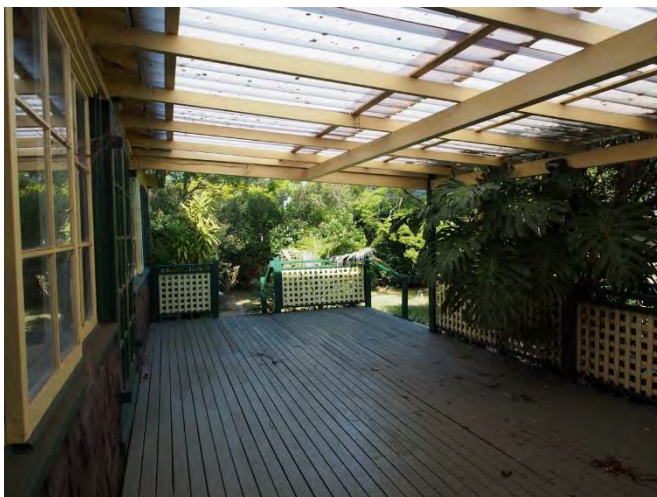
Figure 70. A timber deck has been added to the rear of the original verandah/sunroom to provide an outdoor entertaining area on the same level as the house. A translucent polycarbonate roof has been added.

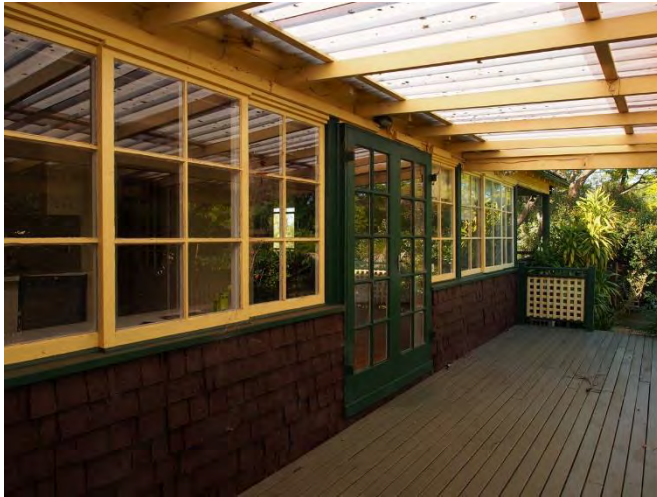
Figure 71. Enclosed verandah and deck.

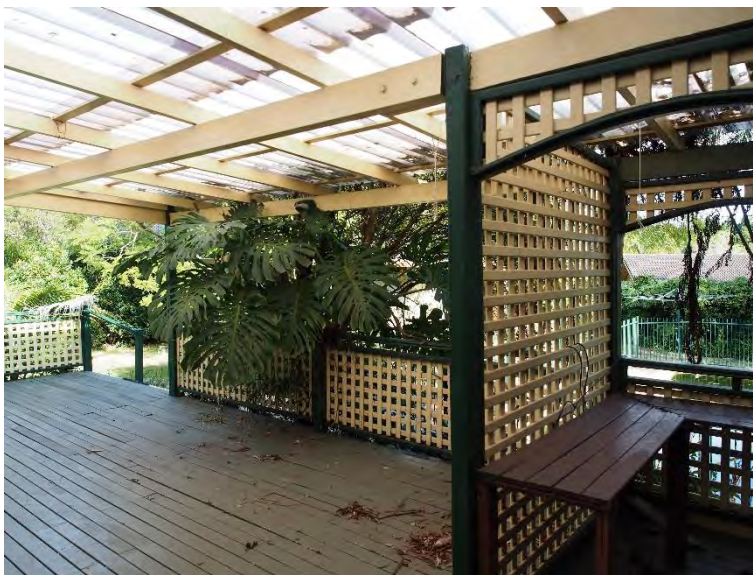
Figure 72. The new deck includes a bench suitable for potting plants etc adjacent to the laundry.

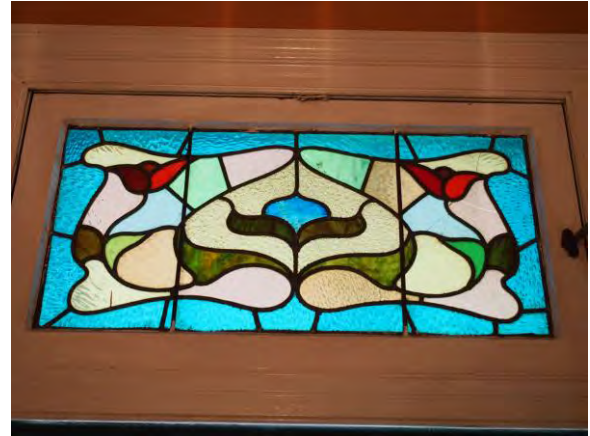
Figure 74. Detail of the leadlight highlight above the front door. This appears to be in very good condition, although some of the glass pieces are slightly cracked, all are original and in position.

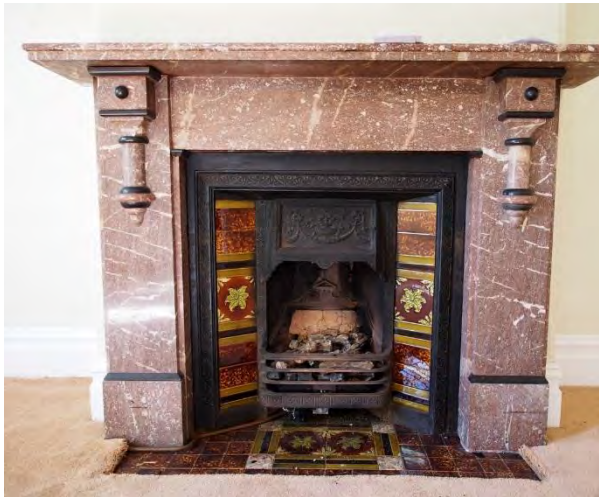
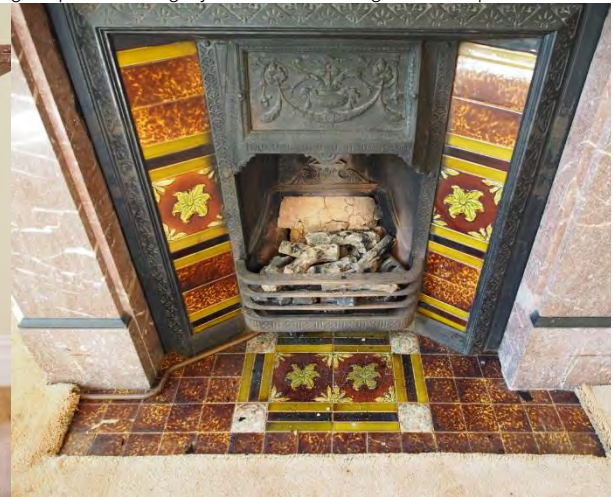
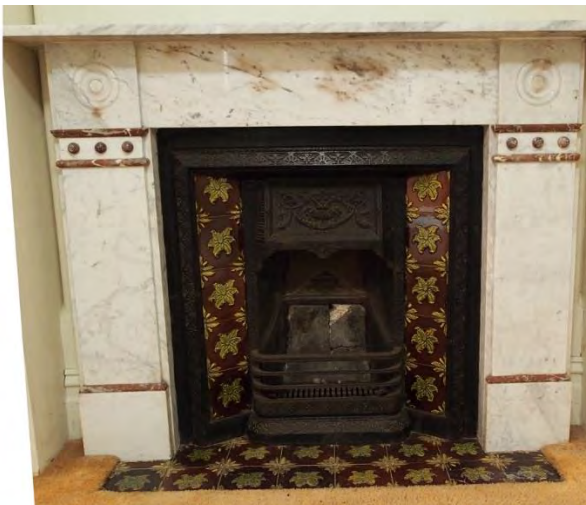
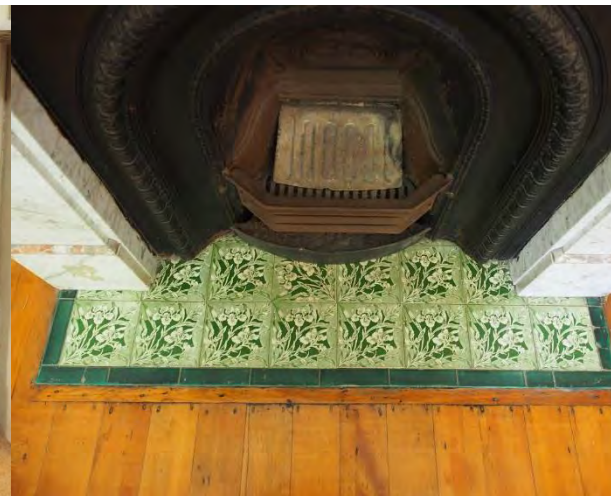
Figures 75-78. Fireplaces – all fireplaces are intact throughout the house and are in excellent condition, with iron grates, marble mantles and encaustic tiles unique to each room. The living room fireplace has been converted to gas operation but all others appear to be unaltered.

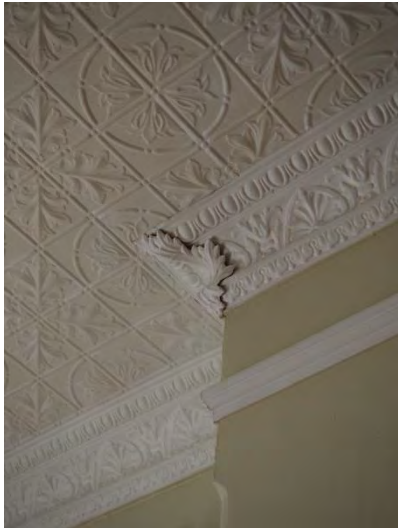
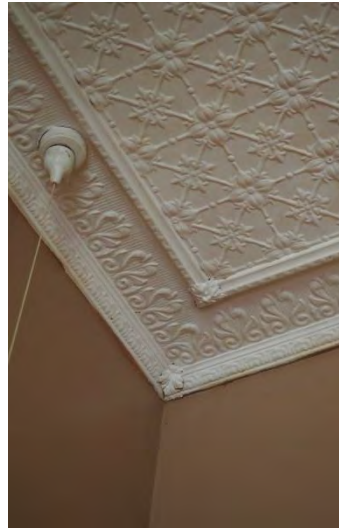
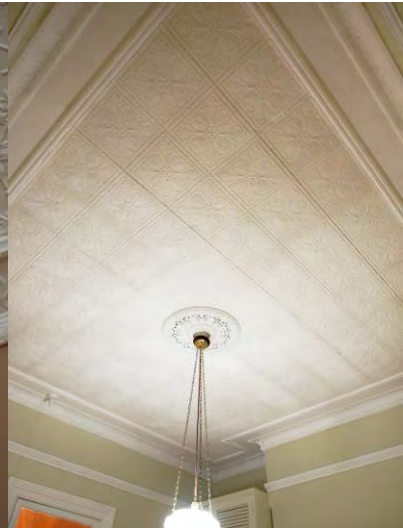
Figures 79-81. Original pressed metal ceilings have survived to all rooms under the main roof with the exception of the utility rooms (kitchen and bathroom) which have timber lining board ceilings; and the rooms created through the enclosure of the verandah which have retained the steeply raked underside of the verandah roof.

The patterns to the pressed metal ceilings are unique to each room, and are notable for their intact condition and survival of the original leaf-fashioned covers to each join in the corners. The main rooms include metal ceiling roses with ventilation holes.

Note also the original cord pull light switches to each room. These have survived intact and operational to each of the main rooms. No wall-mounted switches have been installed in the main house.

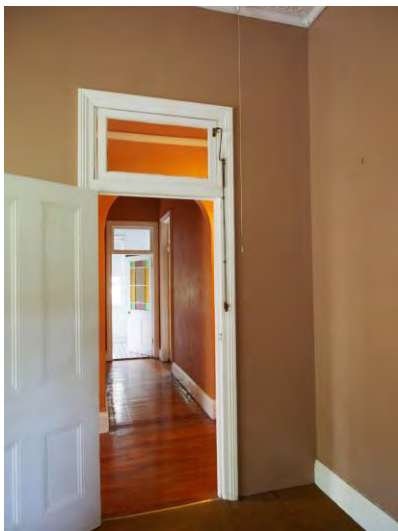
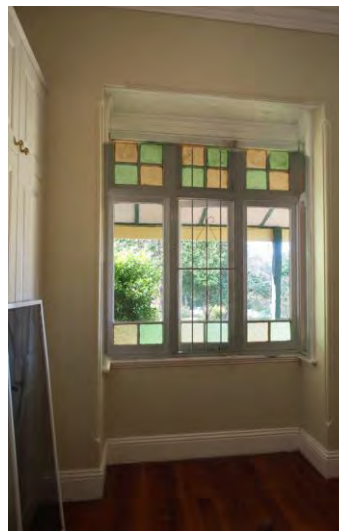
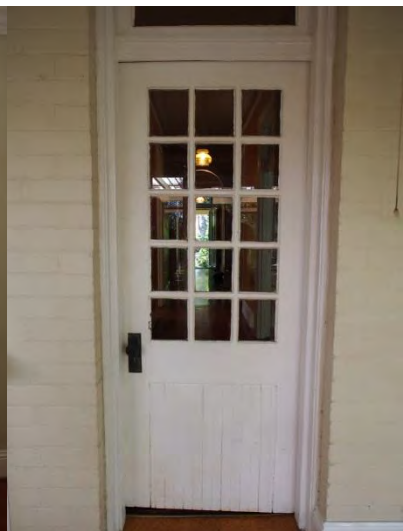
Figure 82-84. The internal joinery appears to be original and is intact throughout the house – including doors hung in the traditional manner to allow privacy to the room beyond (with opening highlight windows). The survival of this detail is rare. In most houses the doors have been re-hung to swing against the wall in the contemporary fashion.

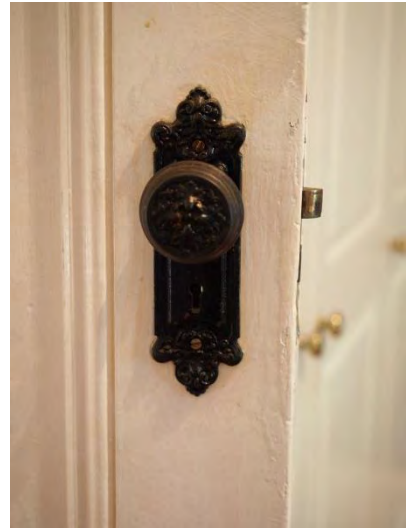
Figures 85-87. Details such as the decorative plaster to the hallway including the archway is intact and of good quality. The original hardware for opening the highlight windows above each door is also intact throughout. Door knobs and finger plates are intact.

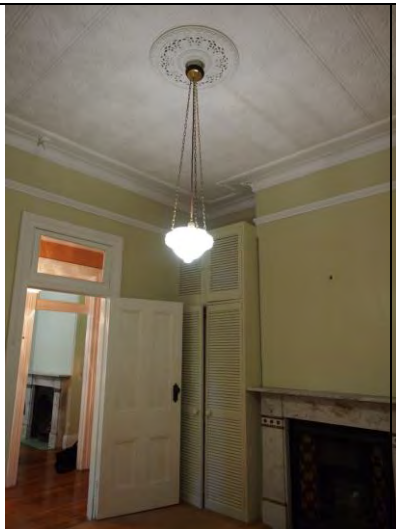
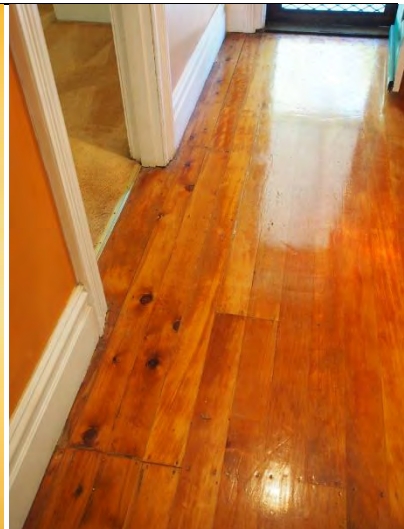
Figures 88-90. Some light fittings appear (from ground level inspection) to be original, others are period-style reproduction. Electric-powered struck door chime in the hallway (cover also extant). The hallway floor is polished timber, the main rooms are all carpeted with carpet in good condition.

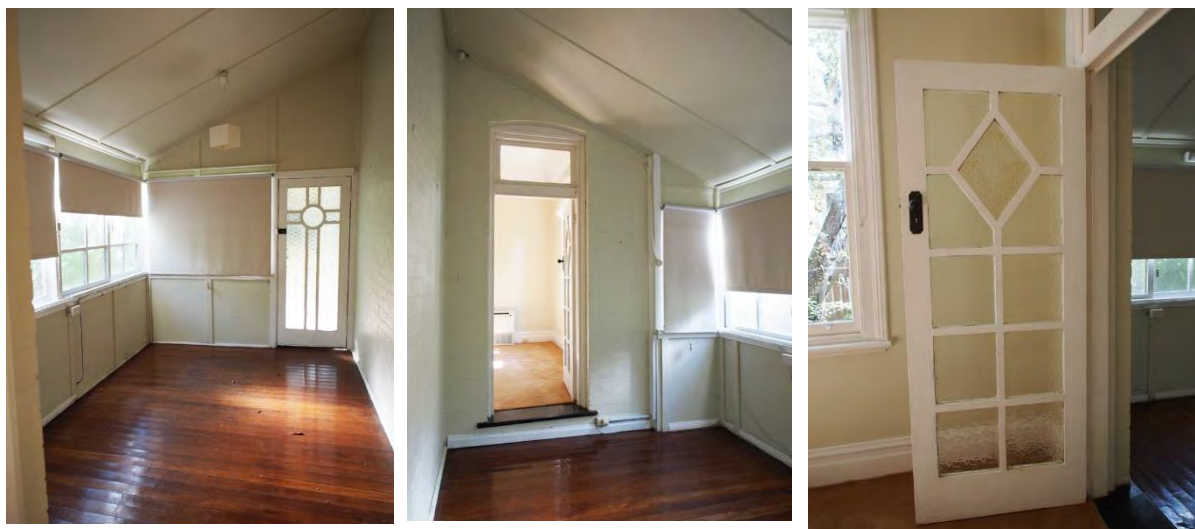
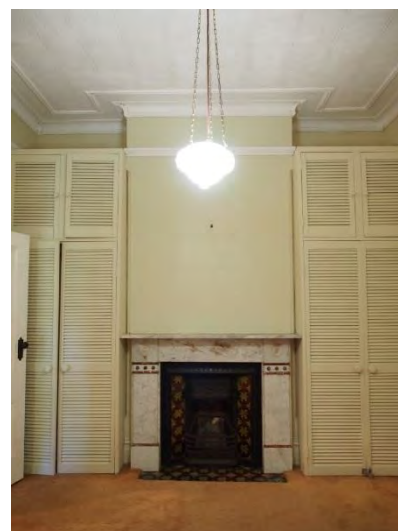
Figures 91-93. The enclosure of the northern return to create a sunroom accessed from the front verandah and the dining/living room was likely carried out in the Inter-War period. The original verandah form to this space remains clearly legible, with the steeply raked roof form retained and the original hardwood boards in situ and polished. The windows are lightweight timber with obscure glazing. The walls to the external faces are batted sheets – potentially asbestos cement. Note that the sheets are sealed by paint and appear to not be damaged.

The arched header to the door to the main house and step down to the verandah set into the original brickwork reveals that it was originally an external door, although note that the door leaf has been replaced. The original door is likely to be one of those re-used elsewhere in the house. The two current doors to the sunroom are characteristic of the Inter-War bungalow style, and represent the two most popular styles with timber framing, obscure glazing and circular/diamond motifs.

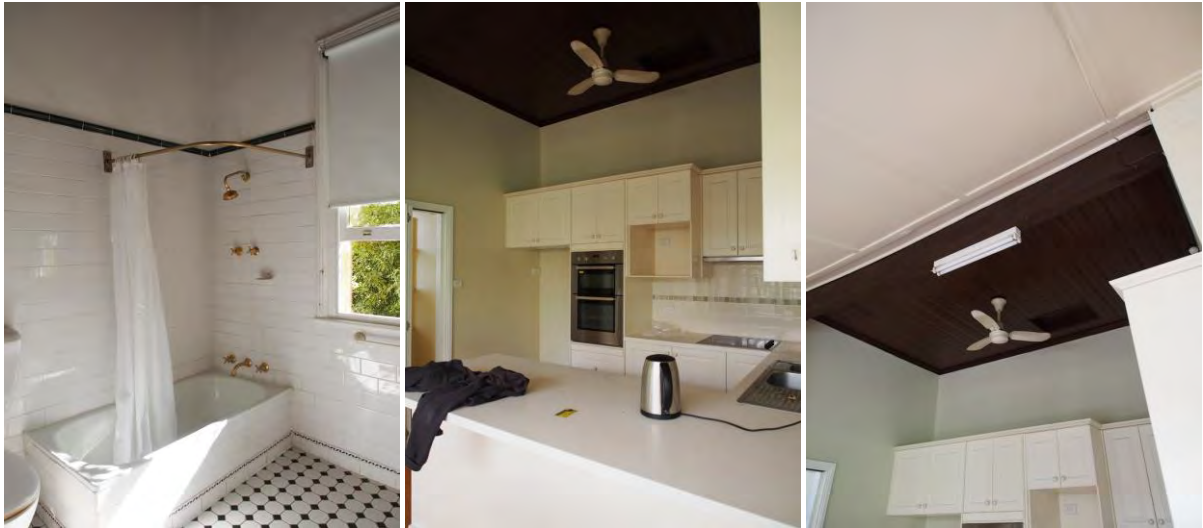
Figures 96-98. The original kitchen and bathroom spaces have been swapped to reflect the changing role of the kitchen in family life in the latter half of the 20<sup>th</sup> Century. The works have been done neatly and the layer reads as a sympathetic one. The original timber lining to the ceiling of each space appears to have been retained (closer inspection would confirm). This work was likely carried out in the latter decades of the 20<sup>th</sup> Century (c.1990 from the evidence of the tiles and fittings used).

This room was originally used as the kitchen but was converted to a bathroom in the 1970s. The original sash window was removed during the building works and then replaced.

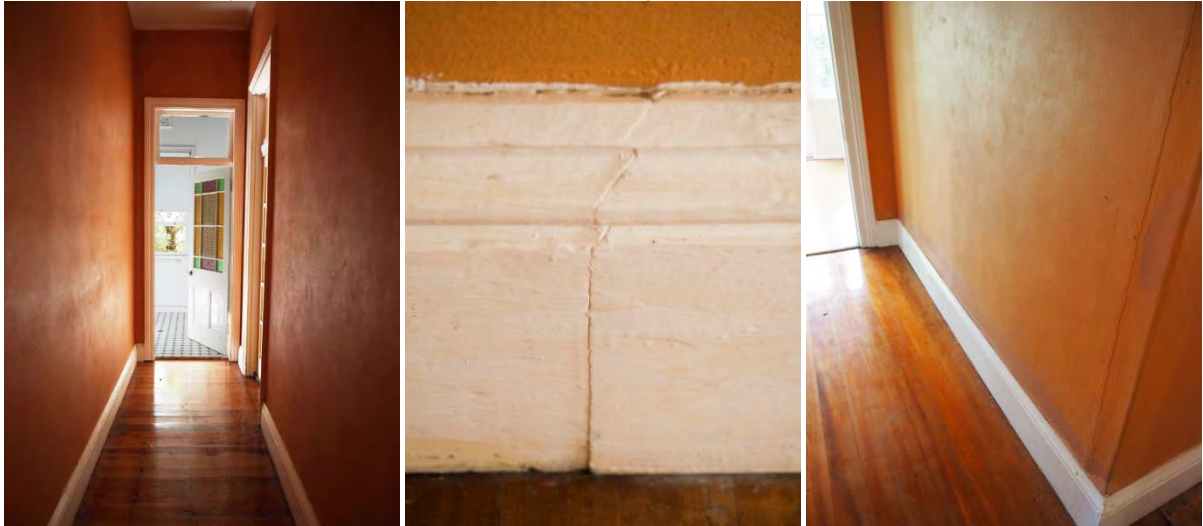
Figures 99-101. Hallway created to provide access to the new bathroom. This space was originally the servery for the kitchen, and provided direct access to the original dining room (now the living room) through the connecting door. The work has been carried out neatly with careful attention to the integration of original and altered fabric. The only readily legible evidence is the neatly cut skirting and change in the wall material from masonry to lightweight.

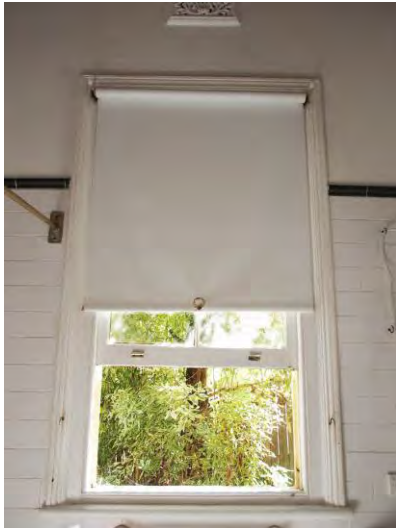
Figures 102-104. The original window to the space was retained as part of the alteration. The joinery and glazing to the door now used to the bathroom matches that of the original front door but the current latch is that of an internal door.

Inter-War period door to the opening between the original kitchen and the dining (now living) room.
