# ASSESSMENT OF HERITAGE SIGNIFICANCE

Glen Brae

28 Cook Road, Killara

August 2015

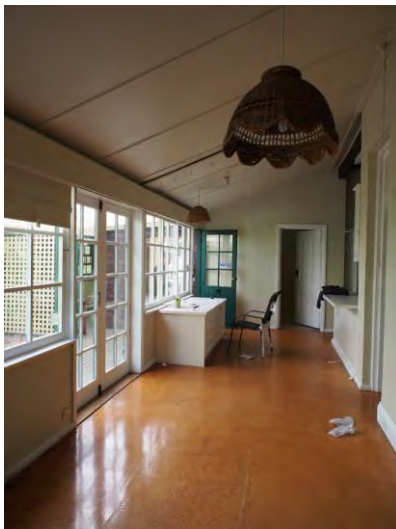
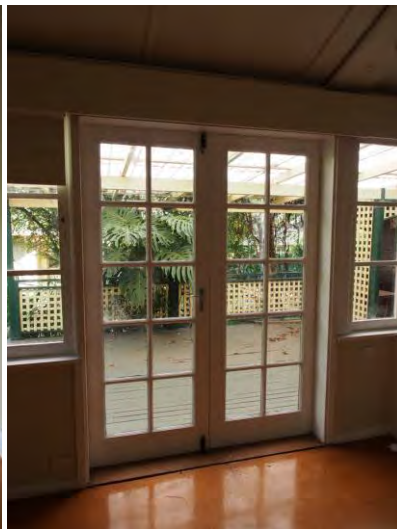
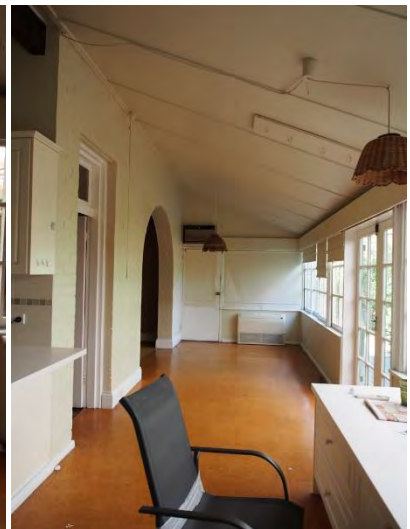
Figures 105-107. The sunroom was created by the enclosure of the back verandah by lightweight glazing. Note the retention of the raked verandah roof line. This alteration was likely to have been made pre-1936 since it is shown as part of the enclosed footprint of the house on the Water Board plans of that year (see Figure 5). The original rake of the roof has been retained and the floorboards covered by cork tiles.

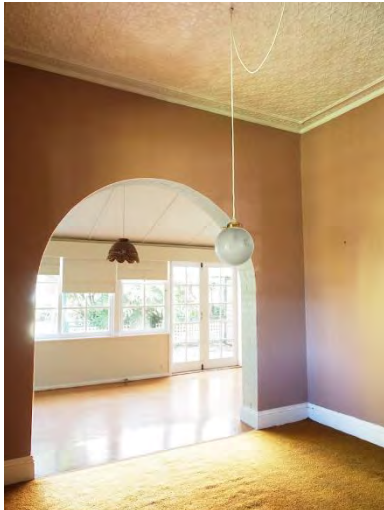
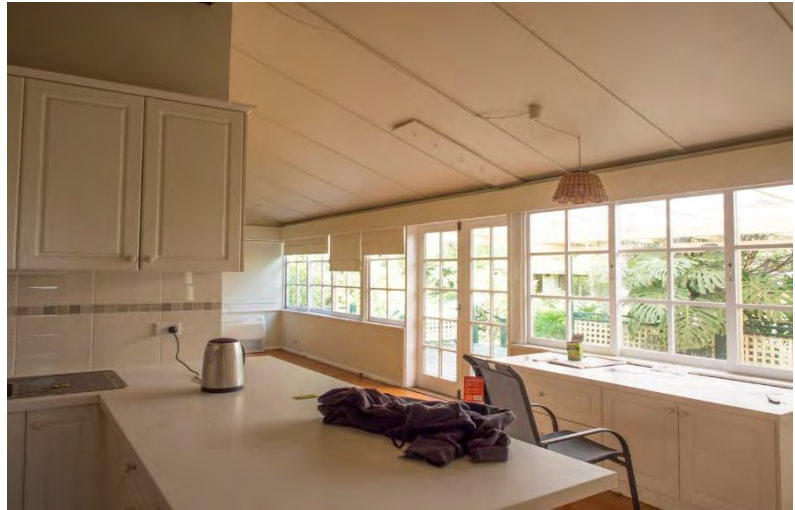
Figures 108-109. Considerable changes have been made to the original rear wall. An arched opening has been formed to the dining room (originally the back bedroom) and the rear wall to the new kitchen has been removed to allow it to integrate with the rear sunroom space. The workmanship of the arched opening reveals that it is not an original detail, although the alteration, which included the partial re-laying of this part of the wall using radius brickwork, has been made relatively neatly. The cutting of the wall to the kitchen space is well concealed by the tiling and cupboards.

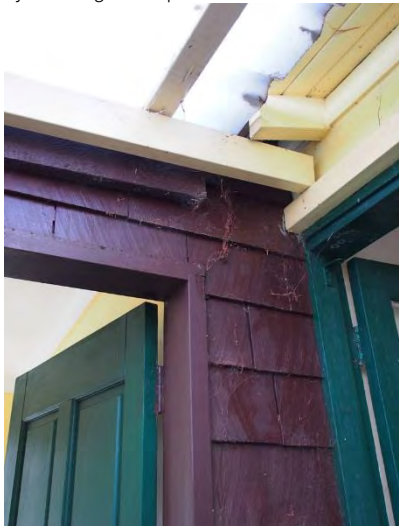
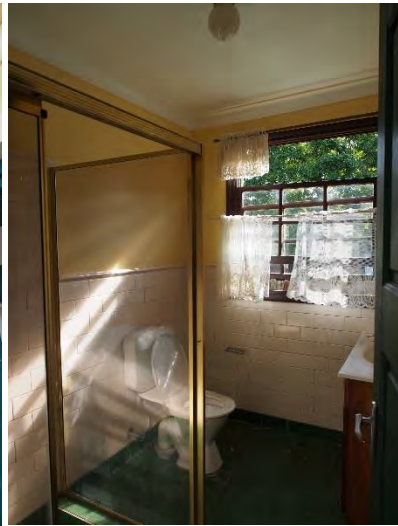
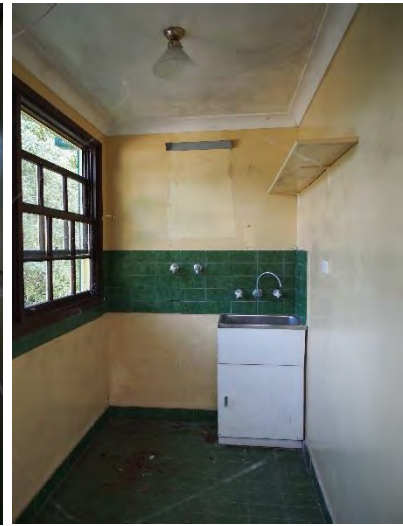
Figures 110-112. A second bathroom and laundry were added as a wing to the rear of the house under a skillion roof, potentially when the deck was added. The windows to these two rooms are timber framed sash but are of uncomfortable proportions and much lighter construction than in the remainder of the house.

These rooms were added in the late 20<sup>th</sup> Century under a skillion room. They are functional but do not demonstrate the quality of workmanship found in the main house.

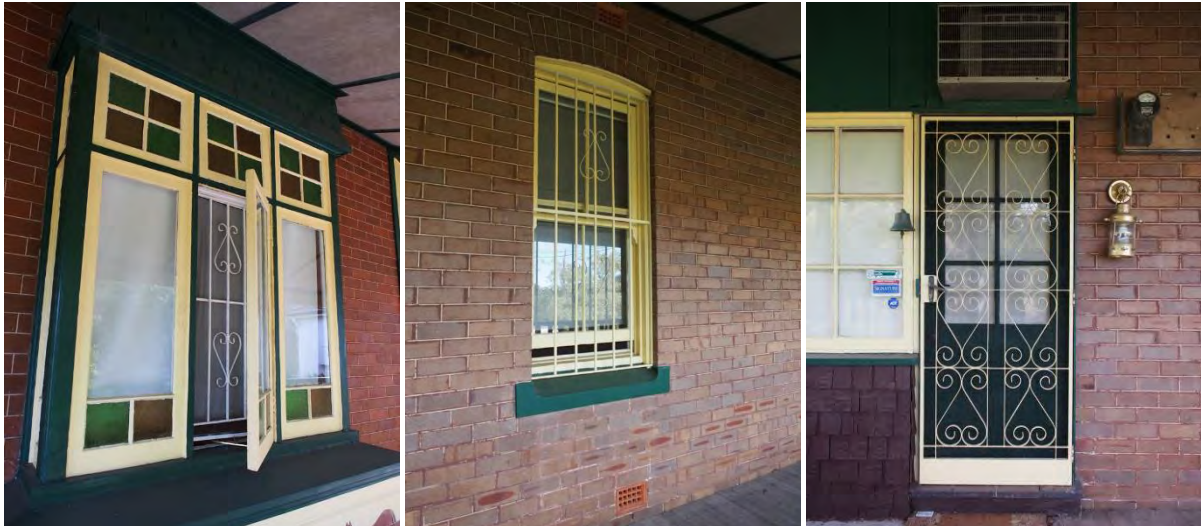
Figures 113-115. Lightweight security bars have been added to the centre casement on the interior face of the windows addressing Cook Road. This allows the casements to open freely to provide security and ventilation to the bedrooms whilst minimising impacts on the aesthetic qualities of this important elevation.

Bars to the sash windows of the rear bedroom are fitted to the exterior but have been constrained within the window recess, helping to minimise the impact on the oblique views of the elevation.

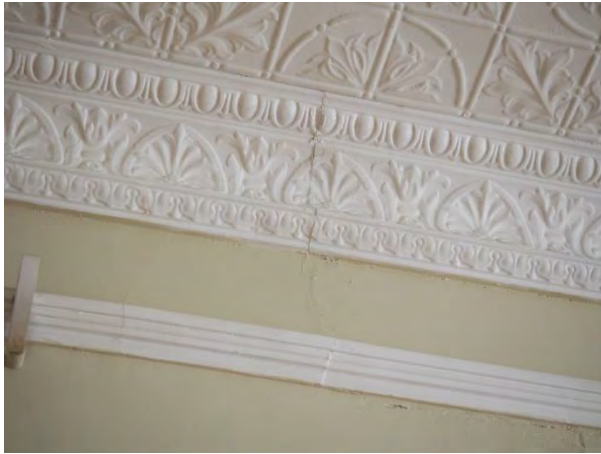
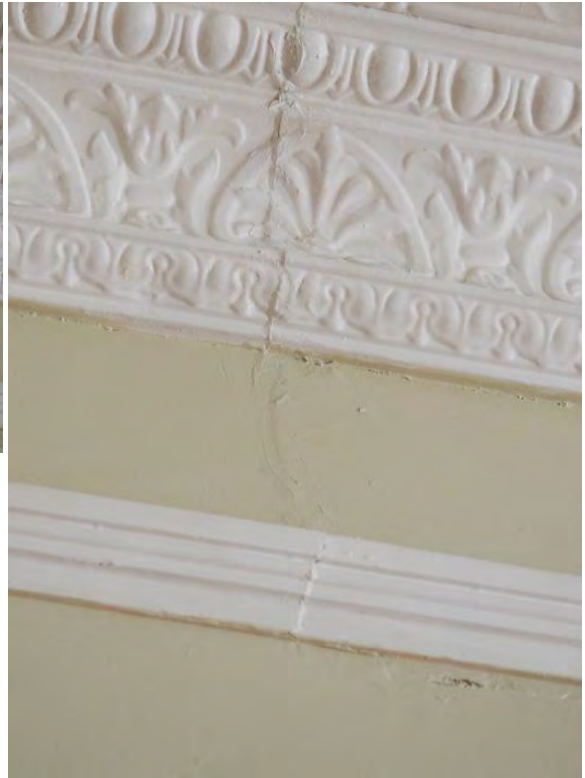
Figures 120-121. Fine crack to the wall and cornice above the doorway in the living room. No corresponding crack to the other side of the wall (to the hallway) could be seen.

Detail. The cracking is minor (0-1mm) and does not appear to extend lower on the wall, nor could it be seen on the other side of the wall (in the hallway).

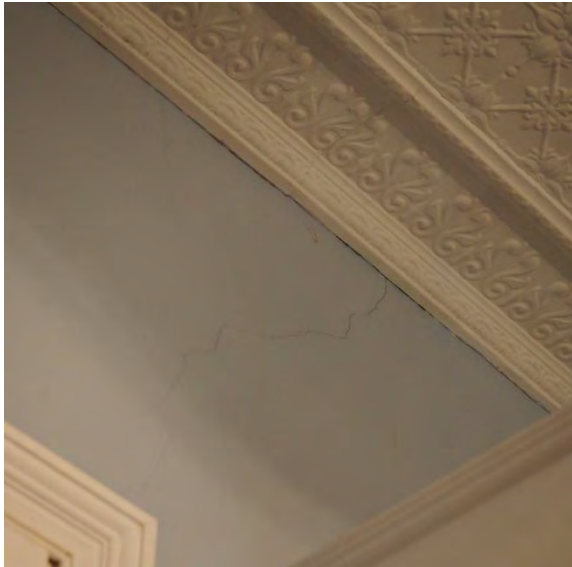
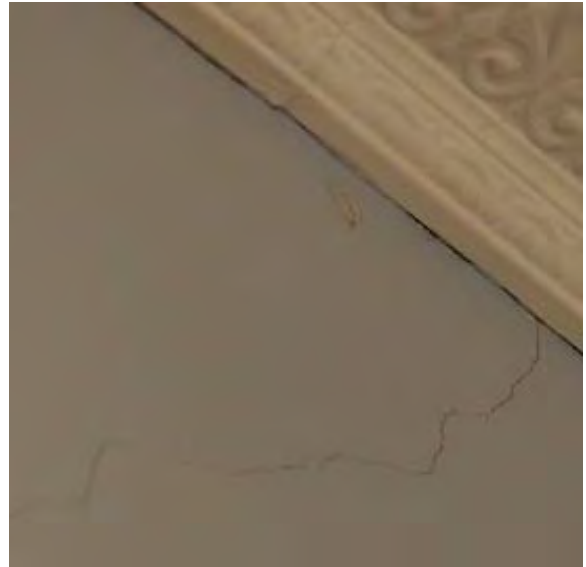
Figures 124-125. Fine cracks to bedroom 3 above door. The slight discolouration of the adjacent cornice suggests that this may have been/is due to water penetration. This should be investigated.

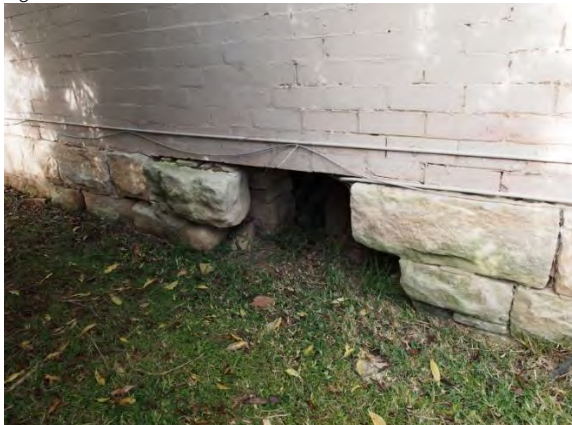
Figure 128. Stone footing stones removed to allow access to the subfloor area – likely as part of kitchen/bathroom works.

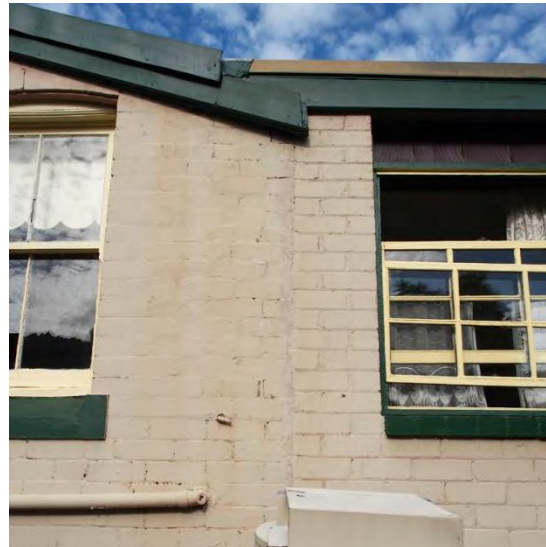
Figure 129. The rear utility wing addition is not built to the same quality as the remainder of the house and elements such as the window sash may need repair.

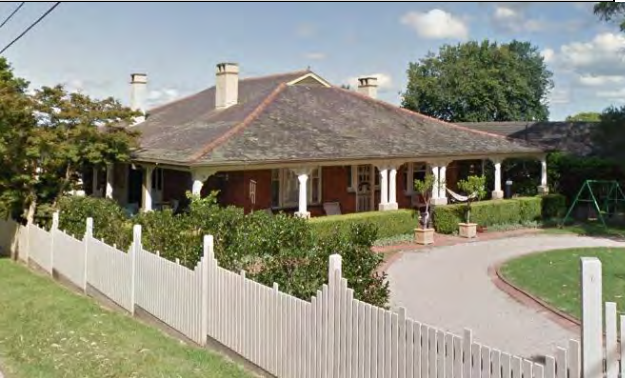
| <p>29 Macquarie Road/Riddles Lane, Pymble.</p> <p>Substantially intact, although a pre-1943 rear addition has been demolished. The site was originally substantial but has been eroded by subdivision. Traditional vernacular form. Verandah under main roof and returns to each side (now partially enclosed). Fabric includes slate roof and timber detailing and valances.</p> <p>Local Heritage Item.</p> <p>Sheet 131</p> | <p>(Google Street view image)</p> |

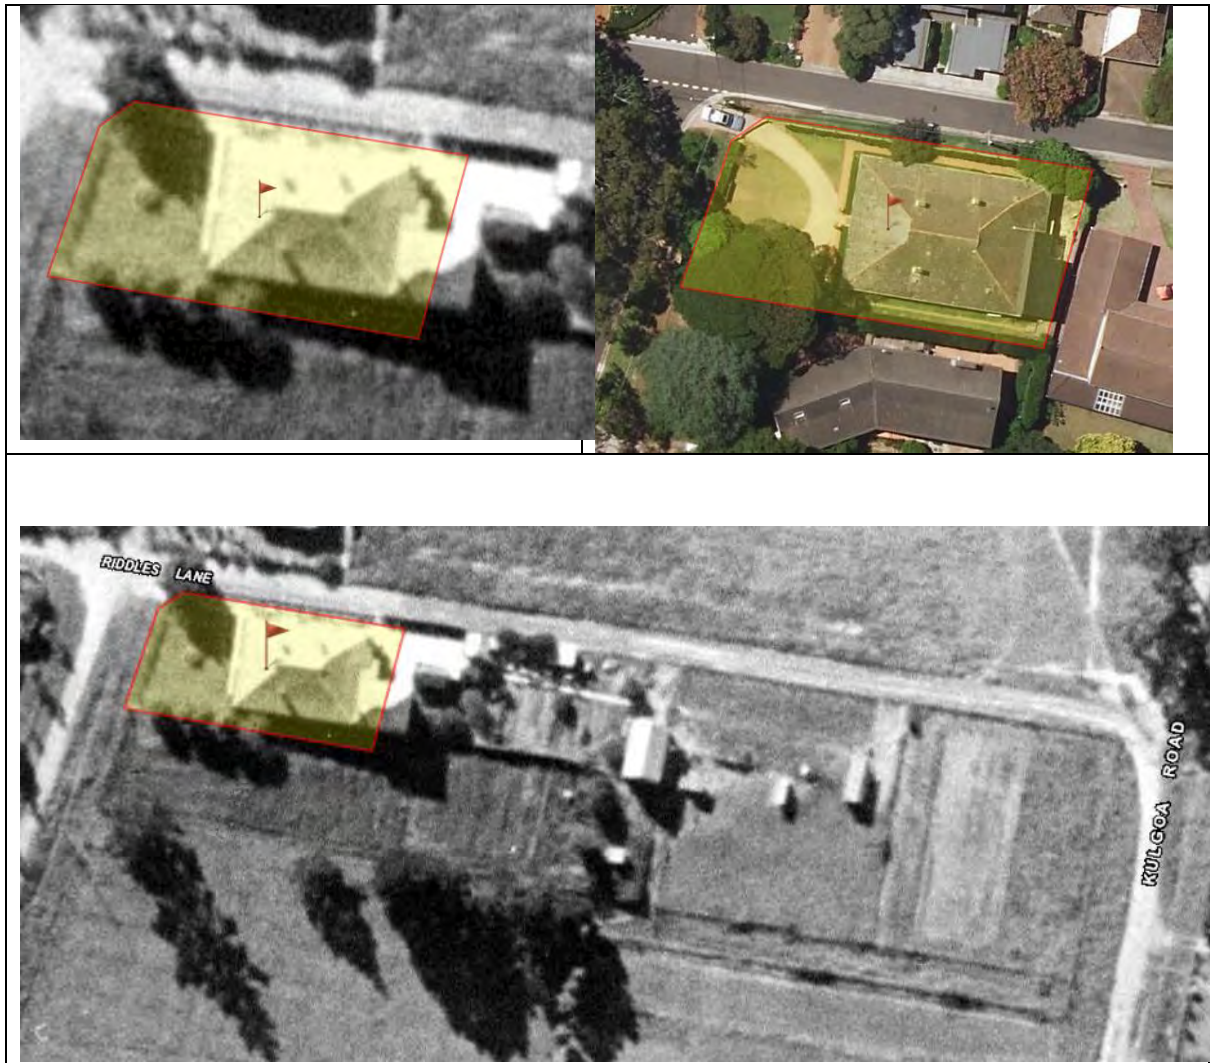
125 Coonanbarra Road, Wahroonga.

Strong traditional vernacular form and character. Return verandahs. Timber/iron construction with masonry wall to verandah. Set on a standard lot (original) with narrow side setbacks.

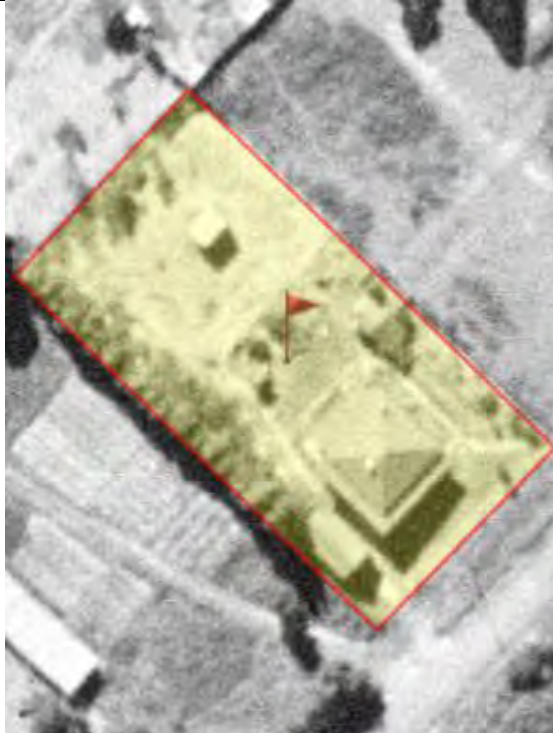
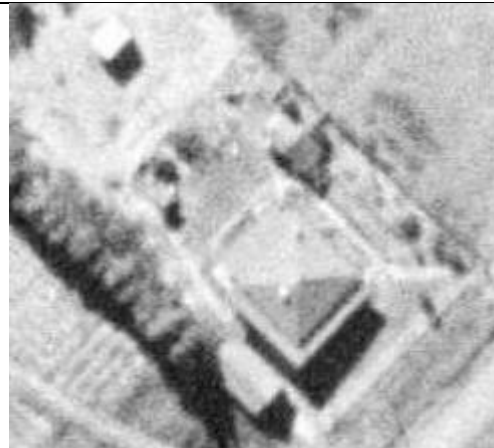
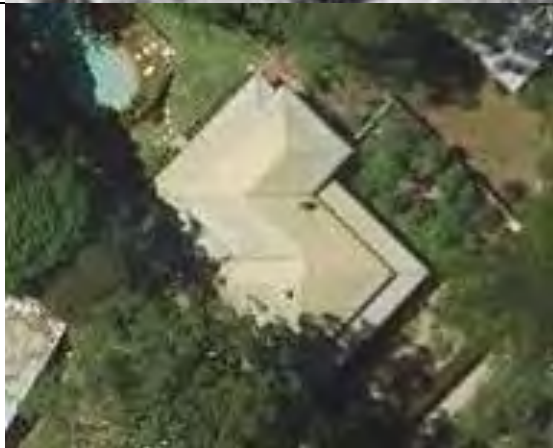
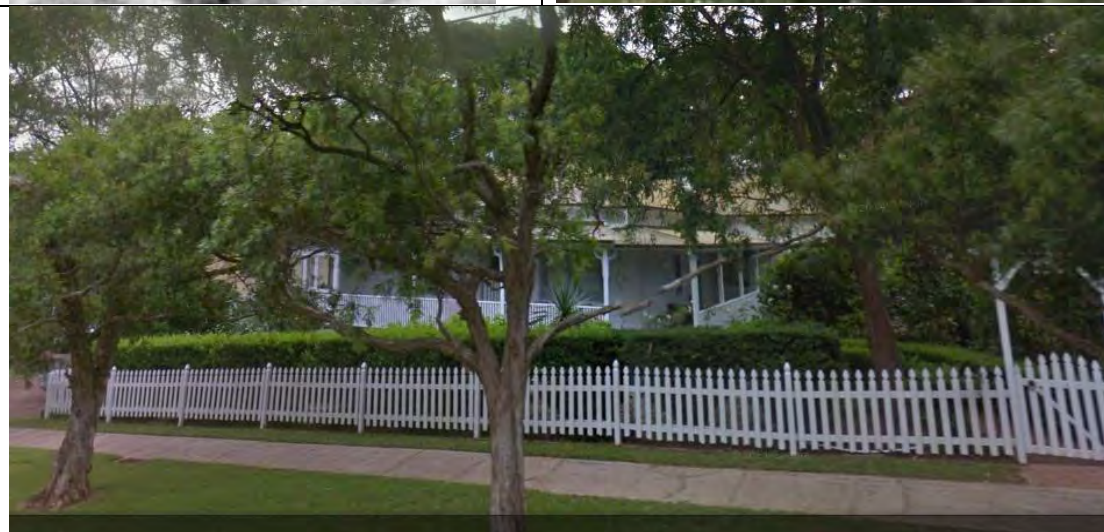
29 Finlay Road, Warrawee

Vernacular timber cottage with return verandahs. Substantially intact, timber construction. Sympathetically scaled and formed addition. Known rural association: built for the gardener of Blytheswood.

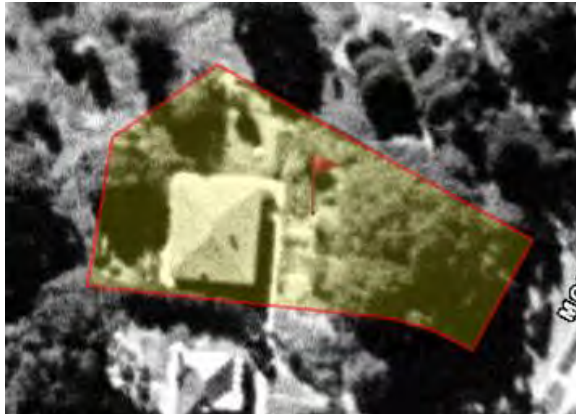
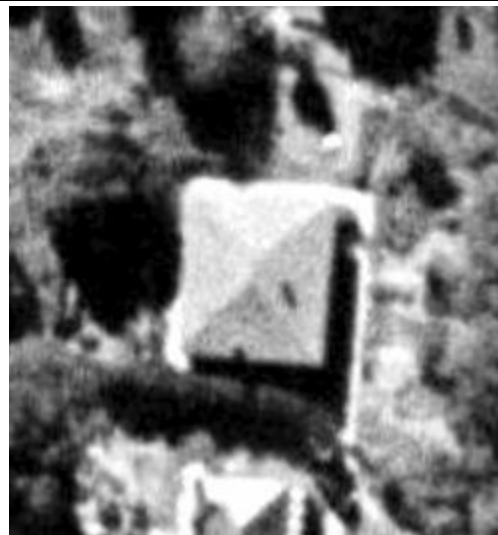
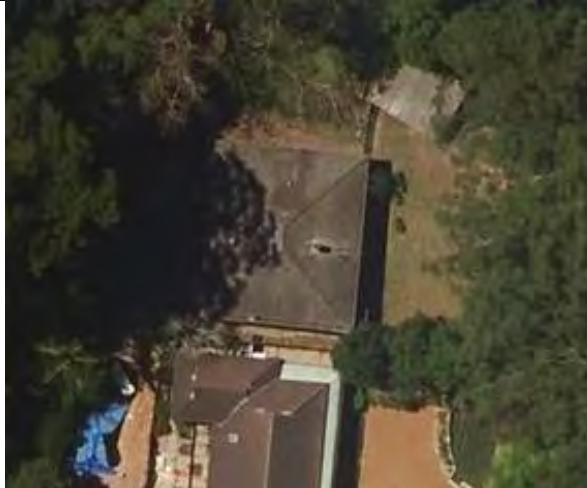
57 Merrivale Road, Pymble

Simple cottage in common brick. Substantially intact with some infill of verandahs but has retained a simple rural aesthetic with differentiation due to the prominent roof vent at the apex. Strongly expressed vernacular roof form and traditional character. Very simple materials and detailing. The width of the street frontage allows side elevation to also read clearly in street views.

The original curtilage has been eroded by subdivision of a lot to the south but the strong street presence due to its atypical built form and position and triangular lot shape has survived.

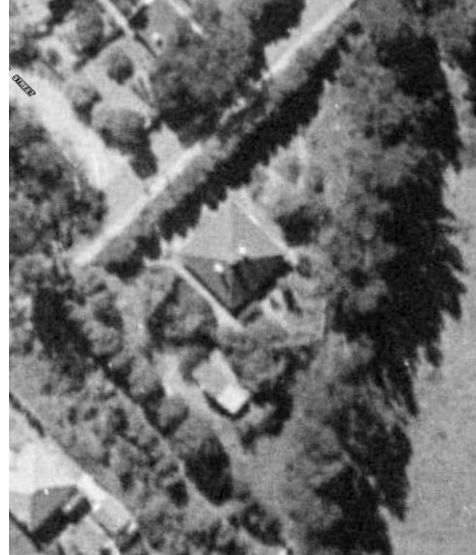
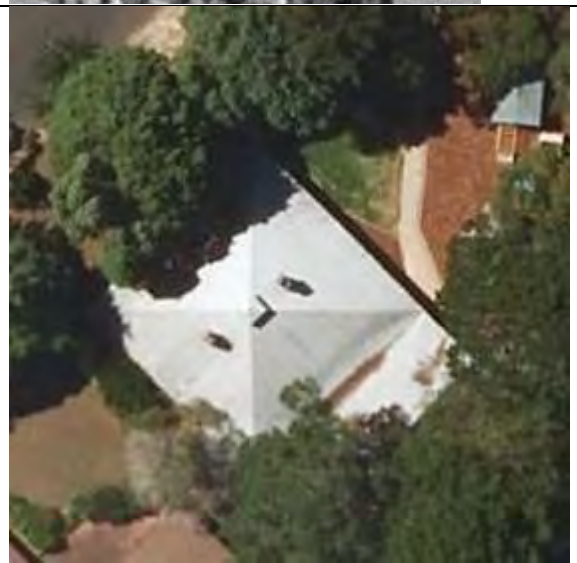
54 Burns Road, Wahroonga

Queen Anne variant of traditional vernacular form. Large-scaled additions and gentrification including painting/rendering (?) of brickwork. Core fabric appears to be reasonably intact.

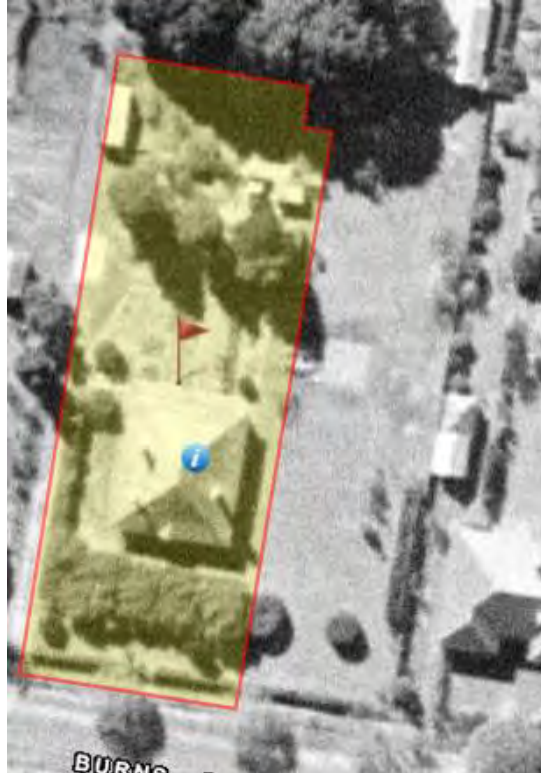
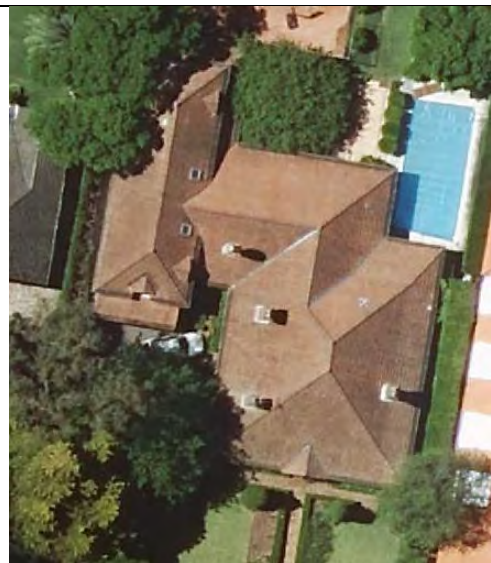
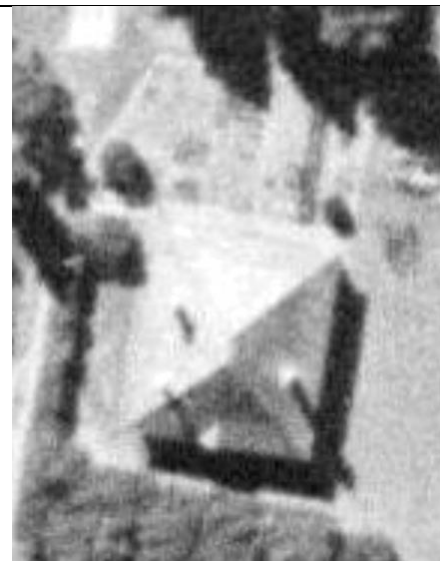
32 Northcote Avenue, Killara

Original cottage has been lost under large scaled and unsympathetic additions and alterations. Original form no longer legible.

Not a comparable example.

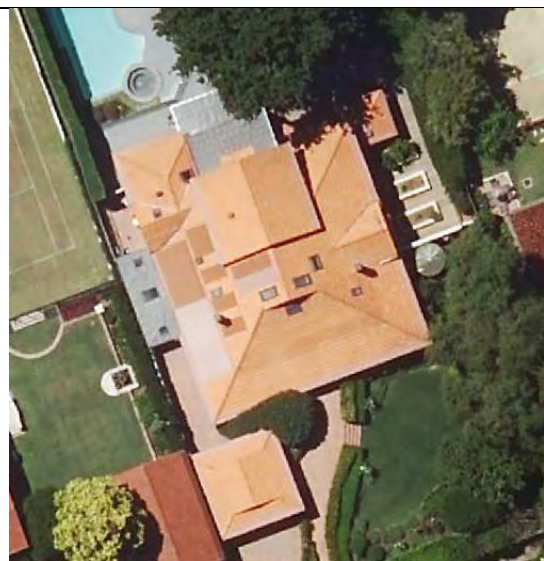
10 Northcote Avenue, Killara

Atypical form that does not read as vernacular due to atypical façade configuration and prominence of the central hipped detail.

Limited comparative value.

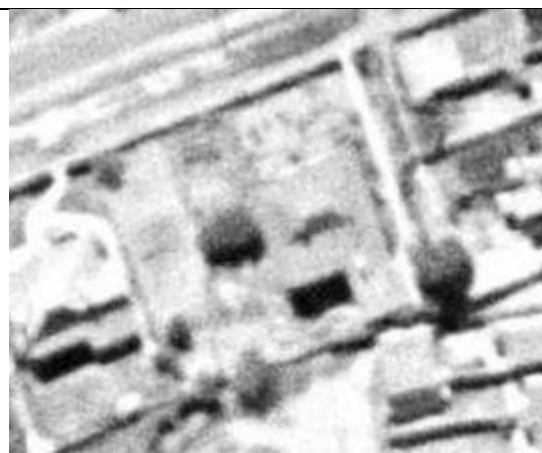
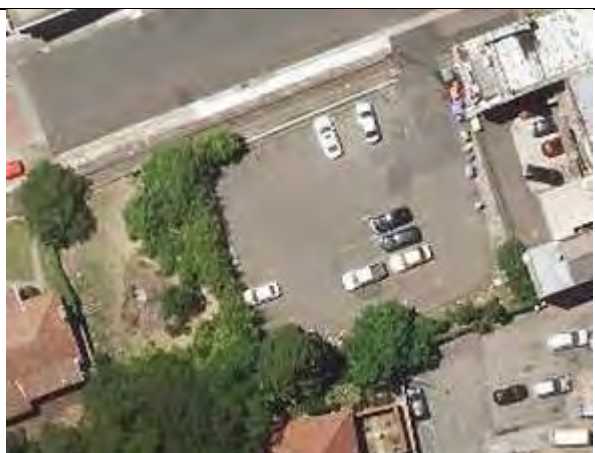
29 Spencer Road Killara.

Appears to have originally included deep verandahs under the main roof form (two sides only). Has been layered heavily with a large addition, painted brickwork and a large carport dominating the street presentation. Front façade either altered or was not symmetrical.

Not a comparable example.

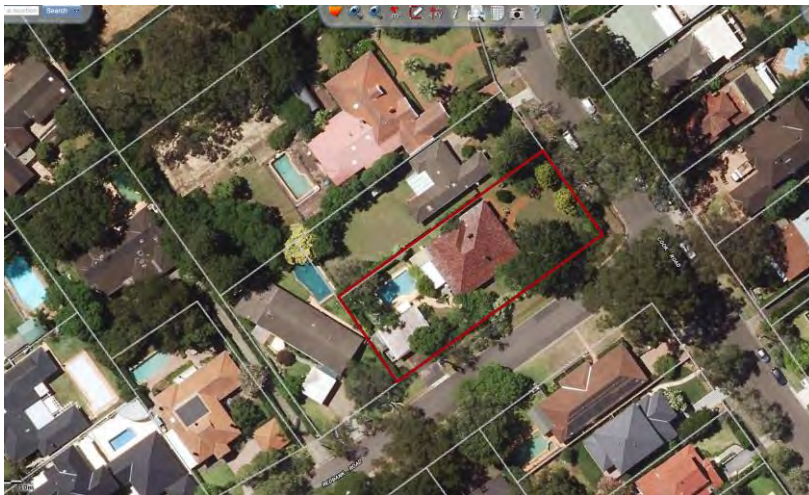
Figure 130. Current legal curtilage. The current lot boundary is the essential curtilage of the site. It is the core of the contemporary significance as it is represented in the local streetscape and is the area recommended for inclusion in any heritage listing.

1. The current lot curtilage (figure 130).
2. The historic curtilage (figure 131).
3. The expanded curtilage (streetscape setting) (figure 132).

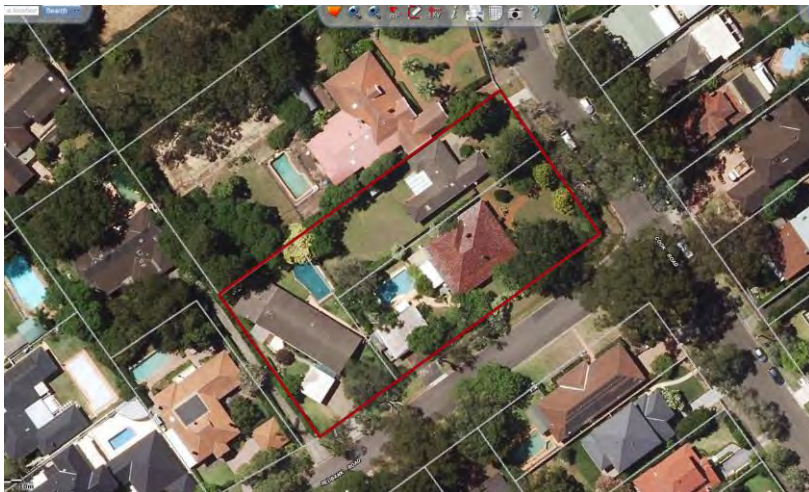
Figure 131. Historic curtilage. The historic curtilage extends over the whole of the original lot and includes the properties now known as 30 Cook Road and 1-3 Redbank Road, including the large trees planted in the garden to the north of the original house but now within the area of 30 Cook Road.

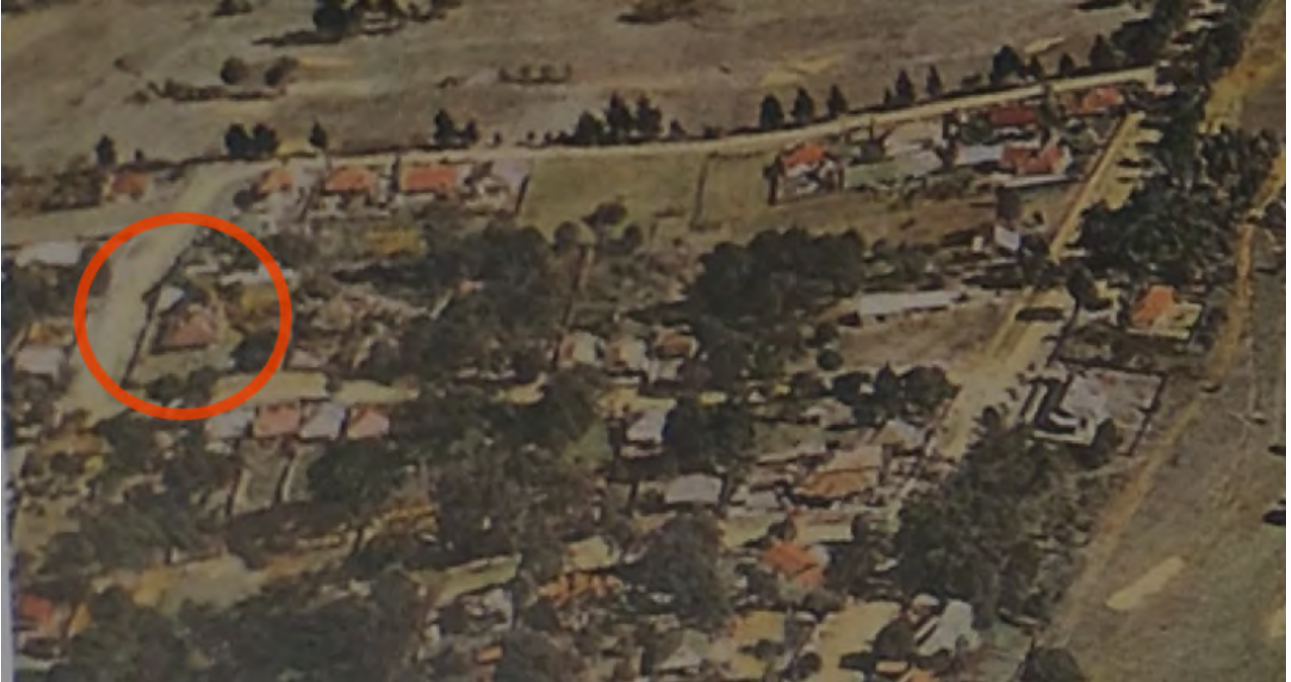
**Figure 6.** Detail from an oblique aerial photograph (hand coloured) of the golf links at Killara dated 1935. Circled is Glen Brae, 28 Cook Road.

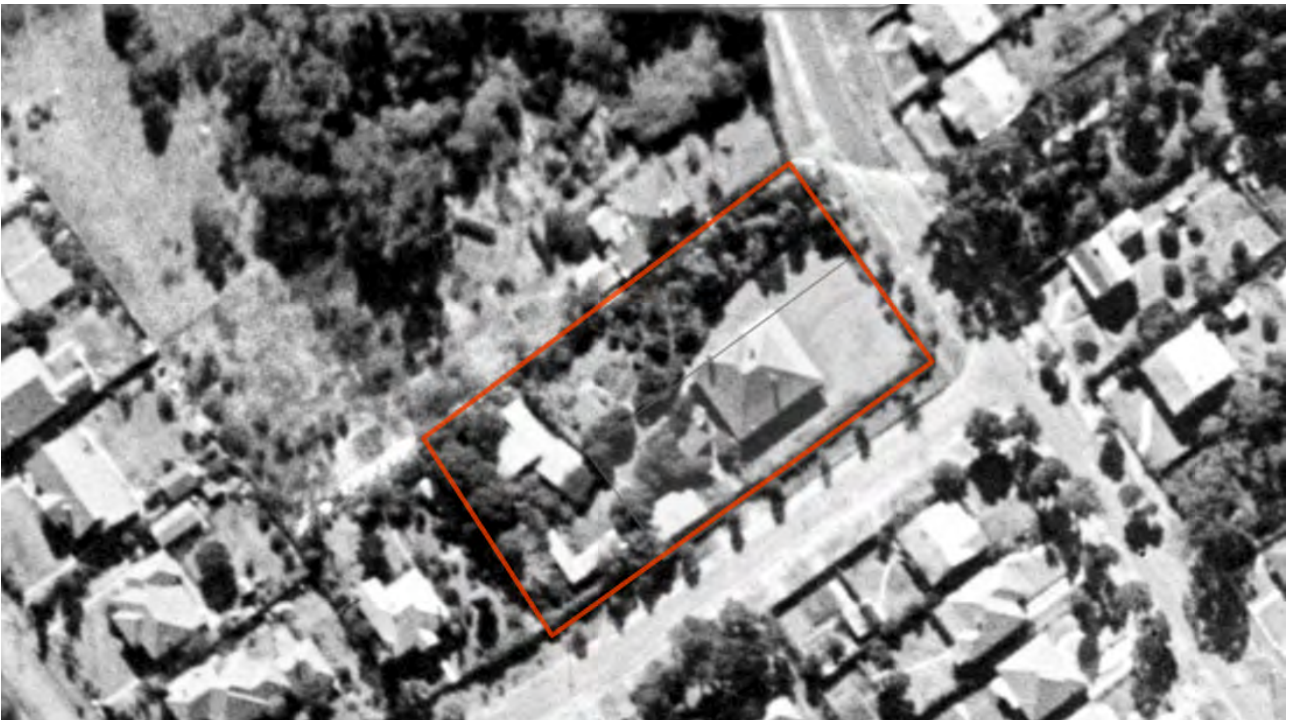
**Figure 7.** Detail from vertical aerial photograph of Sydney dated 1943. The footprint of Glen Brae, extent of the original land area of Lot 34, and garden landscaping were depicted. Note also the cluster of outbuildings at the rear of the property (present day Lot 1 in DP516966) that had been erected post 1936.

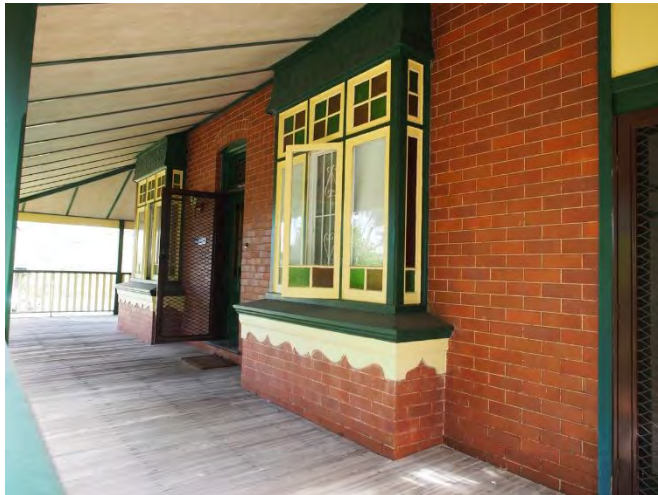
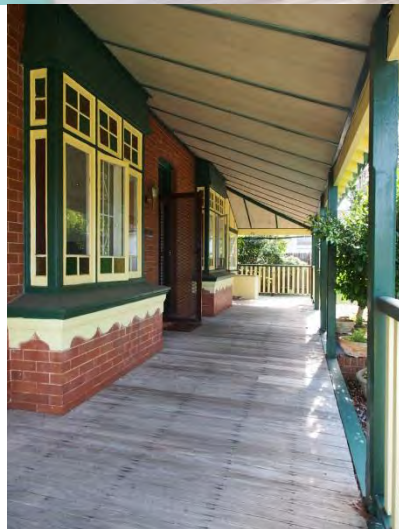
Verandah addressing Cook Road. Note the battened rake of the underside of the roof as it extends over the verandah and the hardwood timber floorboards.

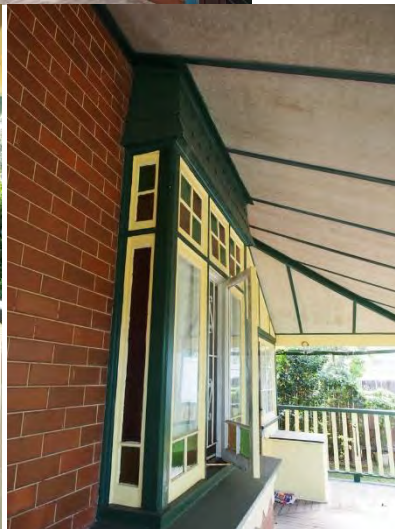
Window detail – showing shallow profile of the bays projecting from the main facade. These allow additional light to enter the rooms whilst retaining the depth of shade afforded by the verandah in summer.

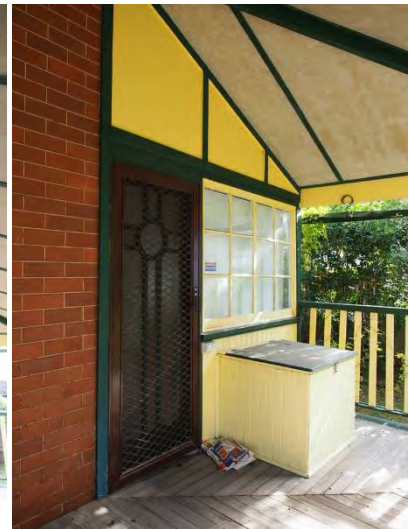
The enclosure of the northern return to the verandah is characteristic of the Inter-War era and has retained the fabric and detailing of the period, including the glazed front door with circular detail.

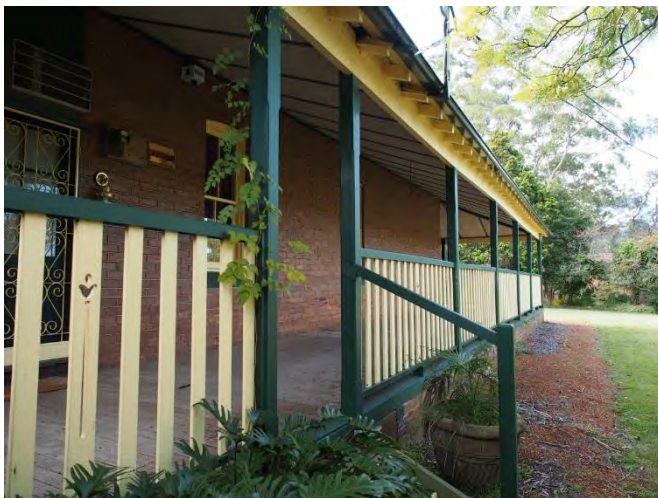
Southern verandah to Redbank Road with simple stairs providing access to the garden.

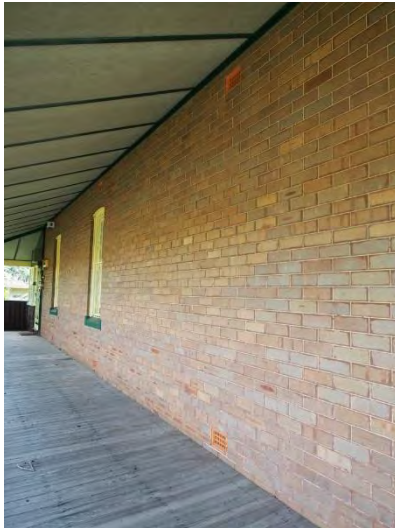
The southern wall is of common brick with no openings other than two simple windows to the rear rooms and a door to the original return to the rear elevation (now enclosed).

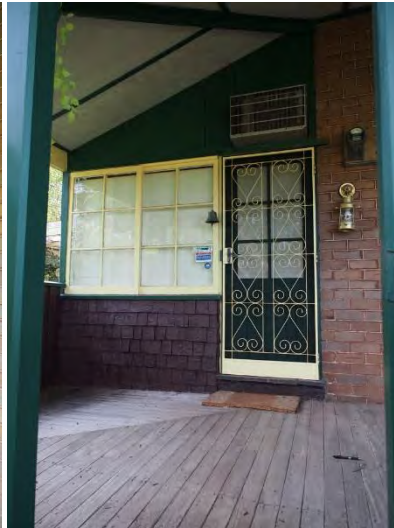
The original rear return of the verandah has been enclosed to create a large sunroom across the back of the house.

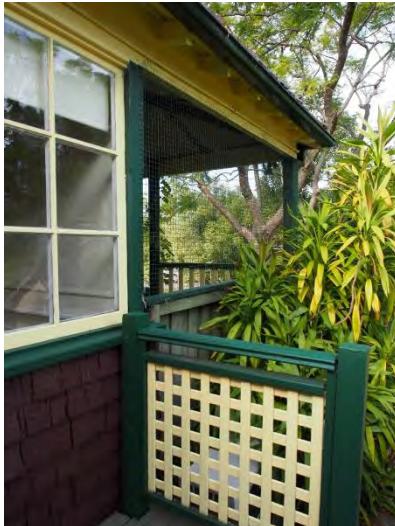
A section of the original vertical timber fencing to the verandah edge has survived at the rear of the side verandah. It is almost hidden by vegetation, but the wider timbers used are clearly evident.

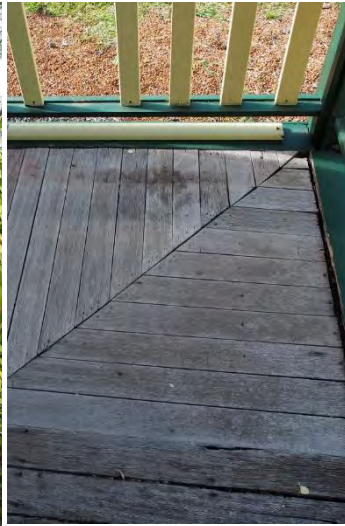
The timber hardwood boards are laid on a rake to facilitate drainage of surface water. The vertical railing in this image is not original.

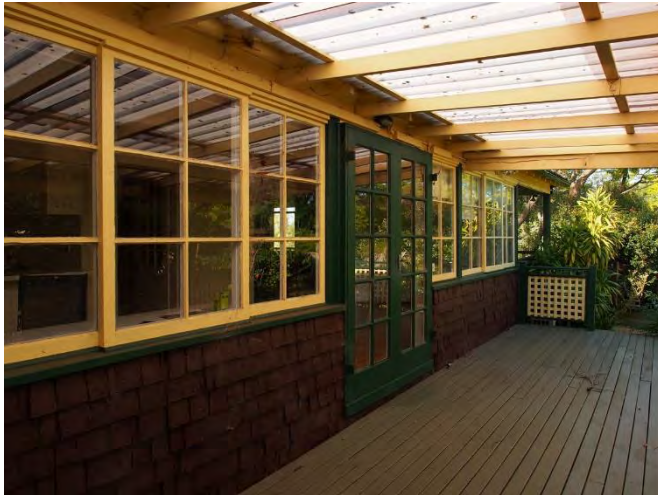
The original rear verandah has been enclosed by lightweight glazing and shingles and a large roofed deck has been added across part of the rear elevation.

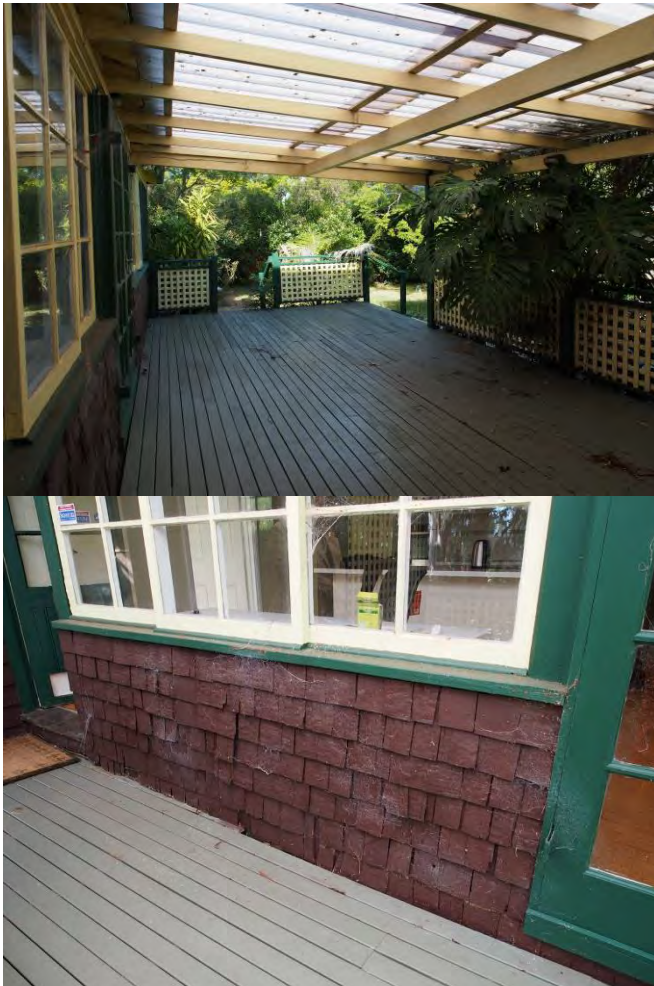
The shingle cladding to the rear wall (formerly the back verandah) is well weathered and is consistent with the detailing of lightweight verandah enclosures in the early 20th Century.

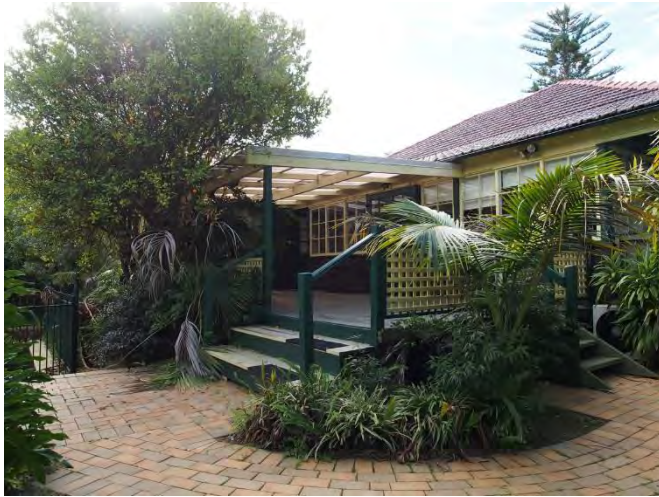
Rear elevation showing the deck addition and steps leading to the back garden. Note the original tiled roof extending over the original back verandah.

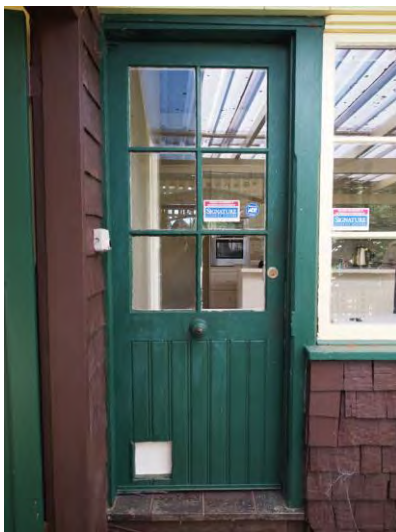
This door was likely to have been the original back door, its hardware matching the front door. Now located at the entrance to the rear sunroom.

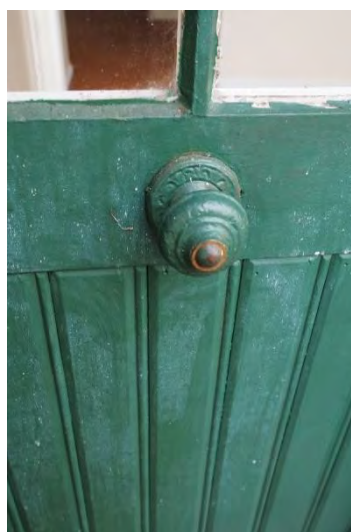
detail of door handle

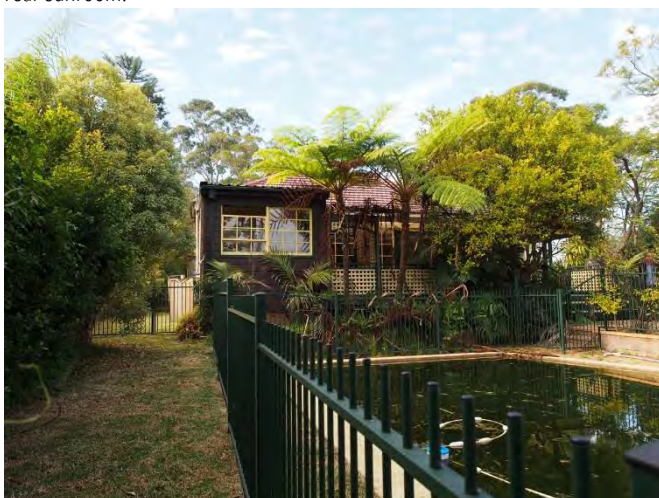
Mid-late 20thC addition to the rear of the property provided a laundry and adjacent plant potting area on the new deck. The swimming pool is in the foreground.

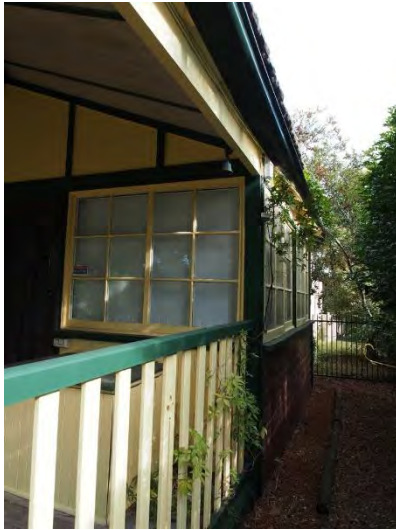
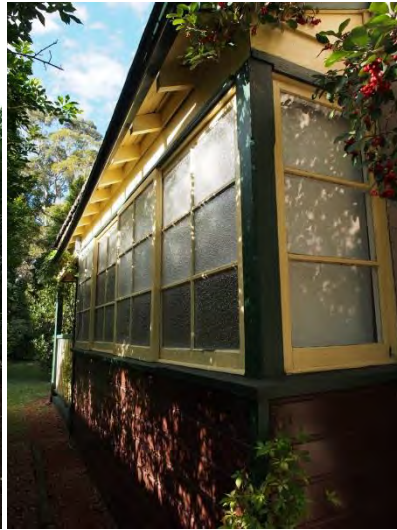
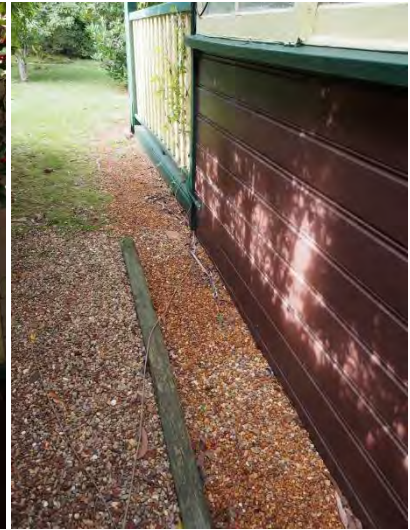
Northern elevation – original verandah return overlooking the wide side garden, enclosed pre WW2.

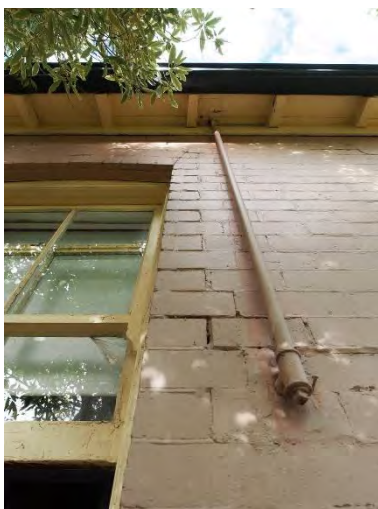
Window to the bathroom showing evidence of bricks to the window being carefully removed and re-inserted.

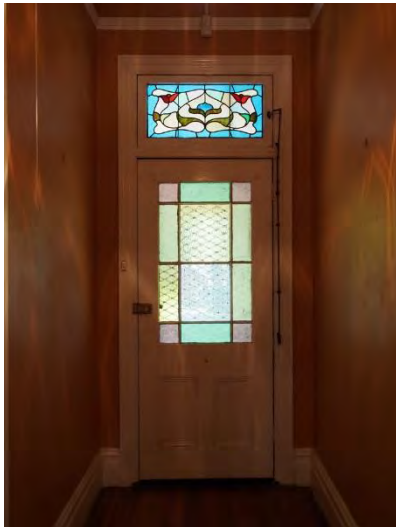
Front door – with leadlight glazing to the highlight. Note also the original winder to open the highlight window to facilitate internal ventilation.

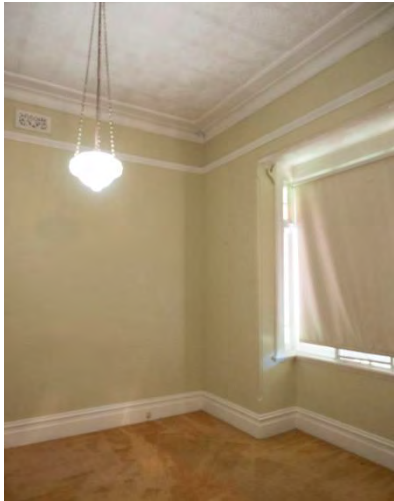
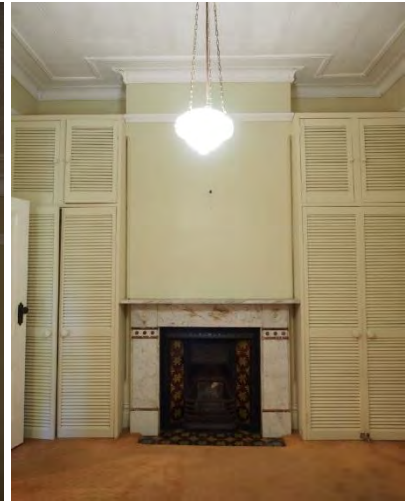
Interior of the room showing the narrow bay window recess, pressed metal ceiling and carpeted floor. Note also the patterned ceiling and central pendant light. See images for Room 3 (the other front room) for details of the window glazing.

The bay windows are shallow with very narrow sidelights that still maximise the amount of light able to enter the room even though the windows are heavily shaded by the wide front verandah. The original timber curtain bracket that screened the bay can also be seen.

Cupboards with louvre doors have been added to each side of the chimney.

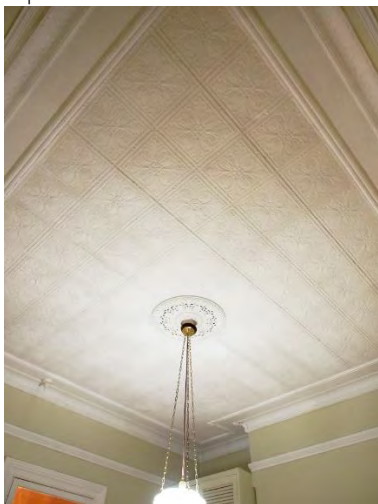
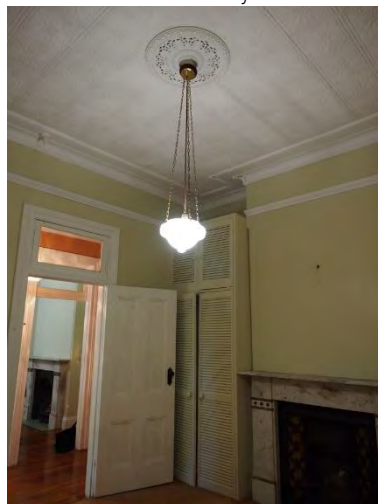
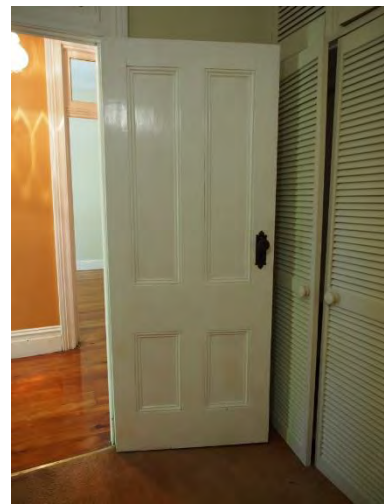
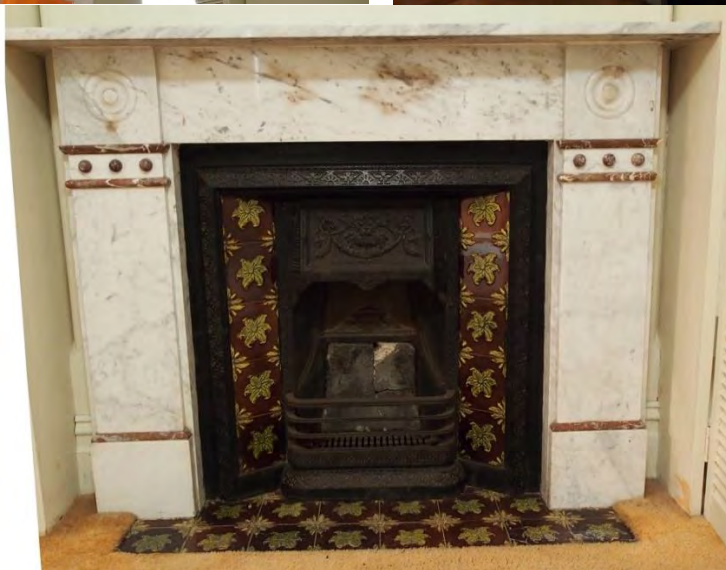
Fireplace and mantel. The mantel is marble and the cast iron fireplace and decorative glazed tiles are intact.

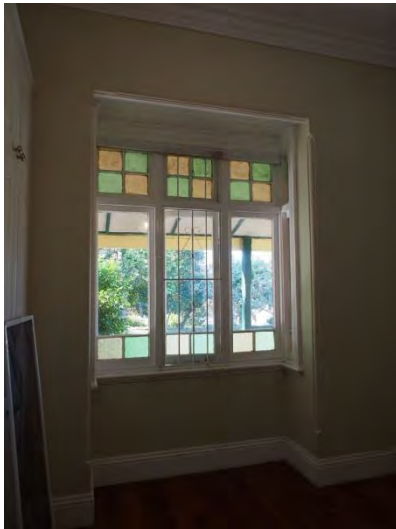
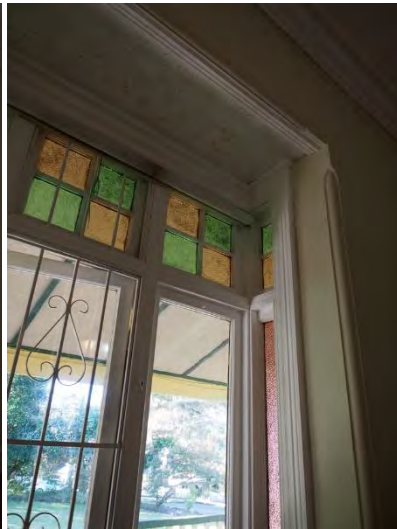
Window showing the highlight glazing. As in Room 2 (the other front bedroom) the shallow bay adds to the aesthetic qualities of the space and allows additional light to enter the room.

Patterned (pressed metal) ceiling and central pendant light.
