# ASSESSMENT OF HERITAGE SIGNIFICANCE

Glen Brae

28 Cook Road, Killara

August 2015

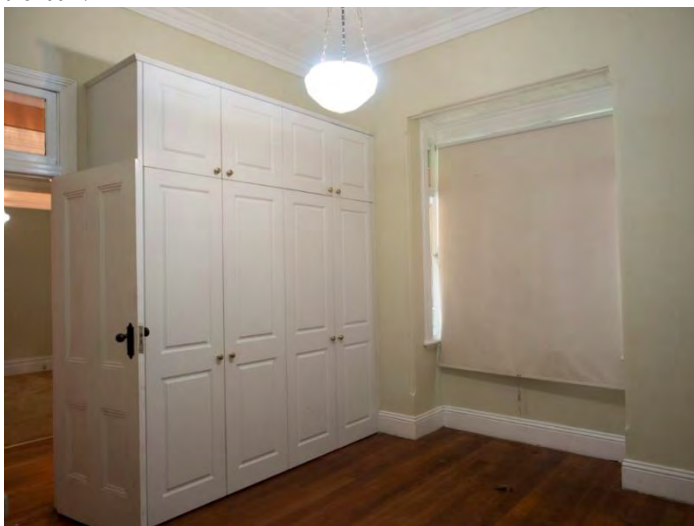
Built-in cupboards have been added.

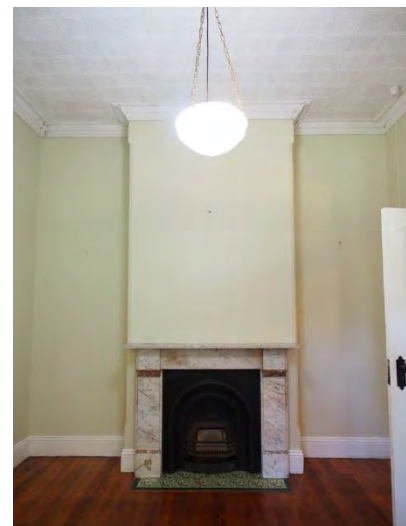
Fireplace and mantle. The mantle is marble and the cast iron fireplace and decorative glazed tiles are intact.

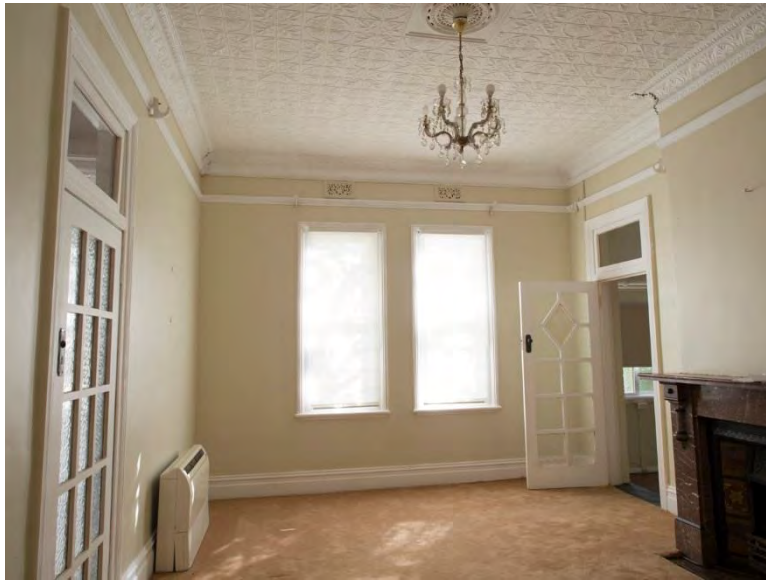
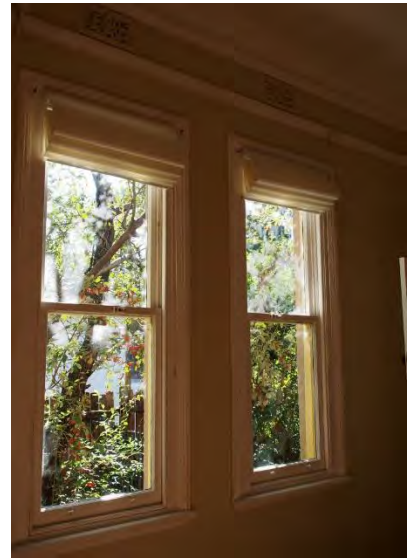
Main living room looking to the windows. This space was originally used as the family dining room, and included direct access to the servery and kitchen via the door on the left of this view.

The windows overlooked the original main garden.

The Inter-War door in the rear corner leads to the room created by the enclosure of the verandah return on the north-western elevation. The evidence of the fabric suggests that it was originally formed as an external door, likely to provide a direct link between the room and garden.

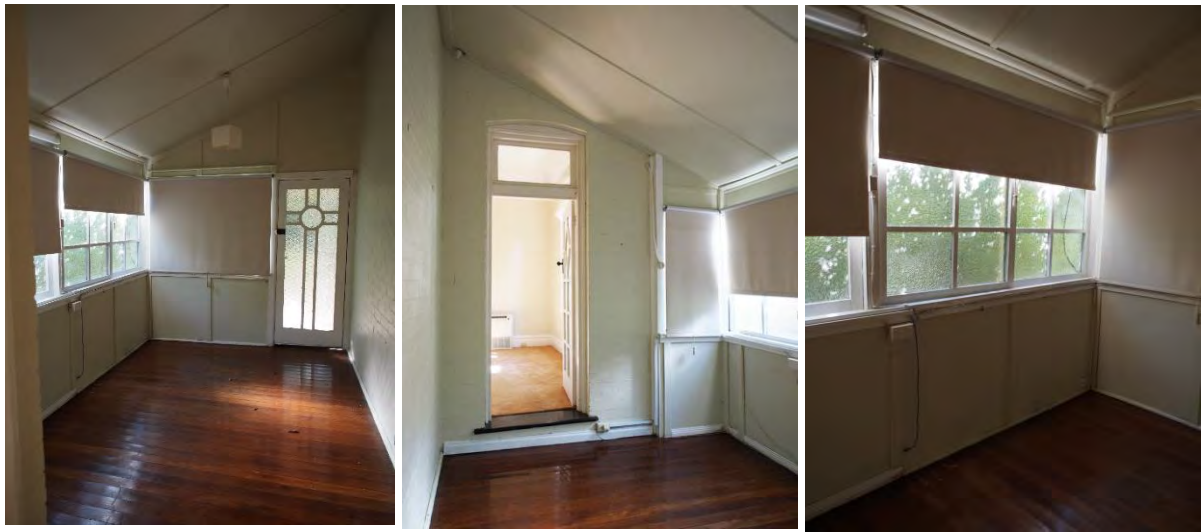
ROOM 5: sunroom off Living room (originally part of the verandah, enclosed in Inter-War period)

Note raked ceiling, characteristic Inter-War door to verandah, lightweight glazed enclosure and polished original verandah boards. Note also painted external brickwork to wall.

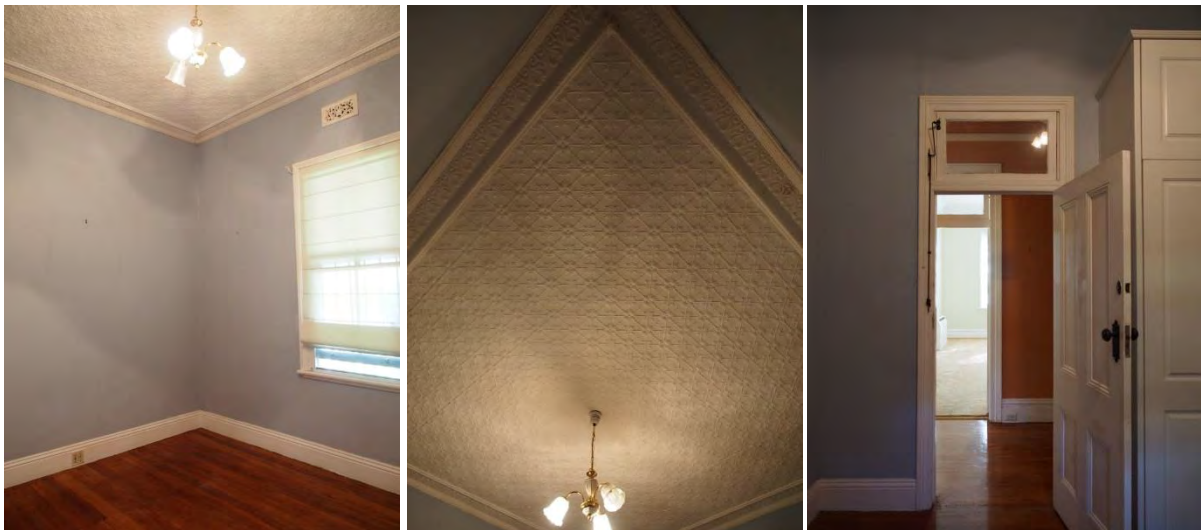
ROOM 6: bedroom 3

This is a simple room used as a minor bedroom. The window is a simple sash and it does not have a fireplace, but details such as the pressed metal ceiling and door hardware are intact. A built-in cupboard has been added. The light fitting is not original although it is operated by a pull-cord, as are all the lights in the main house.

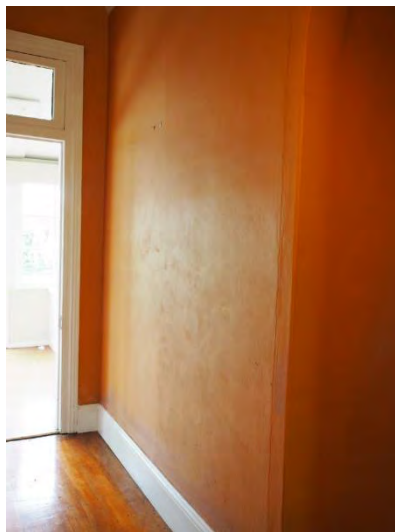
The rear part of the hall has been altered to allow the reconfiguration of original kitchen and bathroom areas. These alterations can be seen through the cut in the skirting and changes in wall materials at the entrance to the secondary hall.

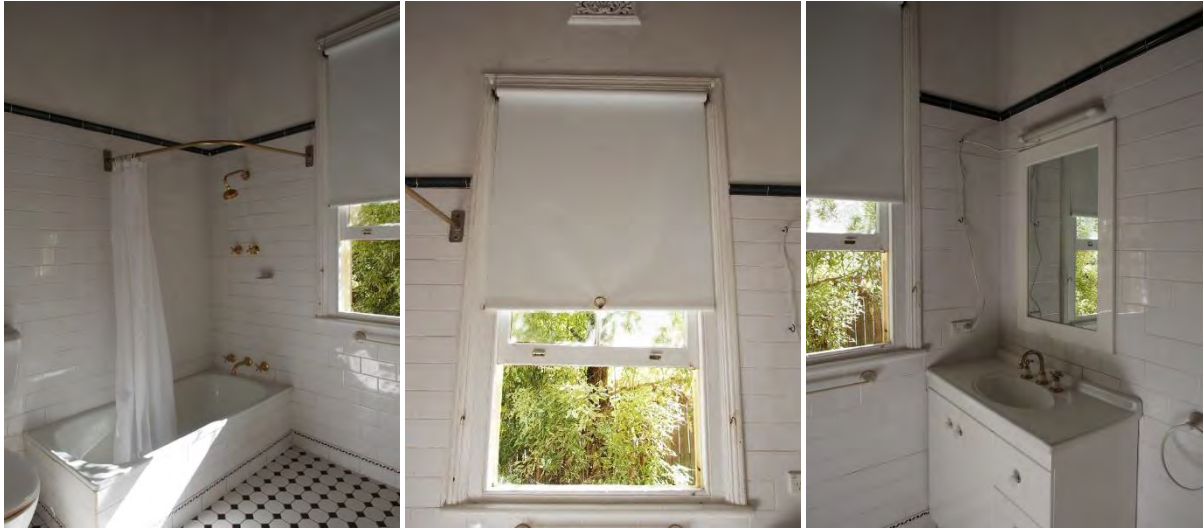
This room was originally used as the kitchen but was converted to a bathroom in the 1970s. The original sash window was removed during the building works and then replaced.

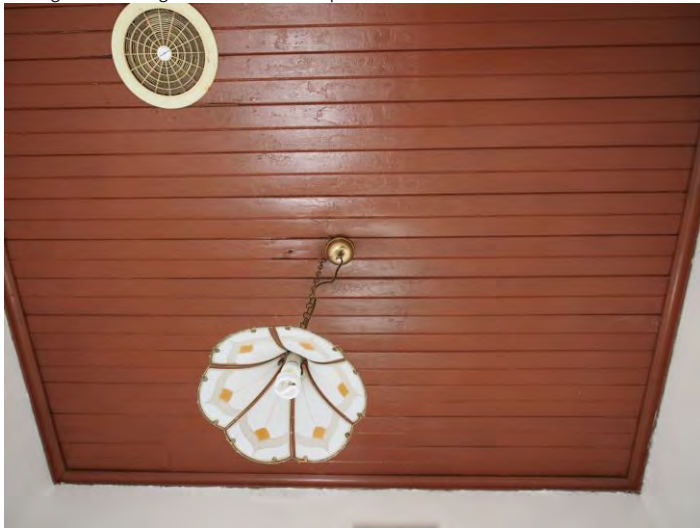
Timber v-groove ceiling lining (the light fitting is not original)

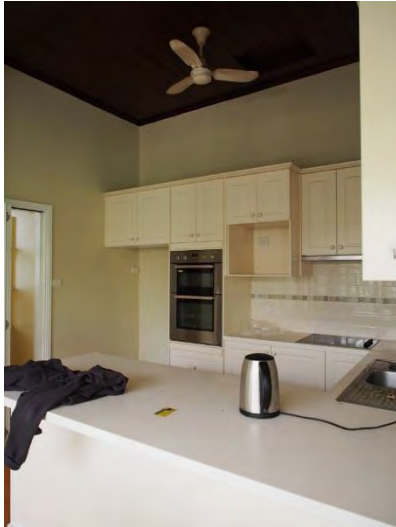
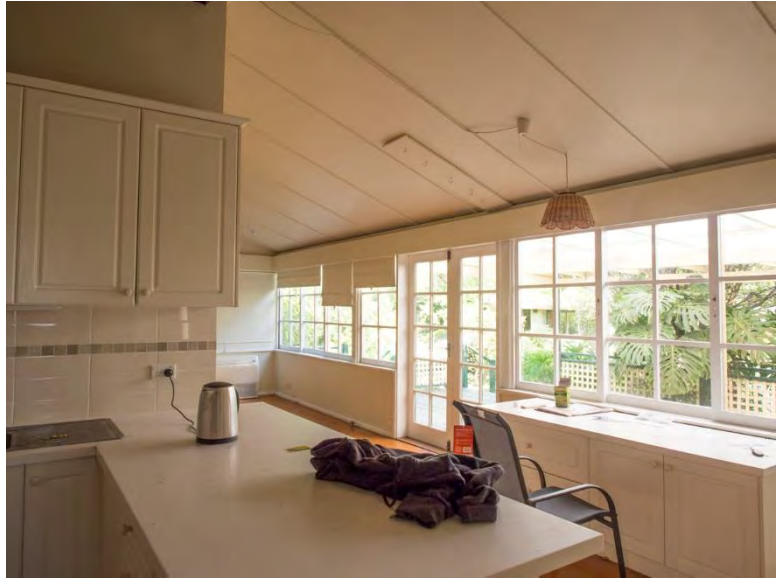
The space was originally used as a utility room/bathroom and opened to the exterior prior to enclosure of the back verandah. It was converted to a kitchen and integrated with the informal living area in the late 20th Century. The rear wall was removed to facilitate this alteration.

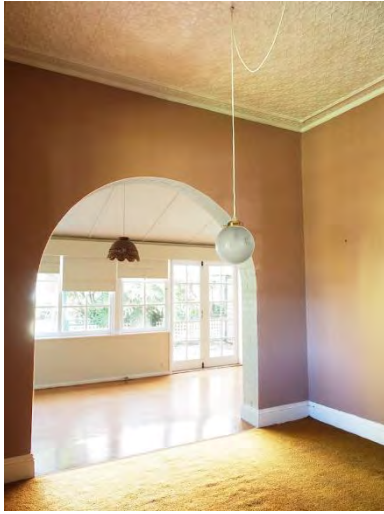
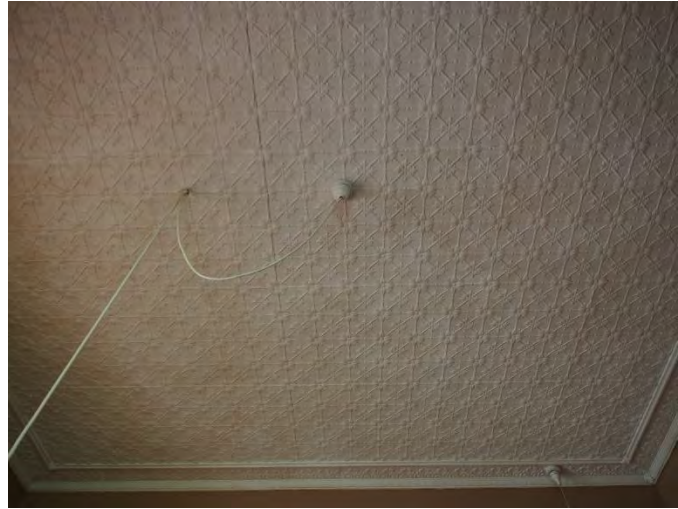
This space was originally used as a bedroom. It was converted to a dining room at an unknown time. The main fabric change associated with the new use was the creation of an arched opening in the original back wall (by partial demolition of the rear wall and re-laying the bricks). The other details of the room remain intact.

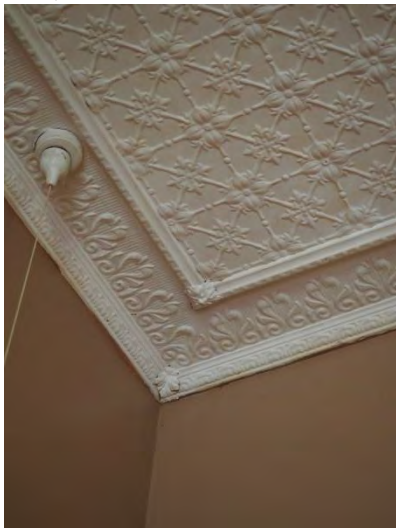
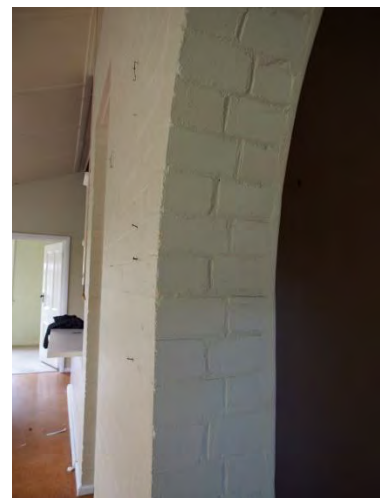
Detail of the opening to the room from the sunroom. The arch has been formed by brickwork, but the craftsmanship is noticeably cruder than the original construction and it is likely that this wall was re-built when the opening was created.

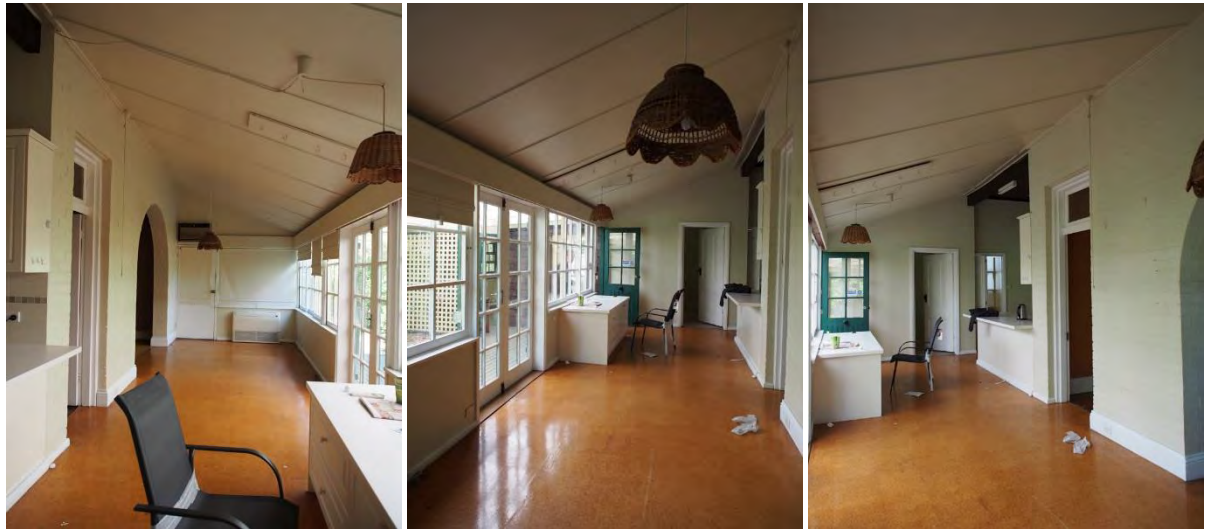
The space is long and narrow and still reads clearly as an adapted verandah with its raked ceiling and lightweight glazing.

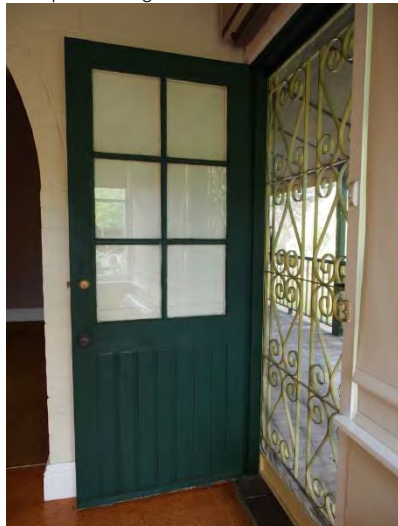
Door to the rear sunroom. This is an external door of similar design to that now on the back door, although the hardware is simpler and it does not include a central handle as is seen on the main doors.

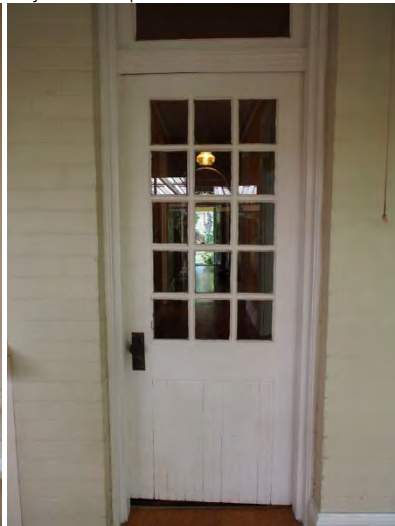
Door to the central hallway. This door was also an external door.

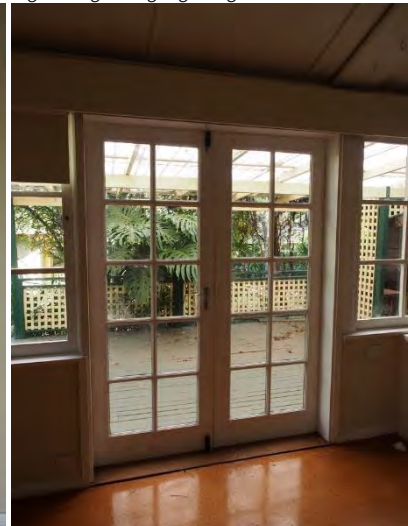
Pair of French doors providing access to the deck.

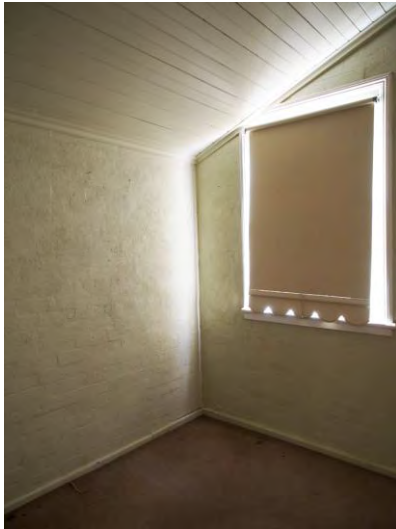
A small room at the northern end of the sunroom has been created for use as a study/additional bedroom. Note the steep rake following the alignment of the original verandah ceiling.

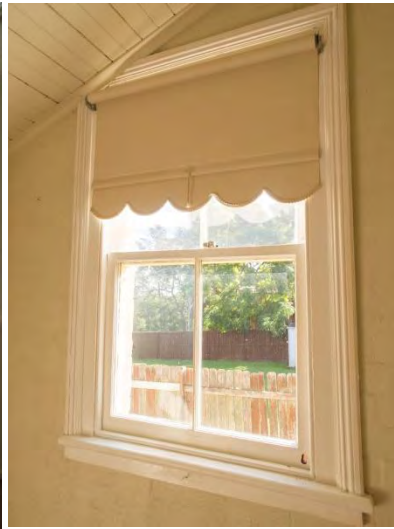
This window is original and consistent with the other windows to the modest rooms, revealing that this room was created at the end of the original back verandah.

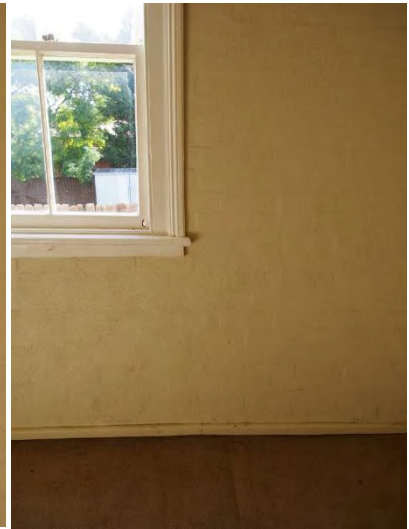
Changes in the floor angle mark the slope of the original floor.

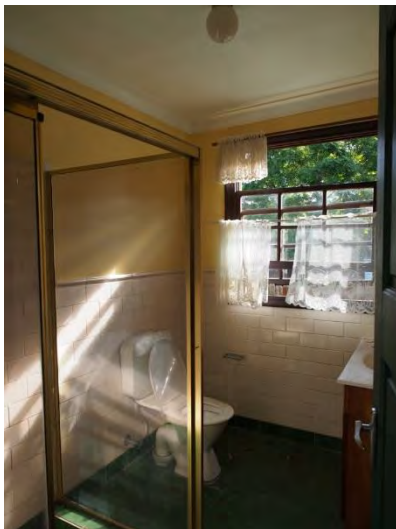
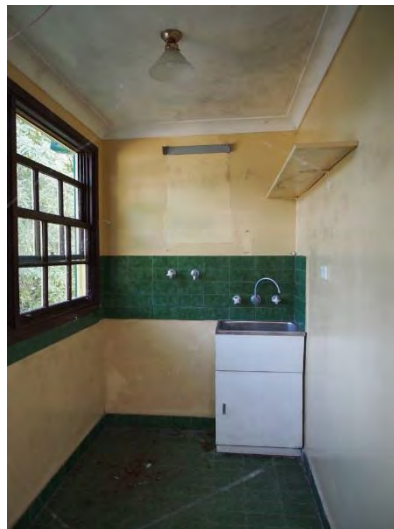
These rooms were added in the late 20<sup>th</sup> Century under a skillion room. They are functional but do not demonstrate the quality of workmanship found in the main house.
