**Franpina Developments Pty Ltd**

**Preliminary Site investigation**

**366-374 Lane Cove Road, 124A-126 Epping Road and  
1 Paul Street, North Ryde NSW**

**4 February 2015**

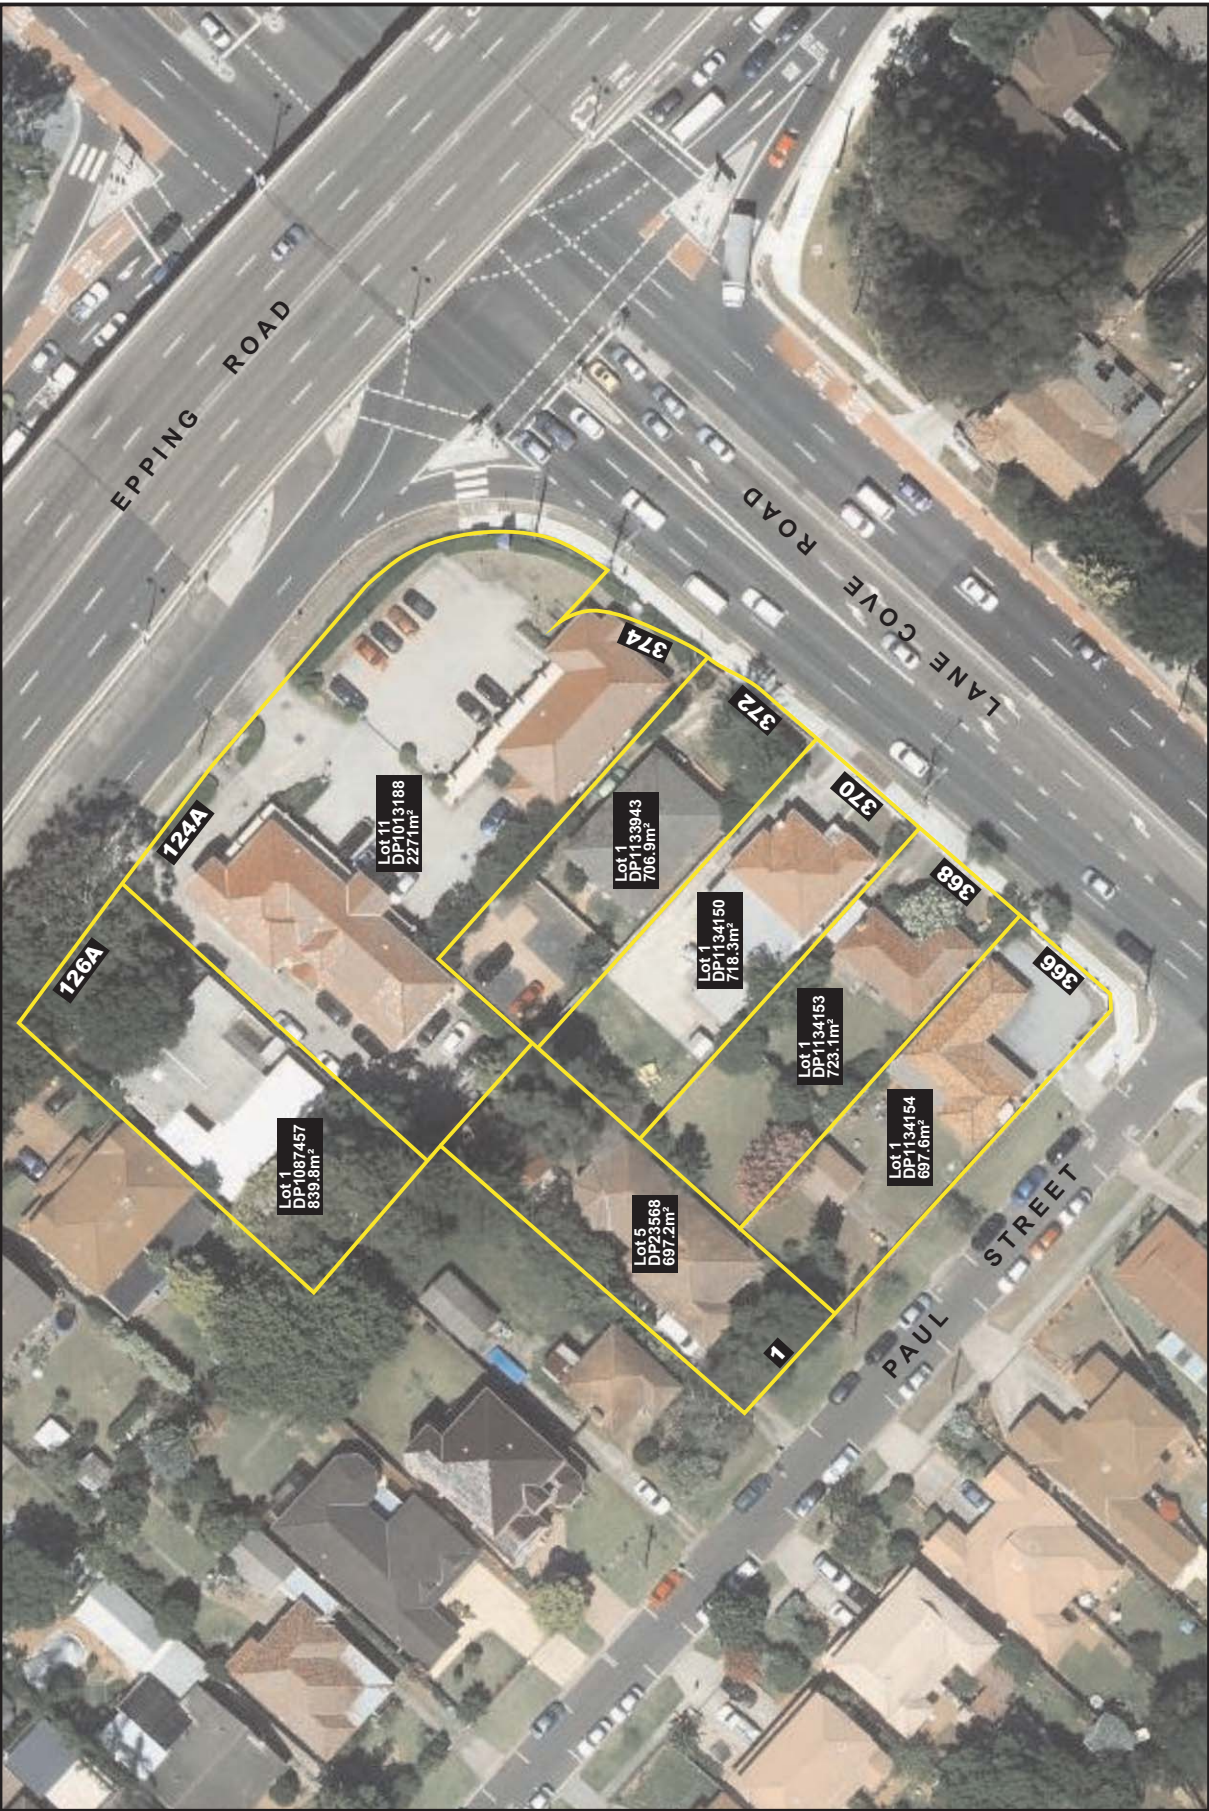
**Figure 2**

Present buildings are shown in Figure 2 with two commercial buildings, six residential buildings and two household garage/sheds. At the time of the site inspection all dwellings and site boundaries appeared in fair condition. As per the historical aerial photograph review of this report all residential buildings were constructed between 1951 – 1970.

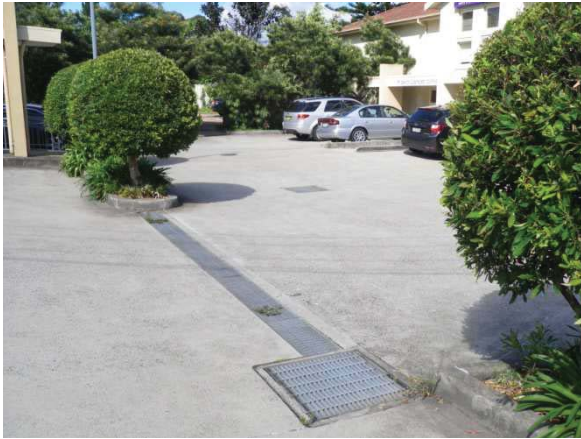
1. Medical centre facility with associated car park, concrete paved driveways and stormwater drains (facing southwest).

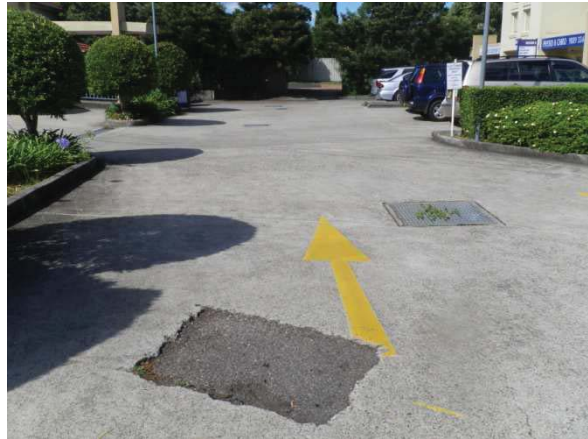
2. Change in paved concrete to bitumen (facing south).

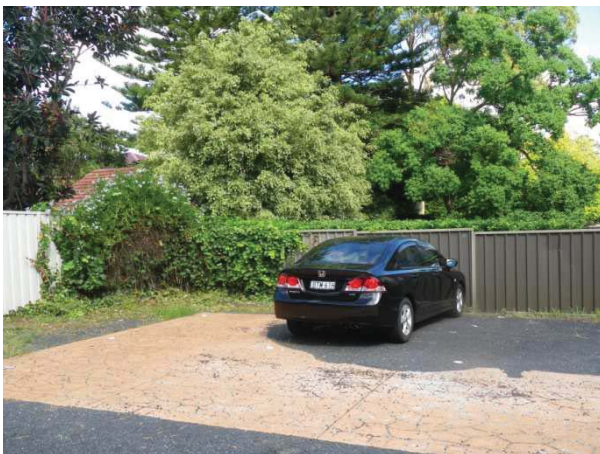
3. Former above ground swimming pool area of Lot 1 DP1133943 – Currently being used as a car park by the medical centre (facing west)

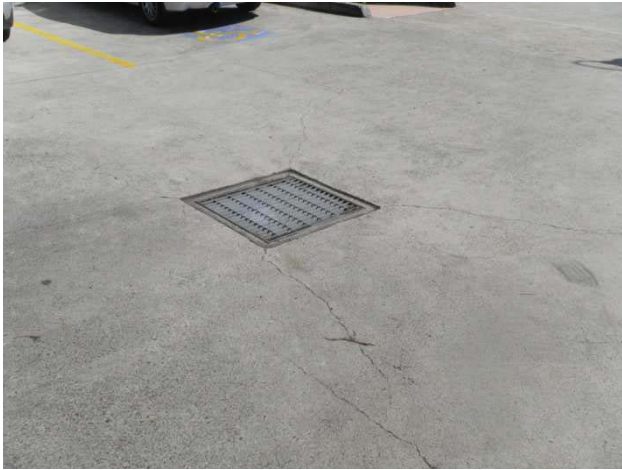
5. Minor cracking around stormwater drains (facing north).

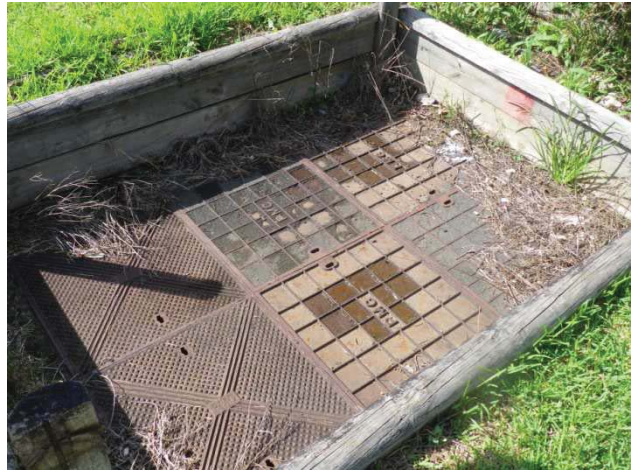
6. Unidentified services pit, PMC manhole covers (facing north).

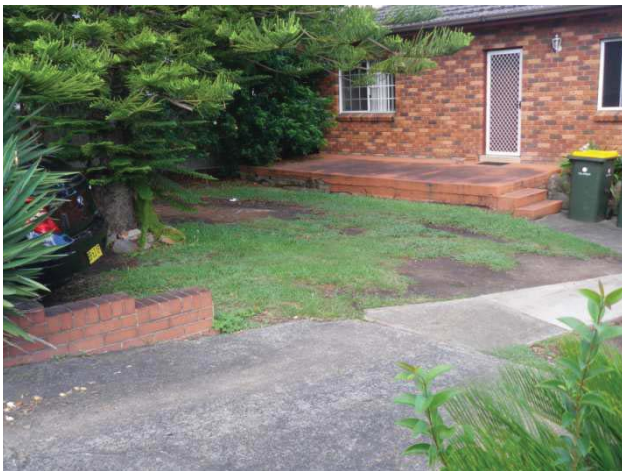
| <b>Lot 1 DP 1133943</b><br><b>372 Lane Cove Road</b> | A single story brick dwelling with a tiled roof was present on site. The eastern boundary comprised brick fencing, colorbond fencing was observed on all other boundaries. A large conifer species of tree was present in the front yard and appeared healthy. Some surface erosion was evident with patchy grass (photo 7). A drop of 500 mm from the footpath to the front yard was noted. | Low |

7. General soil erosion, 372 Lane Cover Rd (facing west).

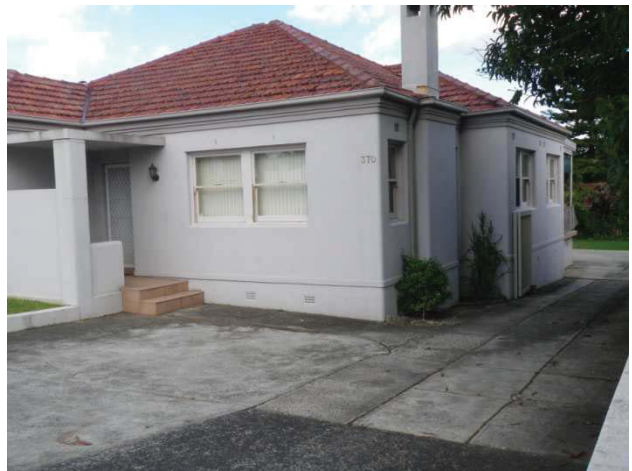
At the time of the site inspection crawl spaces were noted at No. 366 and 370 Lane Cove Rd and No. 1 Paul Street. Crawl spaces are likely to be present at 368 and 372 Lane Cove Rd given the general north westerly sloping topography. These crawl spaces were not inspected as access to the residential properties was not permitted at the time of the site inspection.

8. Crawl space identified at 370 Lane Cove Rd (facing west).

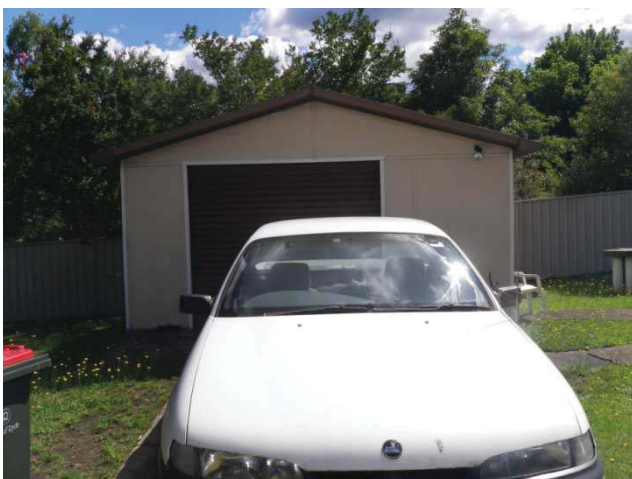
A fibrous sheet shed/garage is located at 366 Lane Cove Road, it is unknown if this contains asbestos. An asbestos survey is recommended to identify the presence of ACM prior to demolition.

| Location | Observation | Risk Rating |
|---|---|---|
| <b>Lot 1 DP 1134154</b><br><b>336 Lane Cove Road</b> | The lot is located on the junction of Lane Cove Road and Paul Street. A single story, brick rendered, tiled building was present. Brick rendered and metal bar fencing was located on the eastern and most of the northern boundaries. The western boundary and second half of the northern boundary extending west was timber fenced. The front yard was noted as to be concrete paved. A crawl space was noted underneath the building (photo 10). A garage/shed was present in the rear yard, North west portion of site. The shed/garage could be constructed from asbestos/fibro material (photo 9). The material was not confirmed. | Low |

9. Garage/Shed located at 366 Lane Cove Rd – fibro sheeting, possible asbestos containing material.

Potential asbestos containing material is present at the site. We recommend that a suitably qualified contractor undertake an asbestos survey on any property to be demolished. If more than 10 m<sup>2</sup> of asbestos containing sheeting is present on site, then this will require monitoring, removal and disposal by an appropriately licensed contractor.

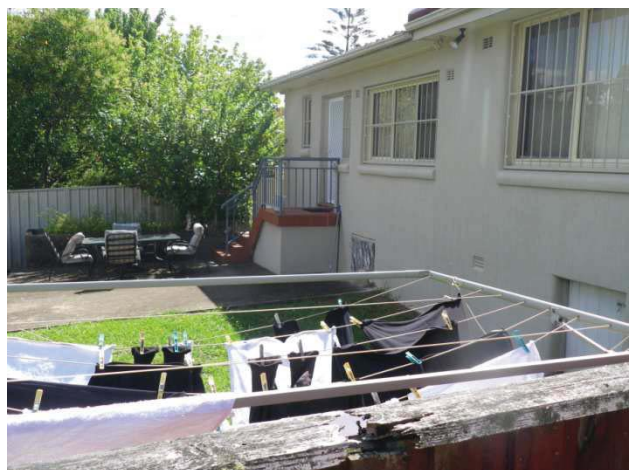
10. Crawl space identified at 366 Lane Cove Rd

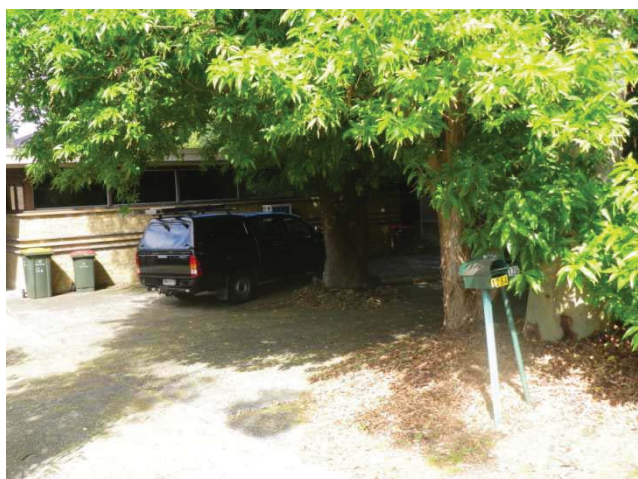
13. 126A Epping road (facing southwest)

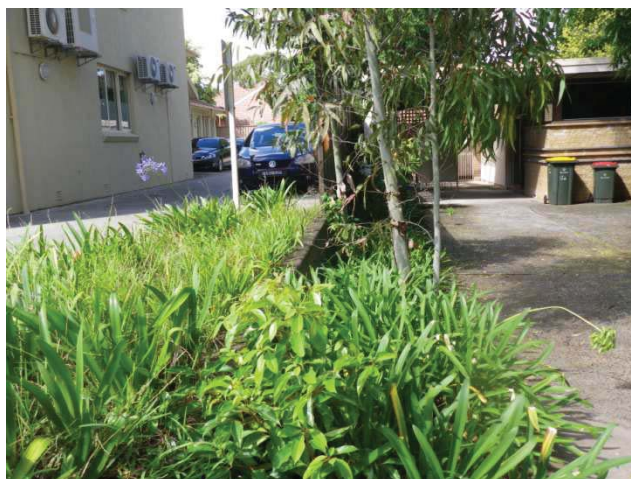
| Location | Observation | Risk Rating |
|---|---|---|
| <b>Lot 1 DP 1087457</b><br><b>126A Epping Road</b> | A single story brick building with a metal roof was present on site. Large, healthy looking trees and vegetation was observed. The front yard was mostly concrete paved with some minor cracking. Colorbond fencing was identified on the eastern boundary with an approximate 500 mm drop from the east neighbouring site noted. The retaining wall mentioned in the photo is retaining the concrete slab and possible fill material (refer to photo 14). | Low |

14. Boundary between 124A and 126A Epping Road (facing south) – retaining wall noted
